PENRICE QUARRY, ANGASTON (PM 86, PM 120, MPL 75, MPL
118 & ML 6233)

Annual Compliance Report

Prepared for: Adelaide Brighton Cement Limited

Date: 28 February 2025

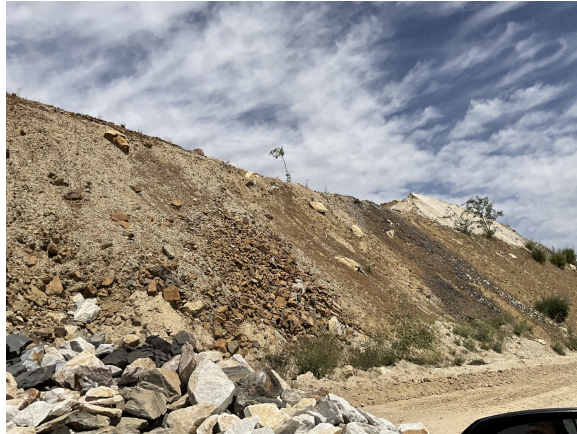
21/11/2024

Weeds and Pests: Some tree tobacco present on quarry walls.

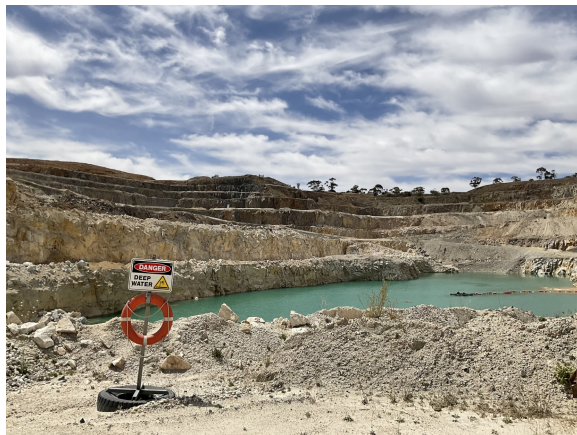
Public Safety: Public safety signage and device within pit area.

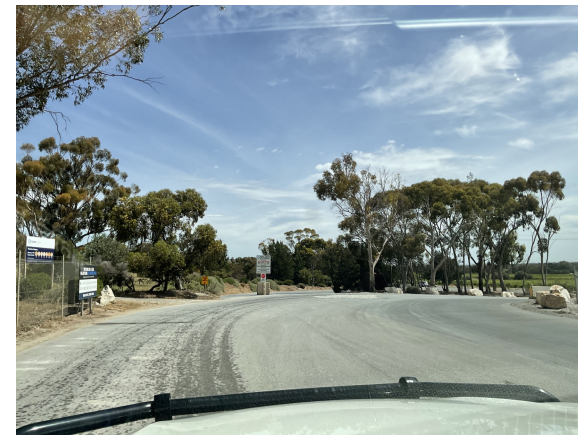
Public Safety: Entrance to Site with public safety signage.

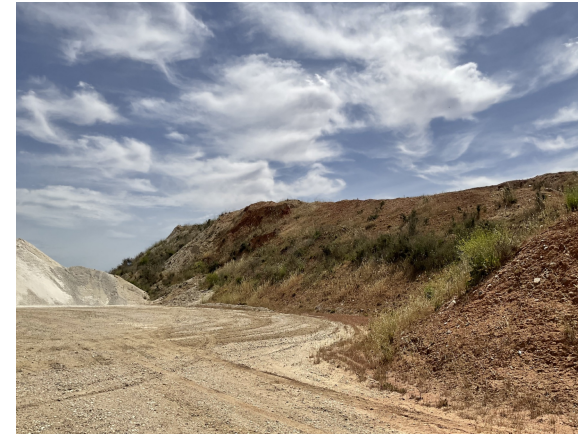
Topsoil: Topsoil stockpiles within PM 120.

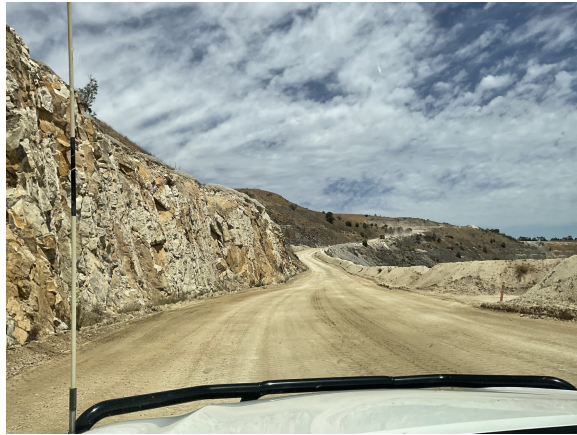
Traffic: Main haul road though pit to Ironstone Road in good condition, free from significant erosion and weeds.

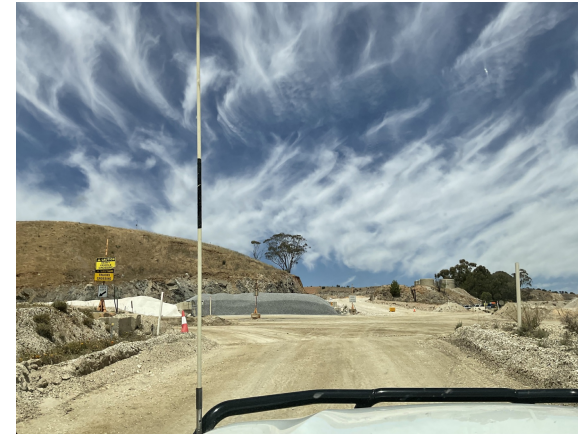
Traffic: Traffic directives within Site. Free from significant weeds and erosion.

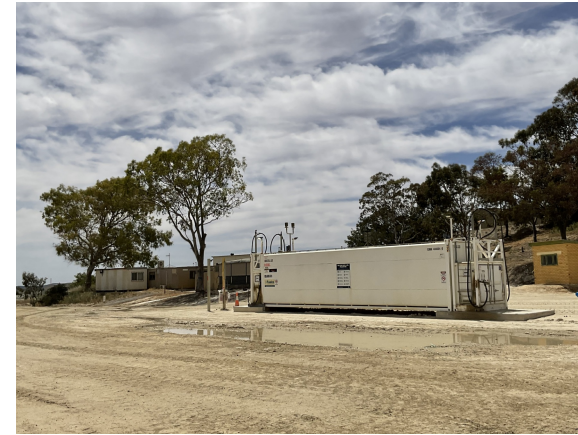
Hydrocarbons: Self bunded diesel tank.

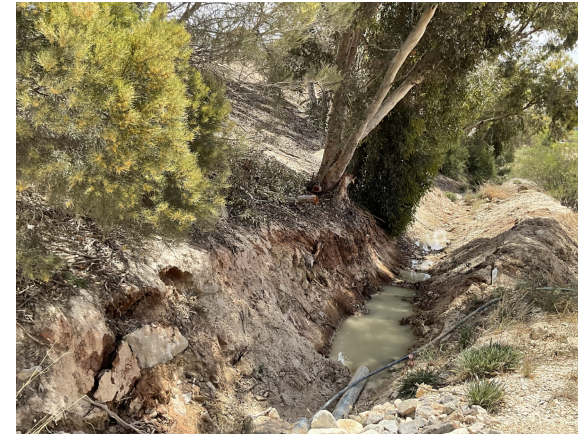
Surface Water: Drainage channel for surface water.

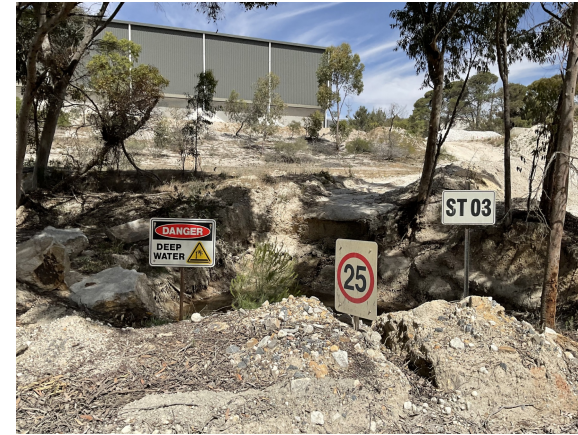
Surface Water: Sediment trap with public safety signage.

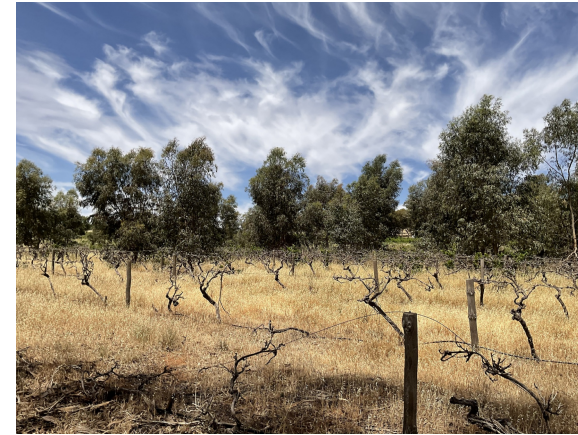
Rehabilitation: Established planted vegetation within MPL 118.

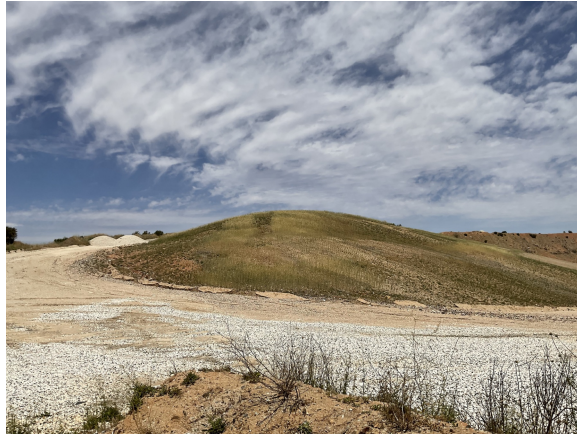
Stockpile 1: View of rehabilitation area with recently spread topsoil and re-seeding. Well maintained with adequate vegetation cover, with no evidence of erosion or serious weeds.

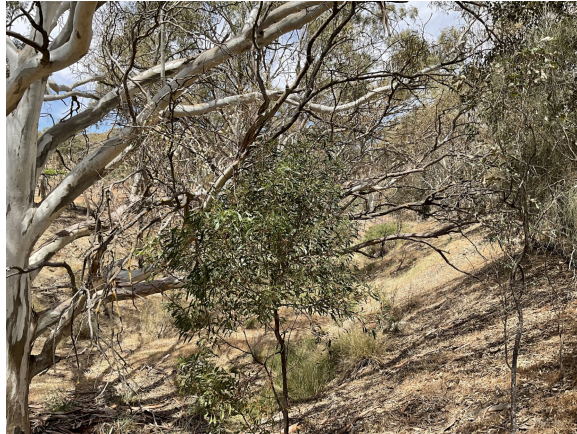
Photo Point 1: Facing east along Jaeckeli Creek. No vegetation clearance evident.

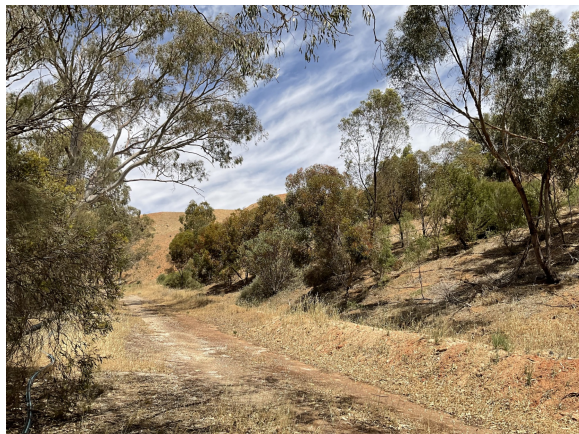
Photo Point 2: Photo of perimeter track and plantings south of Jaeckeli Creek. Vegetation in good condition with no evidence of clearance.

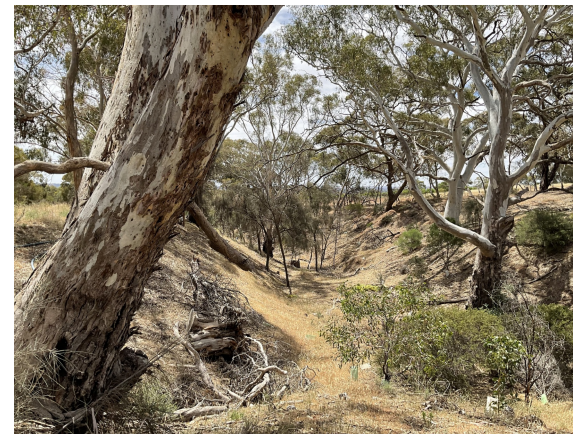
Photo Point 3: Views along Jaeckeli Creek facing west. No vegetation clearance.

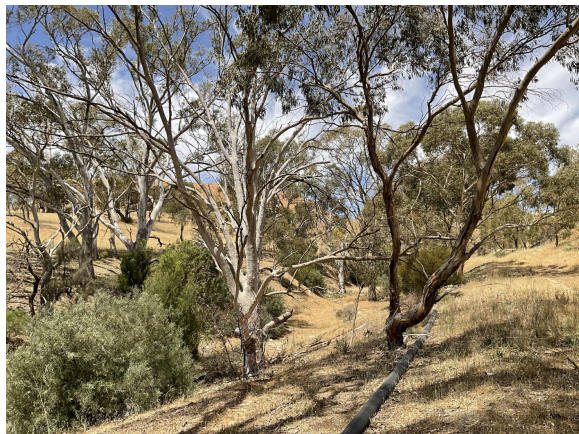
Photo Point 3: Facing east along Jaeckeli Creek. No clearance evident.

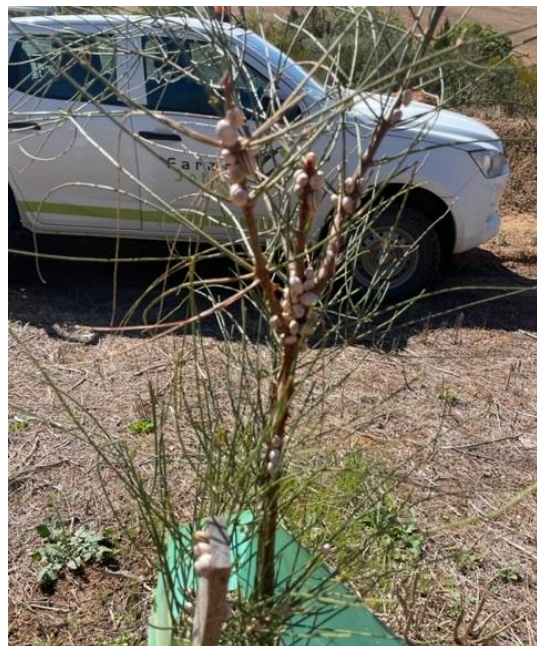
Snails can and have become problematic in the past when undergoing rehab on site through tree planting programs (*see figure 1*). Snails are in abundance at the Quarry as they favour the lime deposits which provide them with the calcium that they need for shell strength. In addition, the excessively dry season has resulted in them chasing the water that is supplied via irrigation making these an even further attractive target. Baiting with the use of metaldehyde will likely be required at planting time to help with plant survival as they generally target the moisture around each tree following irrigation and proceed to feed on plant foliage leading to poor establishment.

Figure 1 - Snails feeding on adolescent trees

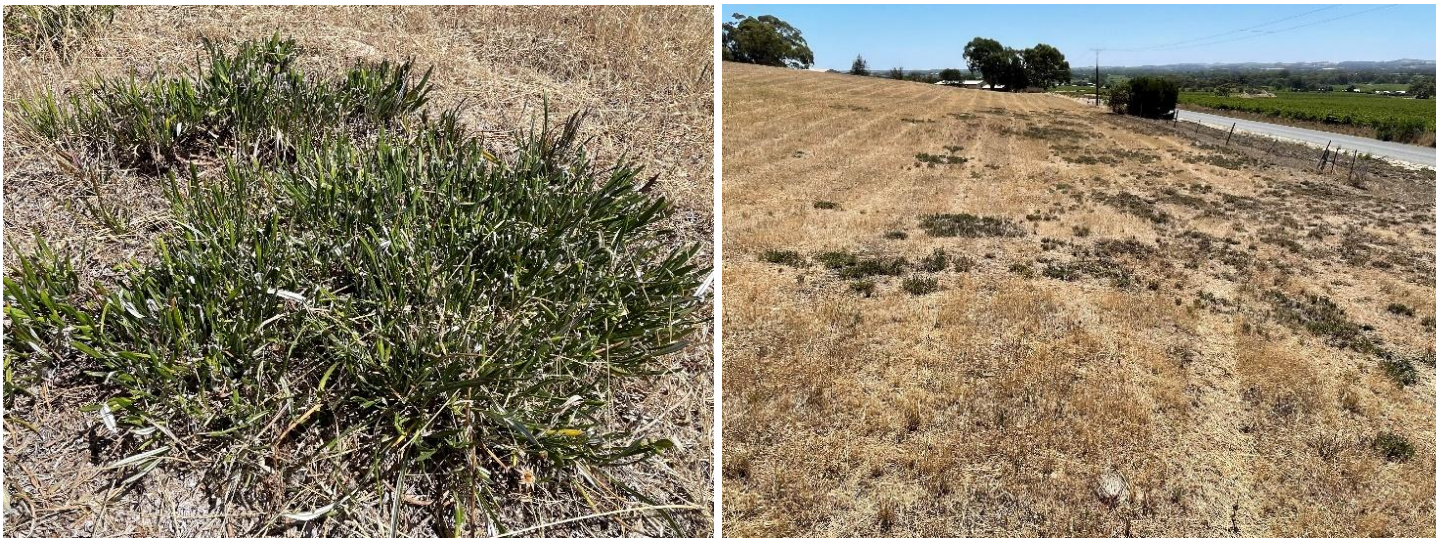
Wild Gazania is a declared weed of South Australia that is highly concentrated in some pockets of the site as indicated in *appendix 1*. It is a deep-rooted perennial herb that forms tussocks and can be quite difficult to control (*see figure 4*). Glyphosate and dicamba is a typically robust herbicide mix on this weed, however it can have its limitations as it cannot be applied through the spring/summer period due to the risk of spray drift onto neighbouring vineyards. Consequently, the timing of chemical control needs to ideally be late winter prior to bud burst.

Figure 4 - populations of wild Gazania on site

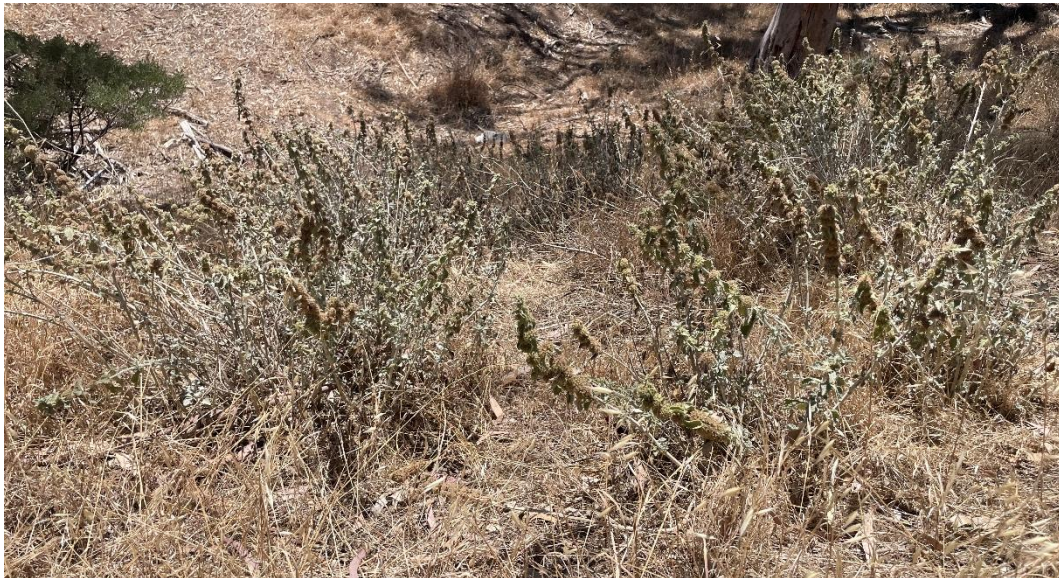
Some horehound regrowth and new germinations have been identified along Jaeckeli Creek (see *figure 5*). This area has been highlighted in the past for horehound populations. This will be flagged for control in the coming months with the use of dicamba. Olive trees have been identified intermittently across the site although considerable control has been achieved in the previous two years via the cut and paste stump method.

Figure 5 - horehound along Jaeckeli Creek

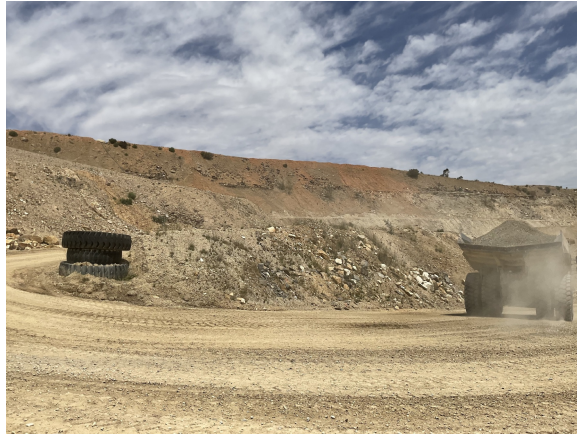
Photo 1: General views towards Ironstone Road from eastern overburden dump. Generally limited to annual grasses with evidence of dieback. Potentially one (1) or more tree tobacco individuals noted.

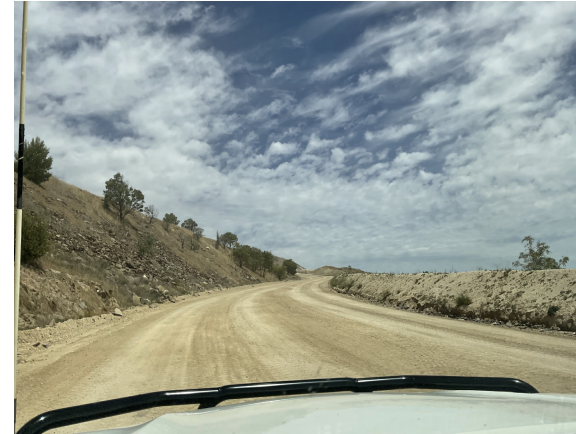
Photo 2: Walls above haul road into pit. Generally limited to annual weeds with dieback evident. Potentially one (1) or more tree tobacco individuals noted.

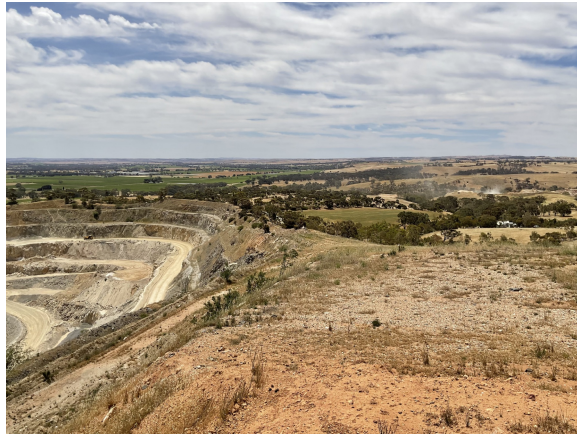
Photo 3: Photo facing north from north eastern corner of PM 120. Some tree tobacco individuals noted on benching. Weeds on landscape outside of disturbed area generally limited to annual grasses with dieback present.

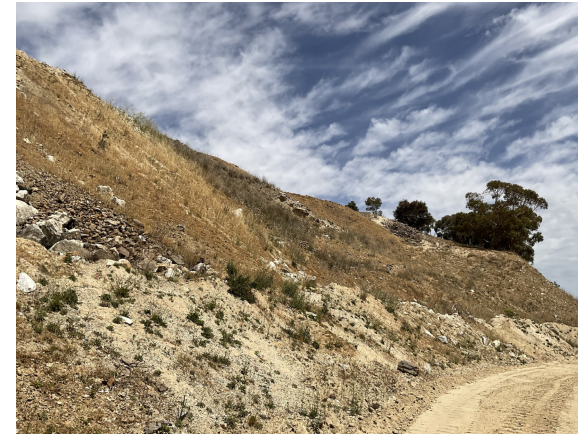
Photo 5: General view of weeds along haul road wall, generally limited to annual weeds with dieback evident.

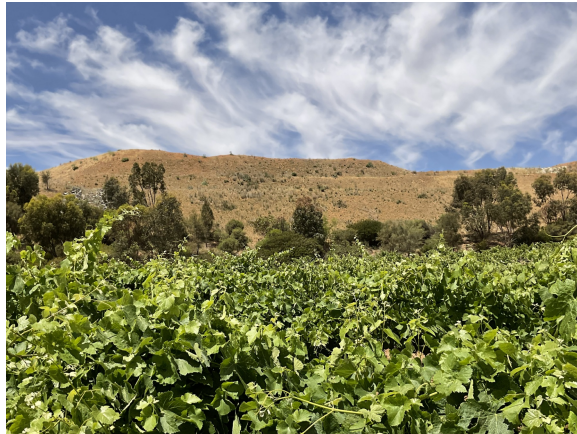
Photo 6: View of eastern overburden dump. Generally limited to annual grasses with dieback evidence. Some tree tobacco noted.

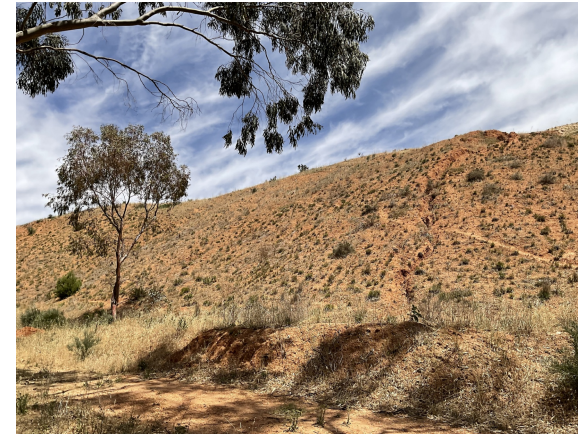
Photo 7: View facing south from Jaekeli Creek in MPL 118. Evidence of weed dieback. Weeds generally limited to annual grasses.

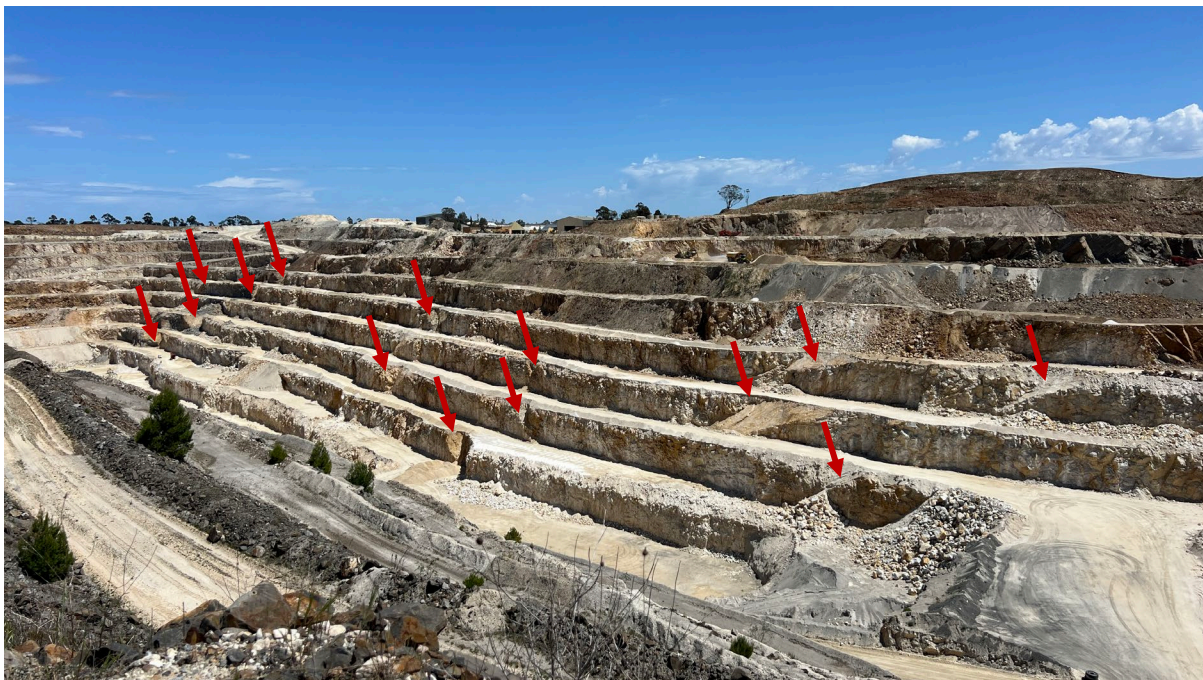
Observations on-site indicate that wedges form across multiple benches, with their orientations generally aligned. This alignment highlights the systematic nature of the underlying conditions driving wedge formation. Recognising that any observed wedge development should not be considered an isolated issue is essential. Instead, it likely indicates a broader, more pervasive structural challenge within the rock mass. Treating these observations as part of a larger pattern ensures that appropriate mitigation strategies are implemented across the affected areas rather than addressing individual wedges in isolation.

Figure 11: High occurrence of wedge failure in the west wall.

- Maintaining sufficiently wide benches to catch falling material.
- Implementing bench crest catch bunds to prevent rocks from rolling over the bench crests.
- Scaling loose material when safe to do so.
- Monitoring for changes in slope conditions, such as an increased frequency of localised rockfalls, as this may indicate stress redistribution in the walls and signal a more significant structural issue, such as wedge formation.

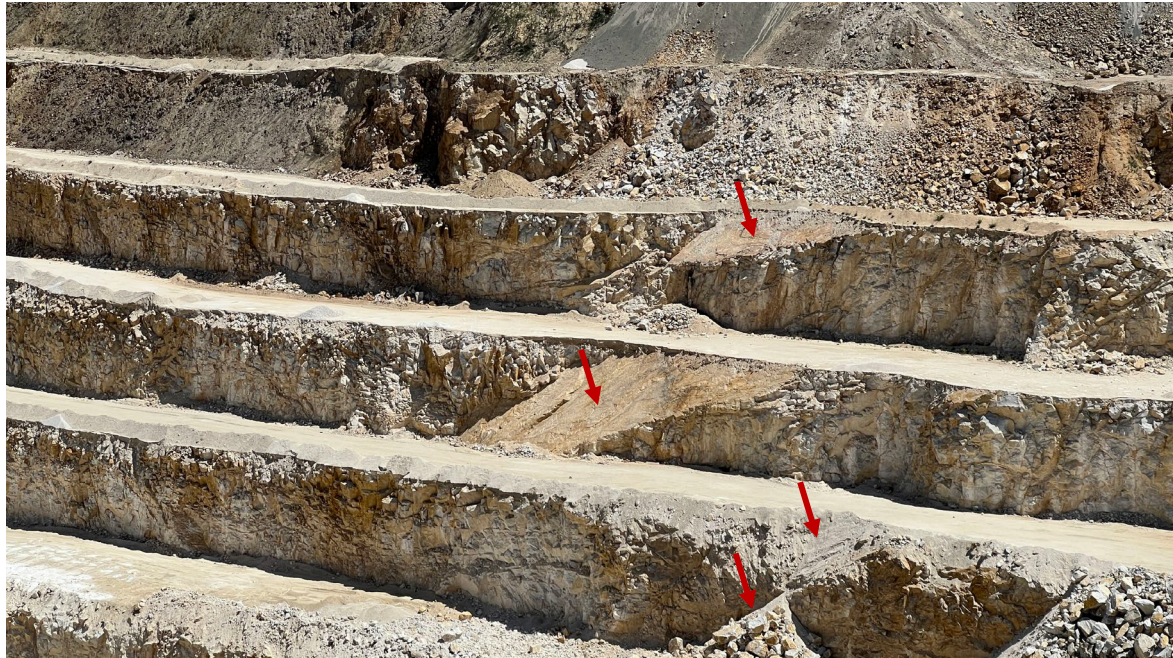
Defects such as joints, fractures, and bedding planes significantly affect the strength of a rock mass. When these are oriented at angles between parallel and perpendicular to the load direction (assumed to be vertical), the rock mass may experience a notable reduction in strength. This weakening increases the likelihood of localised failures, as observed in the high occurrence of western wall wedge failures.

Figure 12: Central west wall slipperybacks, planar and wedge formation.

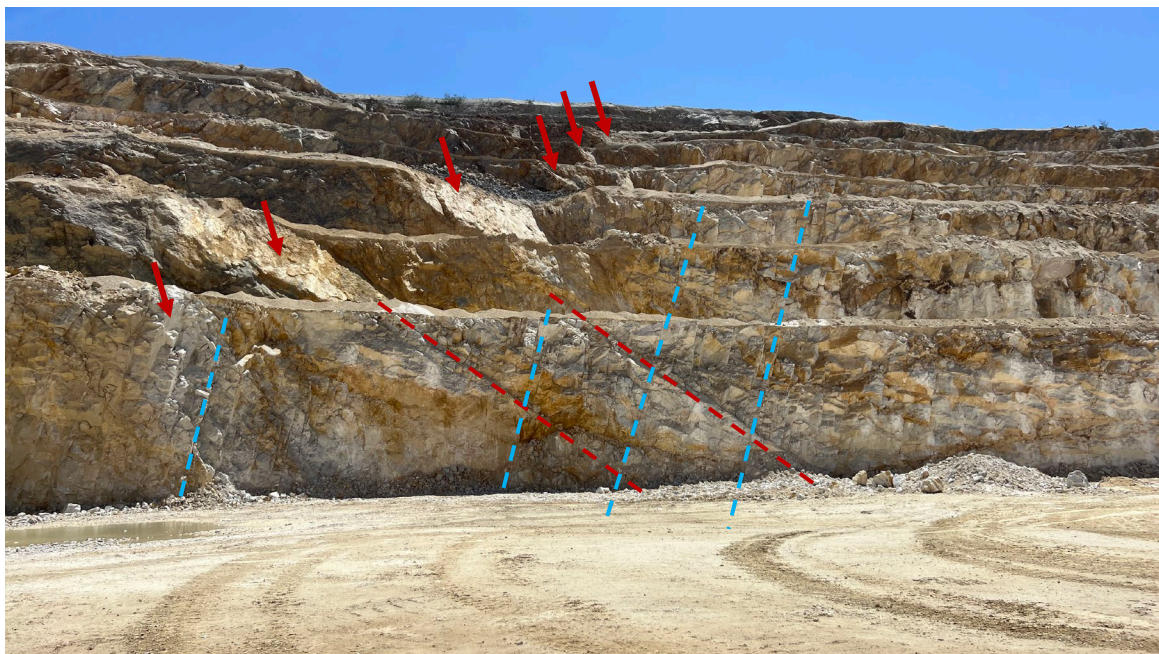
Figure 13: Southwest west wall highlights existing wedges and defects causing wedge formation.

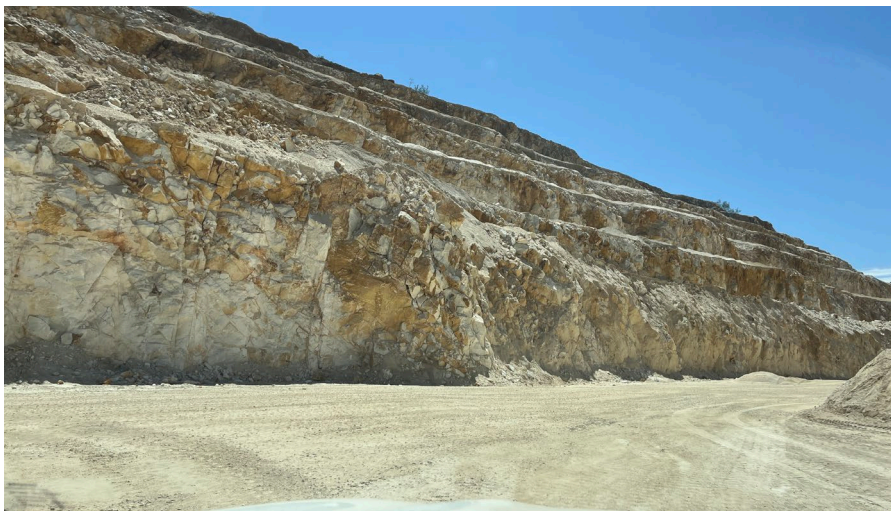
Figure 14: Southwest west wall highly jointed and fractured rock mass.

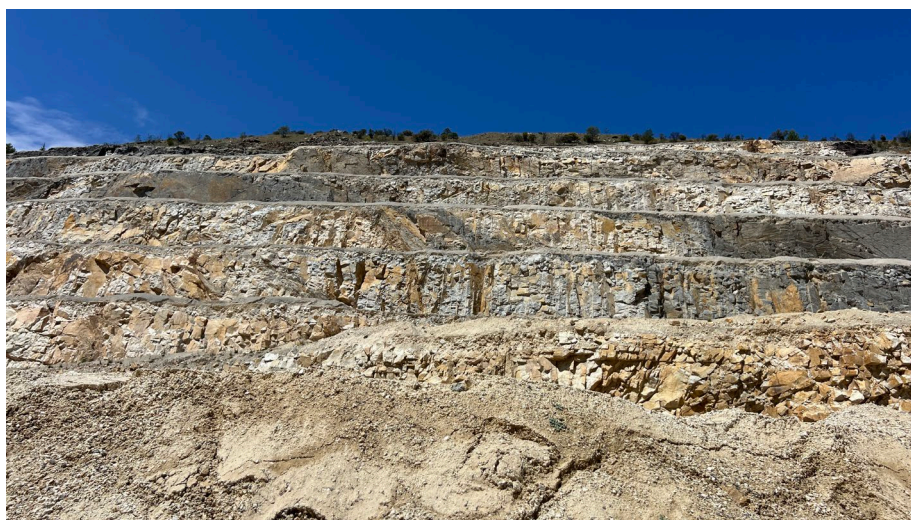
Figure 15: Central east wall highly jointed and fractured rock mass.

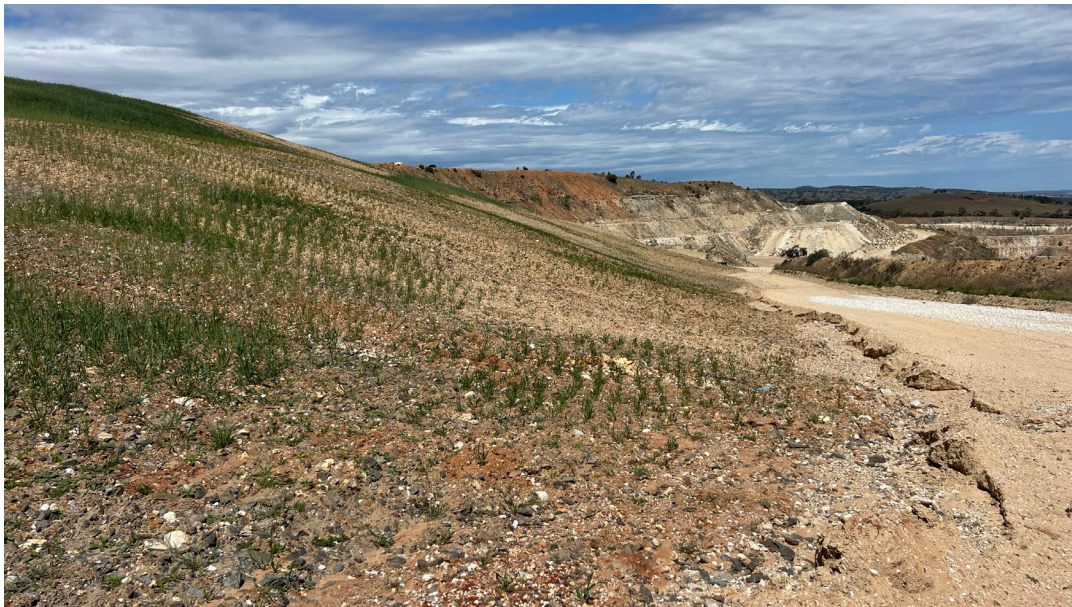
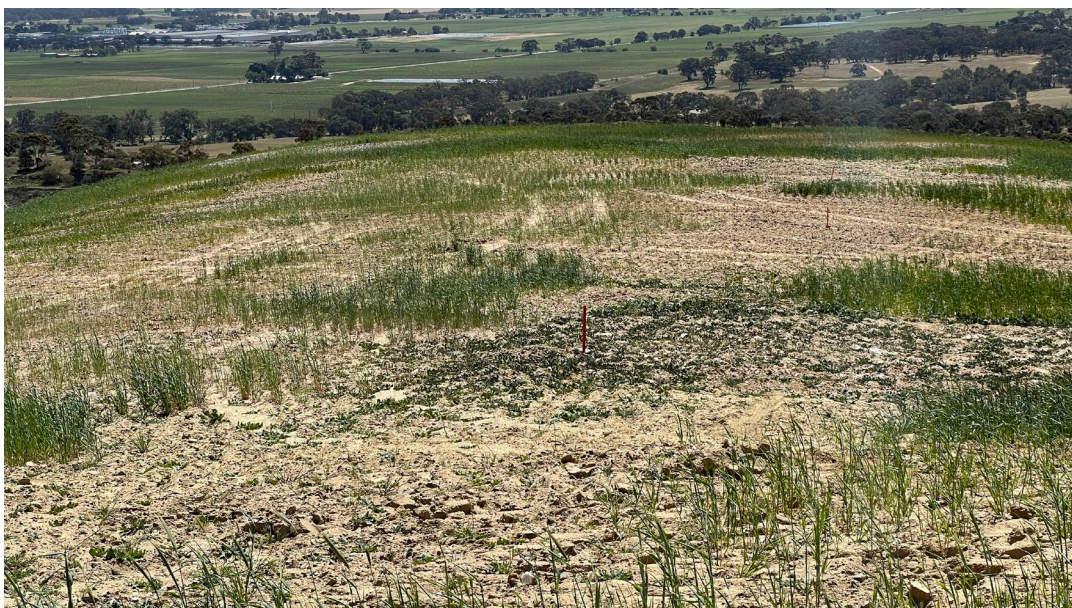
Figure 16: Eastern rehabilitation mound structure toe.

Figure 17: Eastern rehabilitation mound structure crest and top surface.

Although the structure appears structurally sound, it is critical to ensure it remains dry, vegetate any unvegetated areas, and continually monitor for cracks along the top and crest and signs of movement along the toe. This does not need to be an overly burdensome task; a simple monthly or after extreme rain events drive around the structure would suffice.

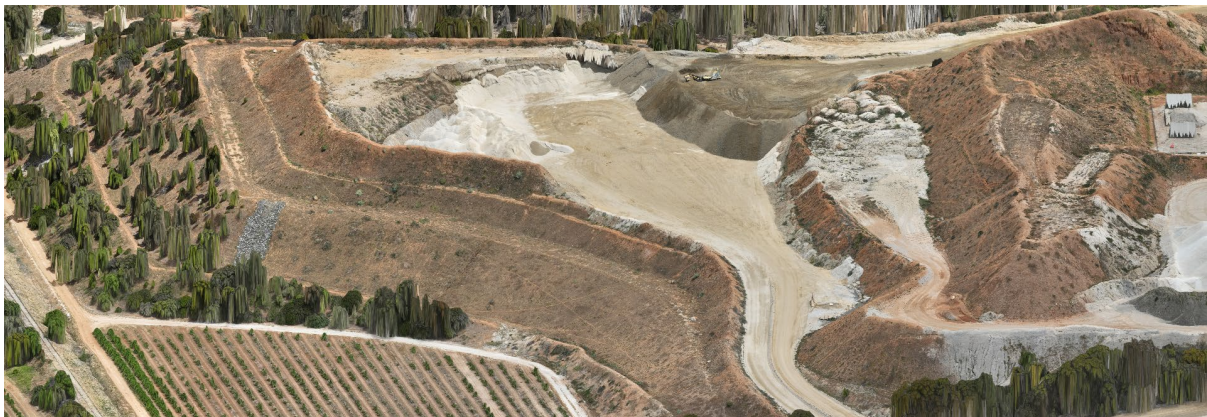
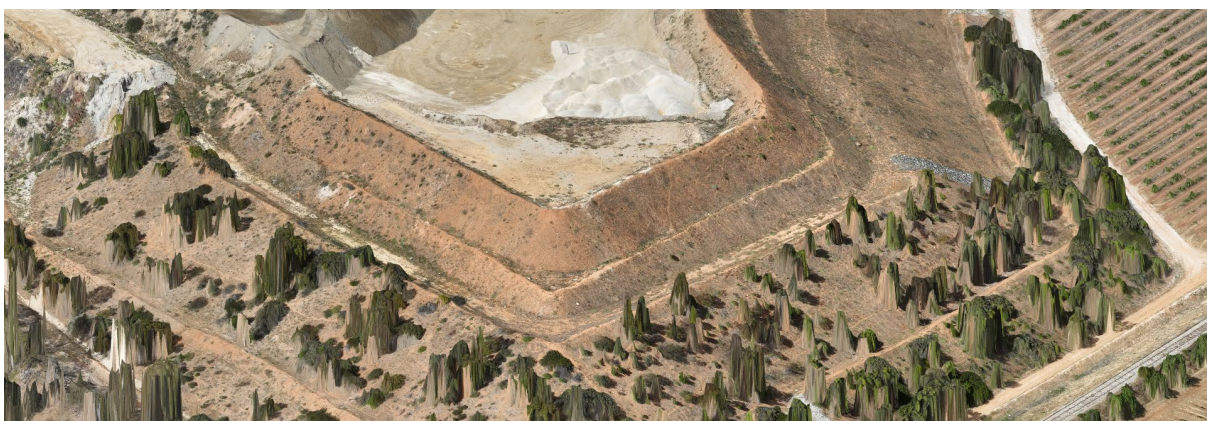
Figure 18: West overburden dump.

Figure 19: West overburden dump.

Although the structure appears structurally sound, it is essential to ensure it remains dry, vegetate the terminal faces where practical, provide suitable channels and pathways for surface water egress, and conduct visual monitoring every few months or after extreme rain events.
