SELLICKS HILL QUARRY (EML 5440, PM 163 & PM 237)

Annual Compliance Report

Date: October 2024

Report period: 31/08/2023 – 30/08/2024

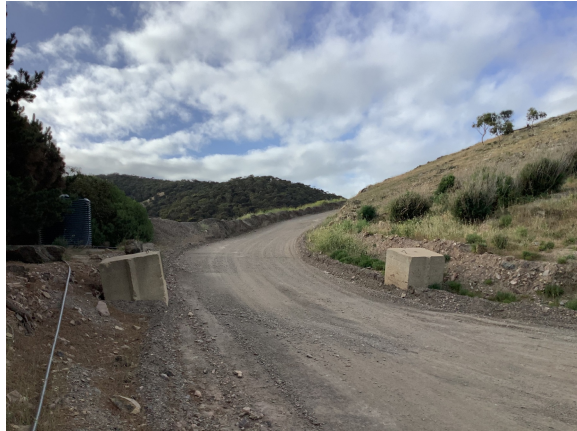
24/10/2024

Dust: Internal haul roads maintained in good condition.

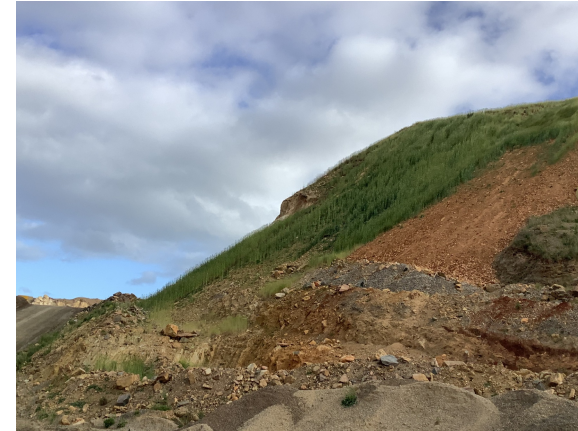
24/10/2024

Dust: Re-seeding of disturbed areas to minimise dust and erosion.

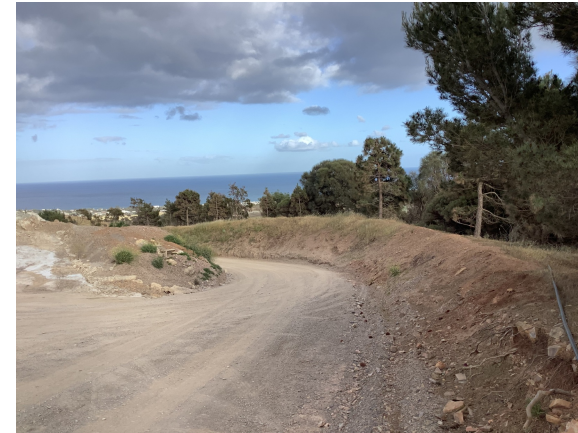
24/10/2024

Traffic: Return concrete area and access road, well maintained and in good condition. Established vegetation acting as visual screening measure from the public..

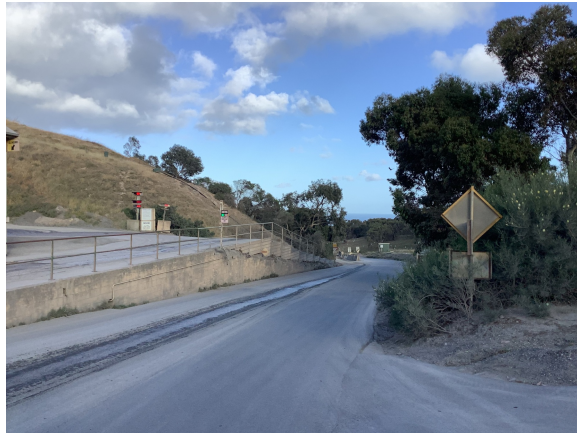
24/10/2024

Traffic: Road signage clear and well maintained.

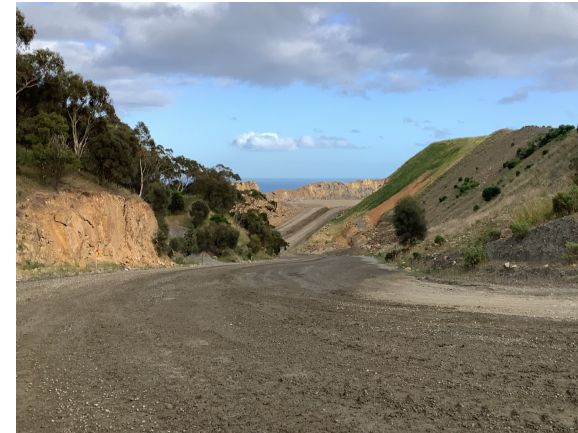
24/10/2024

Traffic: Internal haul roads maintained - in good condition and free from erosion.

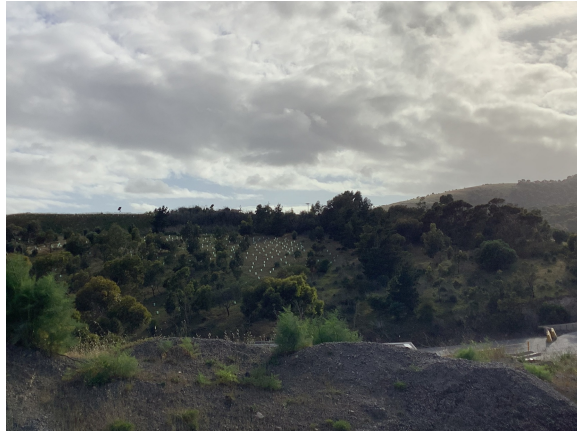
24/10/2024

Native Vegetation: Evidence of rehabilitation and established vegetation.

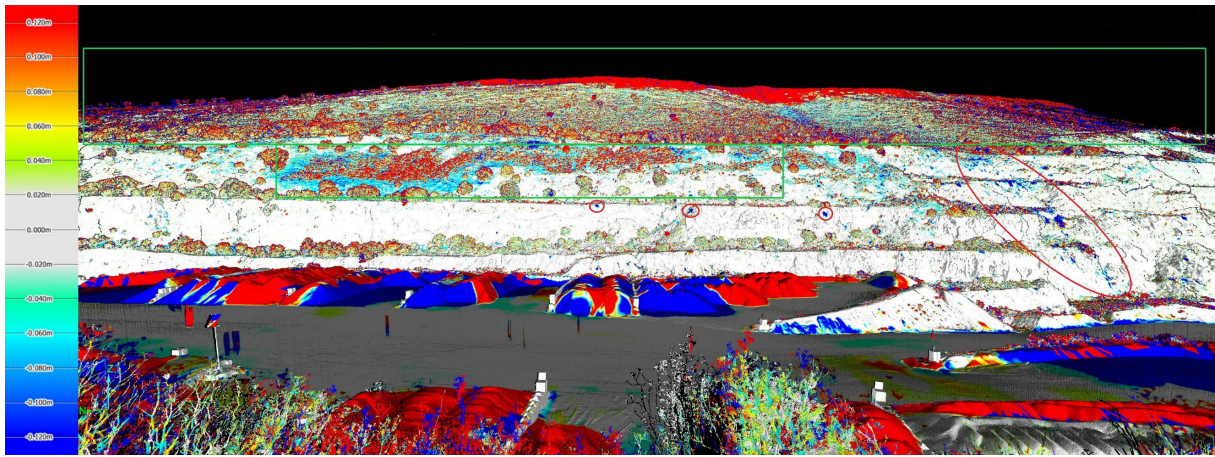
Figure 4: Station 2 3D laser scanning results. Minor rockfall is circled, and the washout/increased erosion areas on the right of the image.

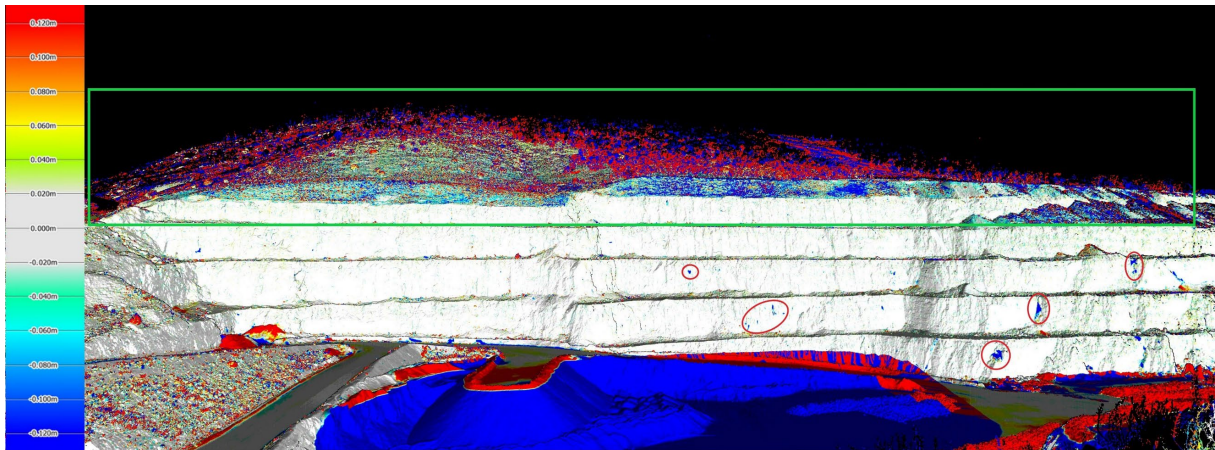
Figure 7: Station 5 3D laser scanning results showing minimal rockfall and no wall displacement.

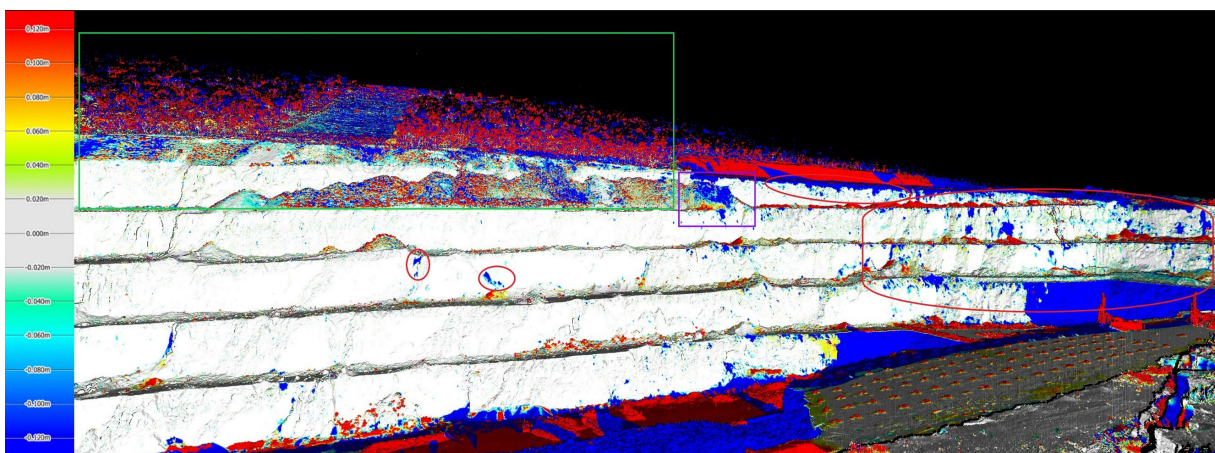
Figure 9: Station 7 3D laser scanning results showing minimal rockfall and no wall displacement.

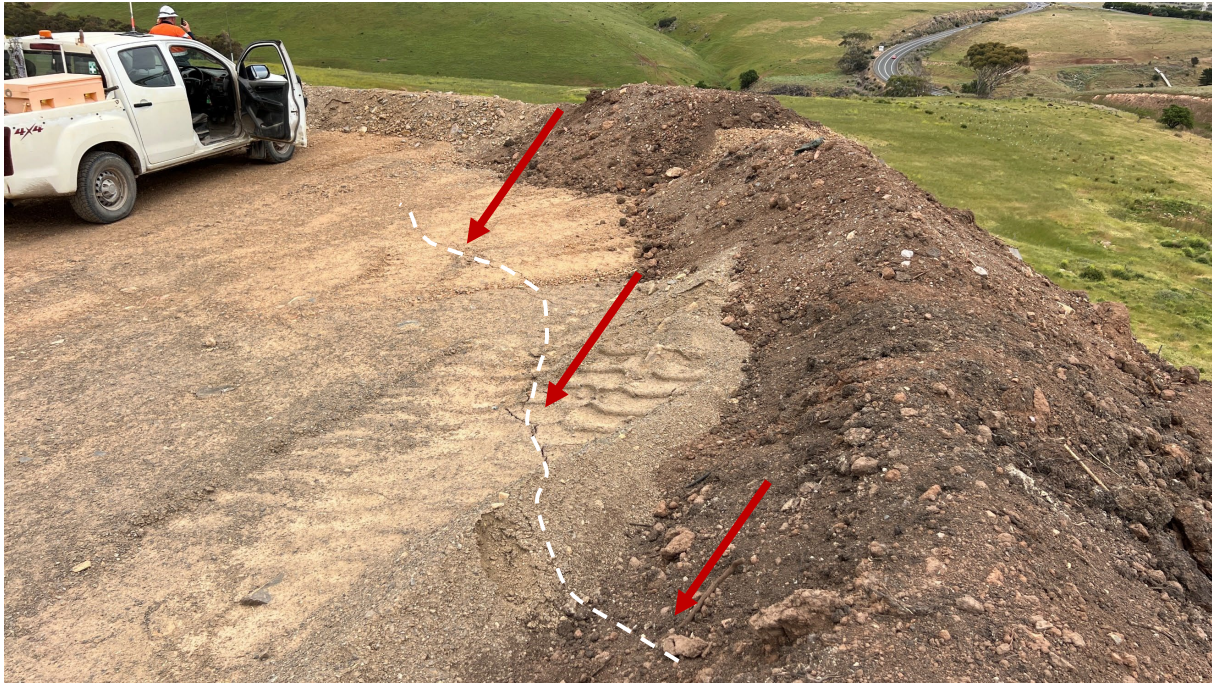
Minor cracking was observed in the southwesternmost apex of the WSM within recent material placement. The material in this area appears to be reasonably compacted. This may result from settlement within the upper few metres of the material or indicative of a more significant structural integrity issue affecting the entire lift or waste dump. Such signs must not be overlooked. The waste dump should be inspected daily, focusing on signs of settlement, slumping, and cracking. These are often early warning indicators of more severe stability issues that may lie deeper within the structure, and timely detection is critical to preventing more significant failures.

Figure 10: Cracks observed in recent lift material placement.

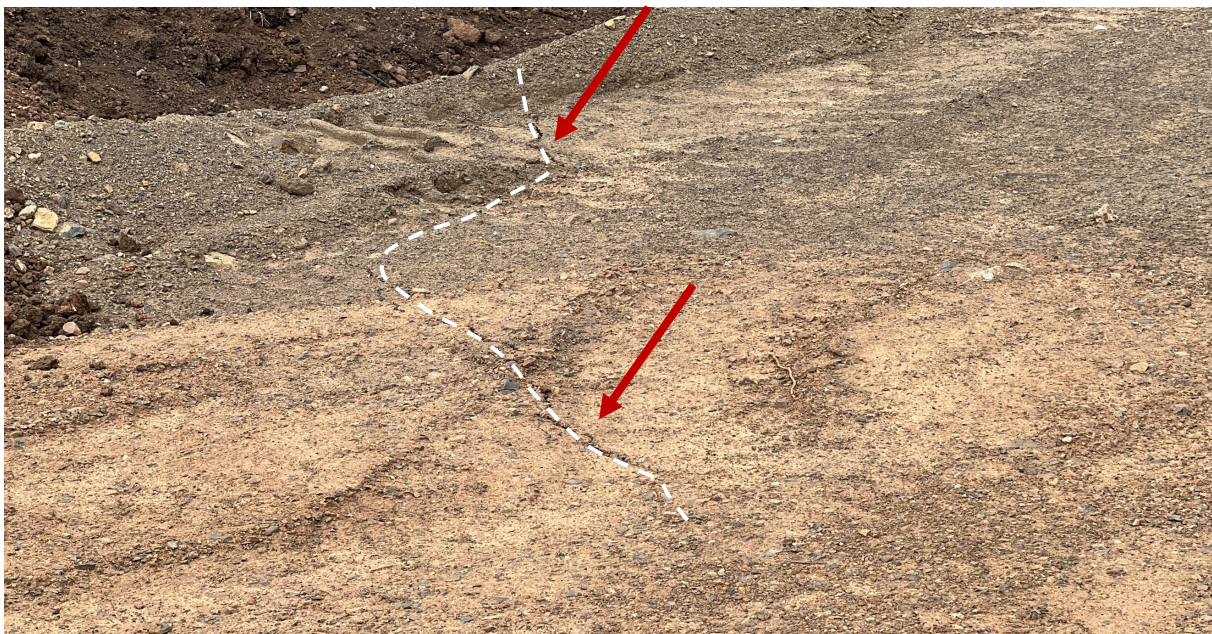
Figure 11: Cracks observed in recent lift material placement.

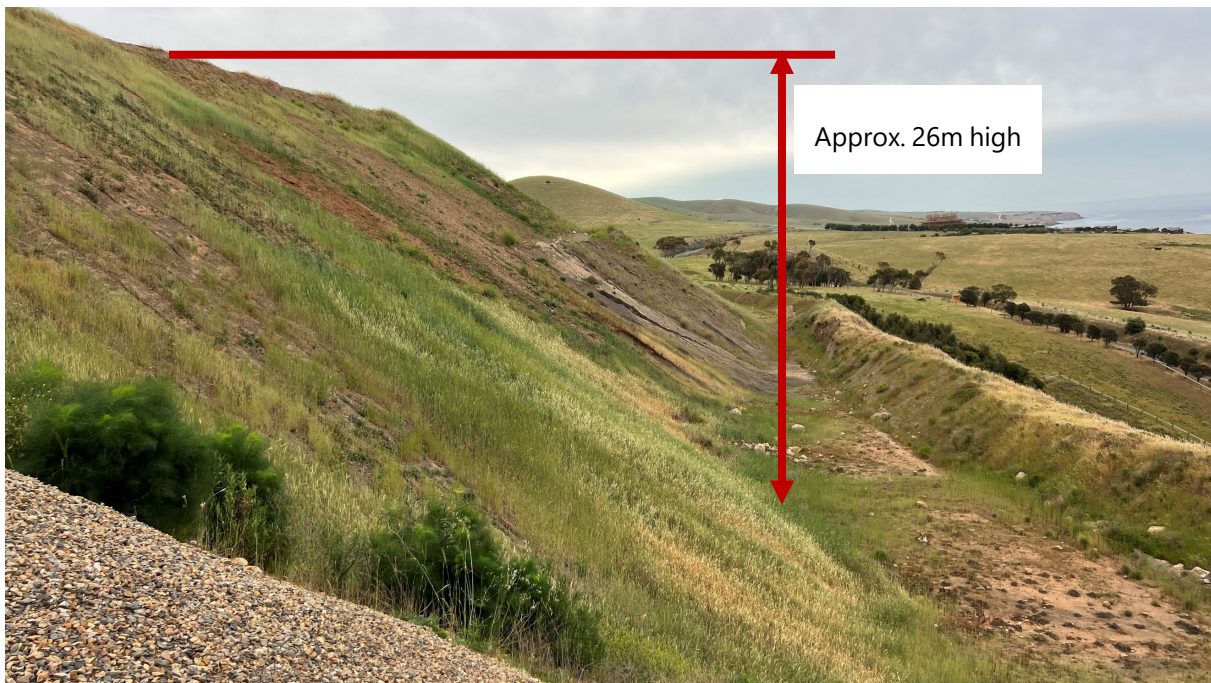
The southernmost end of the WSM structure is quite high, at approximately 26 metres, with minimal benching, which may contribute to potential stability issues if not closely monitored and effectively managed. Regular monitoring should prioritise the identification of any slumping or cracking along the crest, as these could be early indicators of material movement or settling. Furthermore, signs of bulging, ramping, or seepage at the toe of the dump should be carefully observed, as they may suggest deeper instability or water pressure build-up within the structure. Consistent inspections are essential to ensure that potential problems are detected early and addressed before they escalate into more severe stability or safety concerns.

Figure 12: The outer face of the Western Screening Mound has steep slopes and lacks benching.

Groundwork acknowledges that, in discussions with Luke, the Quarry Supervisor, it was understood that benching is planned for future implementation in areas with steep slopes.

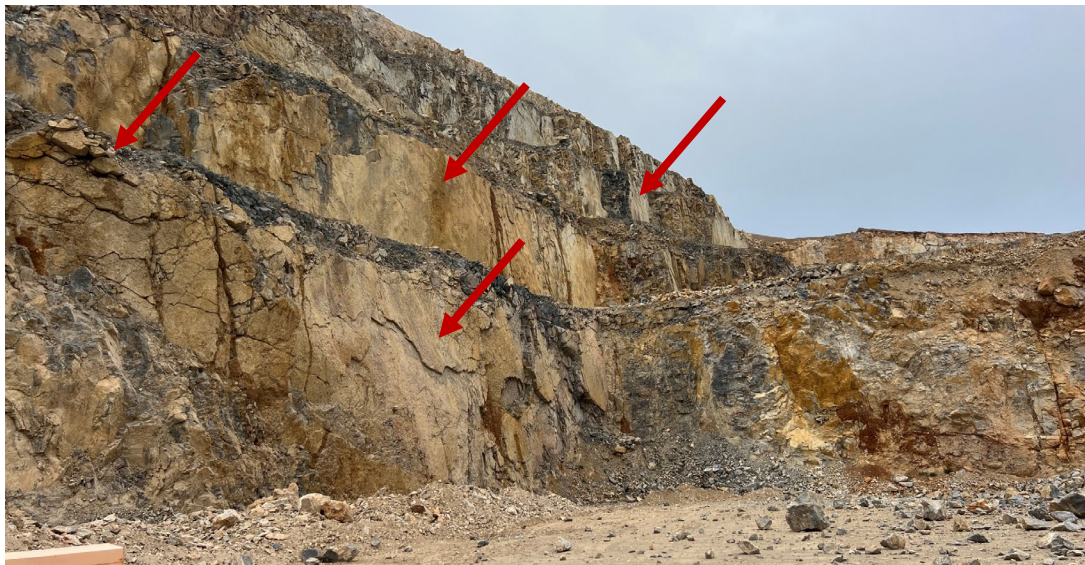
Figure 13: Highwall of the southernmost end of the pit displaying crest damage sliding potential.

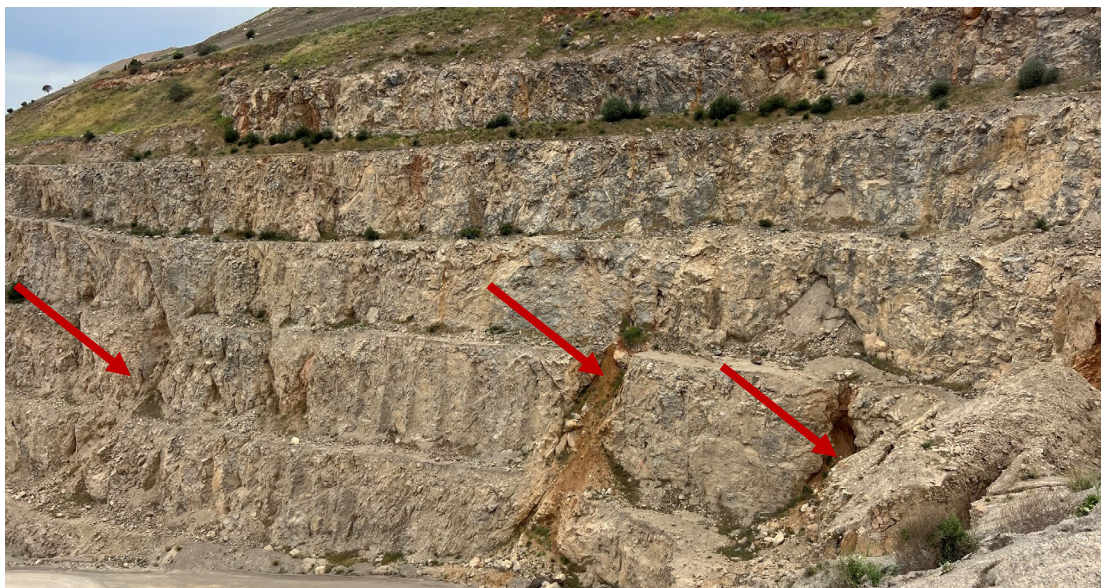
In several areas, surface water has eroded channels in the highwall faces along structures of weaker geology; refer to **Figure 14**. Although these issues are not currently causing significant concern, they should not be overlooked and must be respected and monitored. These locations are prime candidates for future rockfall and localised low-volume material mobilisation due to increased erosion and rock dislodgement.

Figure 14: Highwall adjacent to the main haul ramp to the upper level and immediately behind the plant.

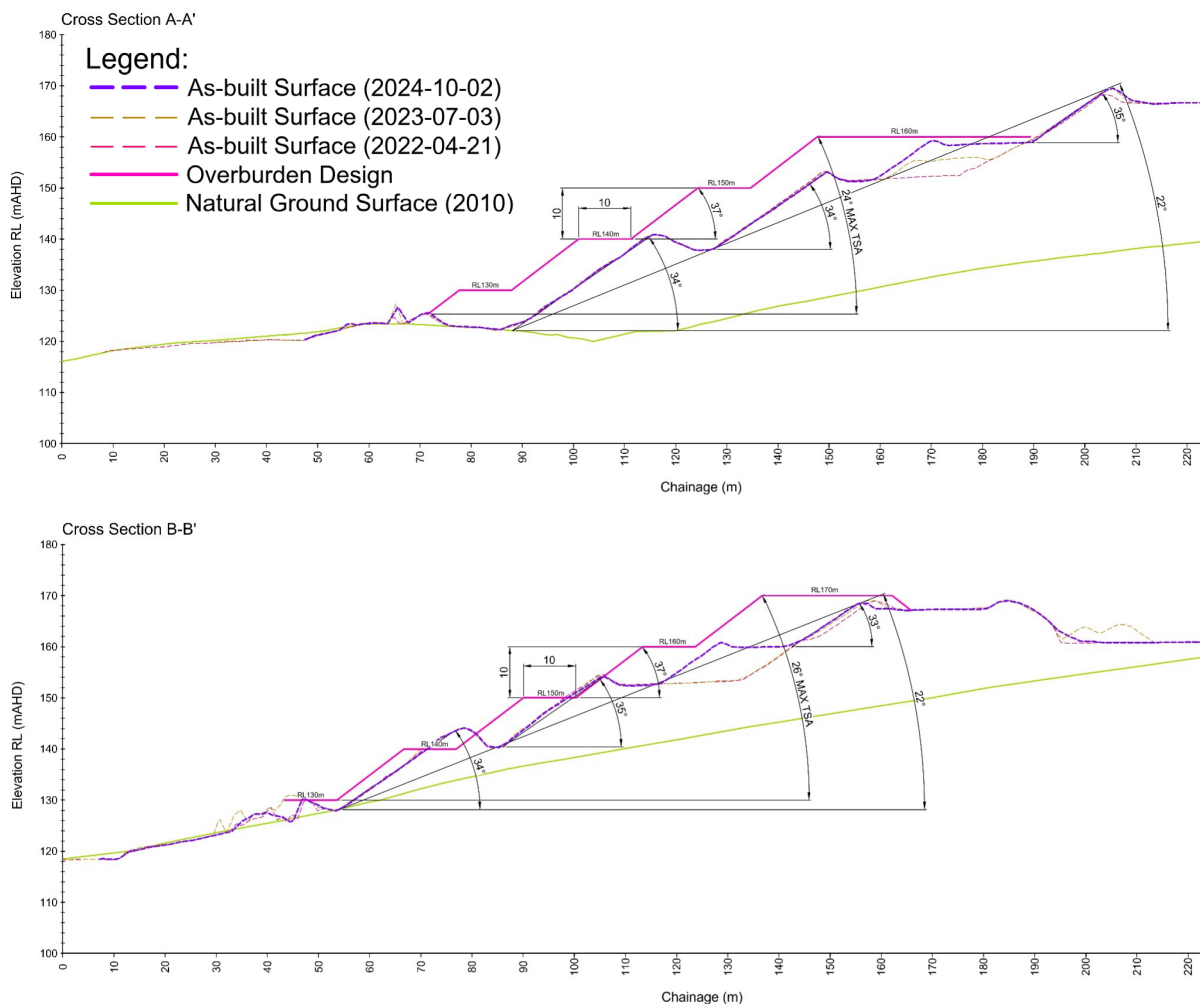
Section A and Section B indicate that the WSM tier/lift slope face angles are below the maximum of 36 degrees. The TSA from the toe of the structure to the crest of the top bench is 22 degrees, which is below the permitted maximum of 25 degrees; refer to **Figure 16**.

Figure 16: Western Screening Mound cross sections A and B.

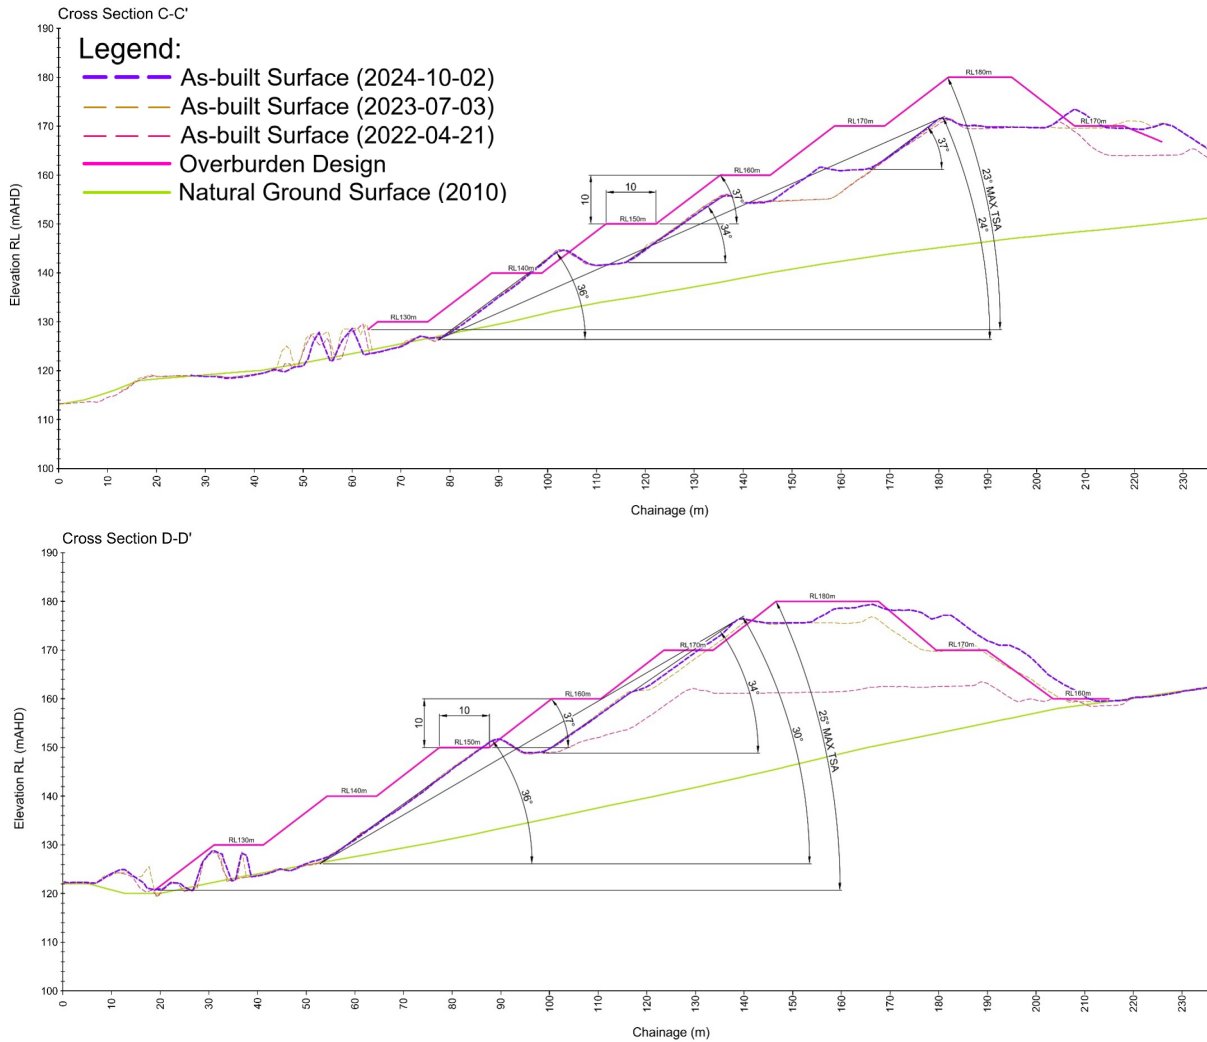
Section D highlights that the WSM tier/lift slope face angles are at or below the permitted maximum of 36 degrees. However, the TSA from the toe of the structure to the crest of the top bench is 30 degrees, exceeding the allowed maximum of 25 degrees; refer to **Figure 17**. The upper lift is also significantly high, with no benching, reaching a total height of approximately 26 metres.

Figure 17: Western Screening Mound cross sections C and D.

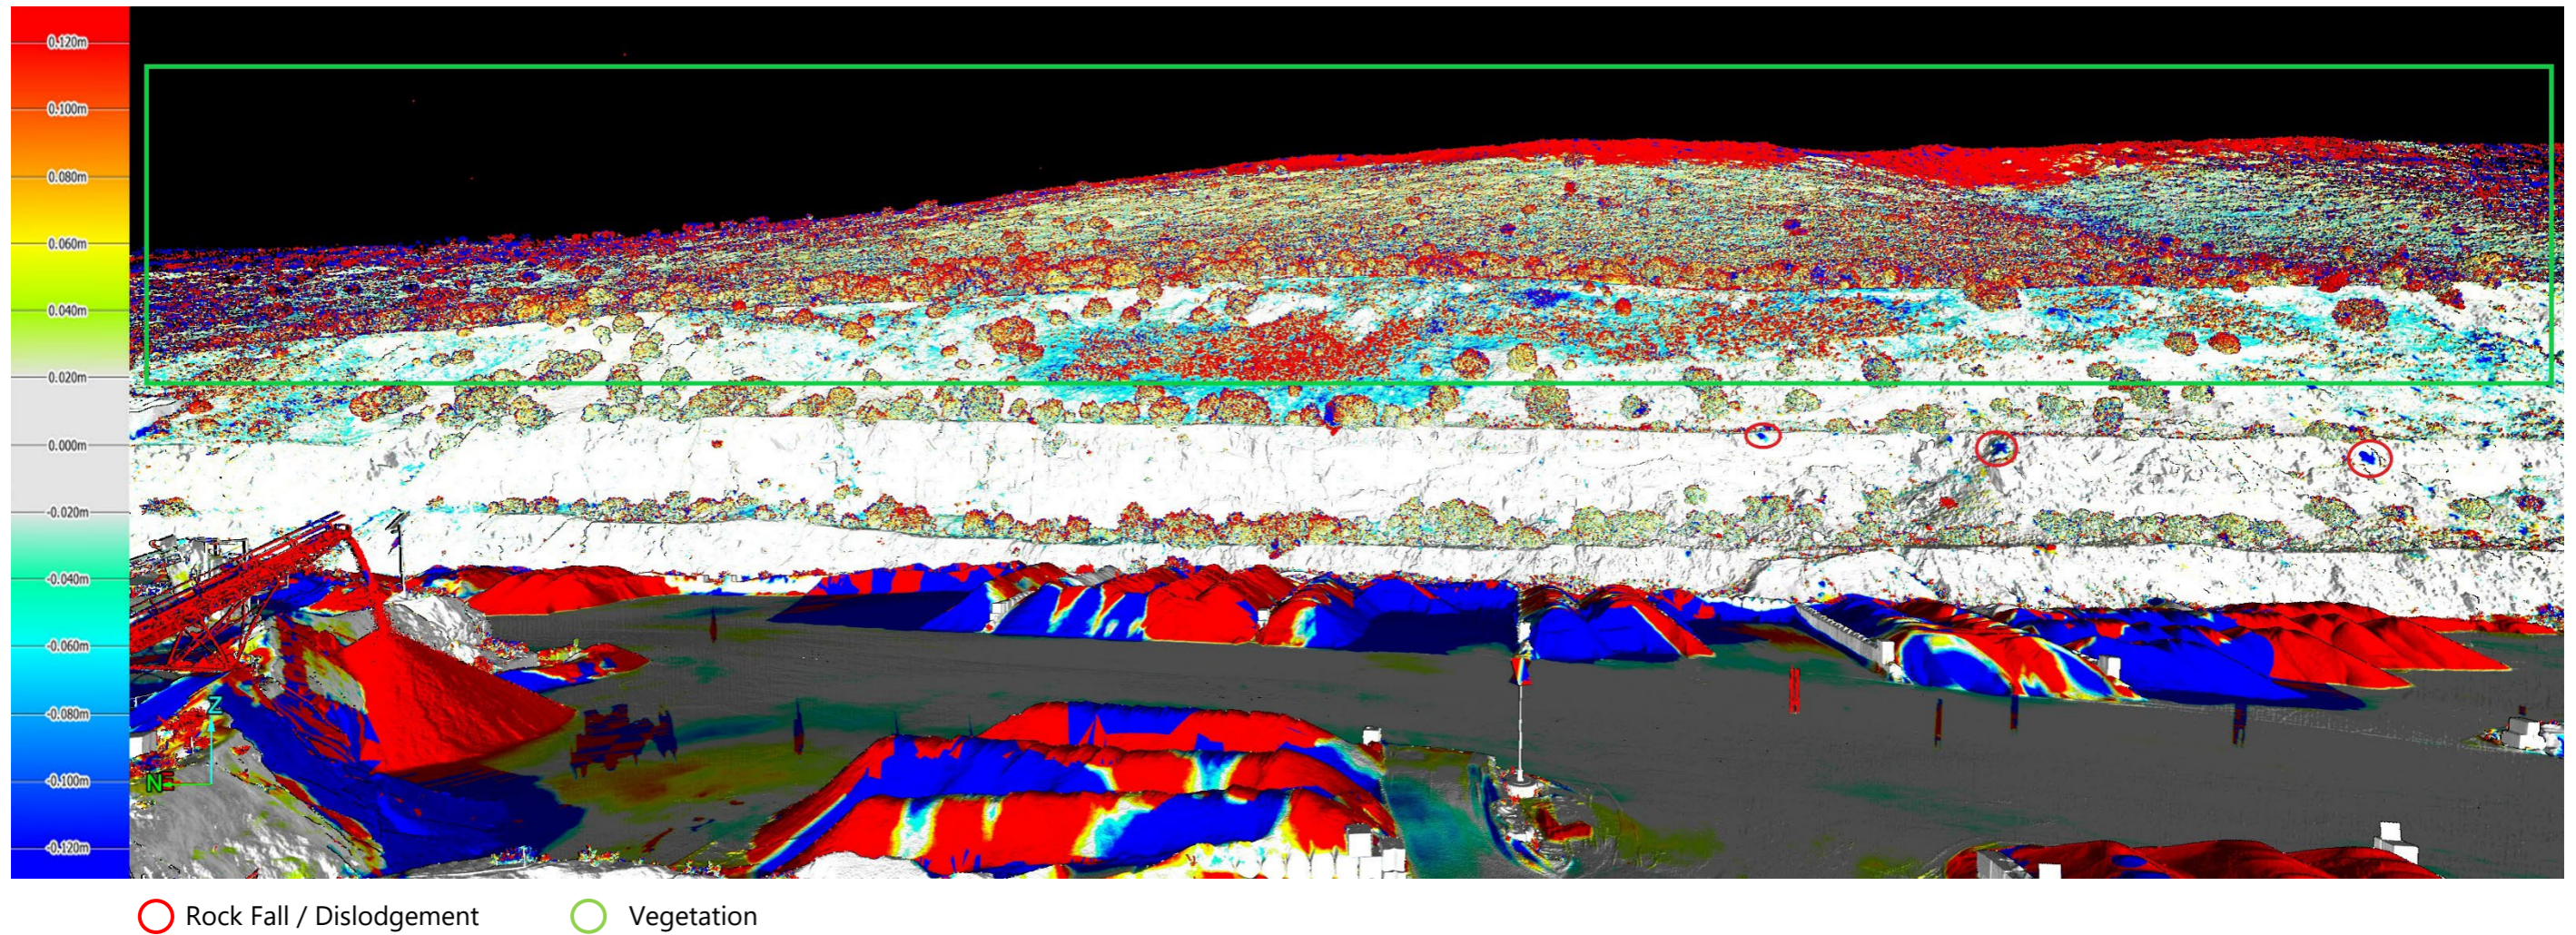
A few minor rock falls were observed as identified by the red circle polygons. The upper bench and Hillside have large, vegetated areas which show deformation (Cut/Fill) in the heatmap as identified within the green polygon. This is due to vegetation growth over the period and may not be attributable to movement.

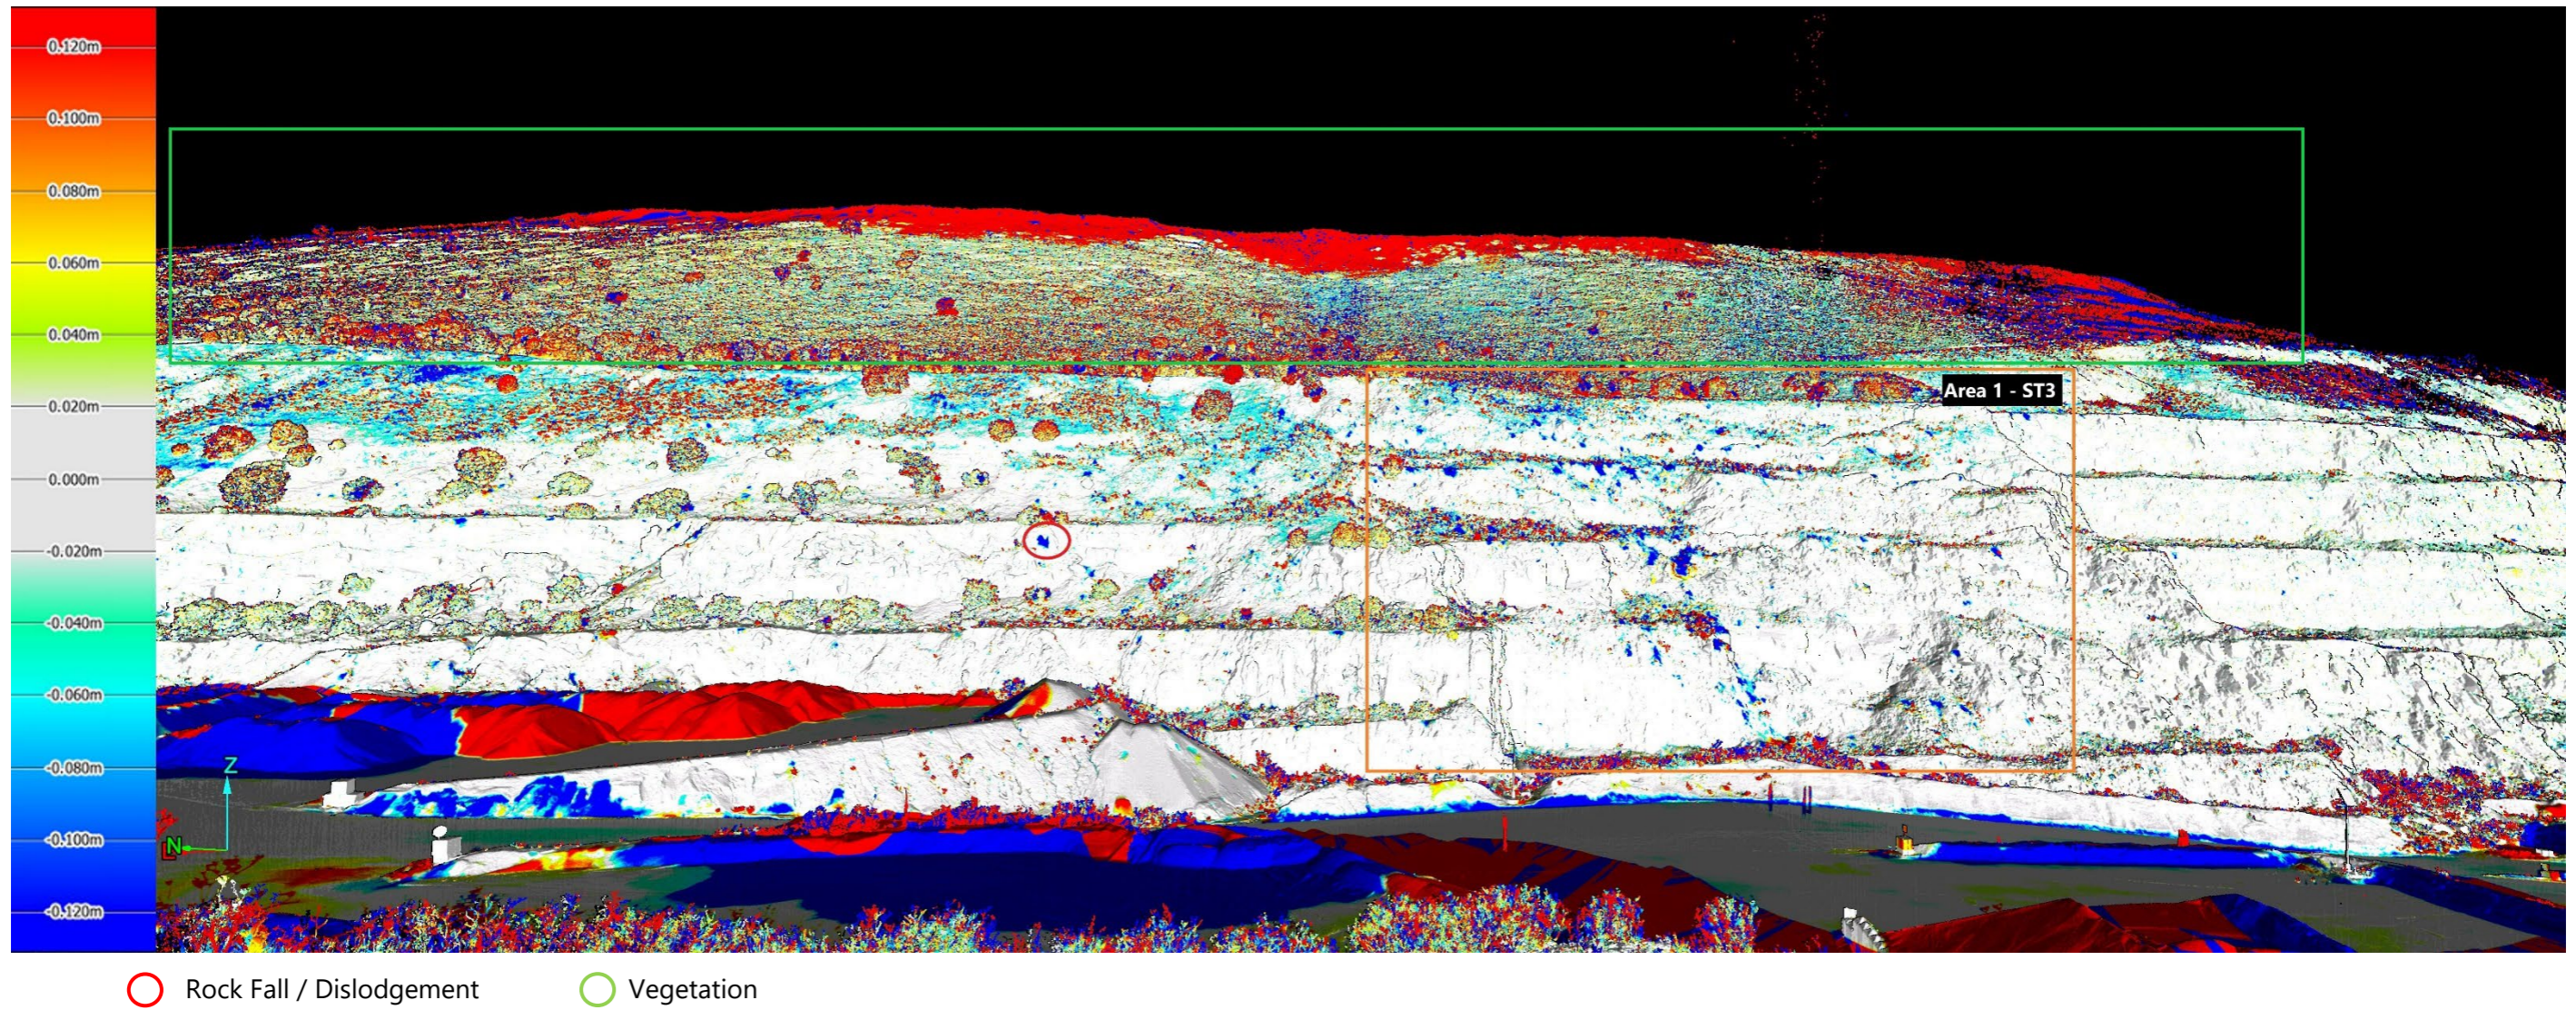
A few minor rock falls were observed as identified by the red circle polygons. Within area 1 – ST3, there were a number of rock falls observed across multiple benches. These rock falls are occurring in an area where walls exhibit loose and disjointed masses of rock. This area is shown in more detail below. The upper bench and Hillside have large, vegetated areas which show deformation (Cut/Fill) in the heatmap as identified within the green polygon. This is due to vegetation growth over the period and may not be attributable to movement.

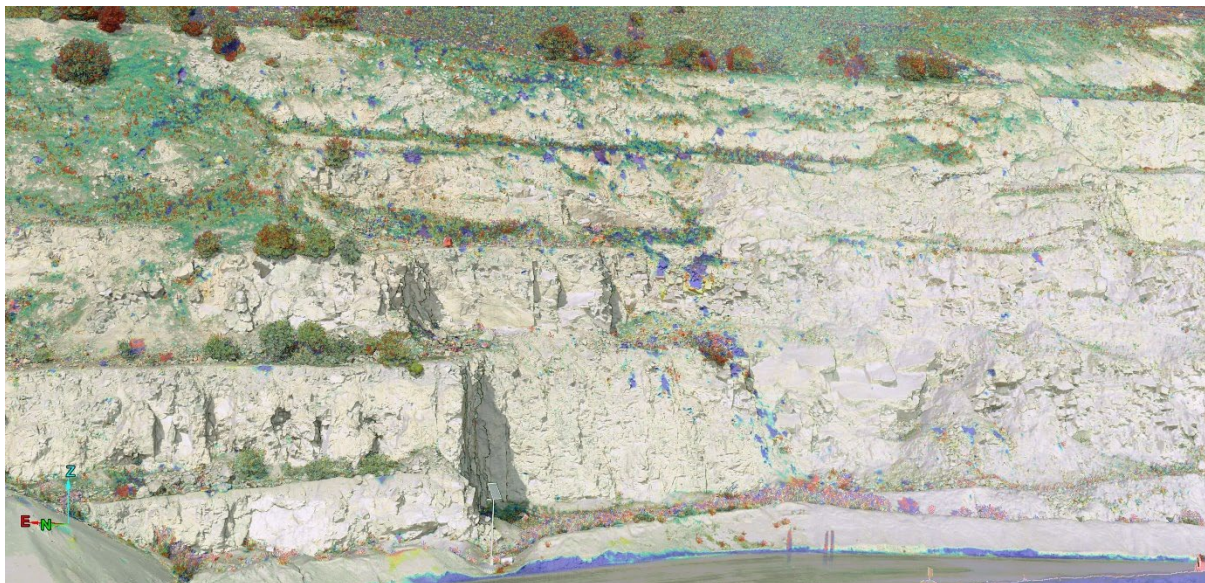
Small localized/wedge and toppling failures can be seen within this area. The previous period deformation scan also showed a number of rock falls occurring in this same area. As the haul road below is frequented by Mobile equipment (Including HME, HV, and LV) this area needs to be closely monitored and ensure that appropriate toe bunding and standoff distances are adhered too. It does appear that all rock fall is being contained behind the current toe bunding.

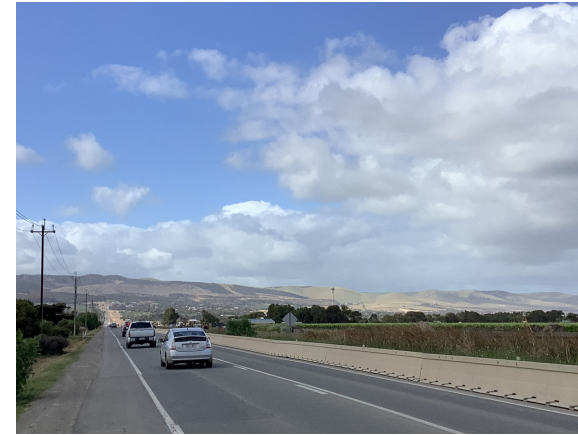
24/10/2024

Photo 5: Views facing South on Main South Road. Minimal views of stockpiling / bunding. No views of operations noted.
