GT BOBCAT NEW QUARRY at COMPTON - M.C. 4562

REVISED MINING PROPOSAL

- Location:** Approx. 8km west of Mount Gambier
Allotment 9 & Pt. Allot.10 Hundred of Blanche, Compton
- Tenement:** Mineral Claim 4562
- Tenement Holder:** GT Bobcat Pty Ltd
- Mined Commodity:** Limestone & Dolomite
- Contact:** Jake Douglas – Ph. 0459 333 350

November 2024 (Version 2)

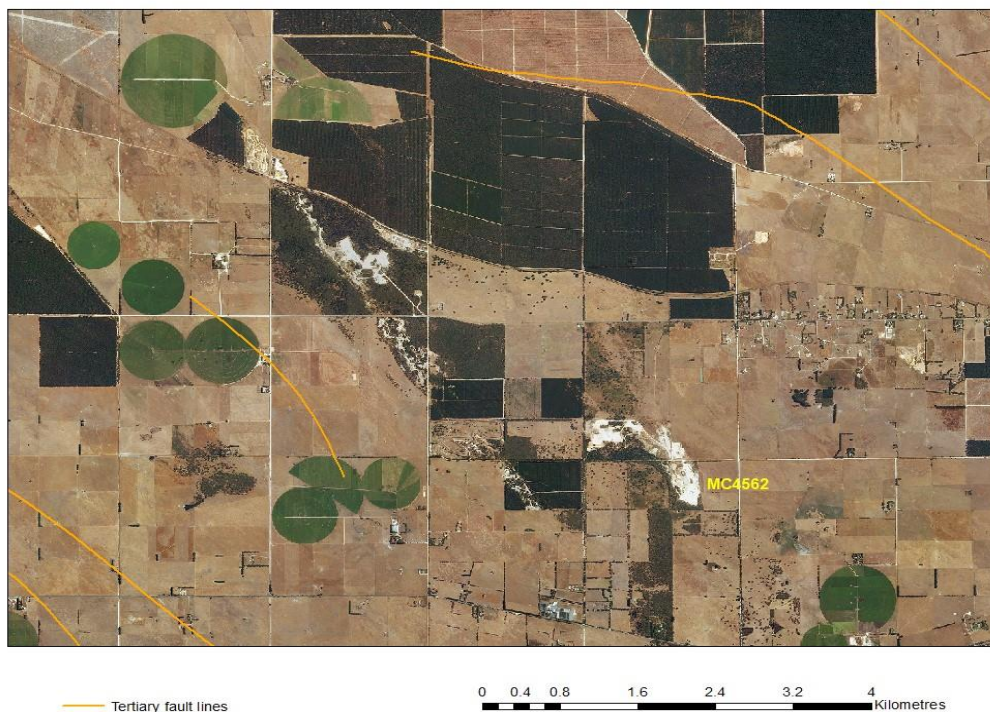
Figure 1. Interpreted Tertiary faults in the area of MC 4562

Within the lower South East region there is a relationship between fracture or cave joints and faulting. These line up in a northwest – southeast pattern which is the rift pattern of Australia’s movement away from Gondwanaland. These are shown in Figure 1. These faults have come from depth and the ground location is subjective to a small degree. As an example the fault immediately west of MC 4562 is probably located slightly east, running through the line of the whaleback limestone quarries which are often described as fault controlled resulting in uplift.

MC4562 - Tertiary faults interpreted to reach ground surface

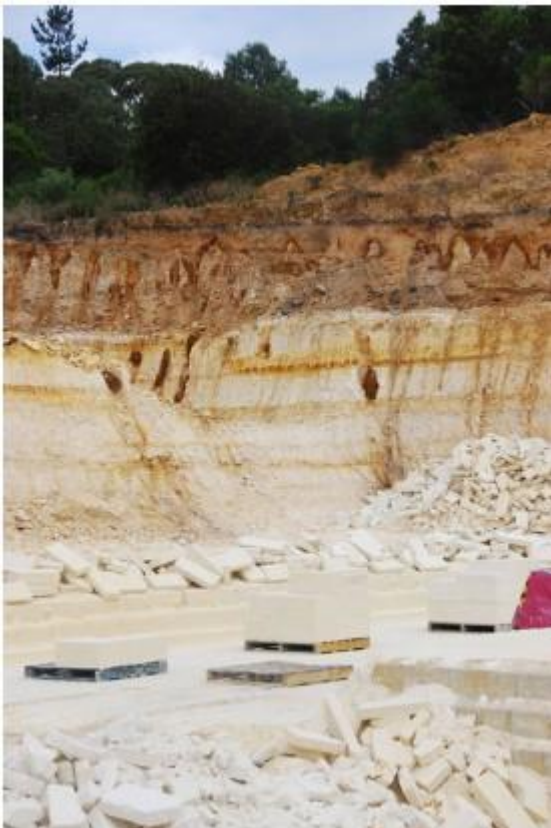
Figure 2. karst activity in a quarry wall

However small karst zones exist within the limestone quarries surrounding this mining proposal site as can be observed from the following two photos. The first photo shows the result of acidic water and clay can leach down through the sandstone into the limestone, with the second photo indicating how that can have a minor effect when cutting limestone ashlar (equivalent of small cavities recorded in drill holes).

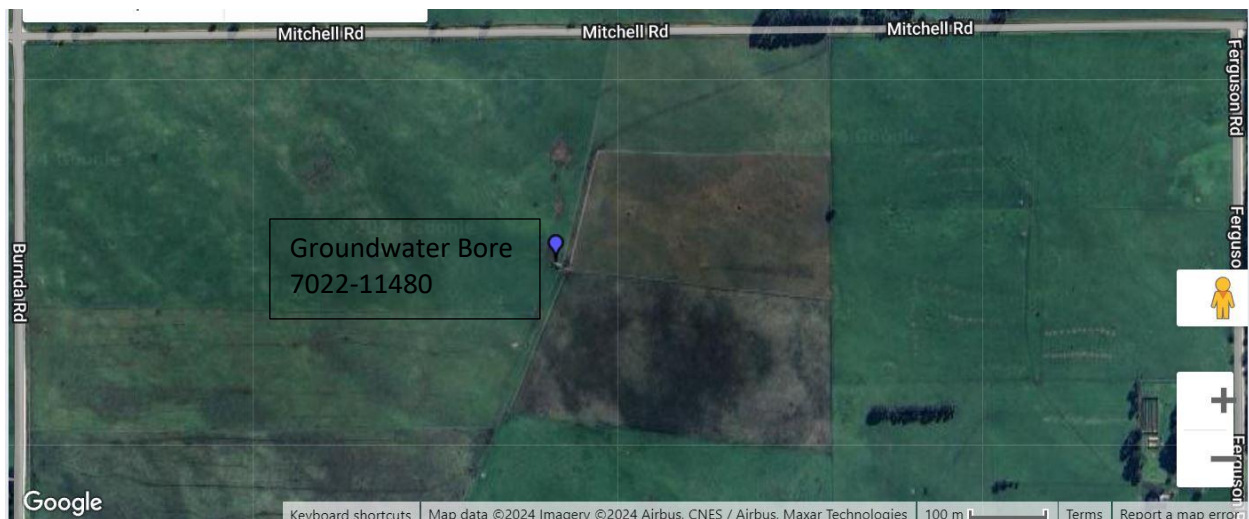
Location

MGA Easting	472721.58	MGA Northing	5812115.49	MGA Zone	54				
Latitude	Degrees 37	Minutes	50	Seconds	16.742	Decimal	-37.8379839		
Longitude	Degrees 140	Minutes	41	Seconds	23.941	Decimal	140.6899836		
250,000 map sheet	SJ5406	100,000 map sheet	7022	50,000 map sheet	3	10,000 map sheet	32	2,500 map sheet	n
Hundred	BLANCHE	Plan	D1608	Parcel	A11	Title	CT5317/438
