Mining Lease Proposal (MLP)

ABCL Klein Point (MC 4581)

Adelaide Brighton Cement Limited

SLR Consulting Australia Pty Ltd

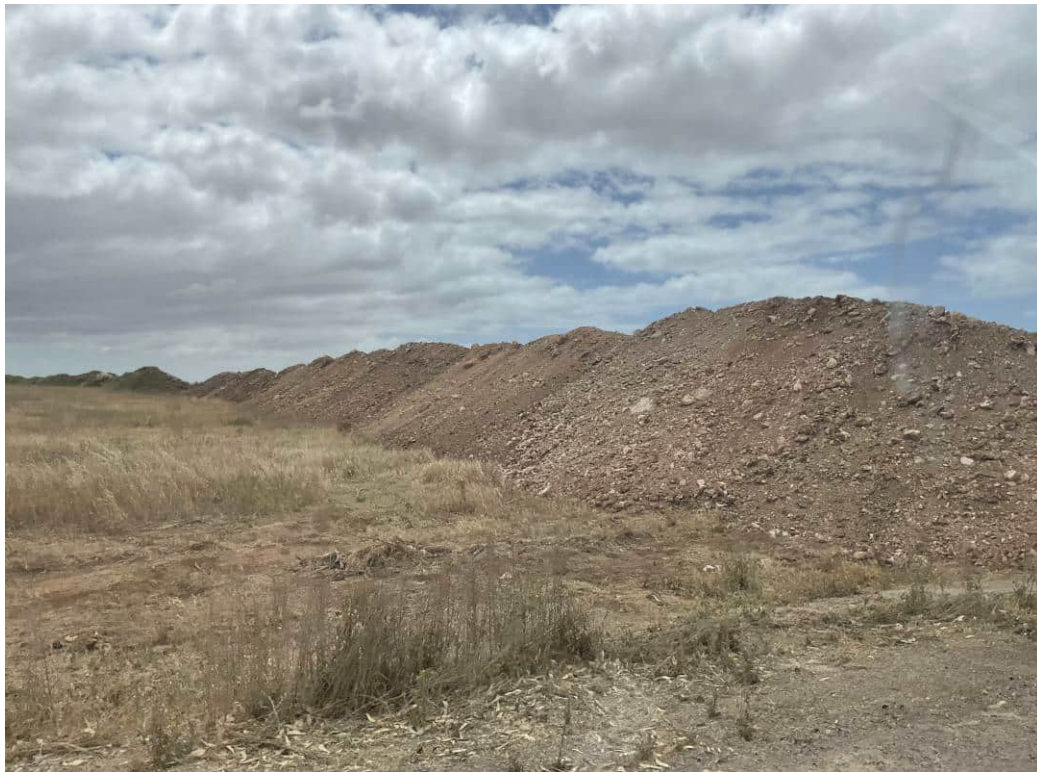
Figure 3 Topsoil along western boundary of ML 5881

Regionally across the MC area, the topsoil comprises of shallow grey to red brown soils of the aeolian origin with a depth from 0 to 0.12 m. The subsoil is fractured and strongly cemented calcrete with yellowish brown to light, very highly calcareous, sandy clay loam in fissures with a depth of 0.12 m to 1.02 m. The overburden consists of red and yellowish heavy clay to sandy clay with abundant carbonate and calcrete fragments with depth from 1.02 m to two (2) m (*The Soils of Southern South Australia, 2006*).

Topsoil is preserved from the very top layer of material extracted; the topsoil is stored in stockpiles no more than three (3) m high to preserve micro-organisms in the soil profile in readiness for rehabilitation. While the industry standard in quarries is to store topsoil stockpiles in rows no more than two (2) m high, the currently approved PEPR for the Quarry has a topsoil condition to ensure stockpile heights are no more than three (3) m high. the Quarry has a history of demonstrated success with the existing topsoil management strategies at the Quarry, refer to **Section 3.9**. Furthermore, if the MLP for MC 4581 is approved, it is the intention of ABCL to submit a combined PEPR encompassing all tenements (refer to **Section 1.1**). On this basis and to avoid the potential for conflicting conditions in a future, combined PEPR, it is proposed that stockpiles for topsoil are limited to three (3) m in height at the Site. This is reflected throughout this document with appropriate control strategies nominated to ensure this strategy remains effective at mitigating potential impacts, refer to **Section 7.6**.

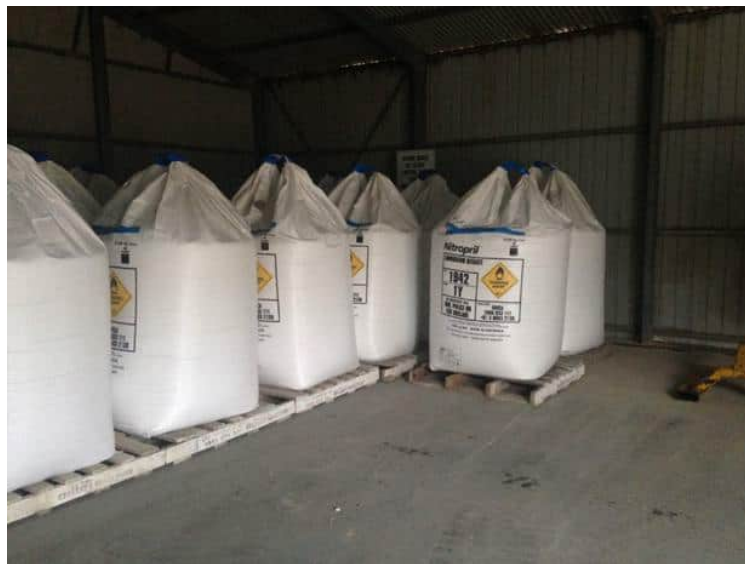
Figure 5 ANFO Storage

ANFO is utilised as the bulk explosive agent. Nonelectric detonation practises are used at the Quarry. All blasts are monitored for vibration and air overpressure. Within each blast design, details of blasting equipment and materials will be determined in accordance with the provisions of *Australian Standard (AS) 2187.2 Explosives – Storage and Use* by the licensed contractor. Blast design and assessments will be made in accordance with the Site geology and weather conditions at the time of the blast and take into consideration the direction and proximity of sensitive receivers and public infrastructure with the Maximum Instantaneous Charge (MIC) or charge mass per delay limited to the lowest possible level for each blast.

Volumes up to 250 kilotonnes (kt) of limestone are detonated at any one (1) time per blast. At an average, the Site blasts every six (6) – eight (8) weeks. Explosives will be stored within the Quarry. **Figure 5** shows the location of the ANFO storage at the Quarry.

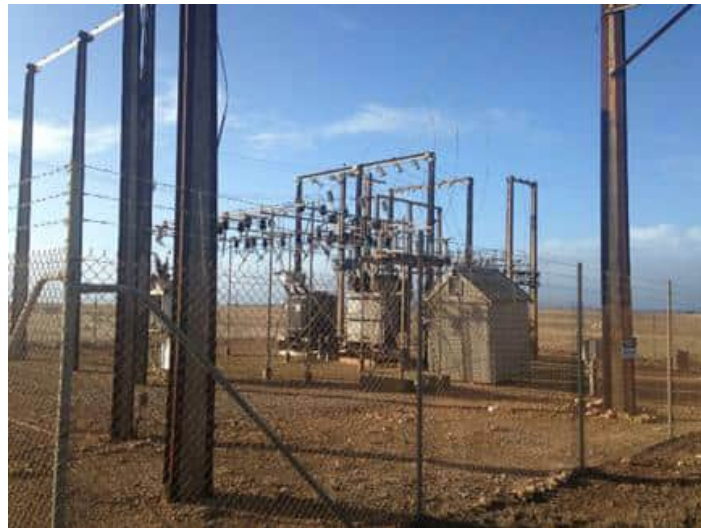
Figure 6 Electrical Substation

substation and potential lifting of the powerline height to allow for mining activities to be undertaken within a safe separation distance to the overhead transmission lines.

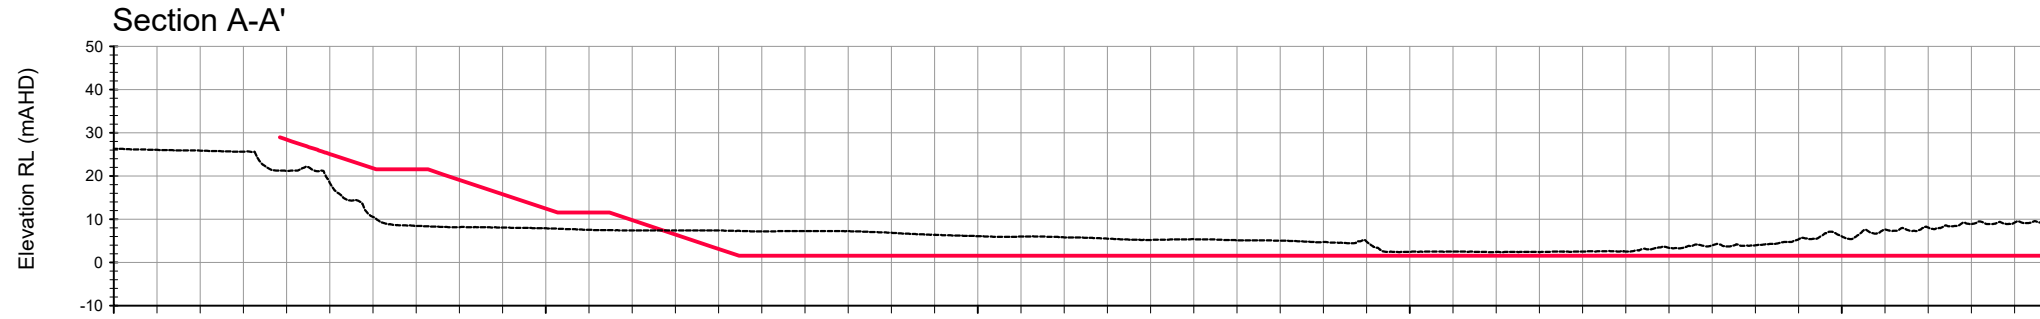
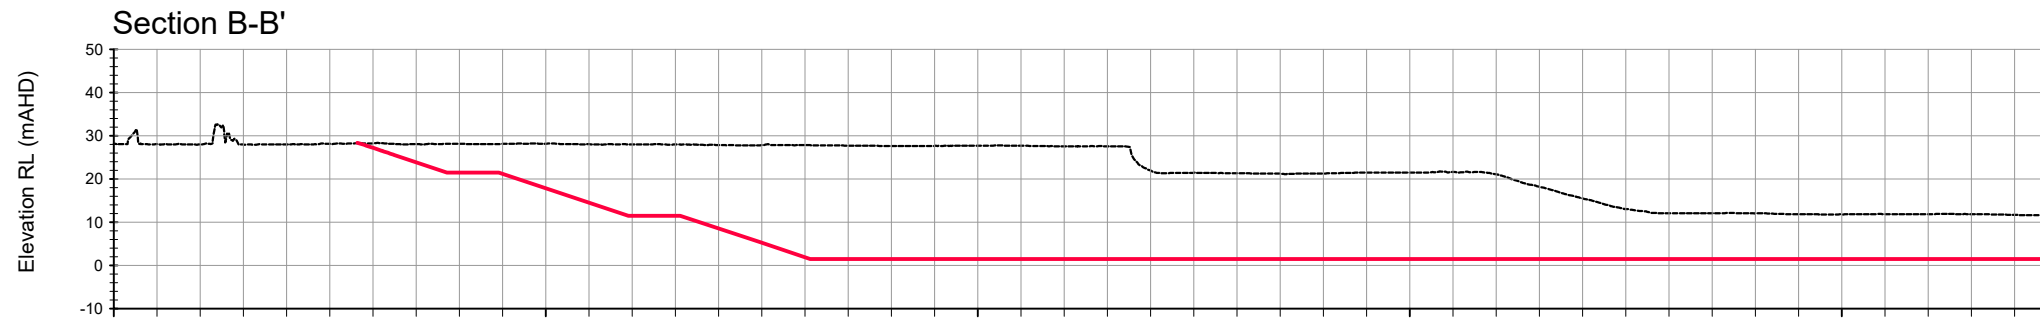
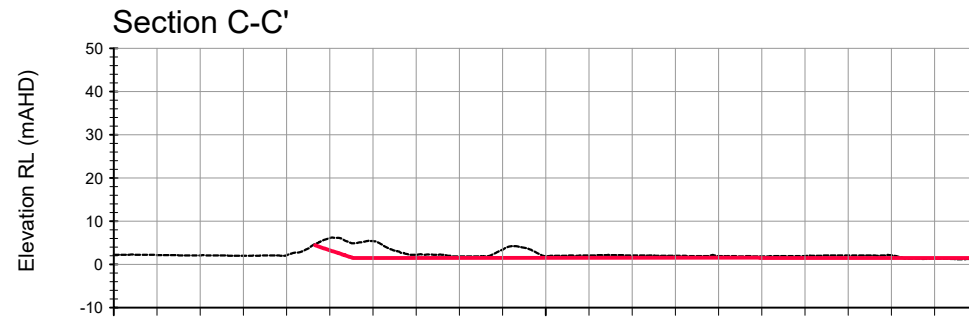
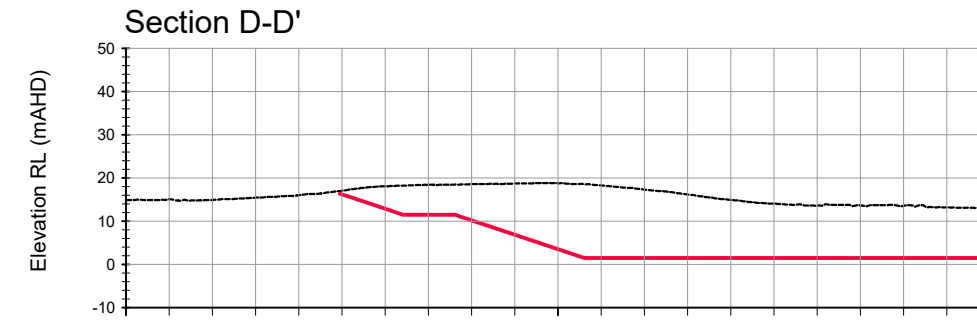
TITLE: Conceptual Combined Pit Shell Cross Sections A-A' to D-D'
 SCALE: 1:1,750
 DRAWING NUMBER: 1940.DRG.082B
 DATE: 5 March 2025
 DRAWN: JR
 CHECKED: JR
 DATUM: HORIZONTAL / VERTICAL / ZONE
 GDA2020 / MGA / AHD / 53

Chainage	10	20	30	40	50	60	70	80	90	100	110	120	130	140	150	160	170	180	190	200	210	220	230	240	250	260	270	280	290	300	310	320	330	340	350	360	370	380	390	400	410	420	430	440	450
Design Level	26.0	25.9	25.6	21.2	18.4	10.5	8.4	8.2	8.1	7.9	7.5	7.4	7.4	7.4	7.1	7.2	7.2	6.8	6.4	6.1	6.0	5.8	5.5	5.2	5.4	5.1	5.0	4.7	4.8	2.4	2.5	2.4	2.4	2.5	2.5	3.4	3.9	4.0	5.3	6.0	7.6	8.1	8.9	9.2	9.4
Existing Level	26.0	25.9	25.6	21.2	18.4	10.5	8.4	8.2	8.1	7.9	7.5	7.4	7.4	7.4	7.1	7.2	7.2	6.8	6.4	6.1	6.0	5.8	5.5	5.2	5.4	5.1	5.0	4.7	4.8	2.4	2.5	2.4	2.4	2.5	2.5	3.4	3.9	4.0	5.3	6.0	7.6	8.1	8.9	9.2	9.4

Chainage	10	20	30	40	50	60	70	80	90	100	110	120	130	140	150	160	170	180	190	200	210	220	230	240	250	260	270	280	290	300	310	320	330	340	350	360	370	380	390	400	410	420	430	440	450	
Design Level	28.0	28.0	28.0	28.0	28.1	28.2	28.0	28.1	28.1	28.2	28.0	28.0	28.0	27.9	27.8	27.8	27.7	27.6	27.6	27.7	27.7	27.6	27.6	21.9	21.4	21.3	21.2	21.3	21.5	21.5	21.6	21.1	21.1	18.2	15.5	13.0	12.1	12.1	12.0	11.8	11.8	11.9	11.8	11.9	11.7	11.5
Existing Level	28.0	28.0	28.0	28.0	28.1	28.2	28.0	28.1	28.1	28.2	28.0	28.0	28.0	27.9	27.8	27.8	27.7	27.6	27.6	27.7	27.7	27.6	27.6	21.9	21.4	21.3	21.2	21.3	21.5	21.5	21.6	21.1	21.1	18.2	15.5	13.0	12.1	12.1	12.0	11.8	11.8	11.9	11.8	11.9	11.7	11.5

Chainage	10	20	30	40	50	60	70	80	90	100	110	120	130	140	150	160	170	180	190	200
Design Level	2.2	2.1	2.0	2.1	6.1	5.4	2.2	1.9	3.4	1.9	2.1	2.1	2.0	2.0	1.9	2.0	2.1	2.1	1.4	1.3
Existing Level	2.2	2.1	2.0	2.1	6.1	5.4	2.2	1.9	3.4	1.9	2.1	2.1	2.0	2.0	1.9	2.0	2.1	2.1	1.4	1.3

Chainage	10	20	30	40	50	60	70	80	90	100	110	120	130	140	150	160	170	180	190	200
Design Level	15.1	14.9	15.4	16.0	17.0	18.1	18.4	18.6	18.7	18.8	18.3	17.3	16.2	14.9	14.0	13.6	13.7	13.6	13.2	13.0
Existing Level	15.1	14.9	15.4	16.0	17.0	18.1	18.4	18.6	18.7	18.8	18.3	17.3	16.2	14.9	14.0	13.6	13.7	13.6	13.2	13.0

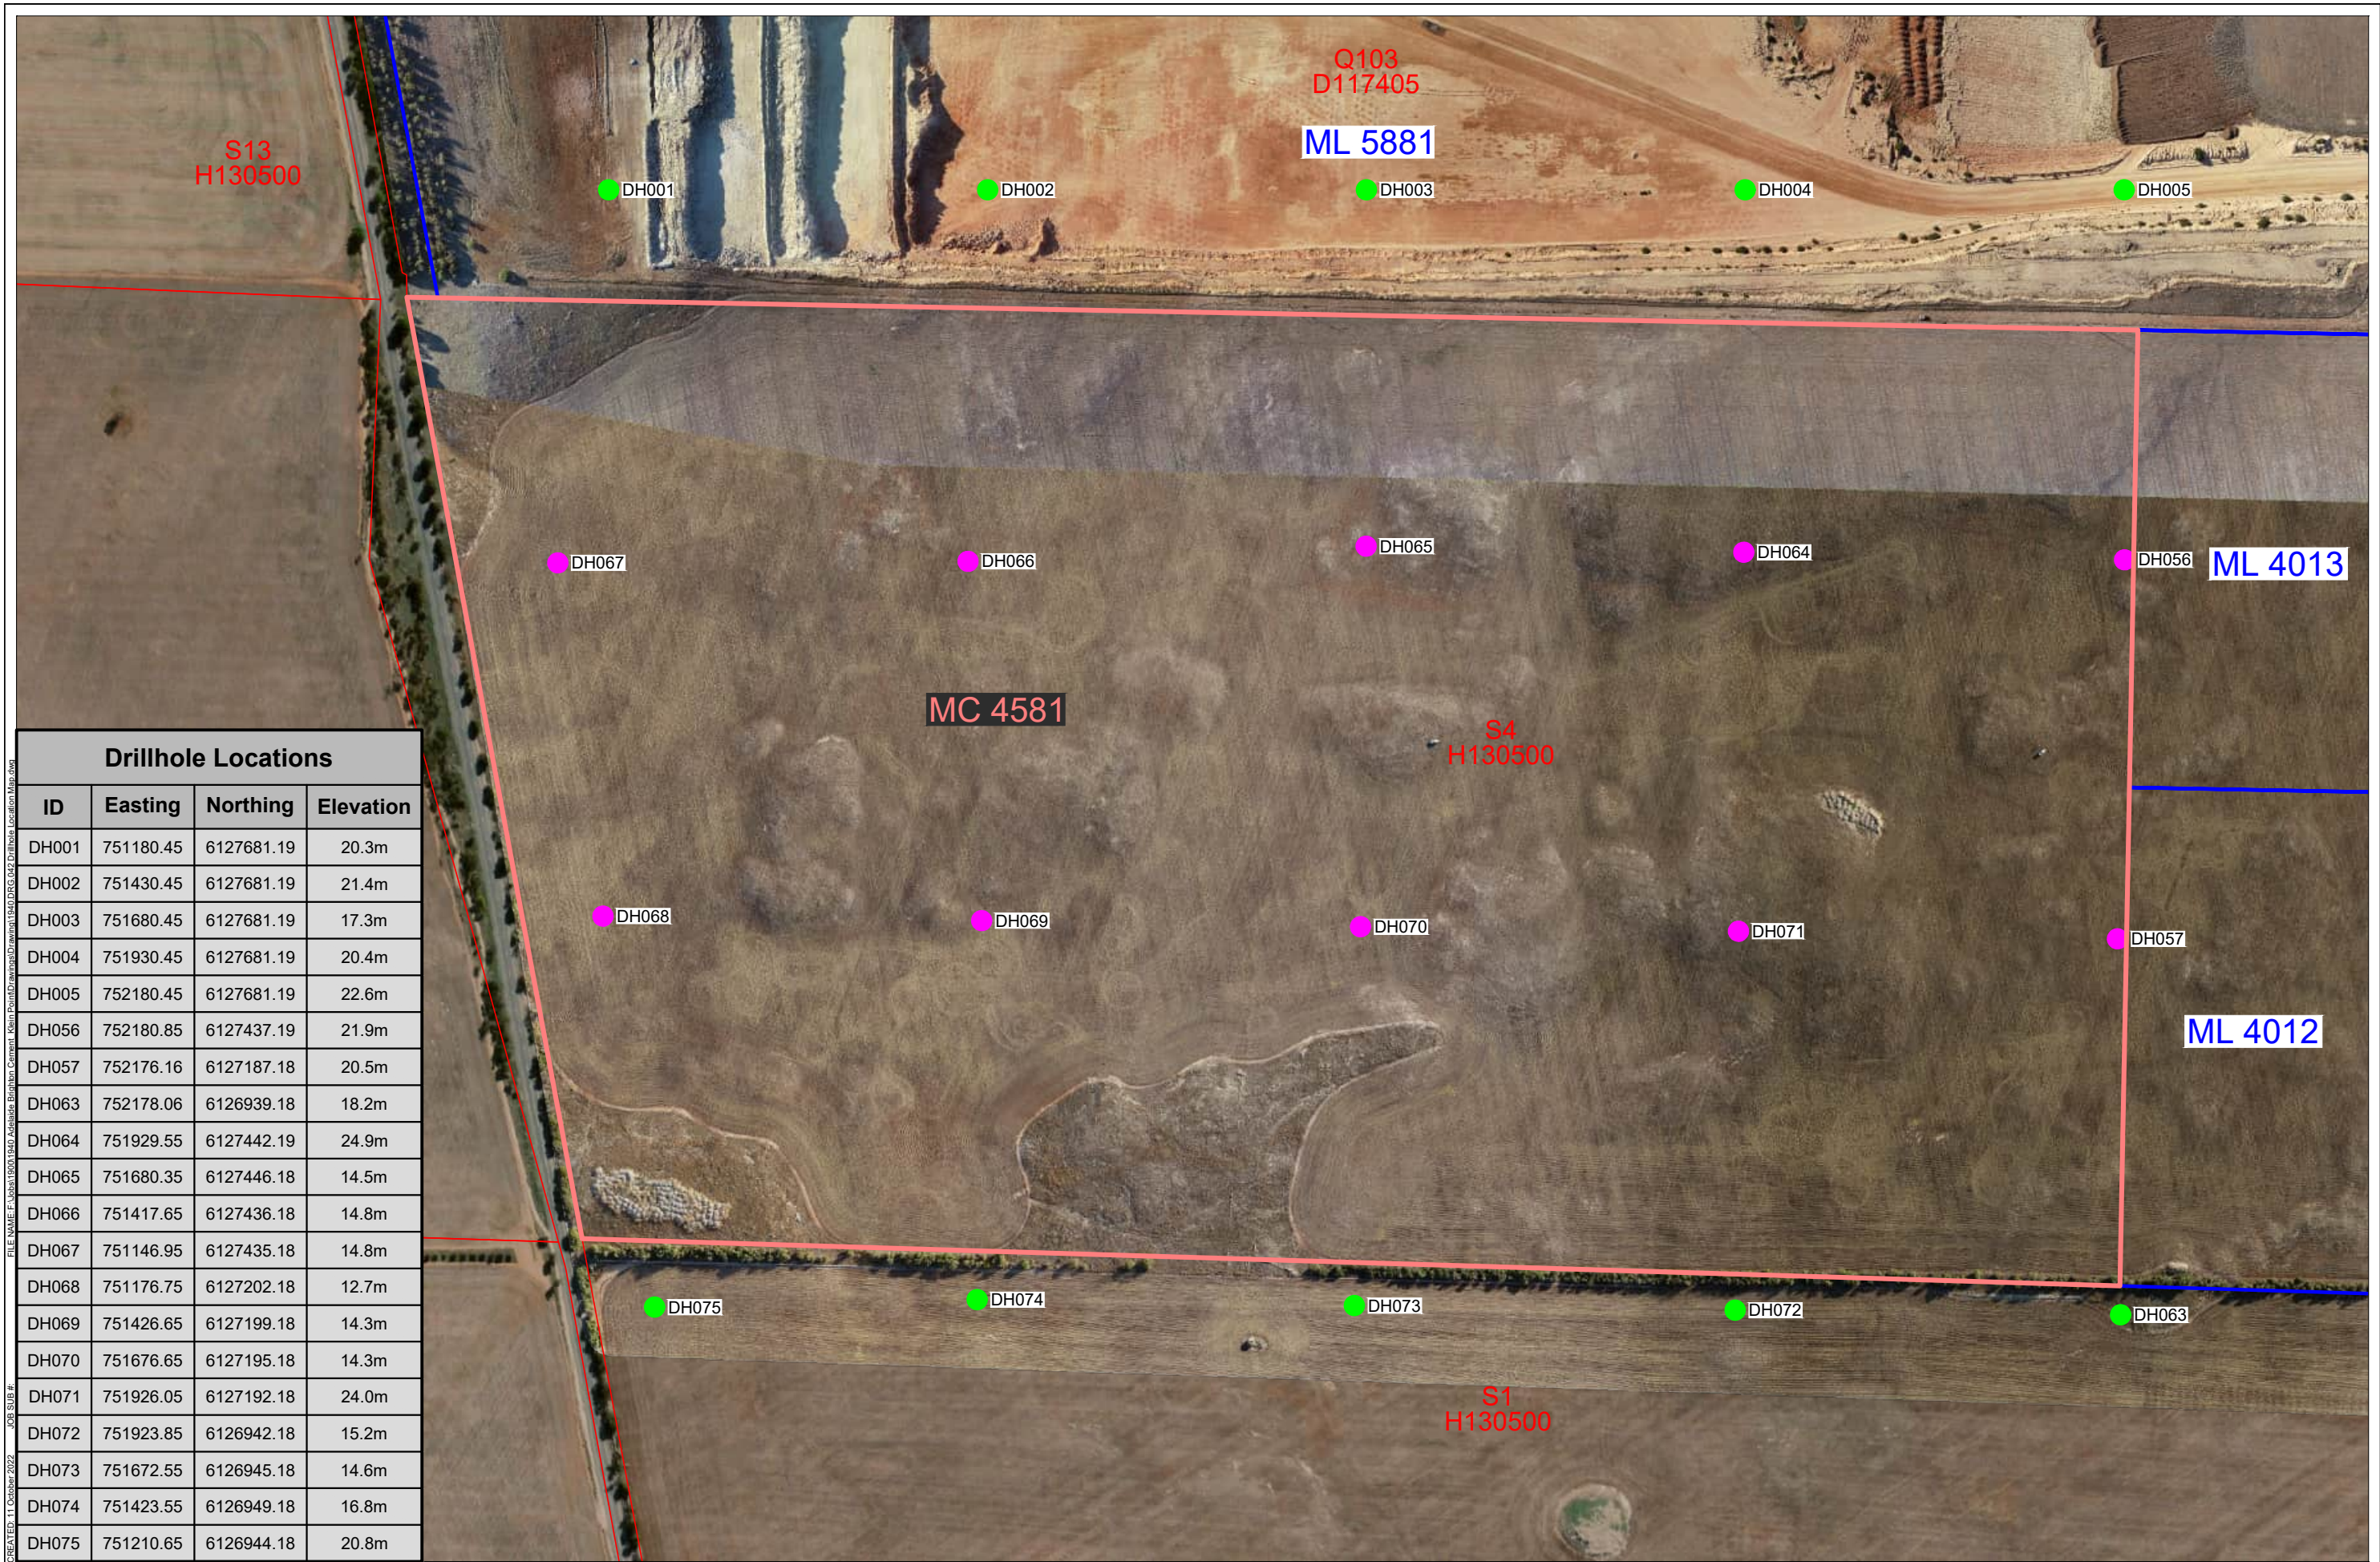
Drillhole Locations			
ID	Easting	Northing	Elevation
DH001	751180.45	6127681.19	20.3m
DH002	751430.45	6127681.19	21.4m
DH003	751680.45	6127681.19	17.3m
DH004	751930.45	6127681.19	20.4m
DH005	752180.45	6127681.19	22.6m
DH056	752180.85	6127437.19	21.9m
DH057	752176.16	6127187.18	20.5m
DH063	752178.06	6126939.18	18.2m
DH064	751929.55	6127442.19	24.9m
DH065	751680.35	6127446.18	14.5m
DH066	751417.65	6127436.18	14.8m
DH067	751146.95	6127435.18	14.8m
DH068	751176.75	6127202.18	12.7m
DH069	751426.65	6127199.18	14.3m
DH070	751676.65	6127195.18	14.3m
DH071	751926.05	6127192.18	24.0m
DH072	751923.85	6126942.18	15.2m
DH073	751672.55	6126945.18	14.6m
DH074	751423.55	6126949.18	16.8m
DH075	751210.65	6126944.18	20.8m

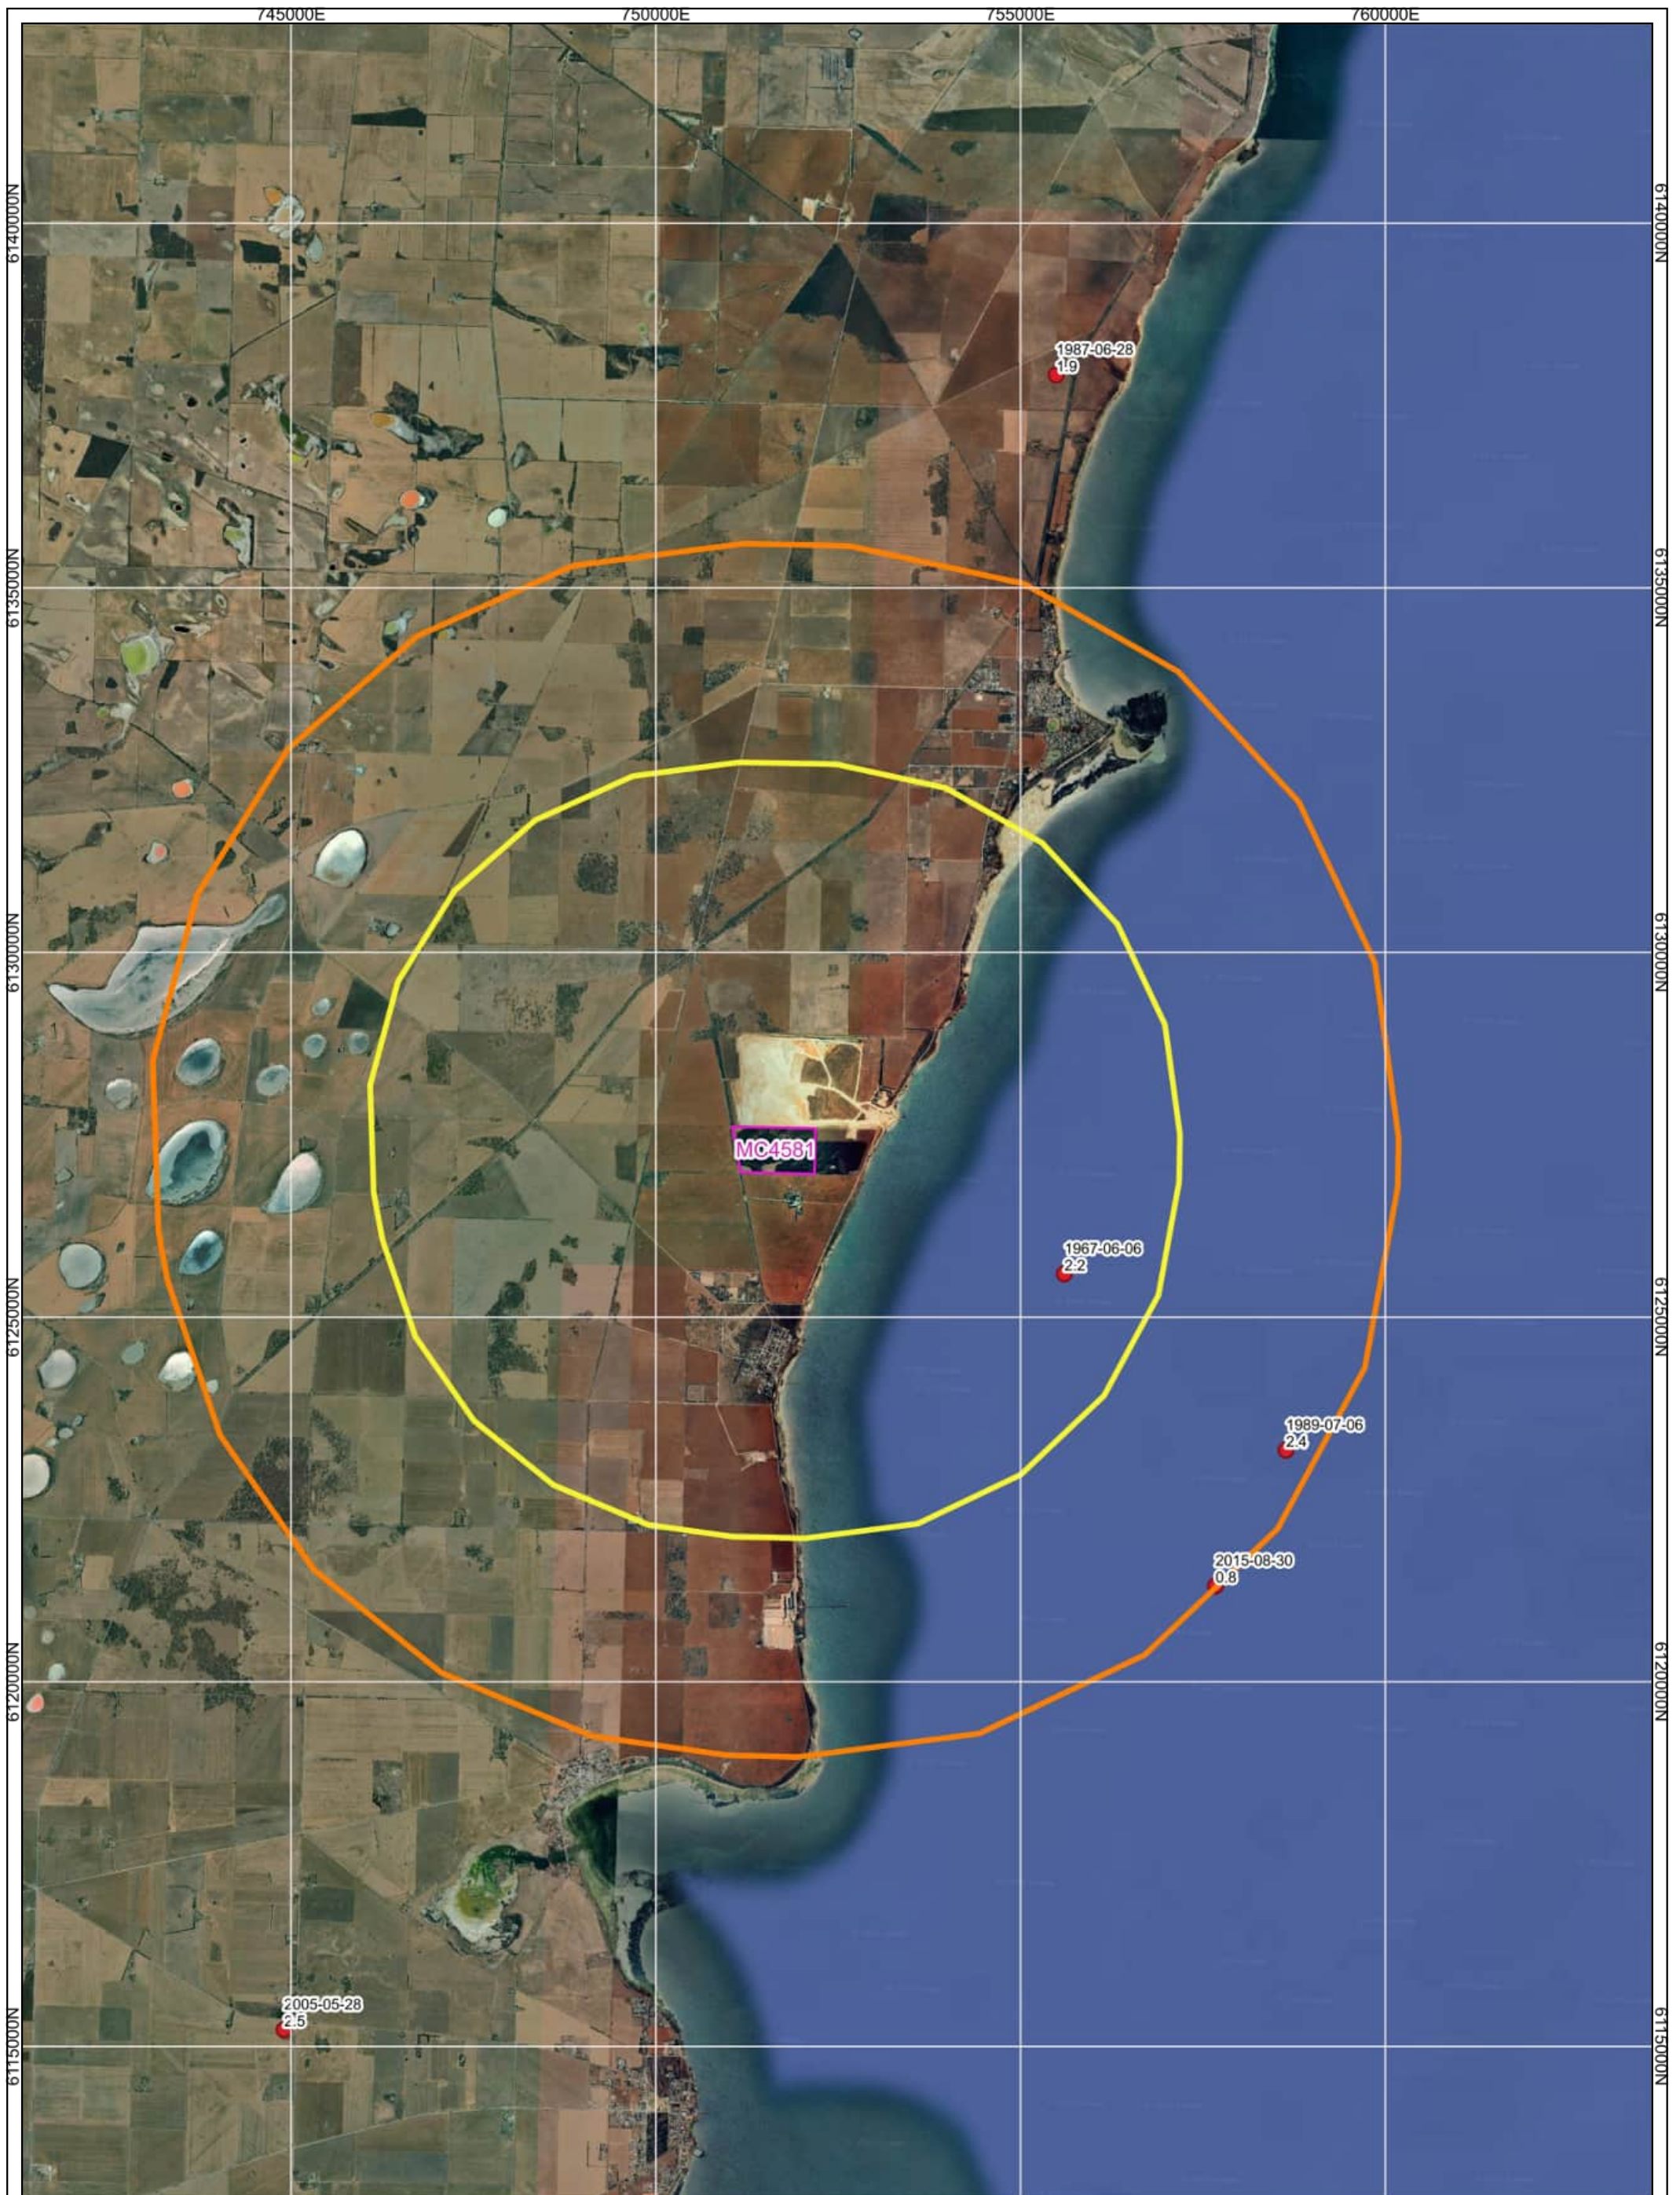
<p>Legend:</p> <ul style="list-style-type: none"> Mineral Claim Boundary 5km Buffer 8km Buffer ● All Earthquakes 		<p>PROJECT: Klein Point</p> <p>CLIENT: Adelaide Brighton Cement Ltd</p>	<p>TITLE: Geohazards Map</p>	<p>SCALE: 1:81,000</p> <p>0 400 800 1,200 1,600 m</p> <p>DATE: 21-January-2025 DRAWN: JC</p> <p>PRINTED: 21-January-2025 CHECKED: CM</p>	<p>DRAWING NUMBER: 1940.DRG.085</p> <p>DATUM: HORIZONTAL / VERTICAL / ZONE</p> <p>EPSG: 7803 MGA / AHD / 53</p>	<p>REVISION:</p>
---	--	---	------------------------------	--	---	------------------

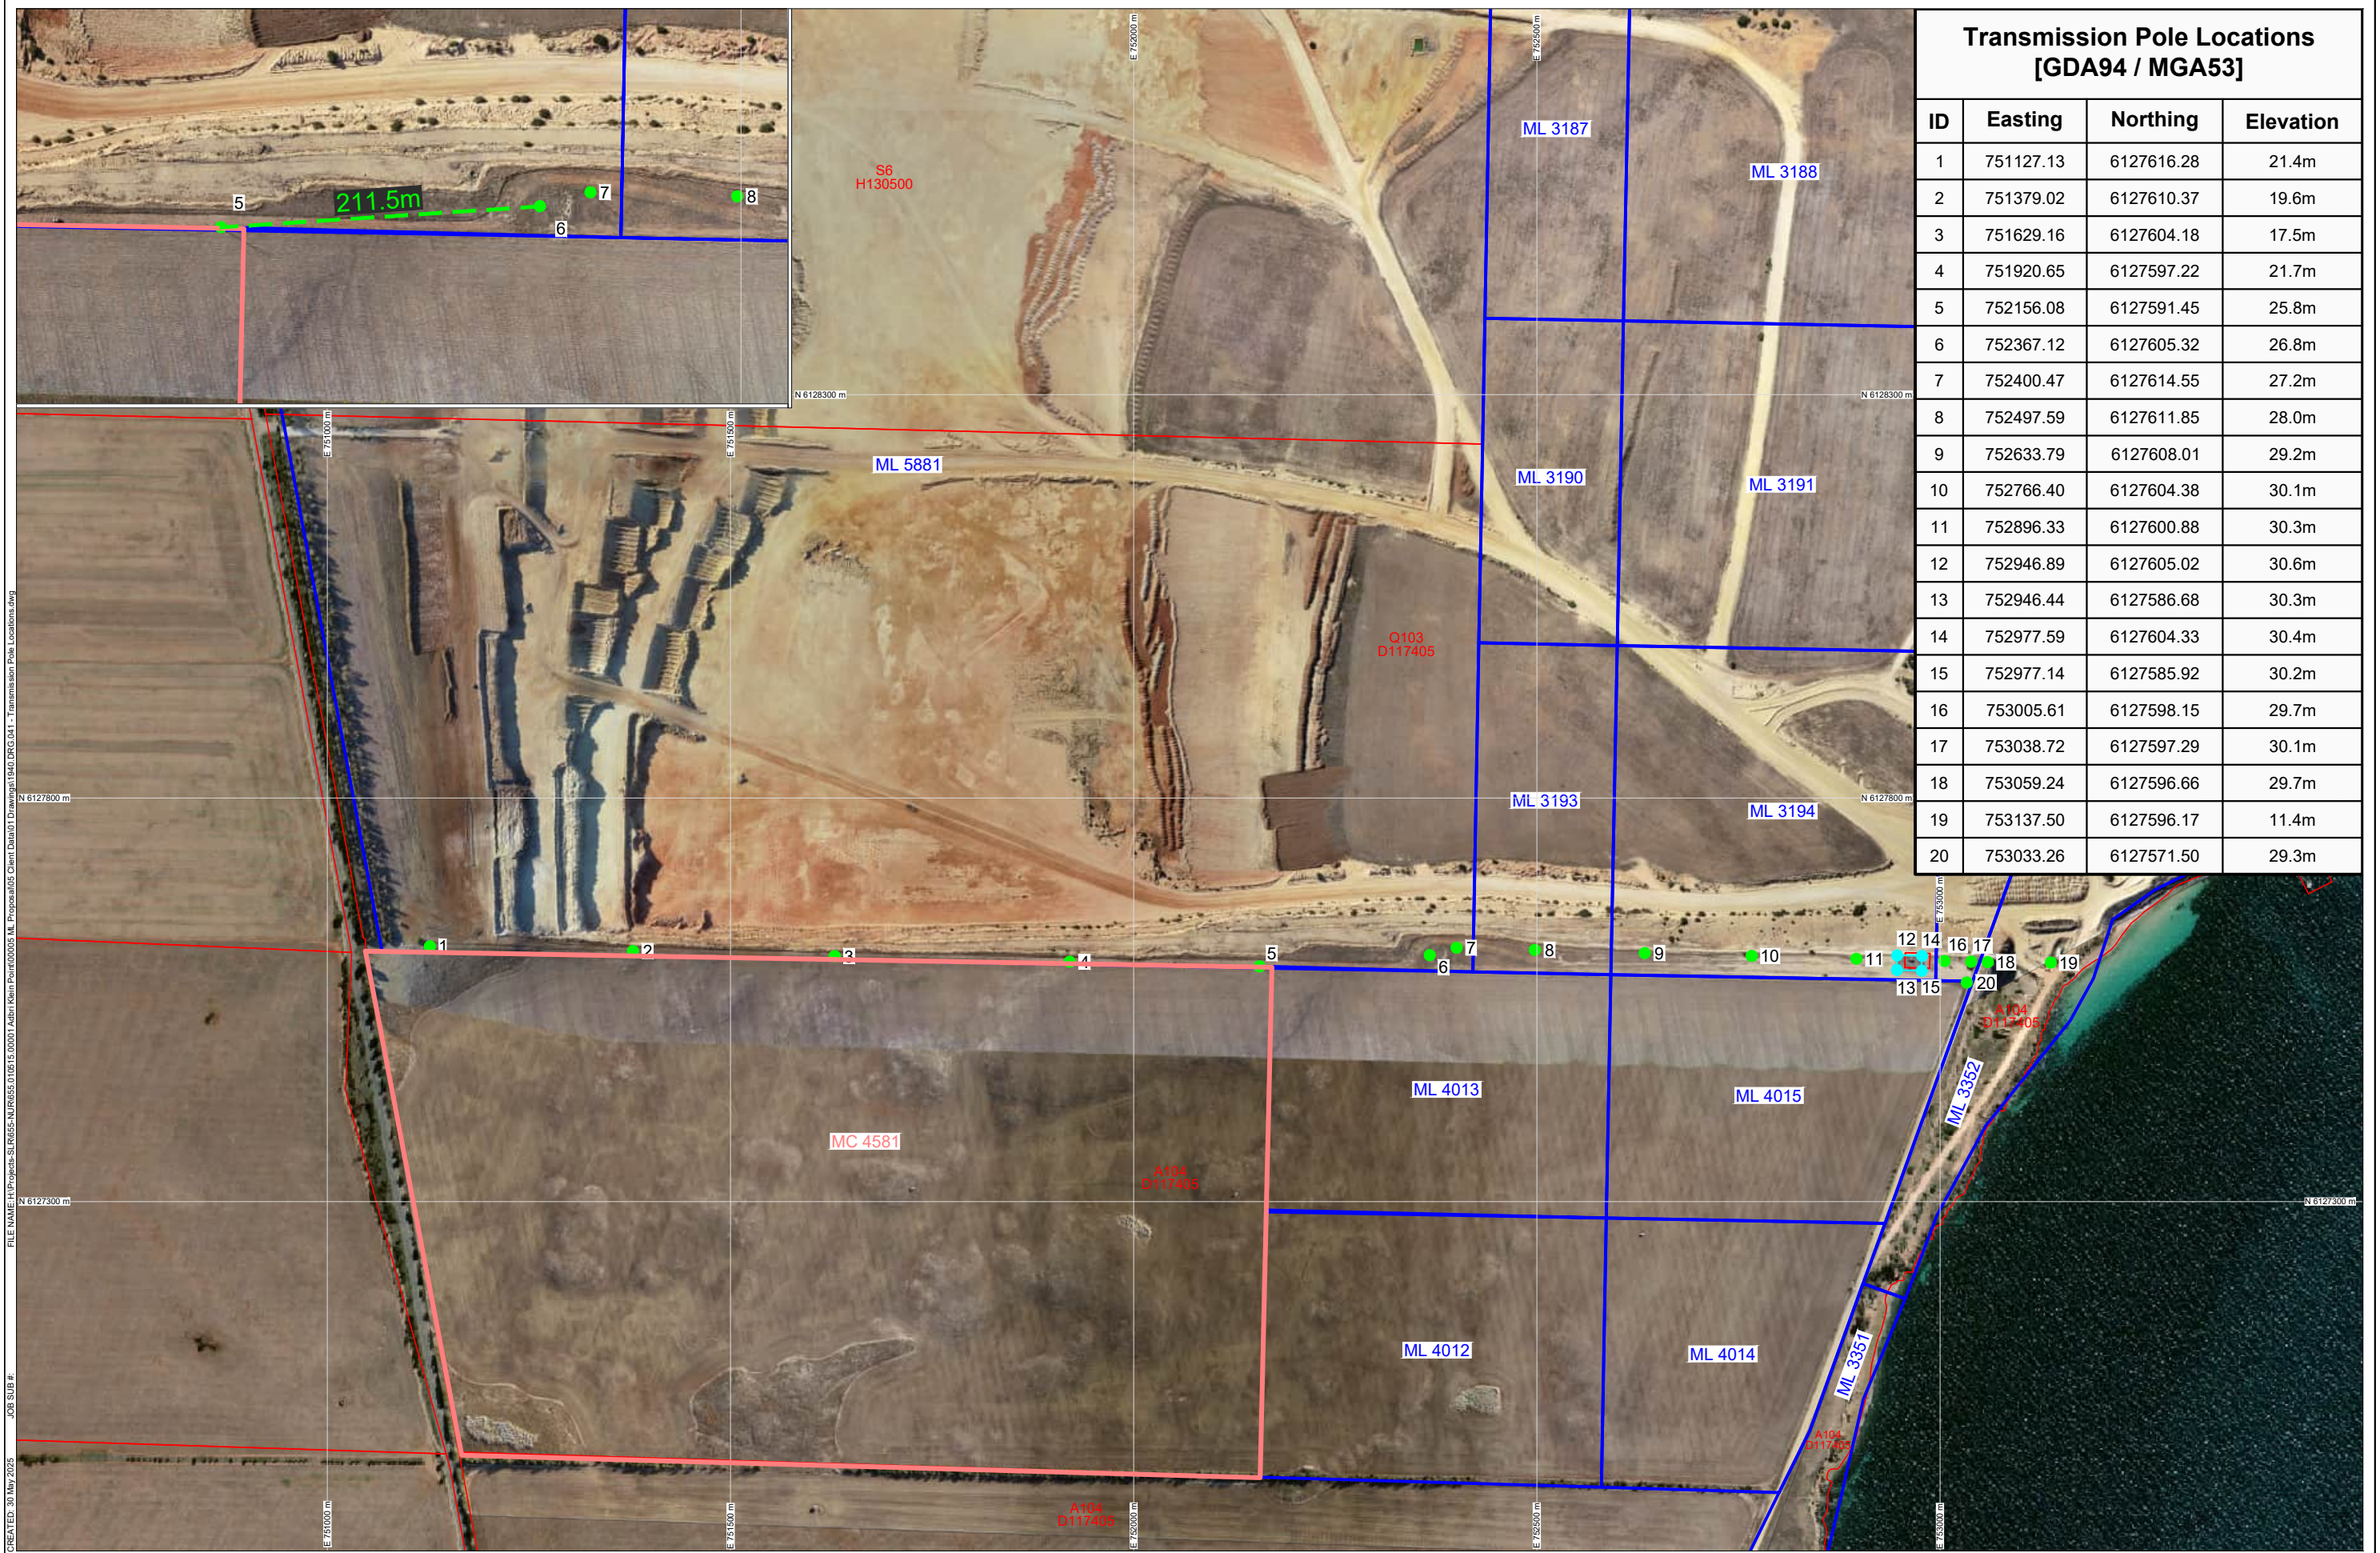
TITLE: Transmission Pole Locations
 SCALE: 1:7,500
 DRAWING NUMBER: 1940.DRG.041
 DATE: 30 May 2025
 DRAWN: JR
 CHECKED: JR
 DATUM: HORIZONTAL / VERTICAL / ZONE
 GDA94 / MGA / AHD / 53

Transmission Pole Locations [GDA94 / MGA53]			
ID	Easting	Northing	Elevation
1	751127.13	6127616.28	21.4m
2	751379.02	6127610.37	19.6m
3	751629.16	6127604.18	17.5m
4	751920.65	6127597.22	21.7m
5	752156.08	6127591.45	25.8m
6	752367.12	6127605.32	26.8m
7	752400.47	6127614.55	27.2m
8	752497.59	6127611.85	28.0m
9	752633.79	6127608.01	29.2m
10	752766.40	6127604.38	30.1m
11	752896.33	6127600.88	30.3m
12	752946.89	6127605.02	30.6m
13	752946.44	6127586.68	30.3m
14	752977.59	6127604.33	30.4m
15	752977.14	6127585.92	30.2m
16	753005.61	6127598.15	29.7m
17	753038.72	6127597.29	30.1m
18	753059.24	6127596.66	29.7m
19	753137.50	6127596.17	11.4m
20	753033.26	6127571.50	29.3m

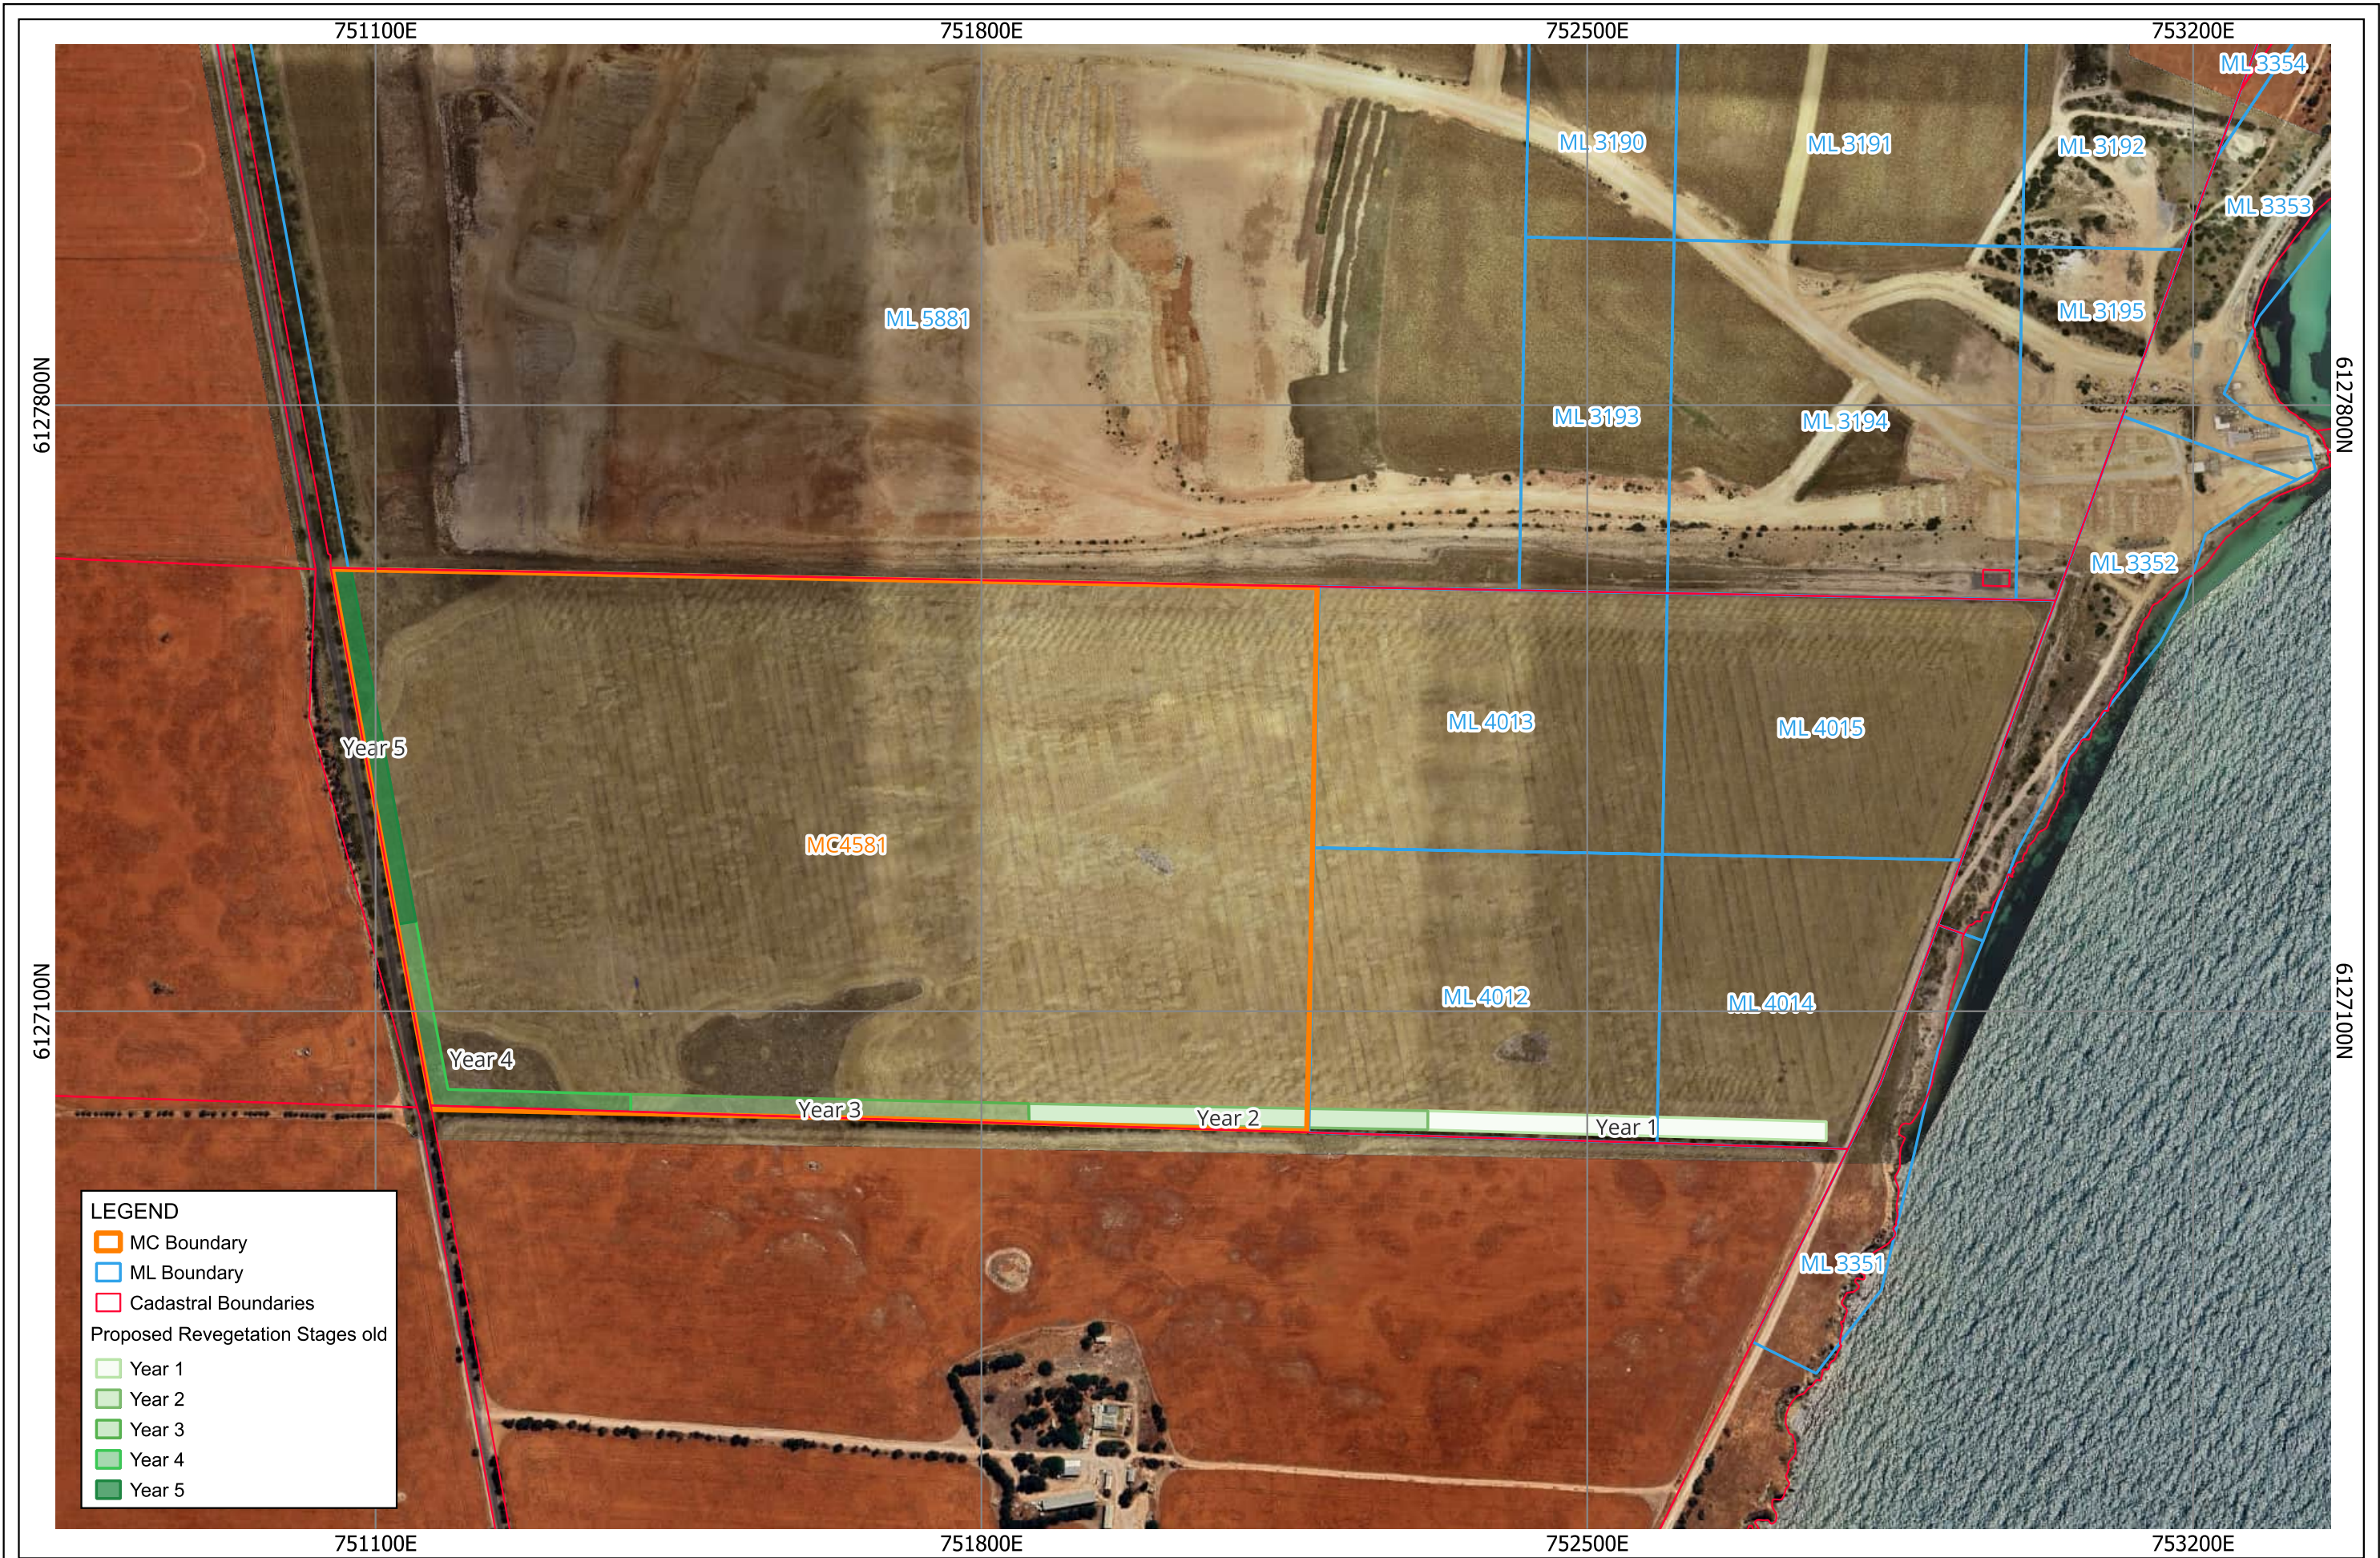
TITLE: Heritage Map		SCALE: 1:30,000	DRAWING NUMBER: 1940.DRG.086	REVISION:
PROJECT: Klein Point		0 100 200 300 400 m	DATE: 26-June-2024	DATE: 26-June-2024
CLIENT: Adelaide Brighton Cement Ltd		PRINTED: 26-June-2024	CHECKED: CM	DATUM: MGA / AHD / 54
