Mining Lease Proposal (MLP)

ABCL Klein Point (MC 4581)

Adelaide Brighton Cement Limited

SLR Consulting Australia Pty Ltd

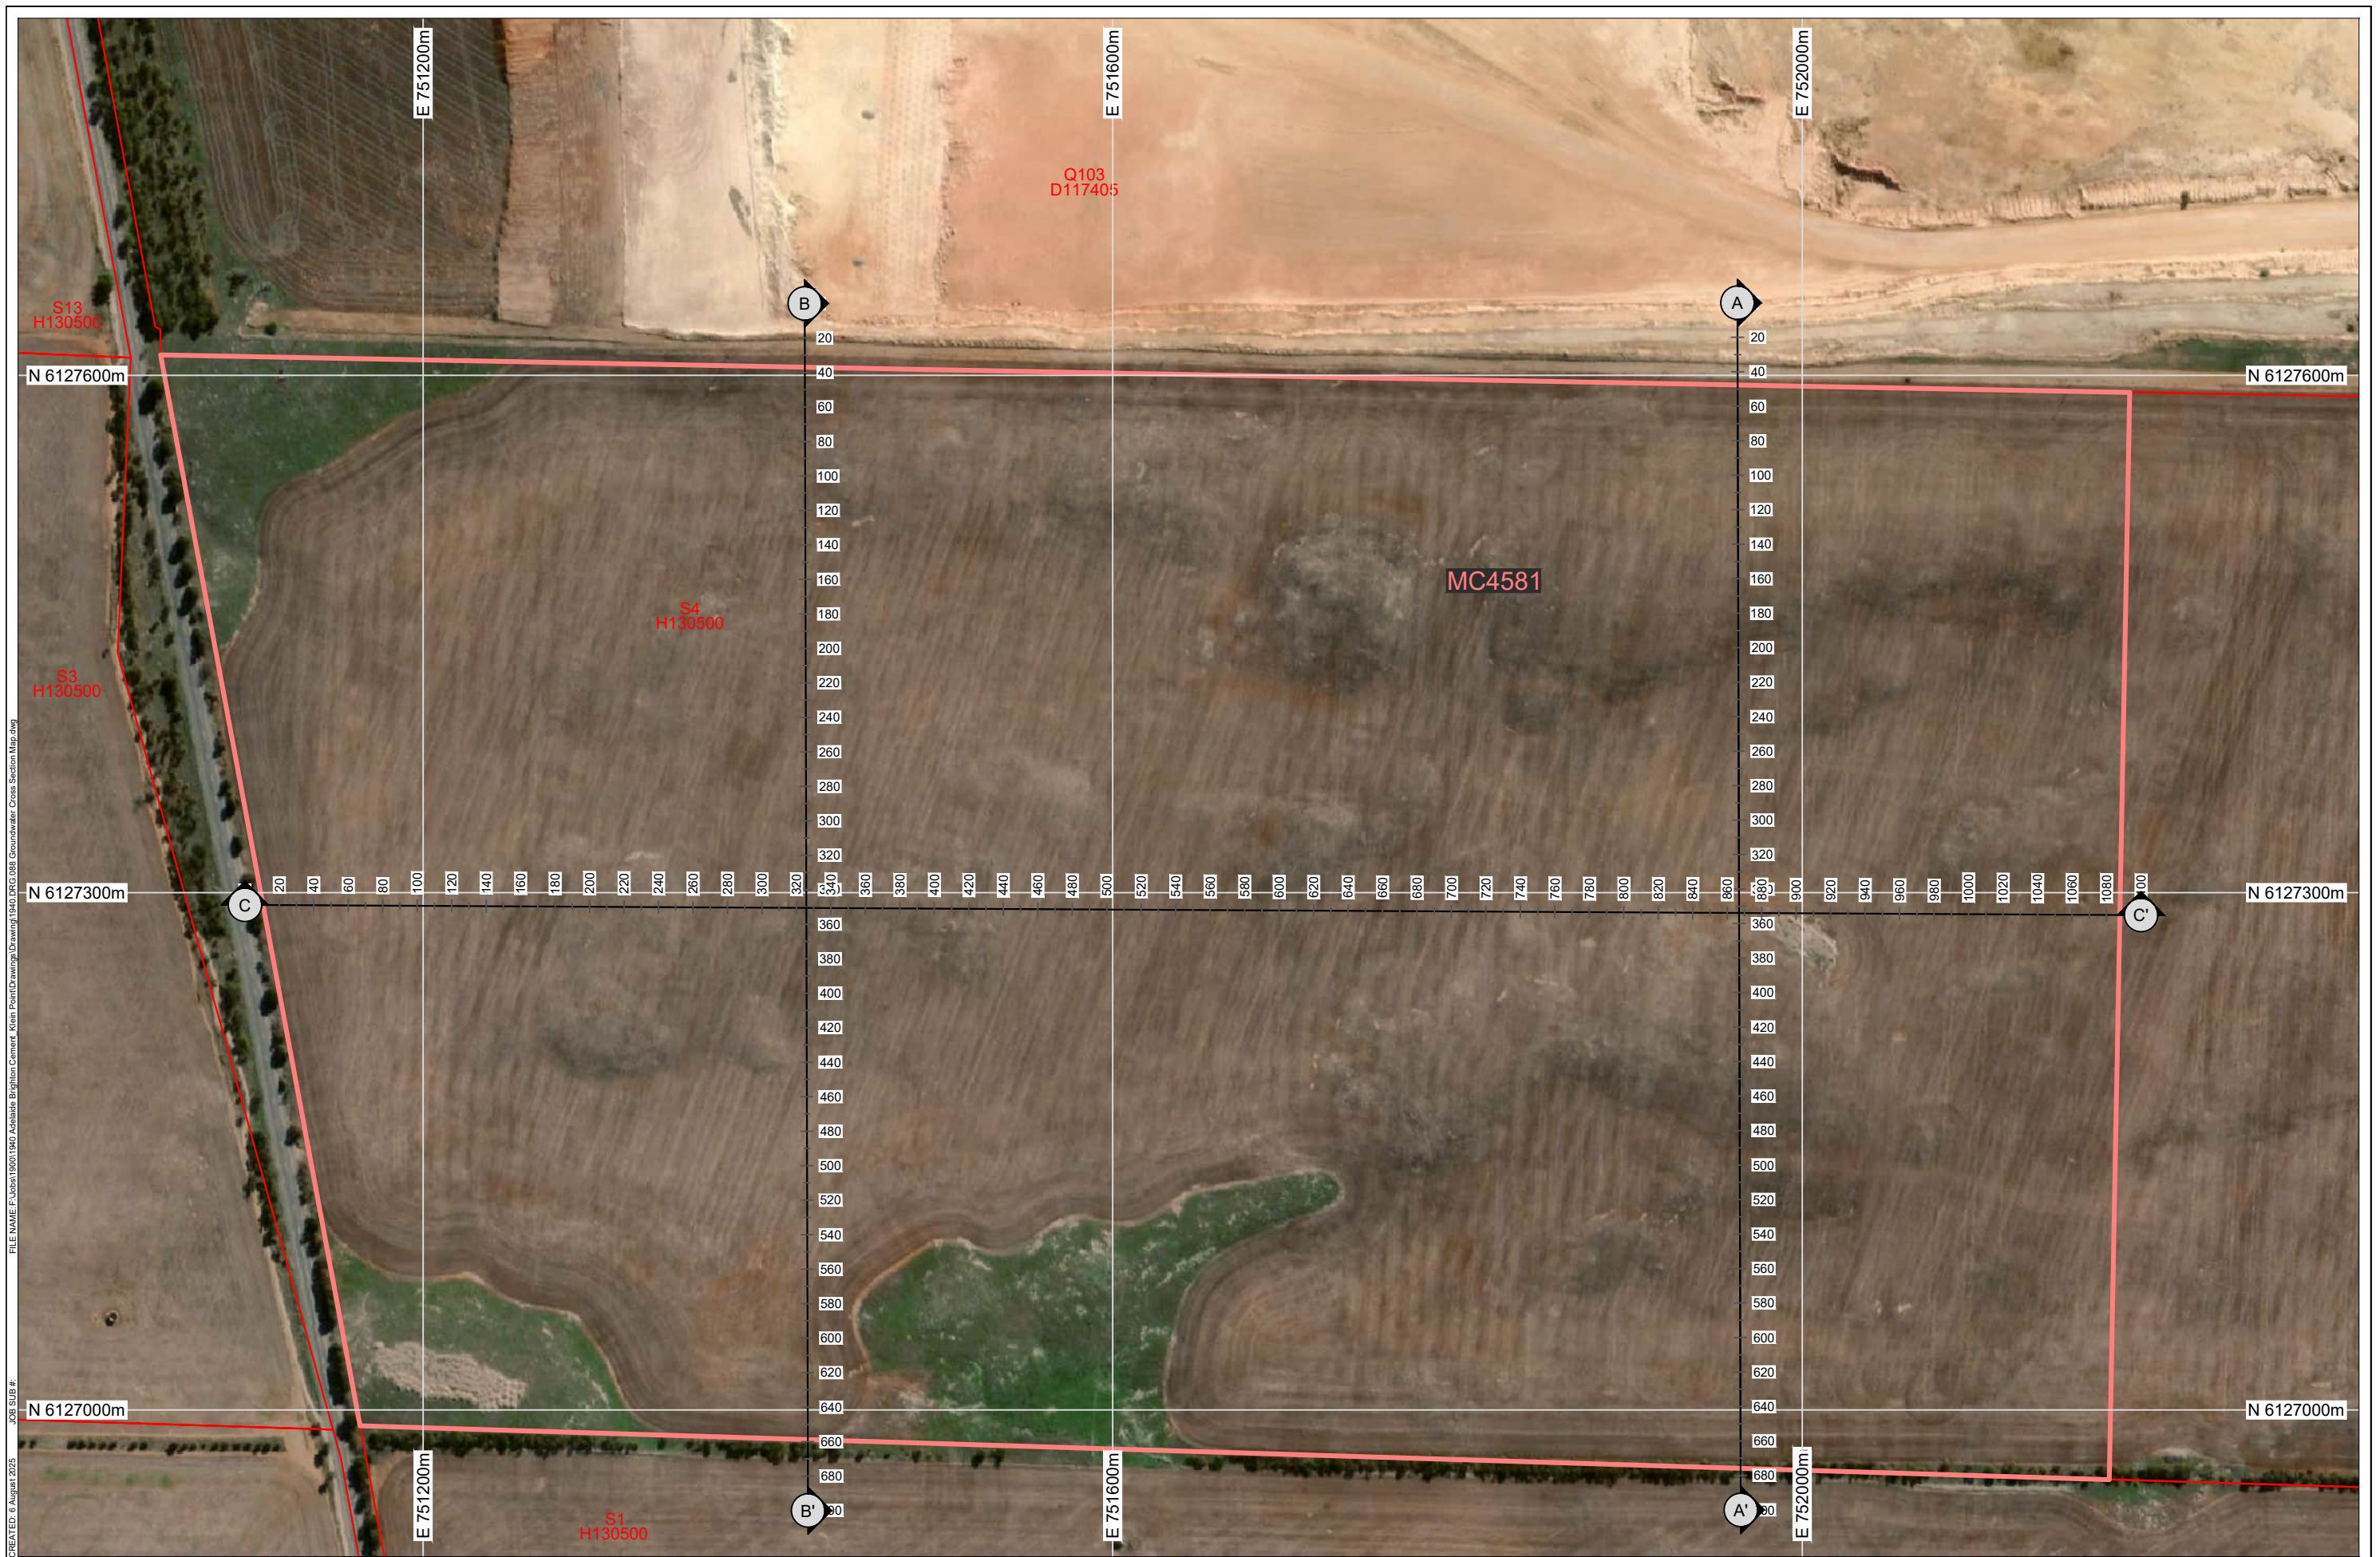
FILE NAME: F:\Jobs\190001940 Adelaide Brighton Cement - Klein Point\Drawings\Drawing\1940.DRG.088 Groundwater Cross Section Map.dwg
 JOB SUB #
 CREATED: 6 August 2025

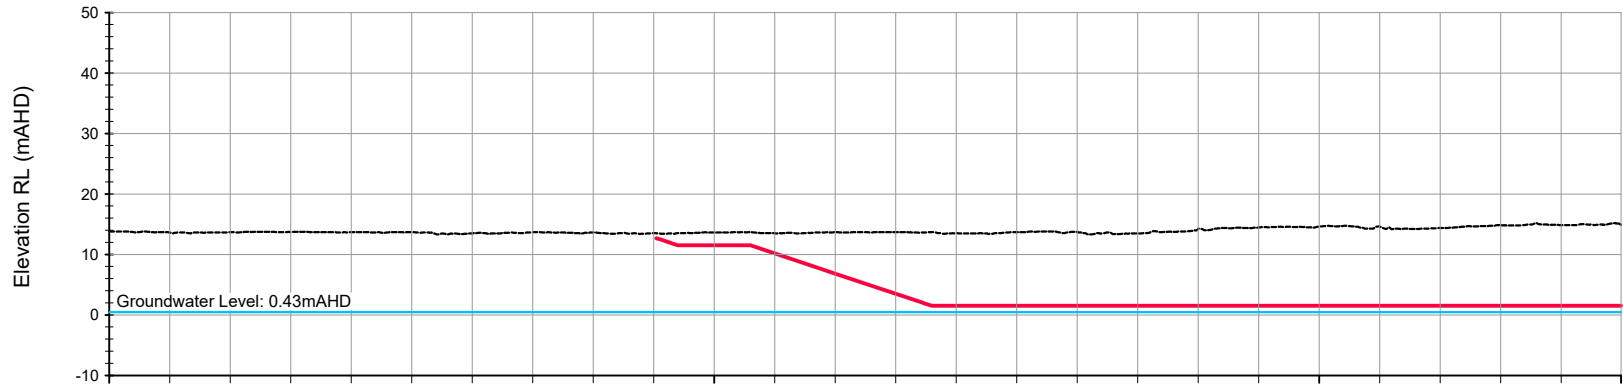
Section A-A'

Chainage	10	20	30	40	50	60	70	80	90	100	110	120	130	140	150	160	170	180	190	200	210	220	230	240	250	
Design Level										11.5	10.2	6.8	3.5	1.5	1.5	1.5	1.5	1.5	1.5	1.5	1.5	1.5	1.5	1.5	1.5	1.5
Existing Level	13.6	13.7	13.7	13.7	13.7	13.5	13.7	13.6	13.5	13.6	13.5	13.7	13.7	13.5	13.7	13.7	13.5	14.2	14.5	14.6	14.6	14.4	14.8	14.9	14.9

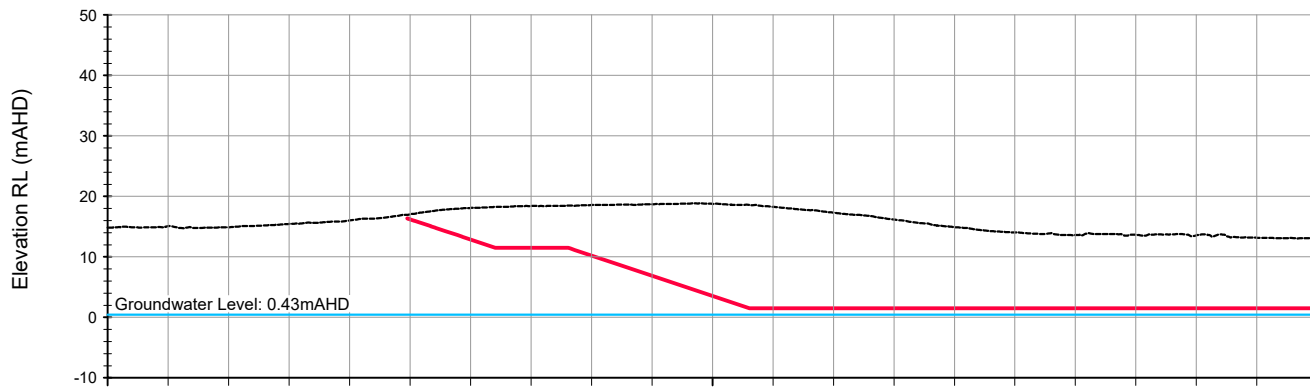
Section B-B'

Chainage	10	20	30	40	50	60	70	80	90	100	110	120	130	140	150	160	170	180	190	200	
Design Level					16.2	12.9	11.5	10.2	6.9	3.5	1.5	1.5	1.5	1.5	1.5	1.5	1.5	1.5	1.5	1.5	1.5
Existing Level	15.1	14.9	15.4	16.0	17.0	18.1	18.4	18.6	18.7	18.8	18.3	17.3	16.2	14.9	14.0	13.6	13.7	13.6	13.2	13.0

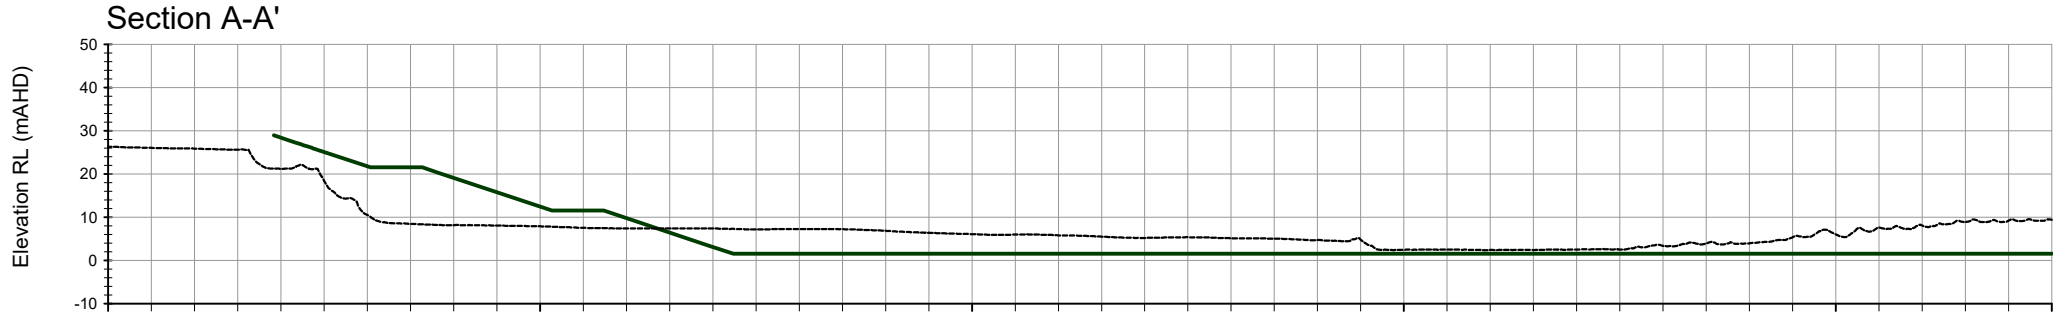
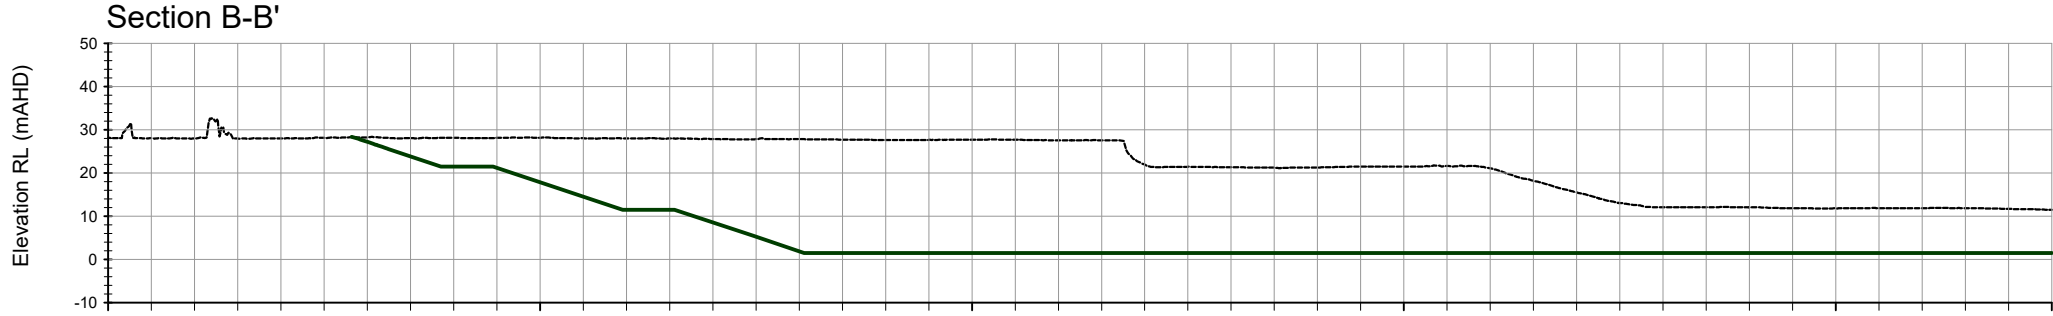
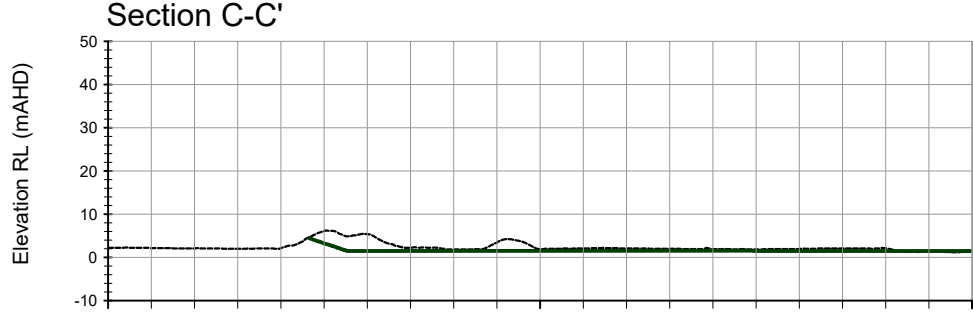
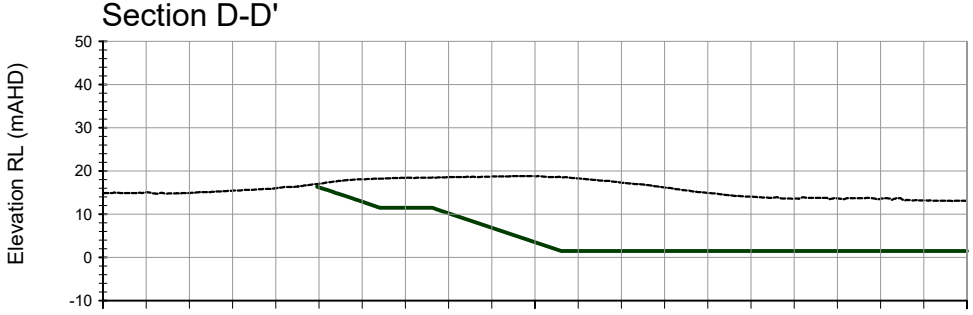
Chainage	10	20	30	40	50	60	70	80	90	100	110	120	130	140	150	160	170	180	190	200	210	220	230	240	250	260	270	280	290	300	310	320	330	340	350	360	370	380	390	400	410	420	430	440	450
Design Level	26.0	25.9	25.6	21.2	18.4	10.5	8.4	8.2	8.1	7.9	7.5	7.4	7.4	7.4	7.1	7.2	7.2	6.8	6.4	6.1	6.0	5.8	5.5	5.2	5.4	5.1	5.0	4.7	4.8	2.4	2.5	2.4	2.4	2.5	2.5	3.4	3.9	4.0	5.3	6.0	7.6	8.1	8.9	9.2	9.4
Existing Level	26.0	25.9	25.6	21.2	18.4	10.5	8.4	8.2	8.1	7.9	7.5	7.4	7.4	7.4	7.1	7.2	7.2	6.8	6.4	6.1	6.0	5.8	5.5	5.2	5.4	5.1	5.0	4.7	4.8	2.4	2.5	2.4	2.4	2.5	2.5	3.4	3.9	4.0	5.3	6.0	7.6	8.1	8.9	9.2	9.4

Chainage	10	20	30	40	50	60	70	80	90	100	110	120	130	140	150	160	170	180	190	200	210	220	230	240	250	260	270	280	290	300	310	320	330	340	350	360	370	380	390	400	410	420	430	440	450
Design Level	28.0	28.0	28.0	28.0	28.1	28.2	28.0	28.1	28.1	28.2	28.0	28.0	28.0	27.9	27.8	27.8	27.7	27.6	27.7	27.7	27.6	27.6	21.9	21.4	21.3	21.2	21.3	21.5	21.5	21.6	21.1	18.2	15.5	13.0	12.1	12.1	12.0	11.8	11.8	11.9	11.8	11.9	11.7	11.5	
Existing Level	28.0	28.0	28.0	28.0	28.1	28.2	28.0	28.1	28.1	28.2	28.0	28.0	28.0	27.9	27.8	27.8	27.7	27.6	27.7	27.7	27.6	27.6	21.9	21.4	21.3	21.2	21.3	21.5	21.5	21.6	21.1	18.2	15.5	13.0	12.1	12.1	12.0	11.8	11.8	11.9	11.8	11.9	11.7	11.5

Chainage	10	20	30	40	50	60	70	80	90	100	110	120	130	140	150	160	170	180	190	200
Design Level	2.2	2.1	2.0	2.1	6.1	5.4	2.2	1.9	3.4	1.9	2.1	2.1	2.0	2.0	1.9	2.0	2.1	2.1	1.4	1.3
Existing Level	2.2	2.1	2.0	2.1	6.1	5.4	2.2	1.9	3.4	1.9	2.1	2.1	2.0	2.0	1.9	2.0	2.1	2.1	1.4	1.3

Chainage	10	20	30	40	50	60	70	80	90	100	110	120	130	140	150	160	170	180	190	200
Design Level	15.1	14.9	15.4	16.0	17.0	18.1	18.4	18.6	18.7	18.8	18.3	17.3	16.2	14.9	14.0	13.6	13.7	13.6	13.2	13.0
Existing Level	15.1	14.9	15.4	16.0	17.0	18.1	18.4	18.6	18.7	18.8	18.3	17.3	16.2	14.9	14.0	13.6	13.7	13.6	13.2	13.0

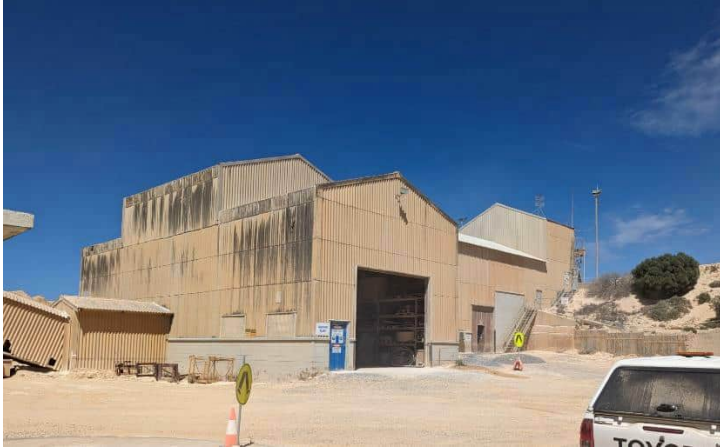
The main door open, where a large amount of dust does exit.

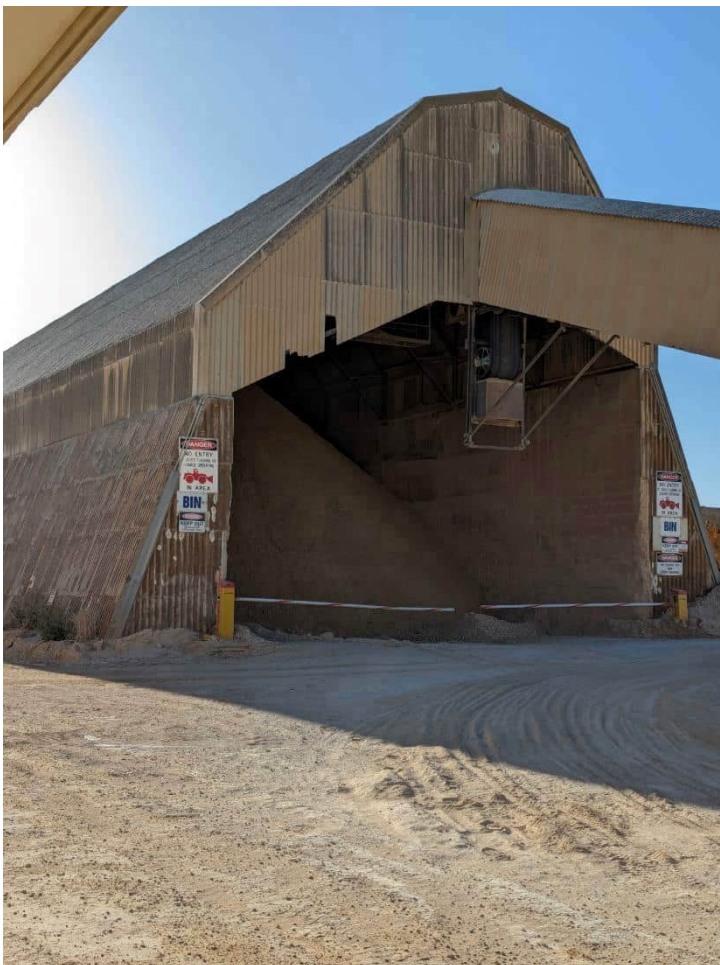
The transfer shed is where a large amount of dust can be produced and dissipate across the site. Only access with a front loader is permitted.

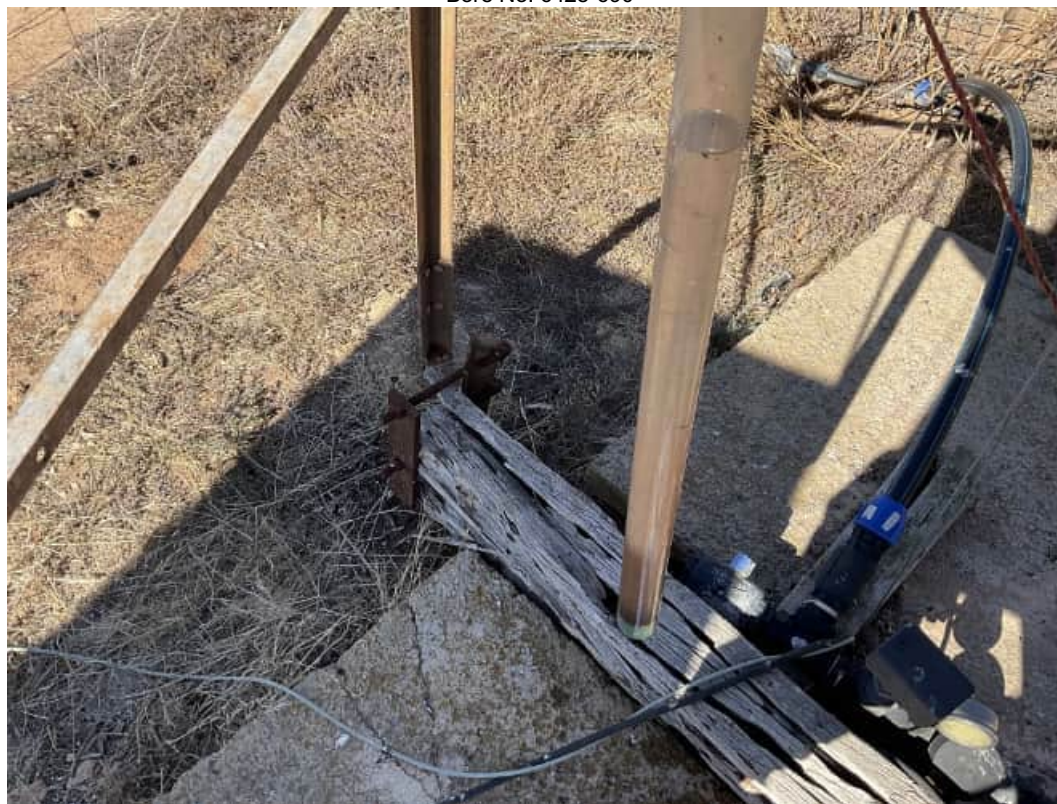
Bore No. 6428-690

31/1/2018 Bore No. 6428-690: Bore depth check, as per PEPR

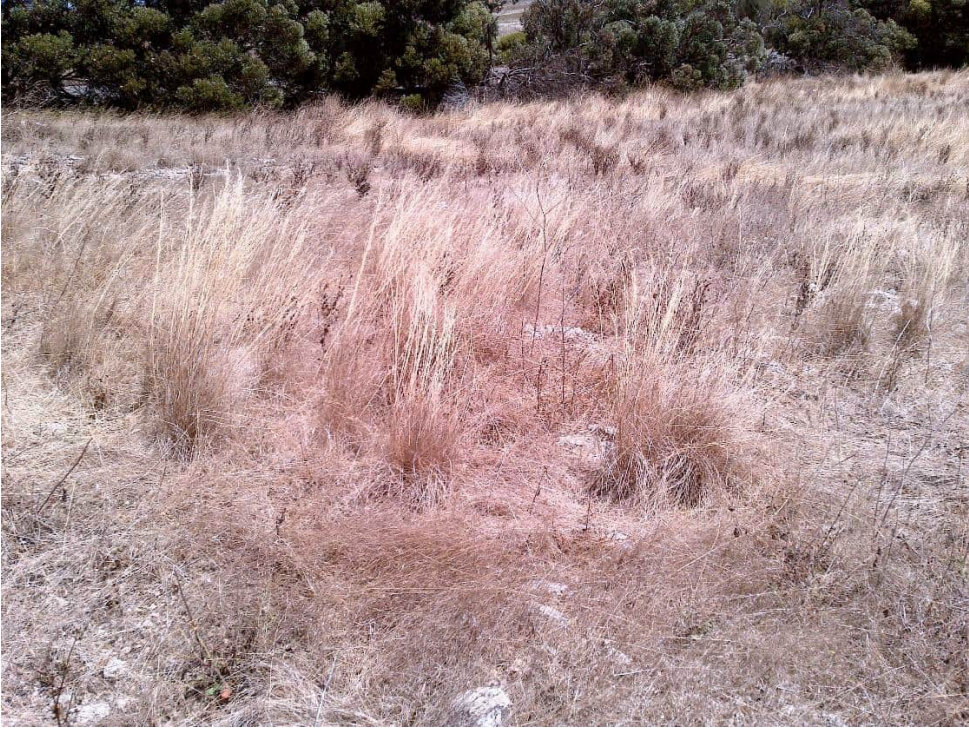
<p>Photo Point 1 – Vegetation Association 1 (MGA Zone 54 S34° 58.079' E137° 45.074')</p>	
General description	Highly degraded native vegetation reduced to scattered clumps of <i>Austrostipa</i> sp. +/- <i>Rytidosperma</i> spp. most likely colonising since original land clearance. Situated within sections of the Site not subject to regular cropping due to their rocky soil composition. Predominately on the fringes of the Site. Association

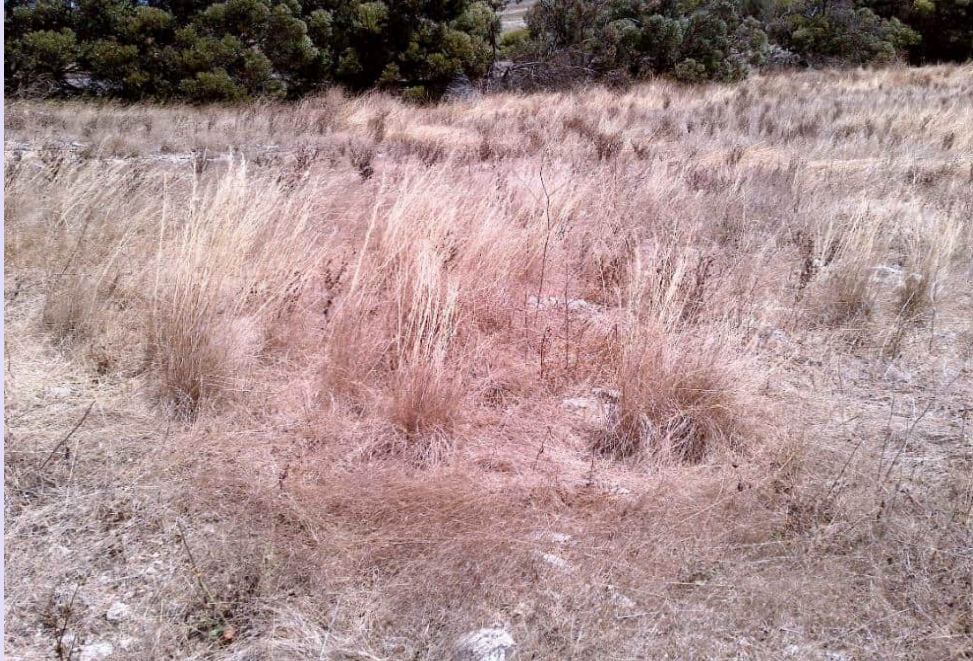
West	
	GPS Reference	
	Datum	
	Zone (52, 53 or 54)	53
	Easting (6 digits)	
Northing (7 digits)		
	Description	
	Highly degraded native vegetation reduced to scattered clumps of <i>Austrostipa</i> sp. +/- <i>Rytidosperma</i> spp. most likely colonising since the original land clearance.

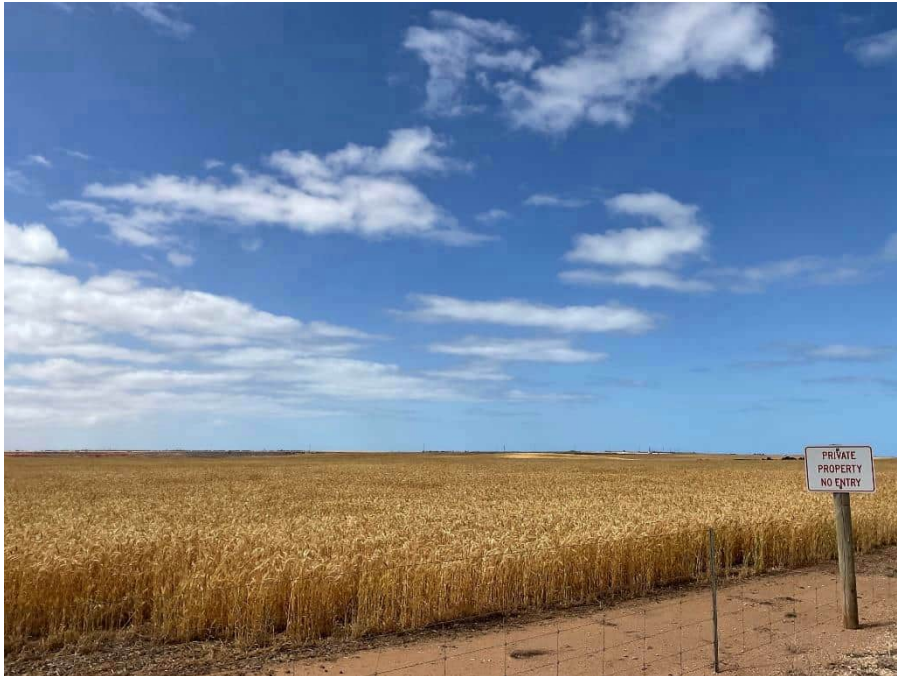
Photo 1: View from Hayward Park Road/Landowner driveway facing north-east. View of working faces and minor view of operations (04/11/2024)

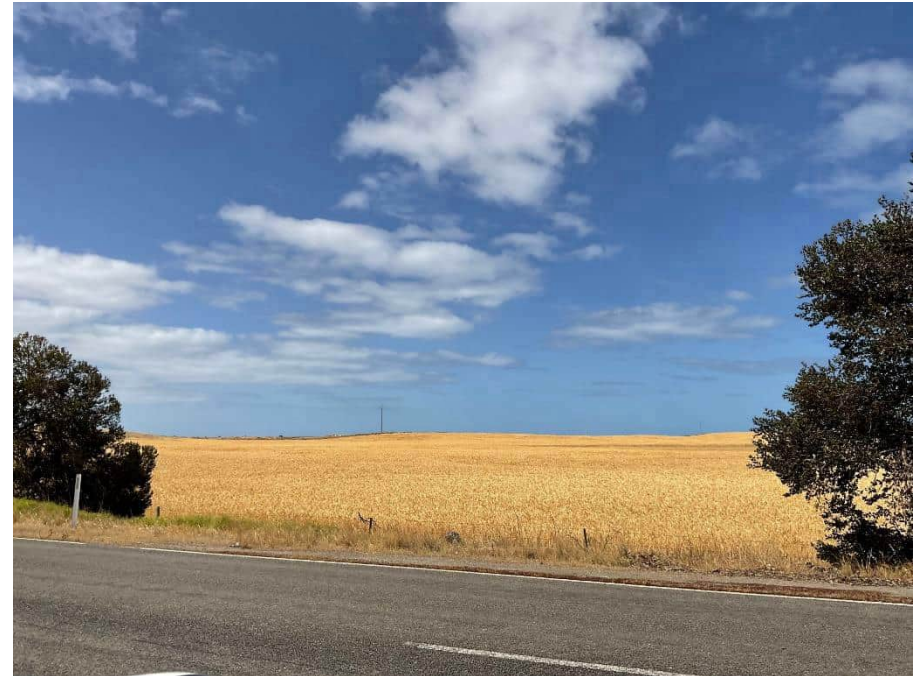
Photo 2: View from Hayward Park Road facing north-east. Views of stockpiling present but no views of operations (04/11/2024)

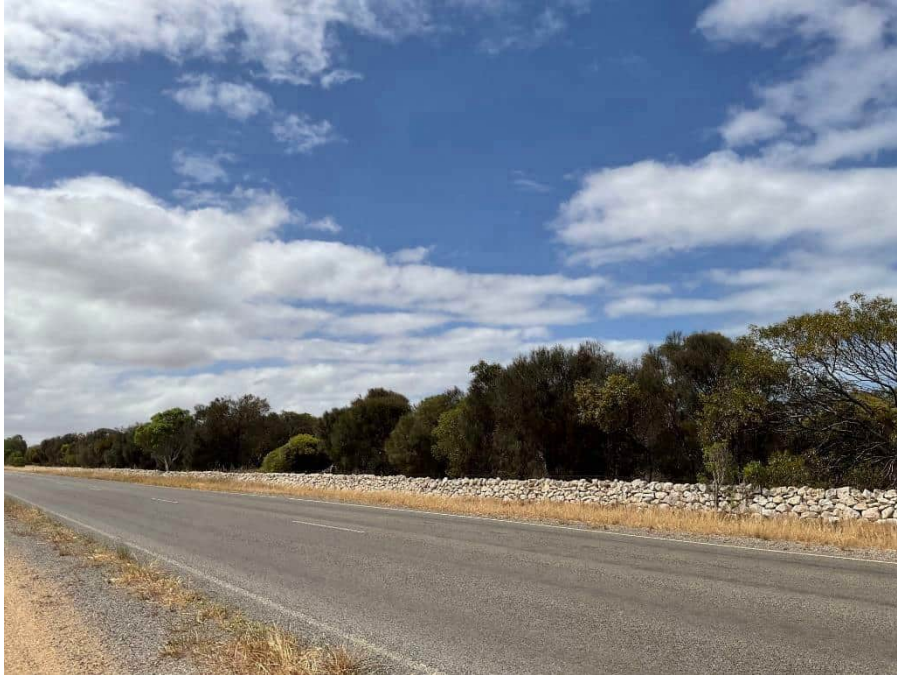
Photo 3: View looking east from Hayward Park Road. No views of Site present due to vegetation screening (04/11/2024)

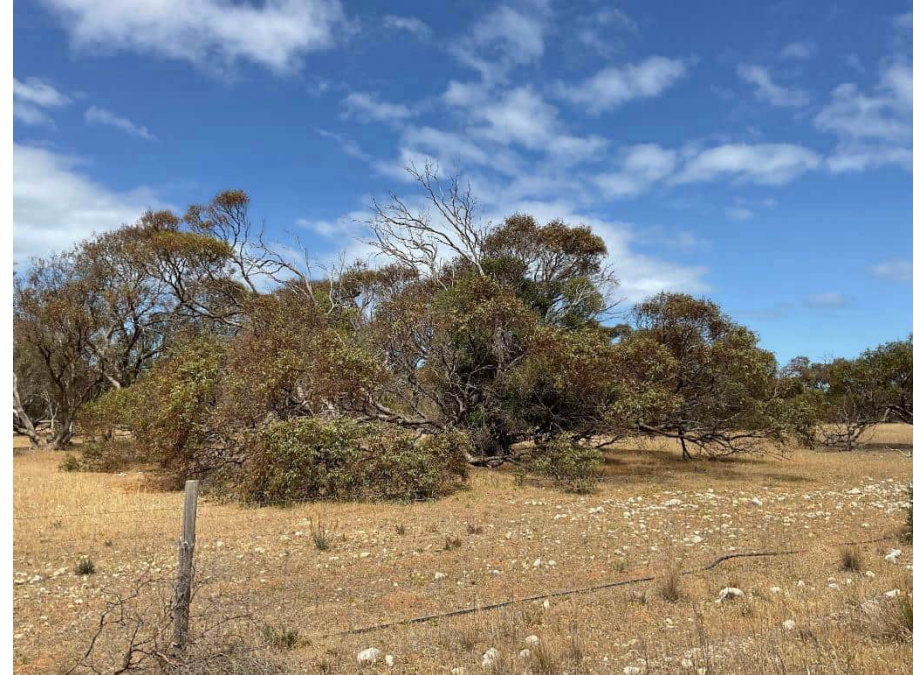
Photo 4: Facing south east from Hayward Park Road. No views of operations due to established vegetation screening (04/11/2024)
