WORLD'S END PIT (EML 6507)

CHANGE IN OPERATIONS APPLICATION

Prepared for:
S.C Heinrich & Co Pty. Ltd.

Date:
November 2024

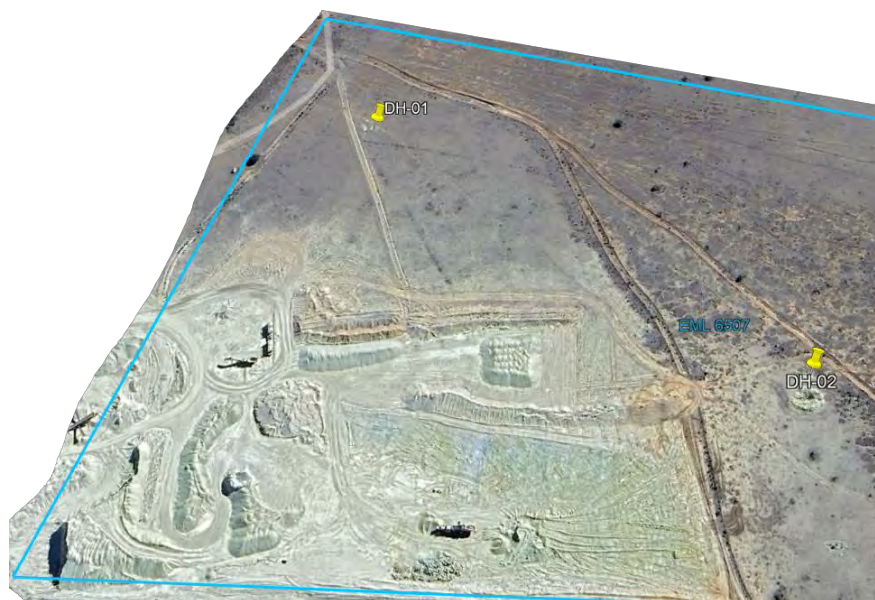
Figure 1 - Current Disturbance and Extracted Area – Stage 1A

** Note – approximately 4.78 hectares (ha) has been disturbed and extracted since the approval of the DI PEPR in 2020 to an average depth of four (4) m below ground level (BGL) (refer to Figure 1 - Current disturbance and Extracted Area – Stage 1A) and approximately 95,795 tonnes which reduces the balance of Stage 1A remaining tonnes to 1,079,205 tonnes and an approximate life of 21 years.

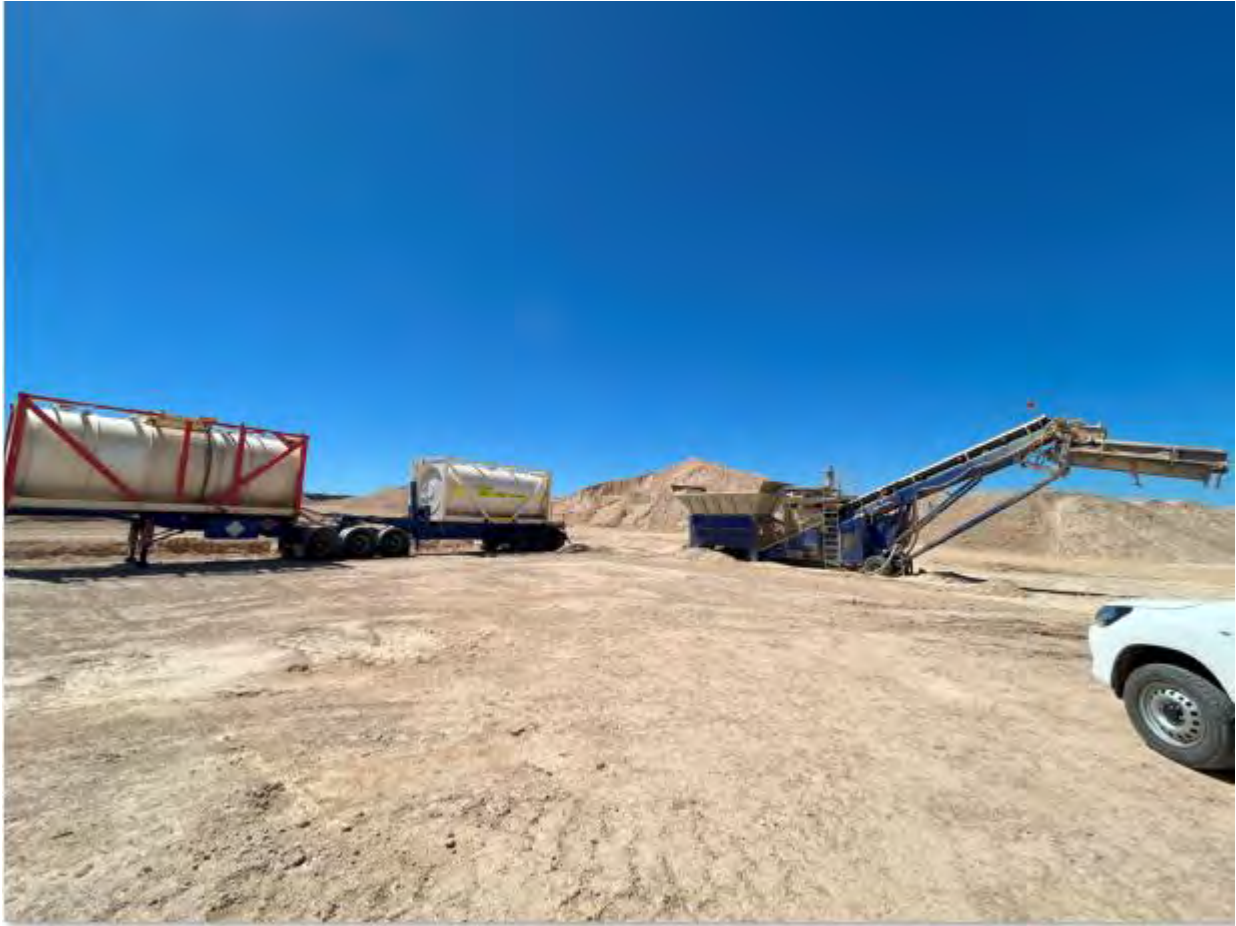
S.C. Heinrich are experienced operators and manage dust impacts as per the control and management strategies required for the Site. The rock source contains a low level of moisture and reduces dust impacts. Photo 1 - Crushing and Screening Operations February 2024 demonstrates water supply to crushing and screening plant as an example of dust mitigation strategies undertaken onsite.

Dust mitigation strategies are included within Section 5.3 Air Quality.

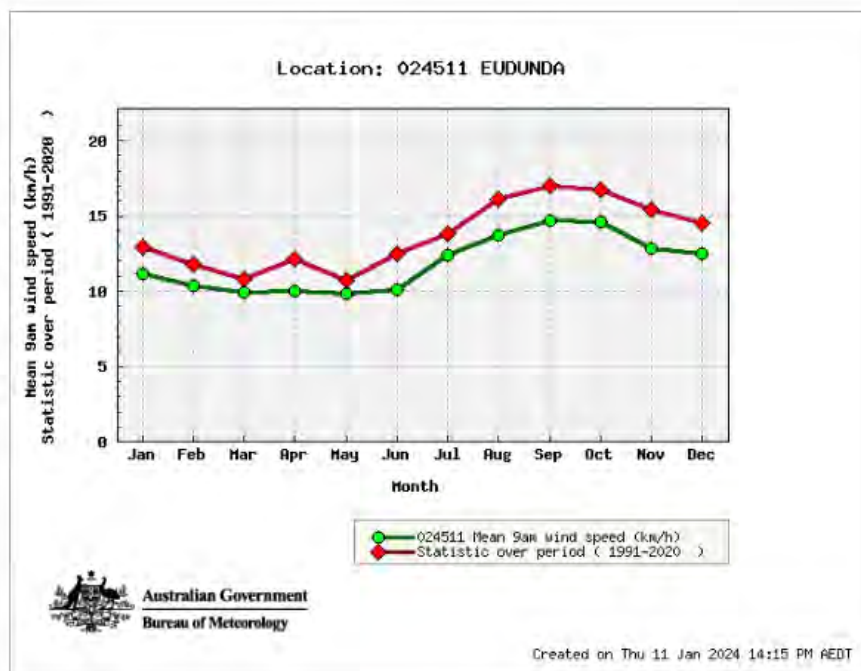
Figure 1 – 9am Average Wind Speed and Figure 2 – 3pm Average Wind Speed demonstrate the maximum mean wind speed for the area is 14.7km/h at 9am in September and 16.7 km/h at 3pm in August.

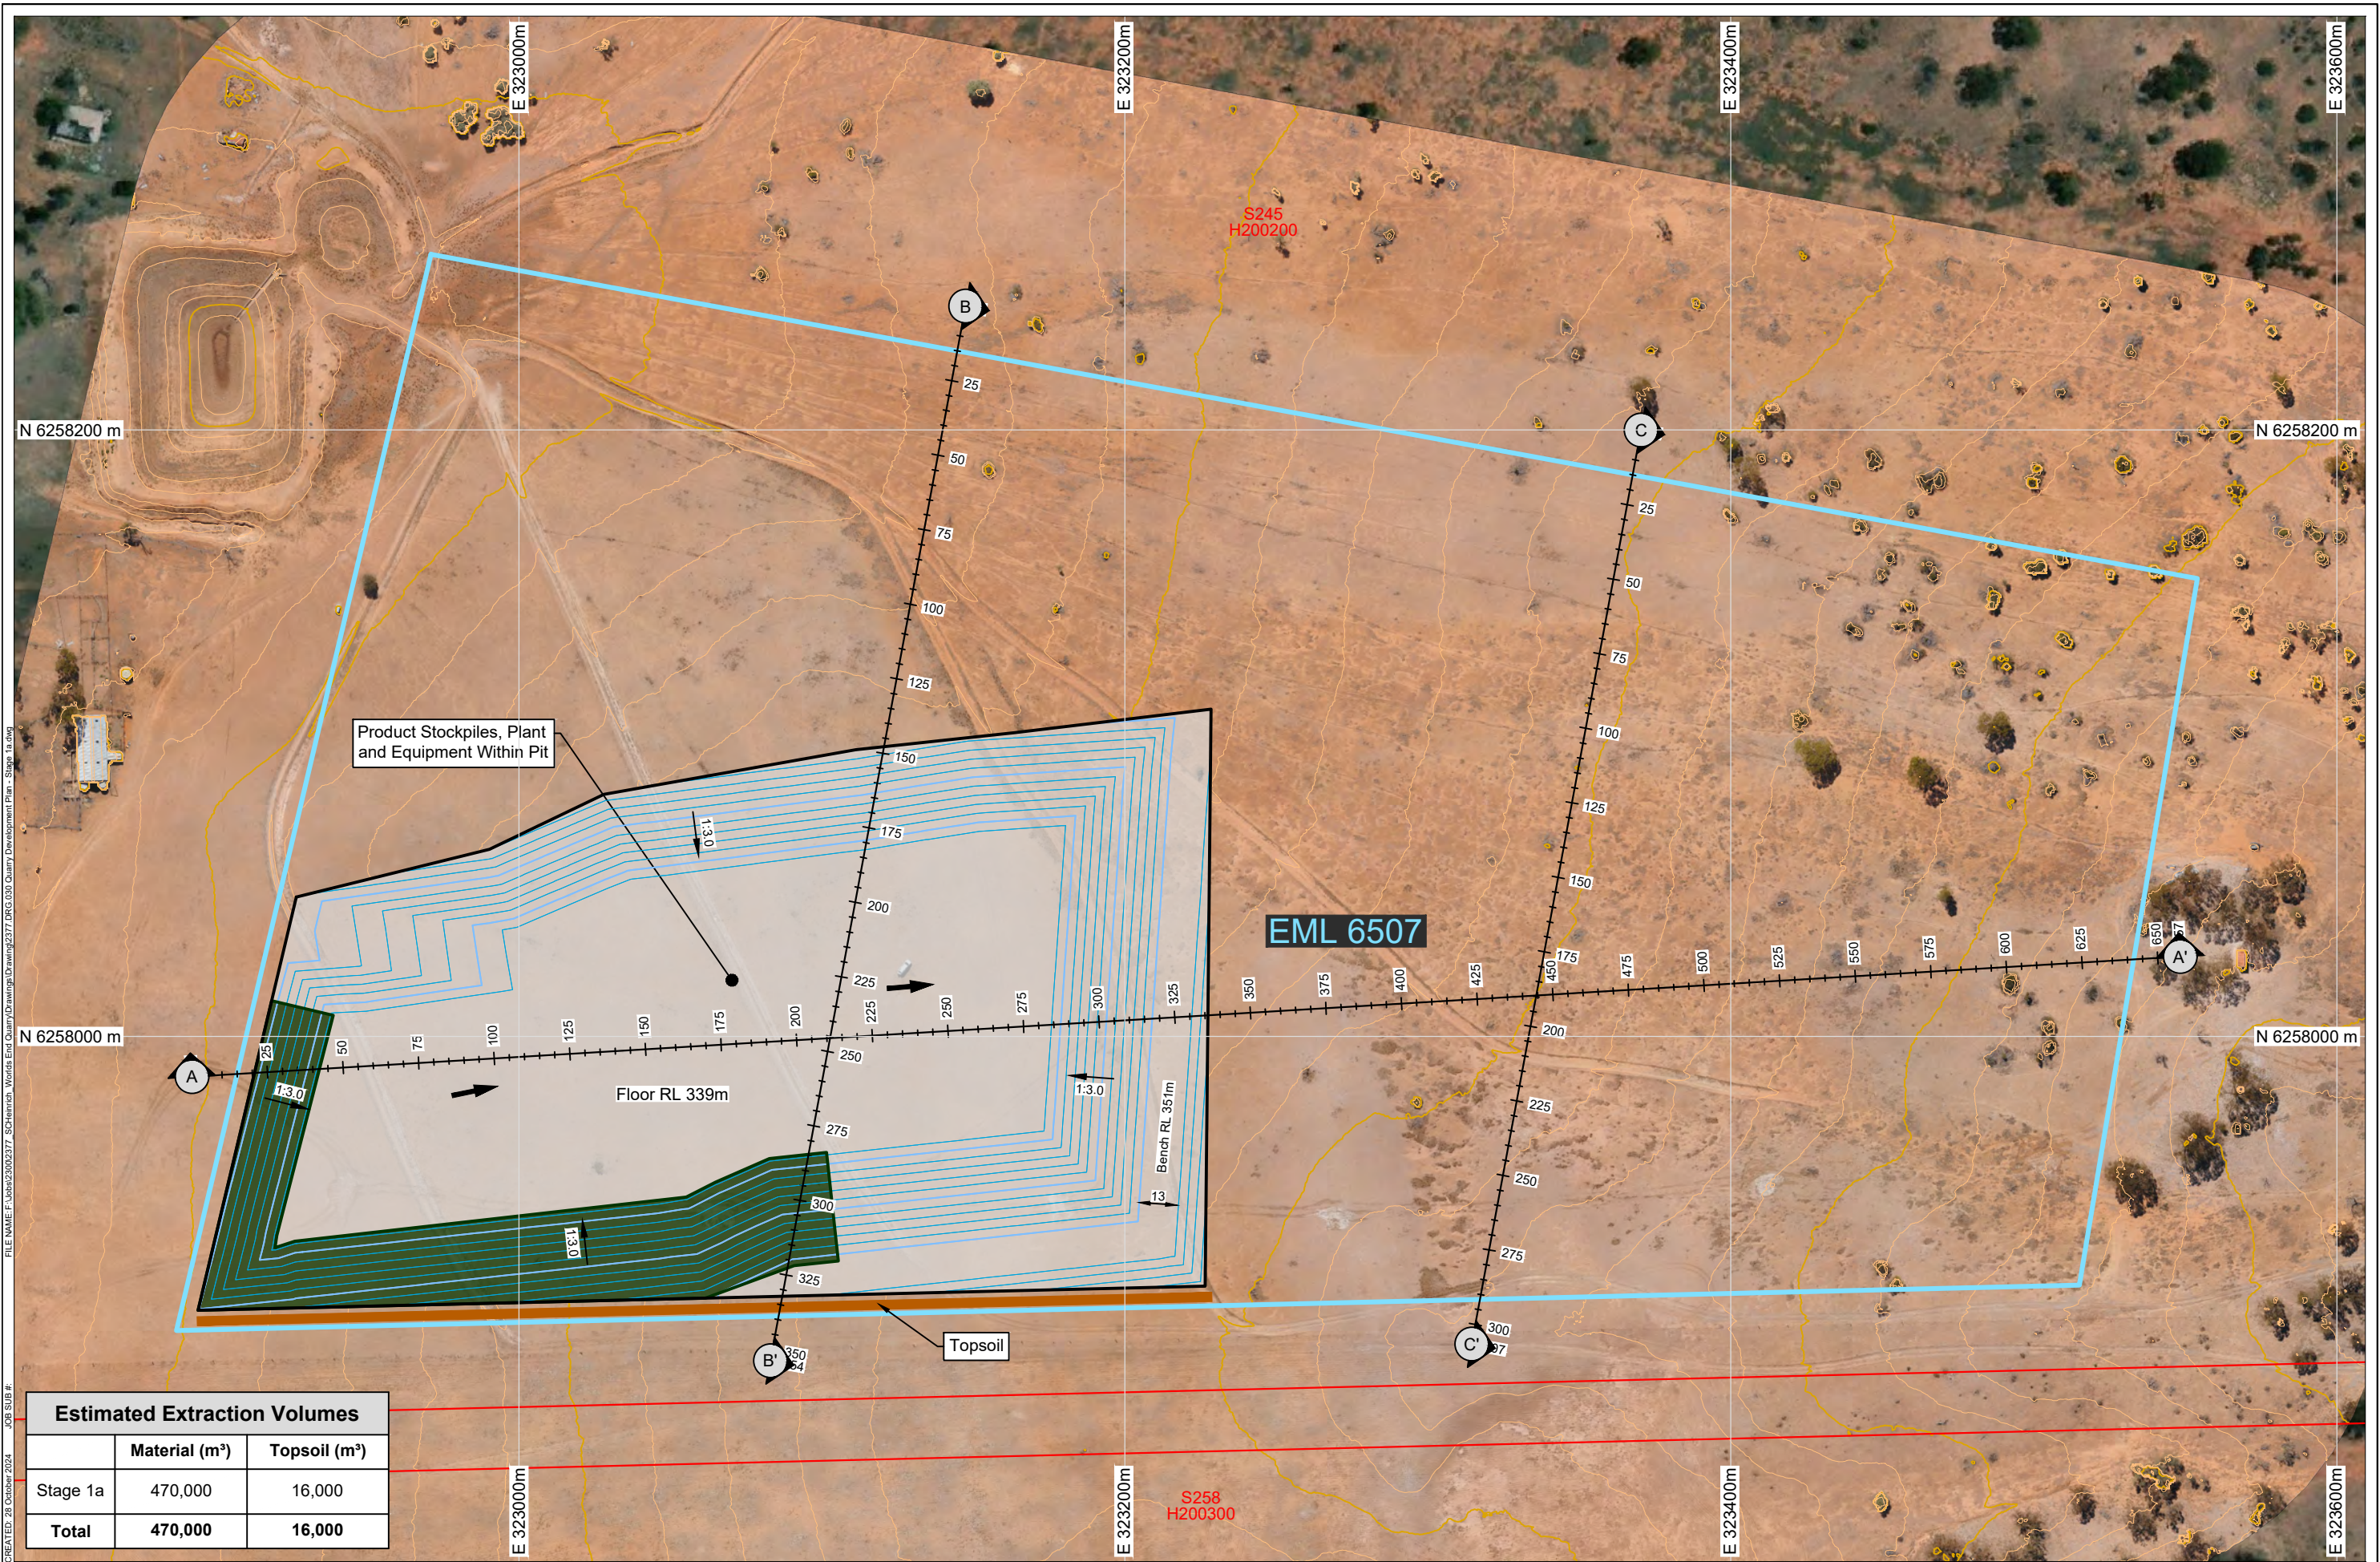
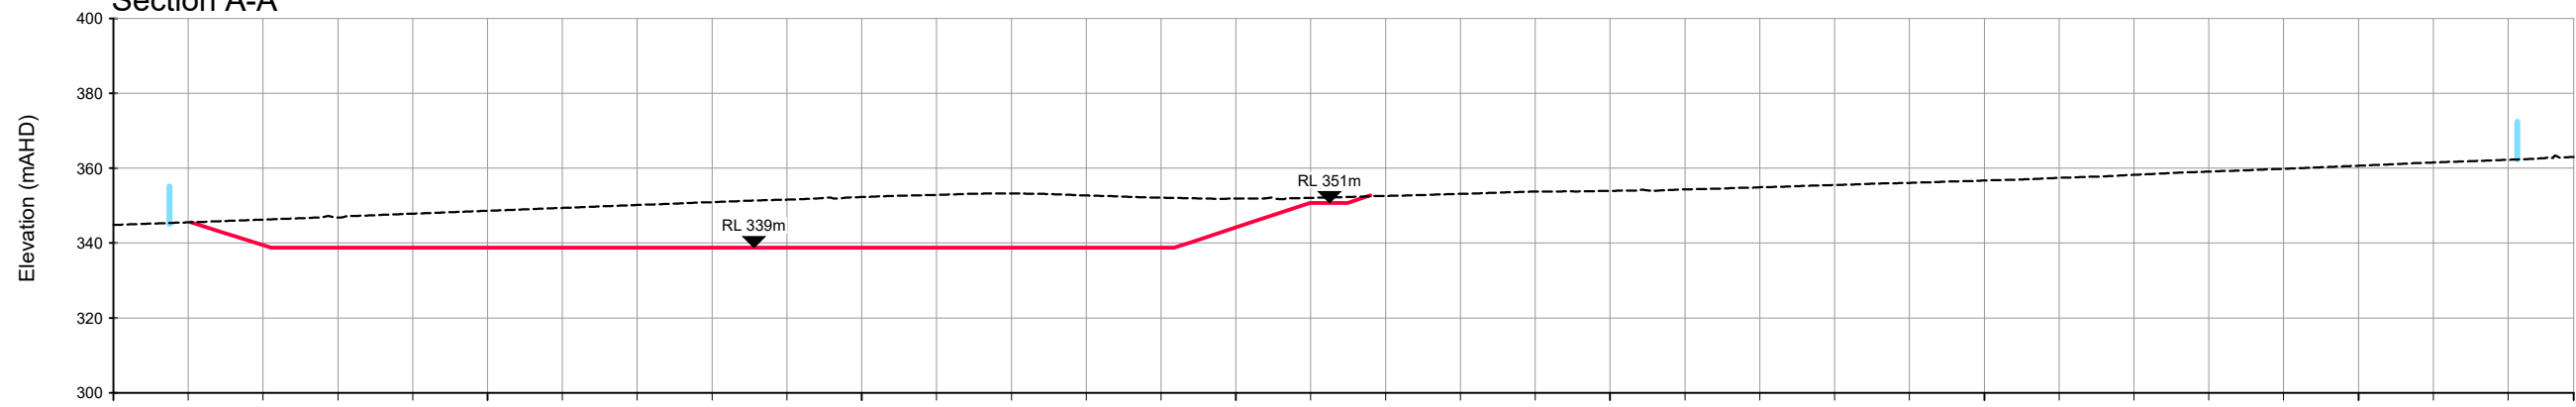
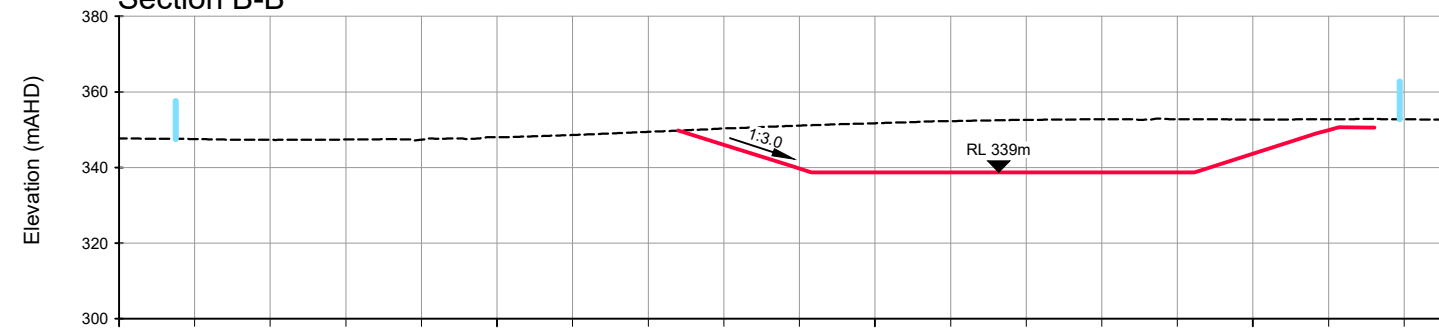
DRAWING NUMBER: **2377.DRG.030B**
 REVISION:
 CREATE DATE: 28 October 2024
 DRAWN: GL
 COORDINATE SYSTEM:
 LAST SAVED BY: CODY.PARHAM
 CHECKED: EM
 GDA94 / MGA / AHD / 54

Estimated Extraction Volumes		
	Material (m ³)	Topsoil (m ³)
Stage 1a	470,000	16,000
Total	470,000	16,000

Chainage (m)	20	40	60	80	100	120	140	160	180	200	220	240	260	280	300	320	340	360	380	400	420	440	460	480	500	520	540	560	580	600	620	640	657		
Pit Depth (m)		6.8	8.1	9.1	9.9	10.6	11.4	12.2	12.9	13.6	14.1	14.5	14.0	13.4	7.7	1.3

Chainage (m)	20	40	60	80	100	120	140	160	180	200	220	240	260	280	300	320	340	354
Pit Depth (m)								4.3	11.4	13.0	13.5	13.9	14.0	14.0	9.0	2.8

Item	Current Operational Conditions	New Operational Conditions	Section Addressed in COA
			<p>Drawing No. 2377.030A – Quarry Development Plan Stage 1A</p> <p>Drawing No. 2377.031A – Quarry Development Plan Stage 1B</p> <p>Drawing No. 2377.DRG.032A – Quarry Development Stage 2</p>

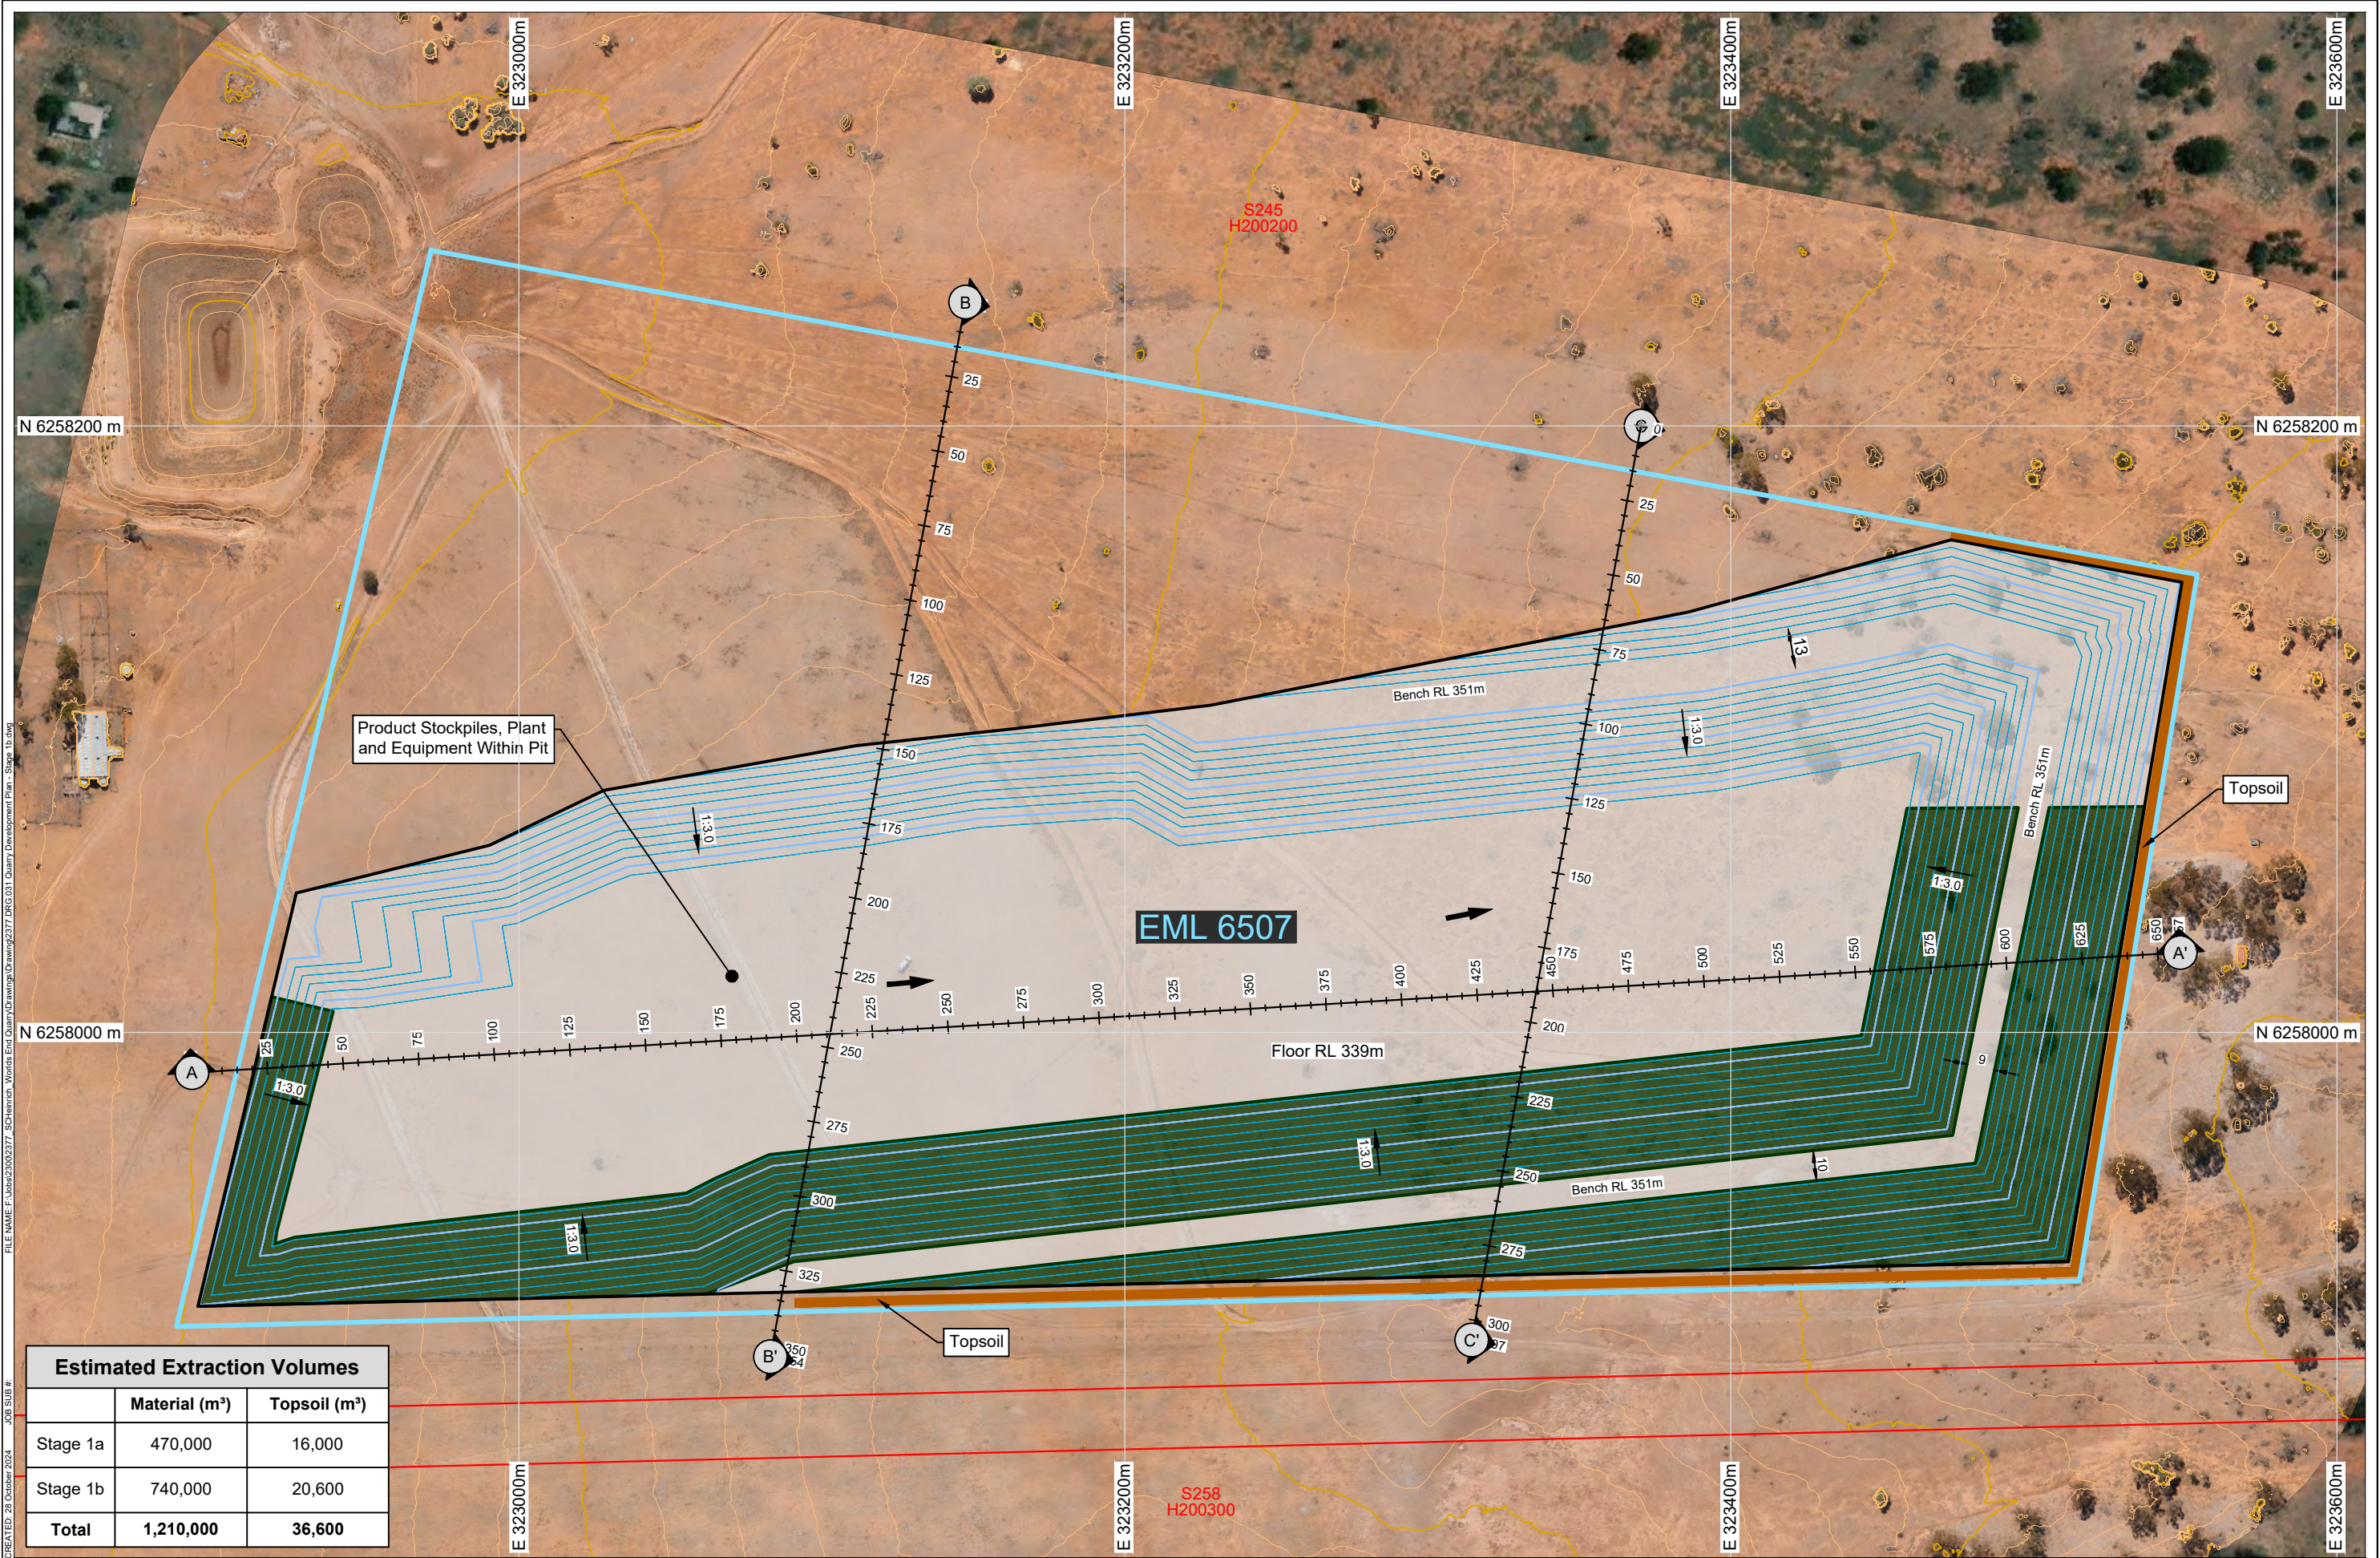
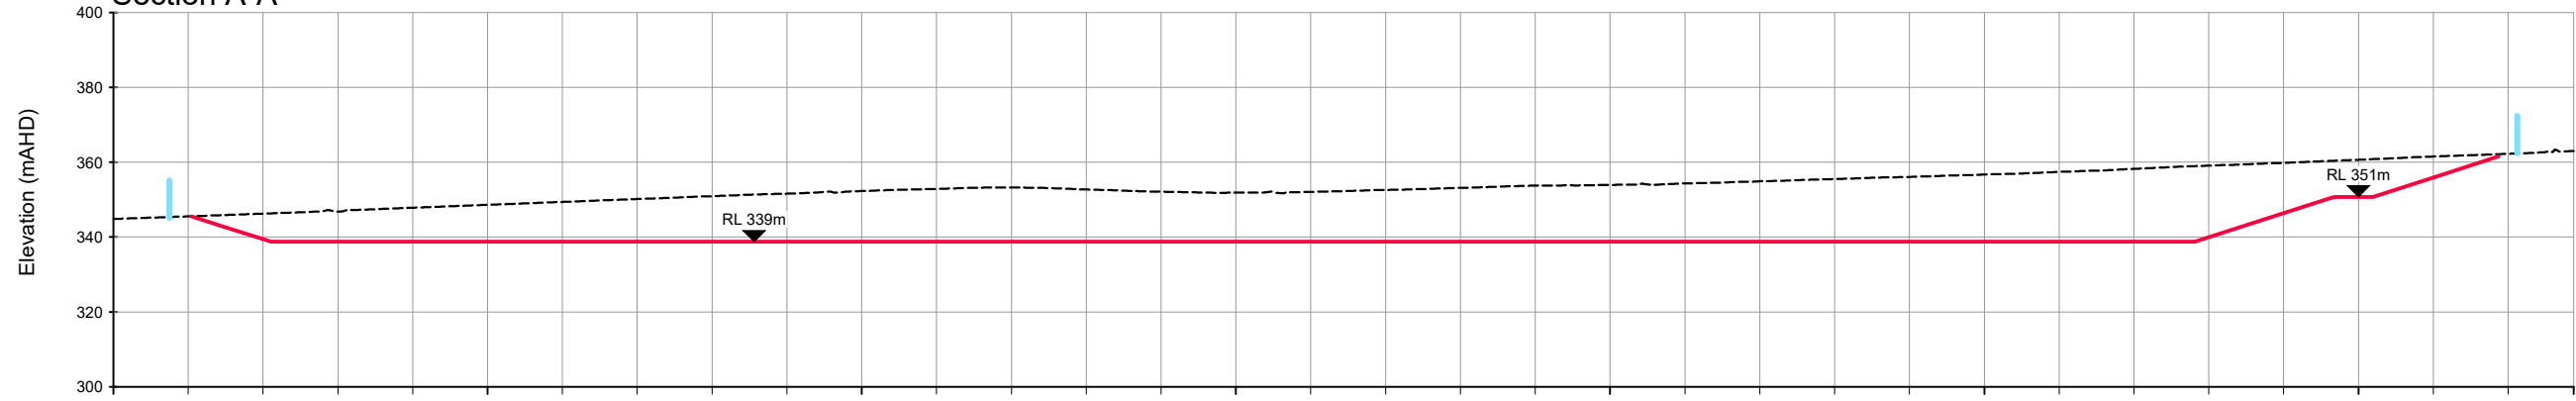
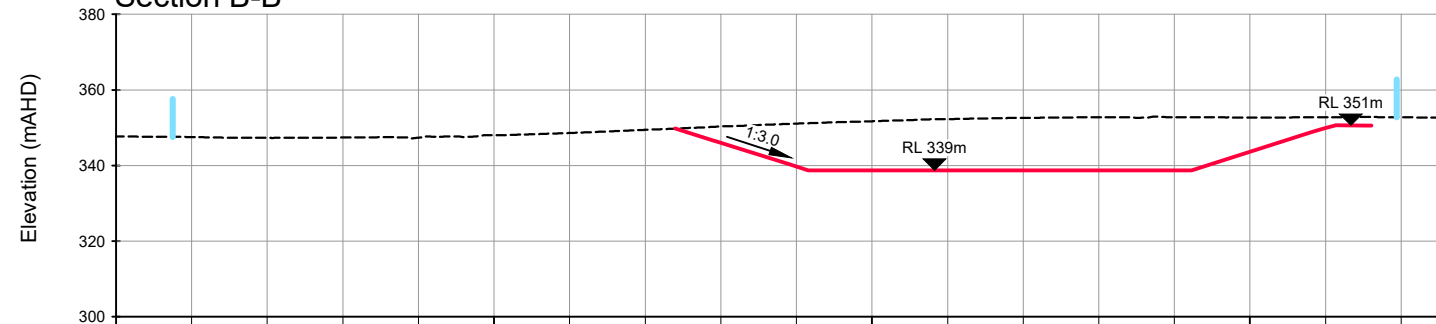
Estimated Extraction Volumes		
	Material (m ³)	Topsoil (m ³)
Stage 1a	470,000	16,000
Stage 1b	740,000	20,600
Total	1,210,000	36,600

Chainage (m)	20	40	60	80	100	120	140	160	180	200	220	240	260	280	300	320	340	360	380	400	420	440	460	480	500	520	540	560	580	600	620	640	657
Pit Depth (m)		6.8	8.1	9.1	9.9	10.6	11.4	12.2	12.9	13.6	14.1	14.5	14.0	13.4	13.1	13.3	13.8	14.4	15.0	15.2	15.6	16.2	16.8	17.3	18.0	18.7	19.5	19.2	13.5	9.9	5.6

Chainage (m)	20	40	60	80	100	120	140	160	180	200	220	240	260	280	300	320	340	354
Pit Depth (m)								4.3	11.4	13.0	13.5	13.9	14.0	14.0	9.0	2.9

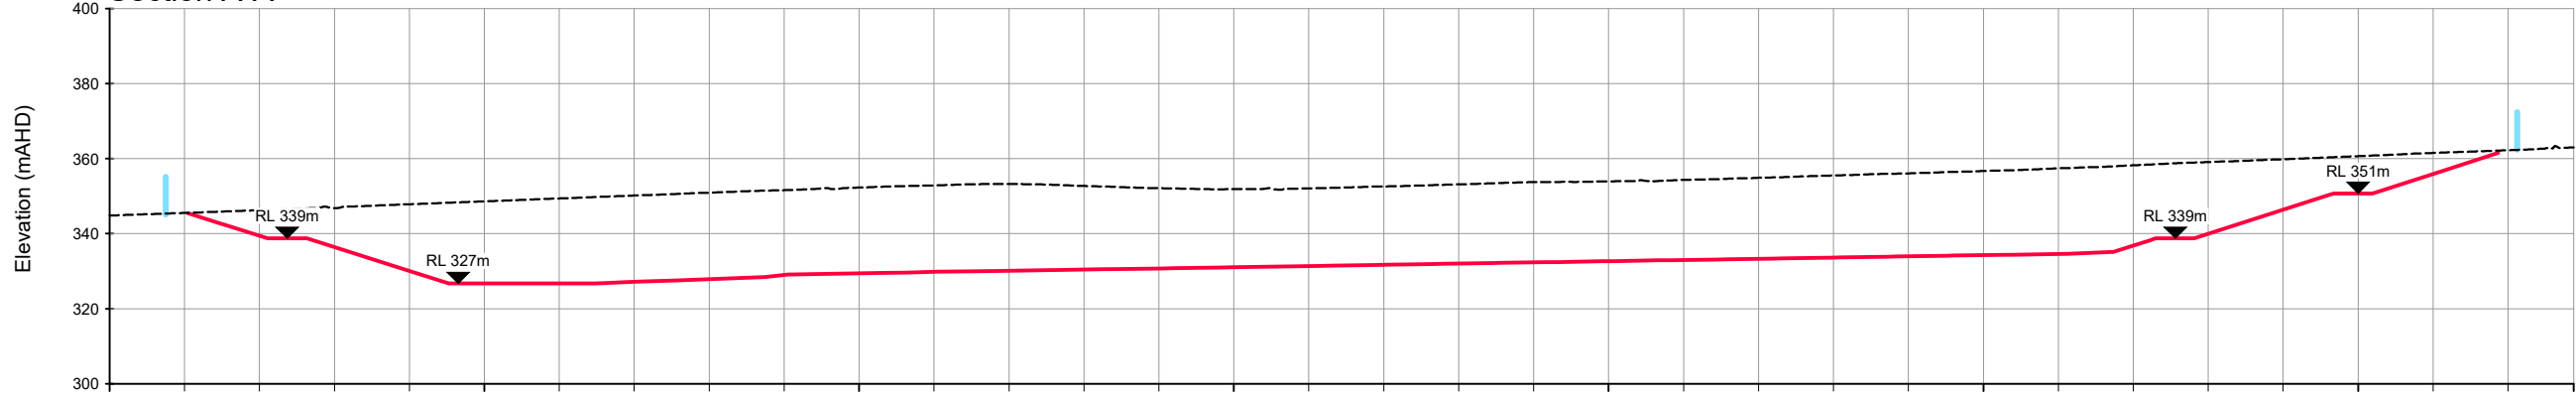
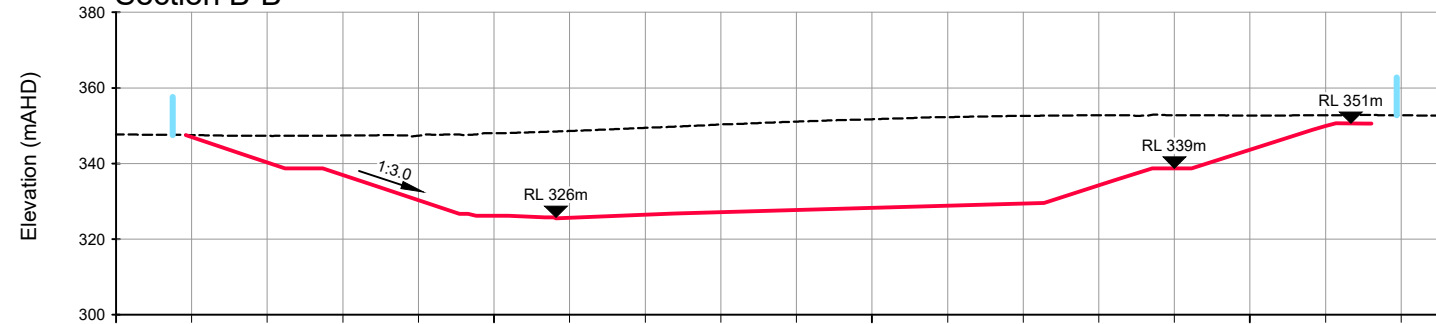
Estimated Extraction Volumes		
	Material (m ³)	Topsoil (m ³)
Stage 1a	470,000	16,000
Stage 1b	740,000	20,600
Stage 2	1,230,000	15,000
Total	2,440,000	51,600

Chainage (m)	20	40	60	80	100	120	140	160	180	200	220	240	260	280	300	320	340	360	380	400	420	440	460	480	500	520	540	560	580	600	620	640	657	
Pit Depth (m)		6.8	10.4	17.8	21.9	22.6	23.0	23.0	22.6	22.8	23.0	23.2	22.3	21.4	20.8	20.7	20.9	21.1	21.4	21.3	21.3	21.6	21.9	22.1	22.4	22.8	21.4	19.2	13.5	9.9	5.6

Chainage (m)	20	40	60	80	100	120	140	160	180	200	220	240	260	280	300	320	340	354
Pit Depth (m)	0.6	7.0	10.4	17.0	21.8	22.9	23.0	23.2	23.4	23.4	23.4	23.1	18.5	14.0	9.0	2.9

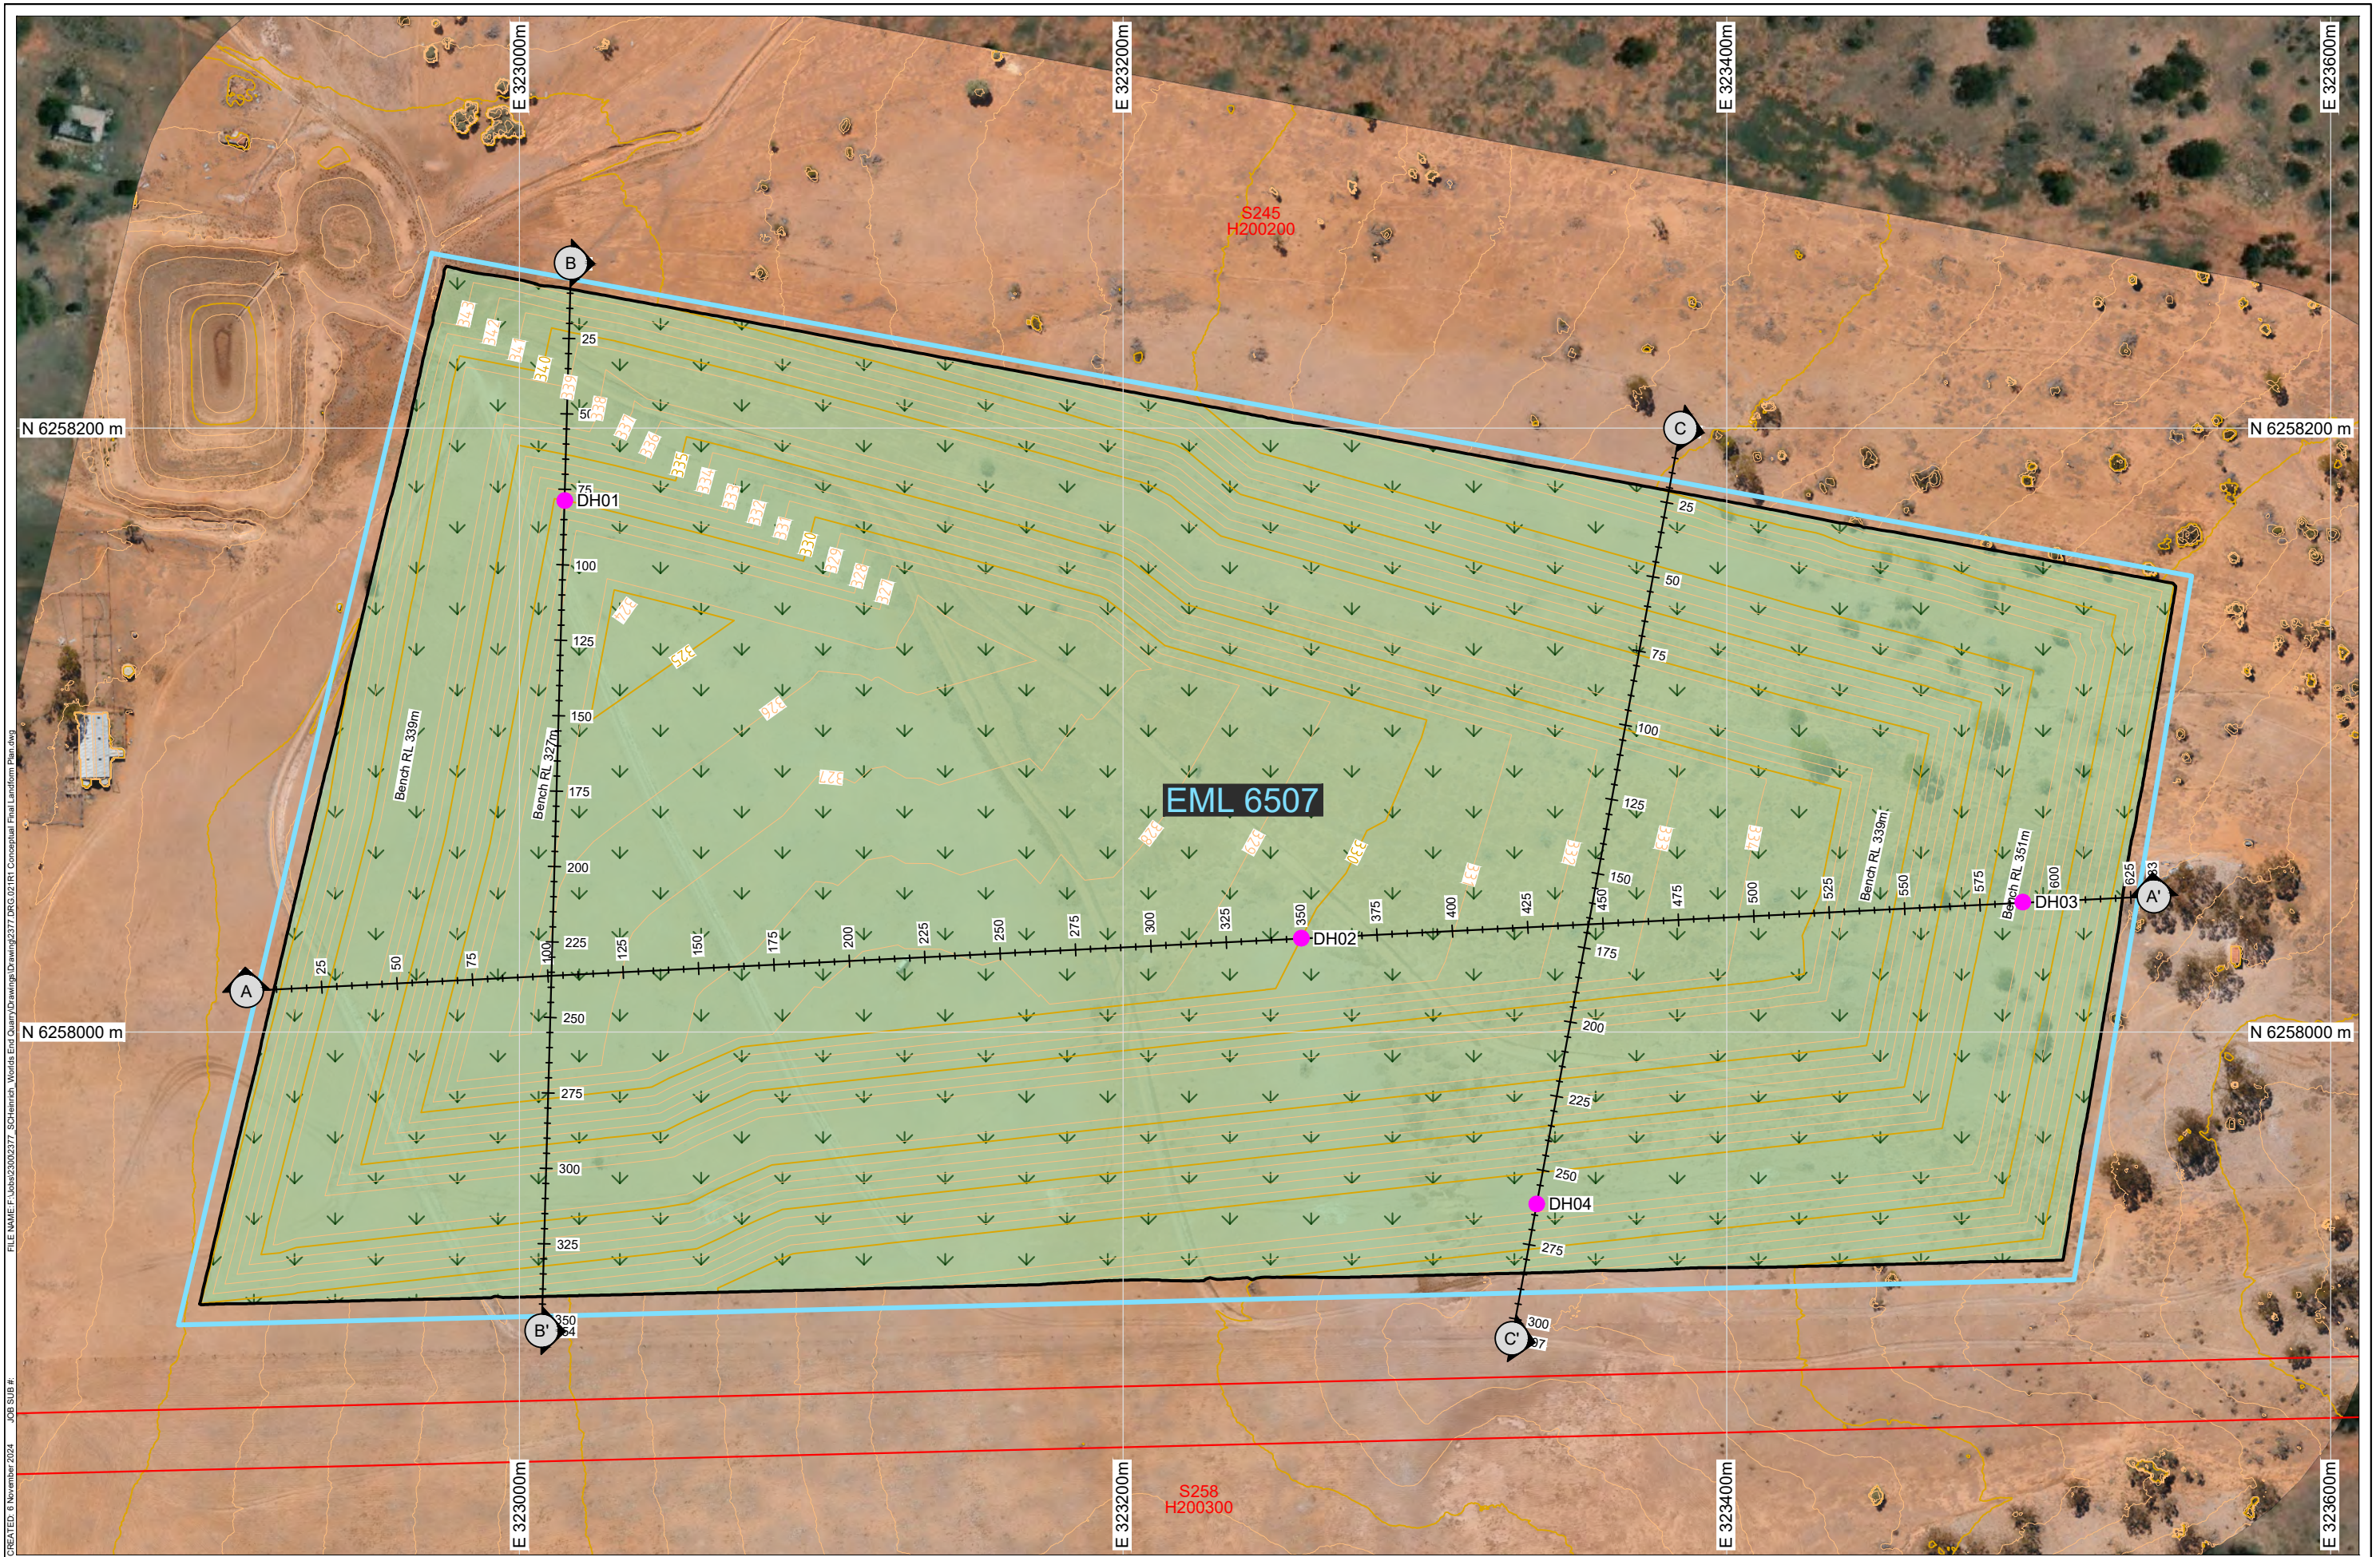
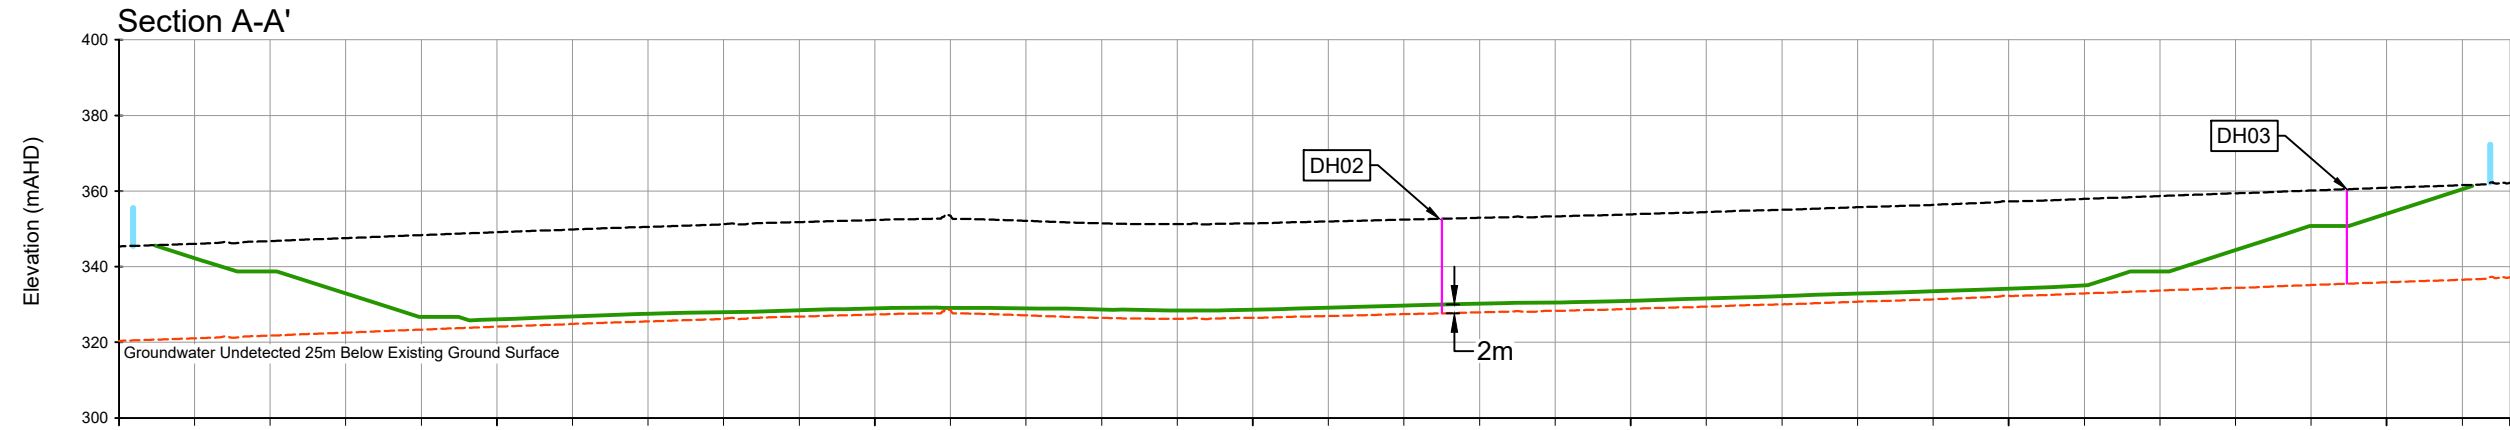
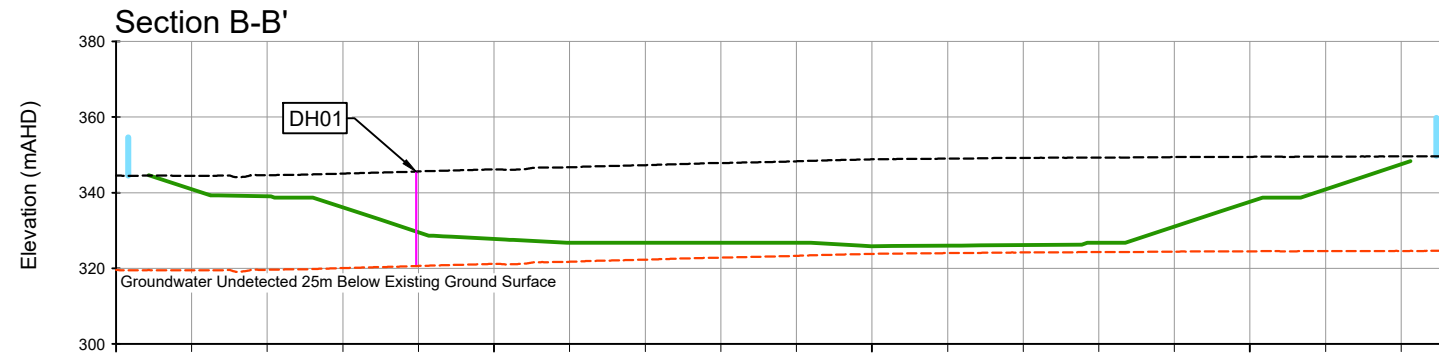
Chainage (m)	20	40	60	80	100	120	140	160	180	200	220	240	260	280	300	320	340	360	380	400	420	440	460	480	500	520	540	560	580	600	620	633
Final RL (m)	342.3	338.7	332.9	326.7	326.1	326.8	327.6	328.0	328.5	329.0	329.1	328.9	328.7	328.4	328.6	329.1	329.7	330.2	330.5	331.0	331.6	332.2	332.9	333.5	334.2	335.0	338.7	344.4	350.7	354.0	360.5	362.2
Buffer Depth (m)	21	17	10	3	2	2	2	2	2	2	2	2	2	2	2	2	2	2	2	2	2	2	2	2	2	2	5	10	16	18	24

Chainage (m)	20	40	60	80	100	120	140	160	180	200	220	240	260	280	300	320	340	354
Final RL (m)	340.9	339.1	336.1	329.6	327.8	326.7	326.7	326.7	326.7	325.8	326.0	326.2	326.7	331.0	337.6	340.9	347.5	349.6
Buffer Depth (m)	21	19	16	9	7	5	4	4	3	2	2	2	2	7	13	16	23

9. Conceptual Final Landform	<p>Return to grazing. Battering and replacement of topsoil.</p> <p>1V:3H batters</p>	Shaping of the final landform with 1V:3H batters, respread of topsoil, stabilisation with grasses if required additional to natural revegetation in accordance with Drawing No. 2377.DRG.021AR1 – Conceptual Final Landform Plan.

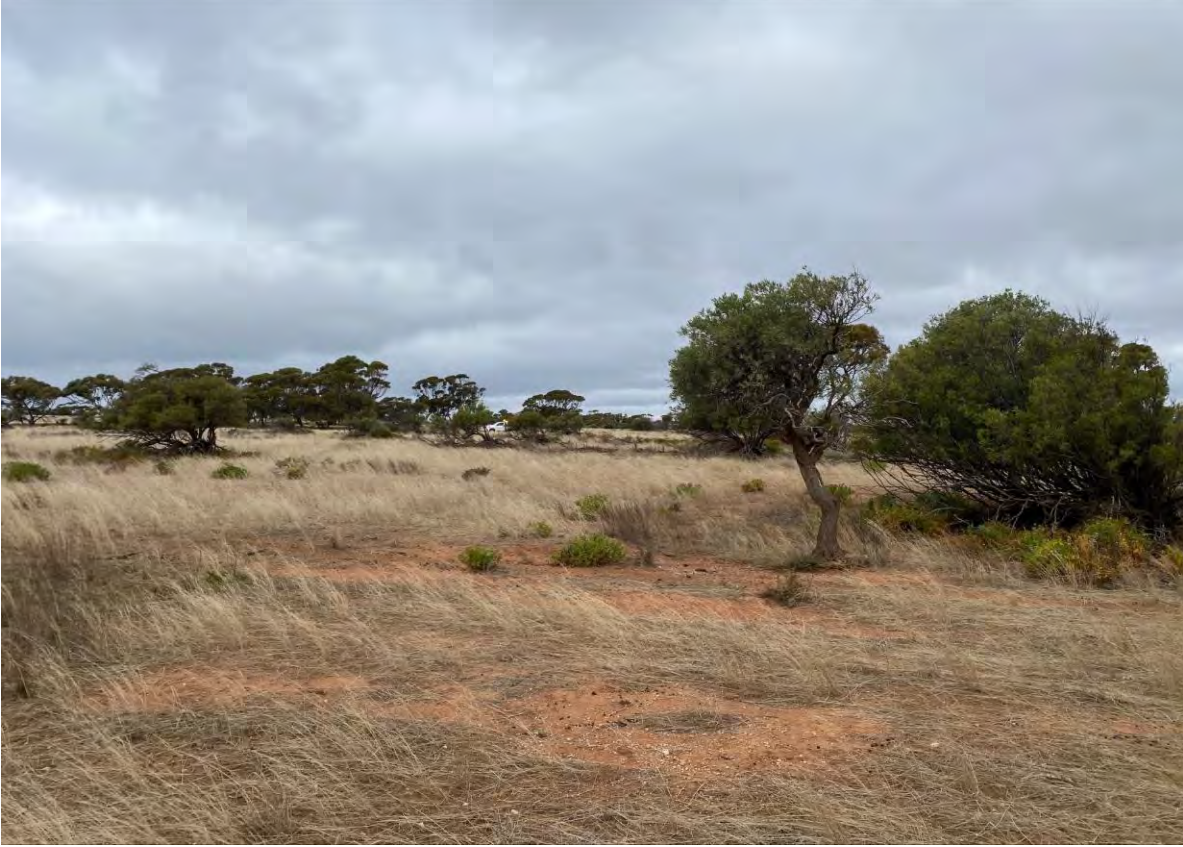
<p>Vegetation Association</p>	<p><i>Geijera linearifolia</i> open shrubland over <i>Roepera apiculata</i> and <i>Maireana brevifolia</i> low shrubland.</p>

<p>Vegetation Association 1, looking east Drawing No. 2377.DRG.018 – Vegetation Association A1 (MGA Zone 54 323175, 6258162.83)</p>	
<p>General description</p>	<p>Vegetation Association 1 is located within the middle of the Site. This area has been historically cleared with large mature shrubs of <i>Geijera linearifolia</i> and Bullock Bush previously retained. The understorey has since been periodically grazed which has led to the regrowth of native understorey species of <i>Austrostipa sp.</i>, <i>Roepera apiculata</i> and <i>Maireana brevifolia</i>. Vegetation is in close proximity to tracks linking the external roads to the extraction area with evidence of edge effect on vegetation condition in the form of higher weed density than vegetation further into the undisturbed remnant vegetation in the north east corner of the Site.</p> <p>Vegetation Association 1 is in fair condition, with reduced overstorey species and few ground cover natives with weed invasion, with the exception of <i>Austrostipa sp.</i> regrowth since grazing has occurred. Historical clearance has likely reduced the overstorey tree density.</p>

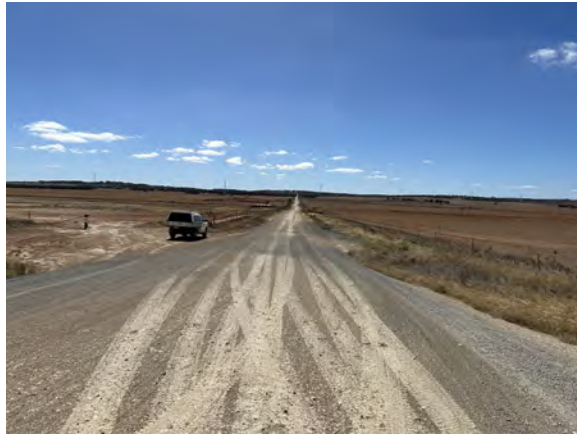
Photo Location 4: View of Satchell Road and Worlds Highway Intersection, noted there is no deterioration of the bitumen in good condition. It is noted drag out present due to road use by Wind Farm trucks, powerlines contractors and quarry trucks.

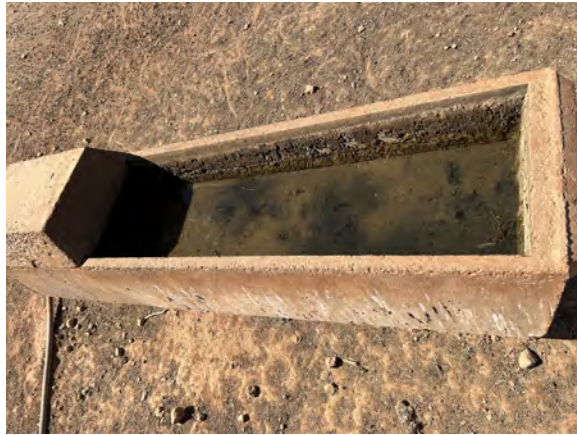
Photo Location 7: View of sheep water trough south side of Satchell Road, shows some troughs in broken condition. and general grazing conditions.
