WORLD'S END PIT (EML 6507)

CHANGE IN OPERATIONS APPLICATION

Prepared for:
S.C Heinrich & Co Pty. Ltd.

Date:
November 2024

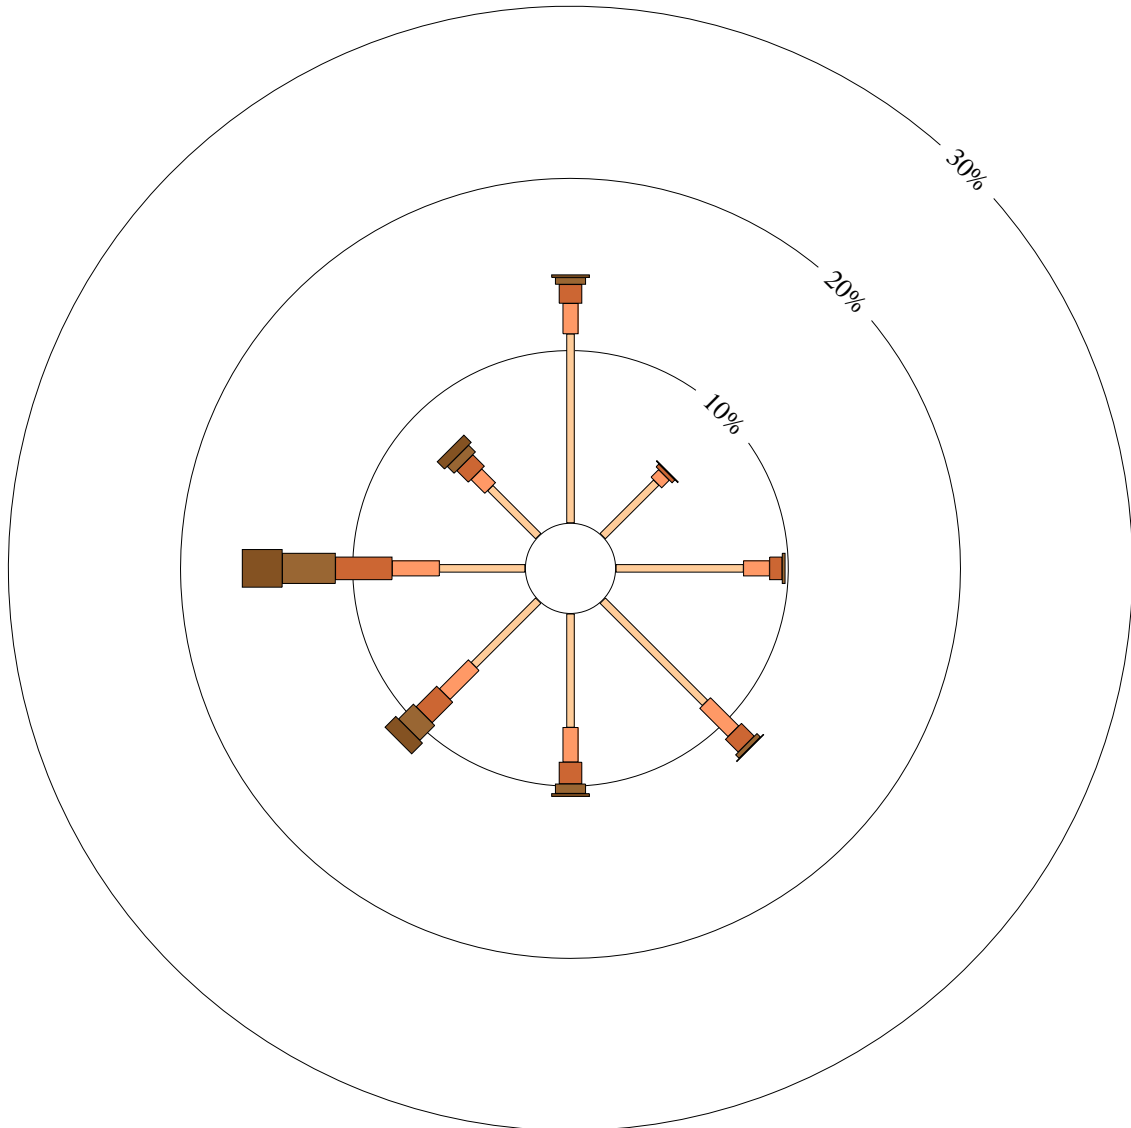
Rose of Wind direction versus Wind speed in km/h (26 Jan 1965 to 10 Aug 2023)

Calm 13%
