**PROGRAM FOR ENVIRONMENT
PROTECTION AND REHABILITATION (PEPR)**

EXTRACTIVE MINERALS LEASE 5331, 5864 and 6449

TOOPERANG SAND QUARRY

Section 257 Hundred of Nangkita

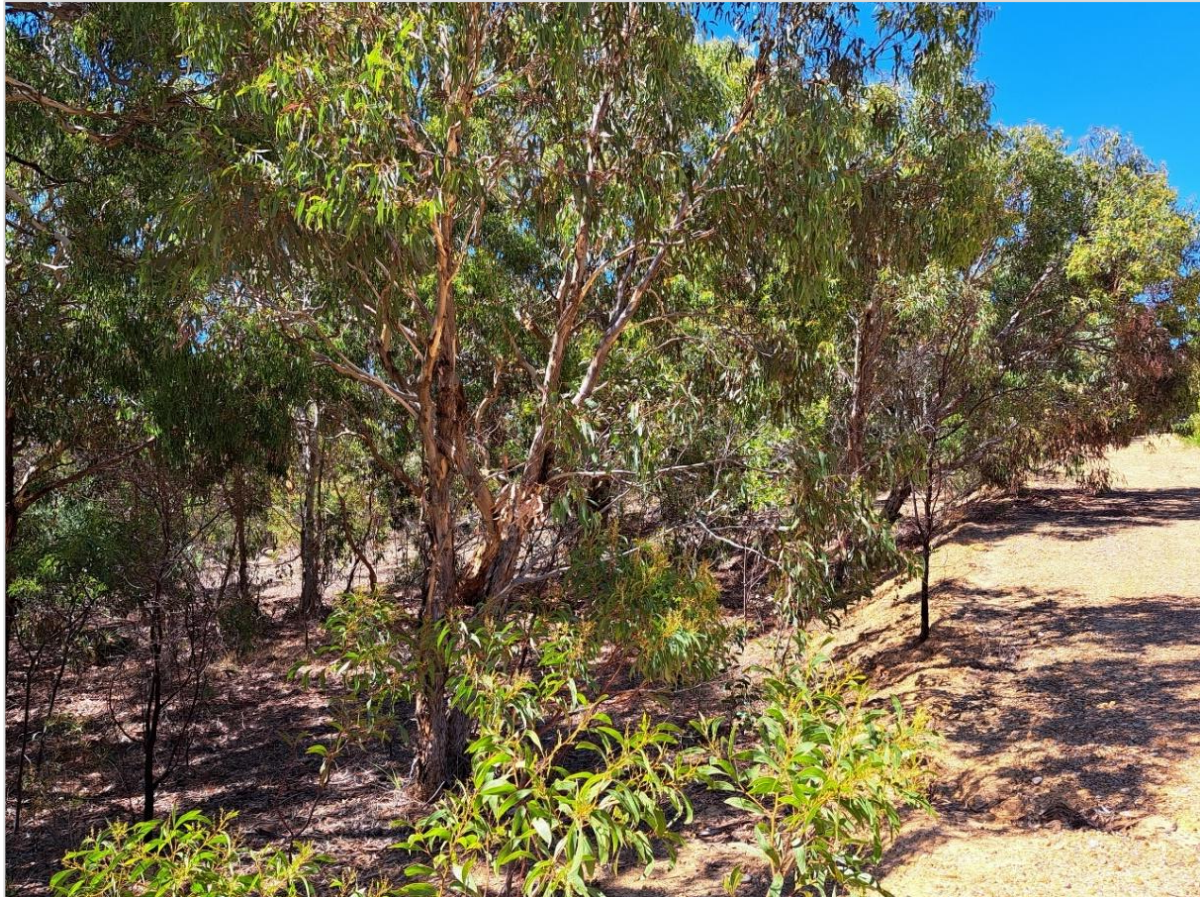
Photo 134846 facing east at wpt 1516 (Latitude: -35.394137; Longitude: 138.754595), along northern side of existing track

General description	<p>Vegetation association A1 is present between Quarry Rd and the existing track at the western end of the proposed route. It is characterised by a tall remnant overstorey of <i>Eucalyptus fasciculosa</i> (Pink Gum) over a sparse native shrub layer dominated by <i>Acacia pycnantha</i> (Golden Wattle). The area has been planted with additional canopy and mid-story species comprising non-local eucalypts (e.g. <i>E. maculata</i> (Spotted Gum), <i>E. saligna</i> (Sydney Blue Gum)), <i>Callistemon</i> spp. and <i>Callitris gracilis</i> (Southern Cypress Pine). One plant of the State Rare <i>Acacia imbricata</i>, which is endemic to the Eyre Peninsula, has been planted near the edge of the track. Native groundlayer species are very sparse and include <i>Styphelia humifusa</i> (Cranberry Heath), <i>Dianella brevicaulis</i> (Short-stem Flax-lily), the vine <i>Billardiera cymosa</i> (Sweet Apple-berry) and <i>Rytidosperma setaceum</i> (Small-flower Wallaby-grass).</p> <p>Weed invasion is low, represented mostly by pasture grasses such as <i>Avena</i> sp. (Wild oats), <i>Ehrharta longiflora</i> (Annual Veldt Grass), <i>Vulpia</i> sp. (Fescue) and <i>Trifolium angustifolium</i> (Narrow-leaf Clover), with a few scattered seedlings of the SA Declared <i>Pittosporum undulatum</i> (Sweet Pittosporum) and <i>Rosa canina</i> (Dog Rose). Seedlings of <i>Acacia longifolia</i> spp. <i>longifolia</i> (Sallow Wattle) and <i>Senecio pterophorus</i> (African Daisy) are also present.</p> <p>Vegetation association A1 is in moderate condition with a very low diversity of native species and moderate structural diversity. Fallen timber and leaf litter provide some habitat value for fauna, but the trees lack hollows.</p> <p>The proposed works will require removal of understory and some mature trees growing close to the track edge but will be limited to canopy pruning where possible.</p>

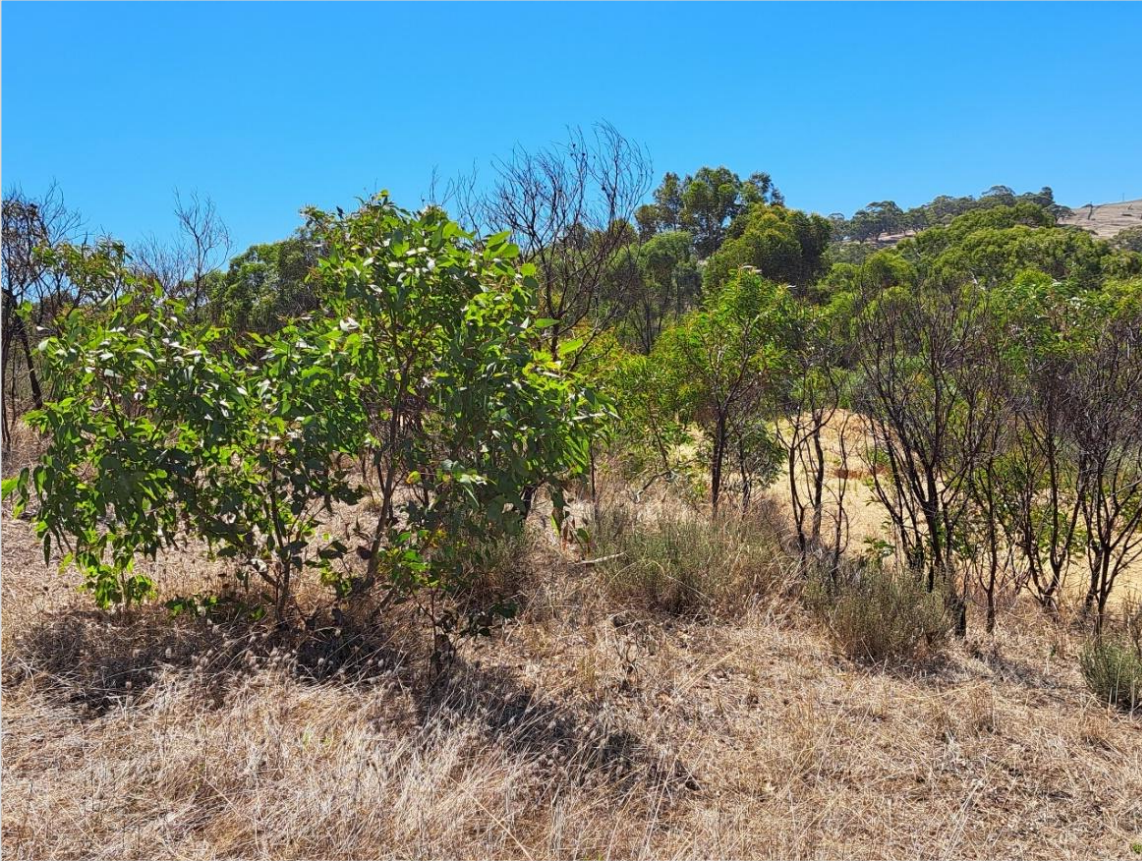
Photo 145803 facing northwest at wpt 1523 (Latitude: -35.395002; Longitude: 138.755879), at eastern end of dry dam

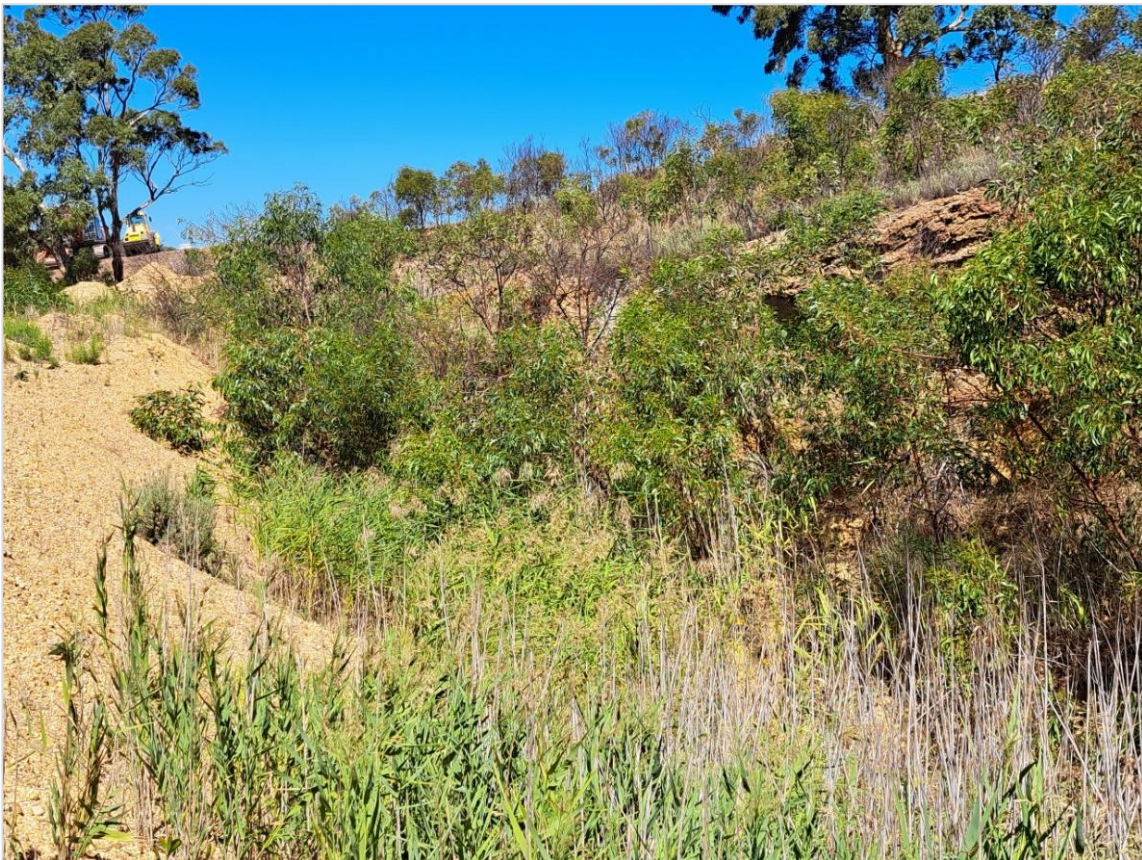
Photo 150828 facing east at wpt 1524 (Latitude: -35.39457; Longitude: 138.755431), along southern side of existing track

General description	<p>Vegetation association A2 occurs within and around the dry dam to the south of the existing track. Dense stands of <i>Phragmites australis</i> (Common Reed) grow in the low-lying sporadically inundated areas, with <i>Acacia pycnantha</i> and *<i>Acacia longifolia ssp. longifolia</i> over pasture grasses occupying the fringing slopes and drier ground.</p> <p>Other native species are sparse and include <i>Juncus pallidus</i> (Pale Rush), <i>Senecio phelleus</i> (Woodland Groundsel), <i>Epilobium hirtigerum</i> (Hairy Willow-herb) and <i>Billardiera cymosa</i>. One <i>Eucalyptus fasciculosa</i> and one *<i>E. platypus</i> (Platypus Gum) are present at the edge of the track.</p> <p>Outside the stands of <i>Phragmites australis</i>, the understory is dominated by introduced grasses, shrubs and forbs including <i>Avena sp.</i>, <i>Dittrichia graveolens</i> (Stinkweed) and <i>Lavandula stoechas</i> (Topped Lavender). The SA Declared weeds <i>Rosa canina</i> and <i>Pittosporum undulatum</i> are also present.</p> <p>Vegetation association A2 is in poor condition with a low diversity of native species and high levels of weed invasion.</p> <p>The dam is not a reliable source of water for aquatic bird species, and the plant community is unlikely to support threatened fauna.</p>

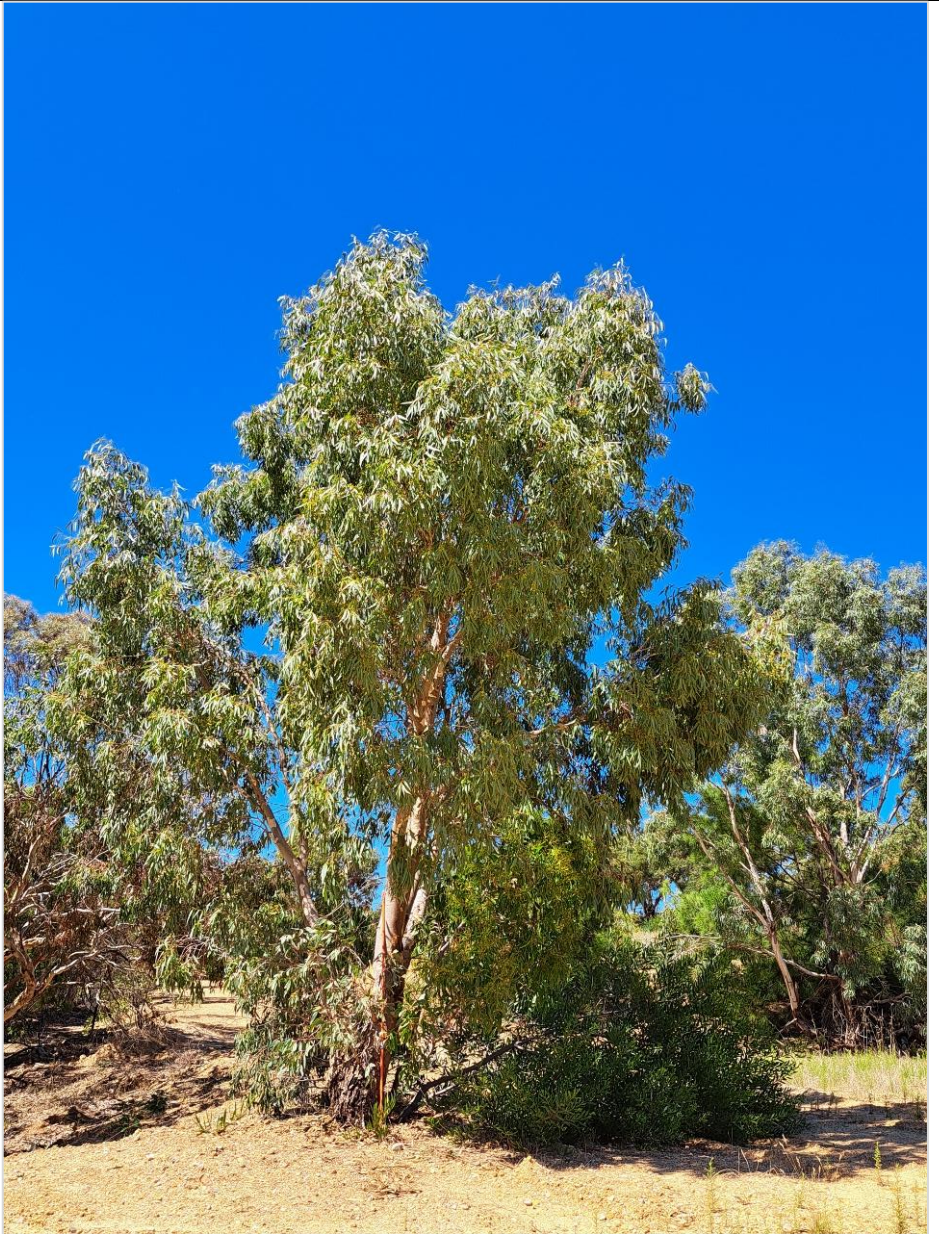
Tree ID – Tree 1

Tree spp. <i>Eucalyptus camaldulensis</i> var. <i>camaldulensis</i> River Red Gum	
Number of trees – 1	
Height (m) – 8	
Hollows – None	
Diameter (cm) – 30	
Canopy dieback (%) – 0	
Total Biodiversity Score – 0.6

Photo 132911 facing east at Wpt 1515 (Latitude: -35.394109; Longitude:138.754101)

Tree 1 is in very good condition with minimal dieback.

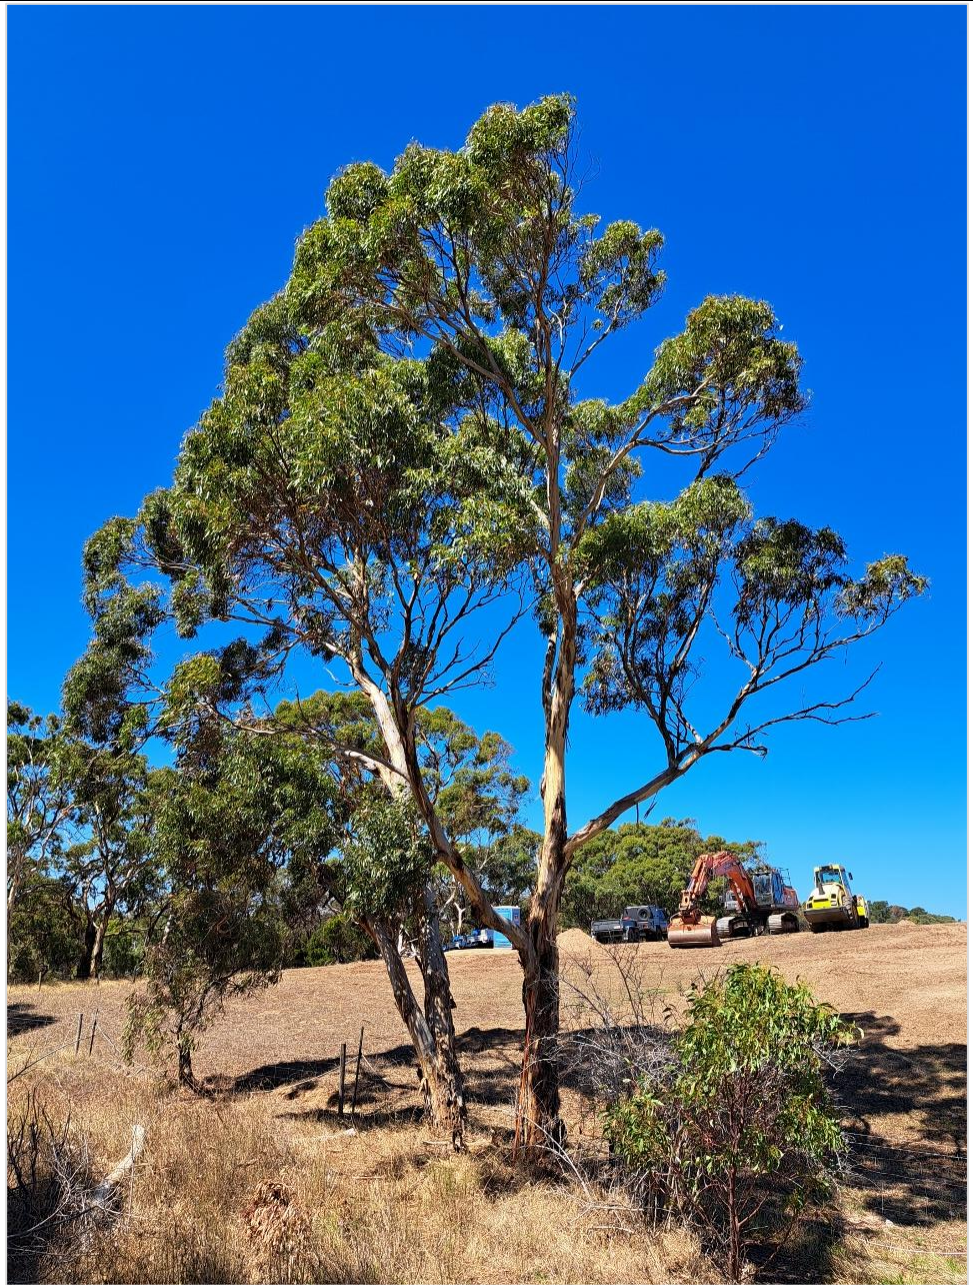
Tree ID – Tree 2
Tree spp. <i>Eucalyptus leucoxylon ssp. leucoxylon</i> SA Blue Gum
Number of trees – 1
Height (m) – 13
Hollows – None
Diameter (cm) – 48
Canopy dieback (%) – 0
Total Biodiversity Score – 2.23

*Photo 142445 facing northeast at Wpt 1520
(Latitude: -35.394888; Longitude: 138.756089)*

This large SA Blue Gum is located next to the fenceline at the eastern end of the proposed route. The understory is comprised almost exclusively of introduced pasture grasses and forbs such as *Sixalix atropurpurea* (Pincushion), *Rosa canina*, *Trifolium angustifolia* and *Lavandula stoechas*.

Tree 2 is in very good condition with minimal dieback.

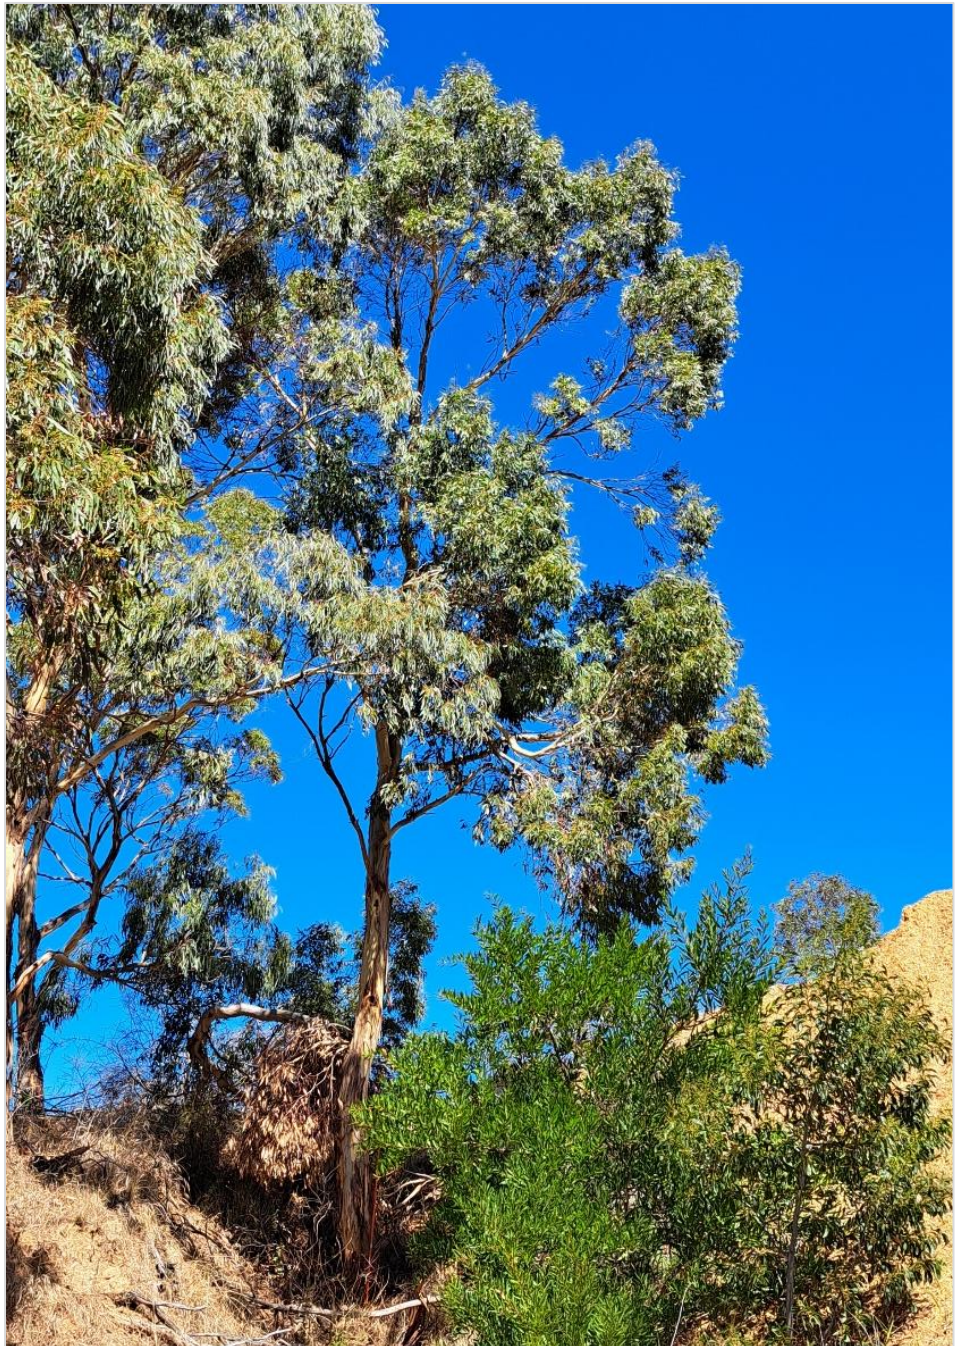
Tree ID – Tree 4
Tree spp. <i>Eucalyptus leucoxylon</i> ssp. <i>leucoxylon</i> SA Blue Gum
Number of trees – 1
Height (m) – 13
Hollows – None
Diameter (cm) – 37
Canopy dieback (%) – 0
Total Biodiversity Score – 1.94

Photo 143644 facing south at Wpt 1522. (Latitude: -35.394781; Longitude:138.755964)

This large SA Blue Gum is located at the bottom of the embankment near the eastern end of the proposed route. The understory is comprised almost exclusively of introduced pasture grasses and forbs such as *Sixalix atropurpurea*, *Rosa canina*, *Trifolium angustifolia* and *Lavandula stoechas*.

Tree 4 is in very good condition with minimal dieback.

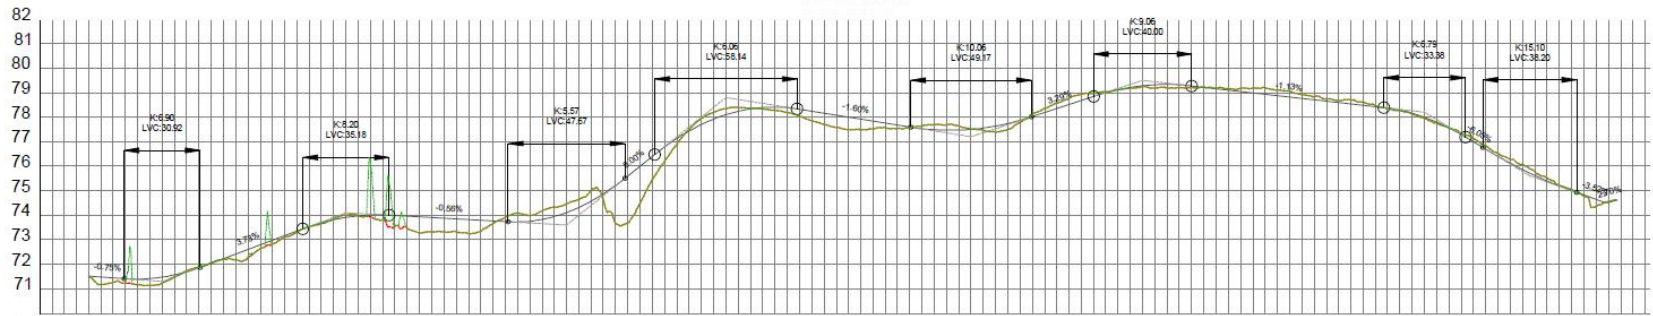
Chainage	-20	0	20	40	60	80	100	120	140	160	180	200	220	240	260	280	300	320	340	360	380	400	420	440	460	480	500	520	540	560	580	600	620																	
Ground Levels		71.524	71.396	71.666	71.727	72.191	73.091	73.847	74.013	73.906	73.794	73.753	74.318	74.637	75.600	77.132	76.899	78.348	78.412	78.273	78.160	77.702	77.840	77.518	77.530	77.644	77.500	77.516	77.868	77.785	78.514	78.769	79.112	79.332	79.192	79.187	79.194	78.936	78.709	78.832	78.483	78.607	78.121	77.291	77.325	76.277	76.124	75.194	75.218	74.566
Design Centreline Level		71.524	71.396	71.695	71.727	72.420	73.197	73.817	74.013	73.906	73.794	73.753	74.318	74.637	75.600	77.132	76.899	78.348	78.412	78.273	78.160	77.702	77.840	77.518	77.530	77.644	77.500	77.516	77.868	77.785	78.514	78.769	79.112	79.332	79.192	79.187	79.194	78.936	78.709	78.832	78.483	78.607	78.121	77.291	77.325	76.277	76.124	75.194	75.218	74.523

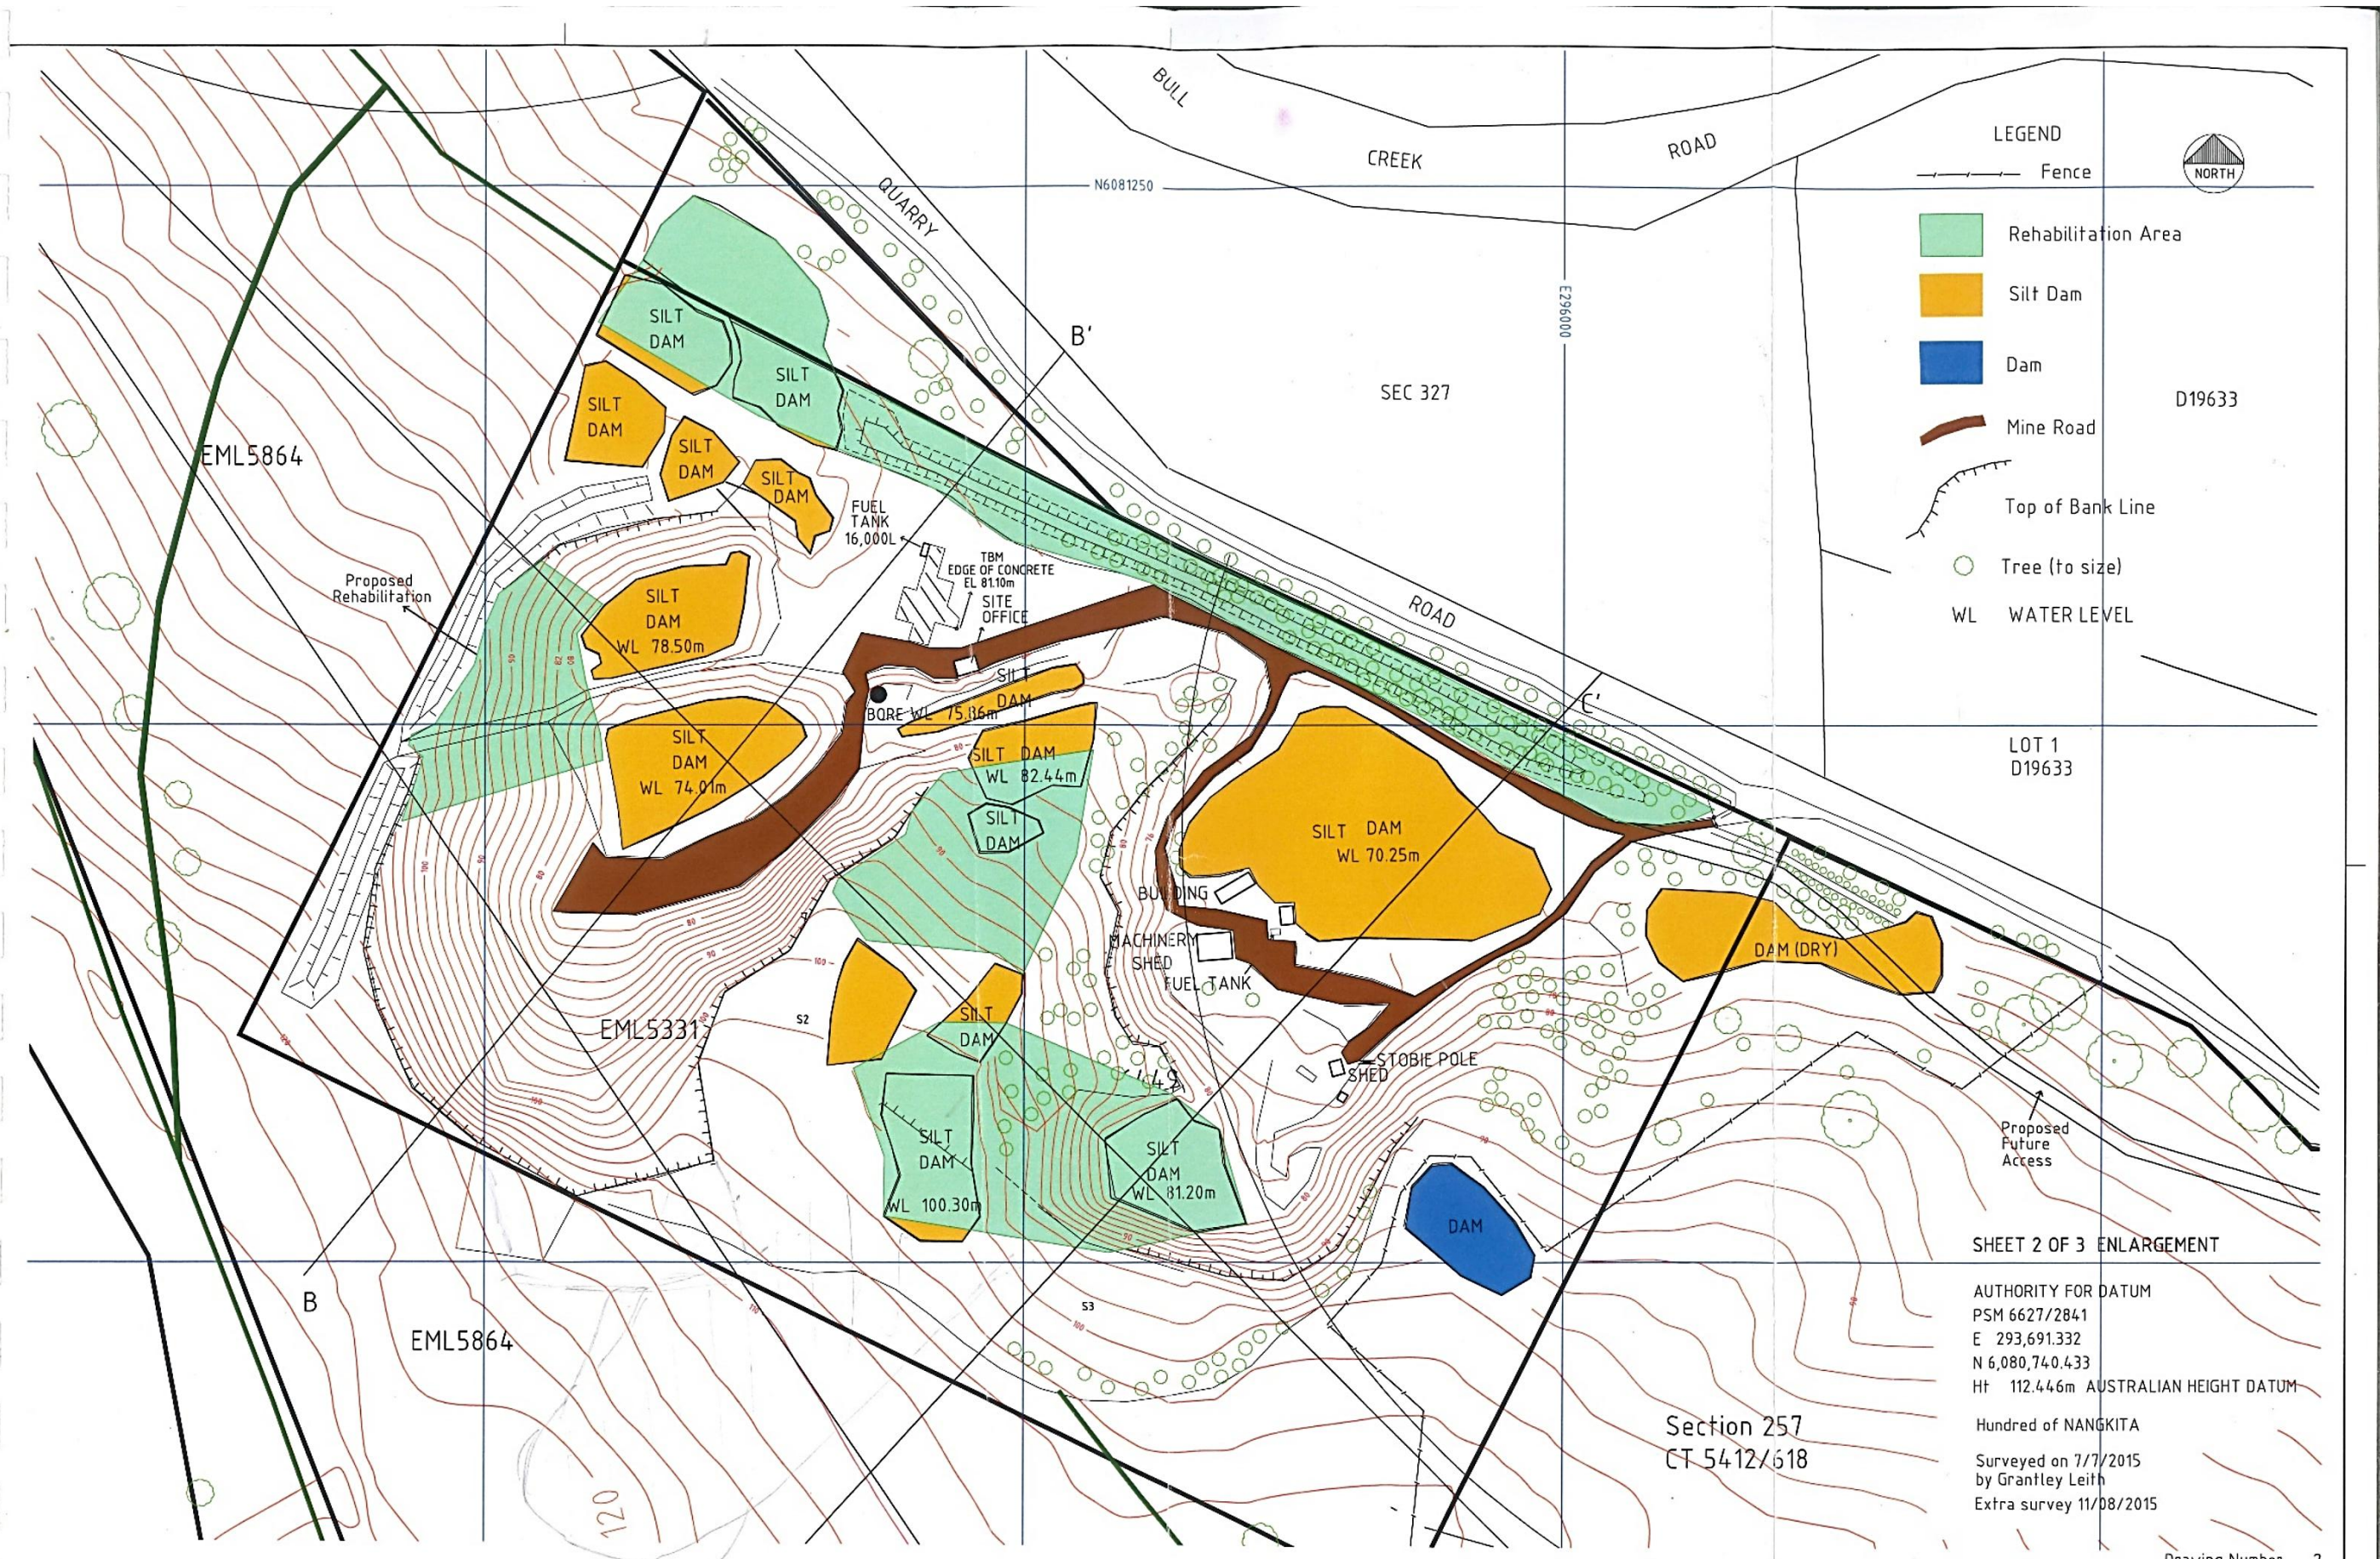
WARWICK STEEN MAYER
 EXISTING CONDITIONS PLAN
 EML5331, EML5864 & EML6449
 TOOPERANG

Progressive rehabilitation is at present being undertaken on an area between cross sections “B-B” and “C-C”. Refer to Existing Conditions Plan “Enlargement” Drawing Number 2, Drawing 2974MN01, which shows the proposed temporary rehabilitation and the rehabilitation undertaken at the present time. At present, the full silt dams are being covered with overburden, topsoiled and sown to permanent pasture. The slope angles are from near flat on the top of the hill. The downward slope will vary between 12 to 14 degrees. It is anticipated that this section of rehabilitation will be completed by 2018.

The undulation of the haul road towards the entrance gate into EML 5331 rises slightly upwards for a few metres then into a depression which means that no water or silt can leave the site. The elevation of the main silt retention dam in the old quarry is approximately 1.5 metres below the drainage level at the entrance to the quarry. Refer to Existing Conditions Plan, Drawing Number 2, Drawing 2974MN01. (WL stands for water level at the time of surveying.)

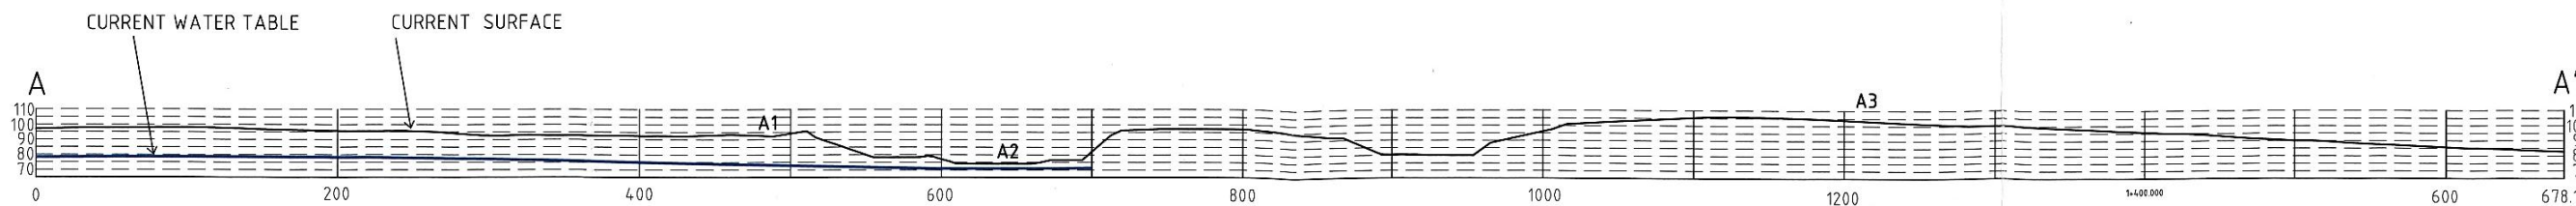
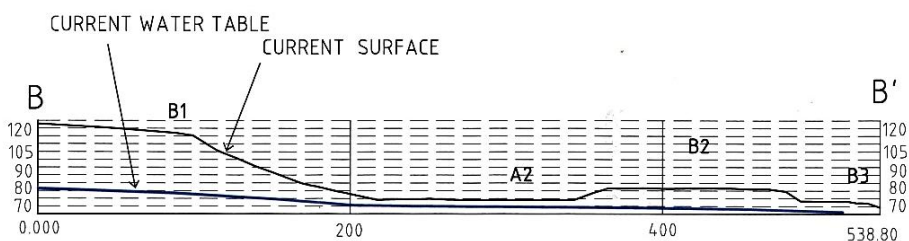
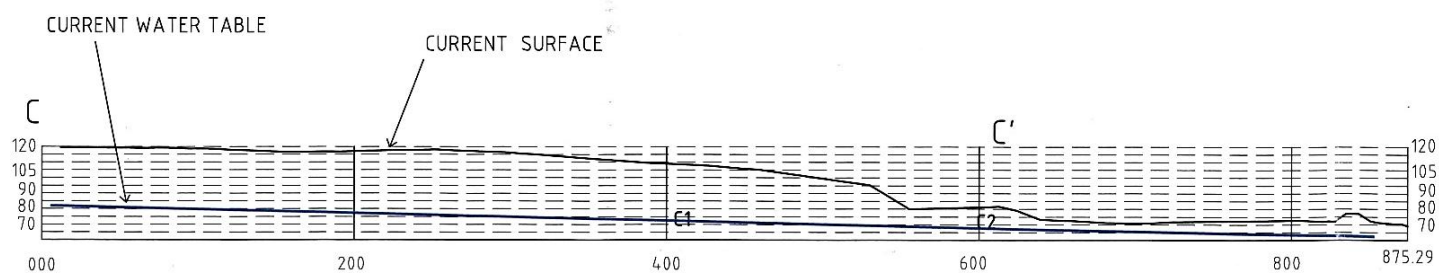
Drawing Number 3

SHEET 3 OF 3 INITIAL CROSS SECTIONS

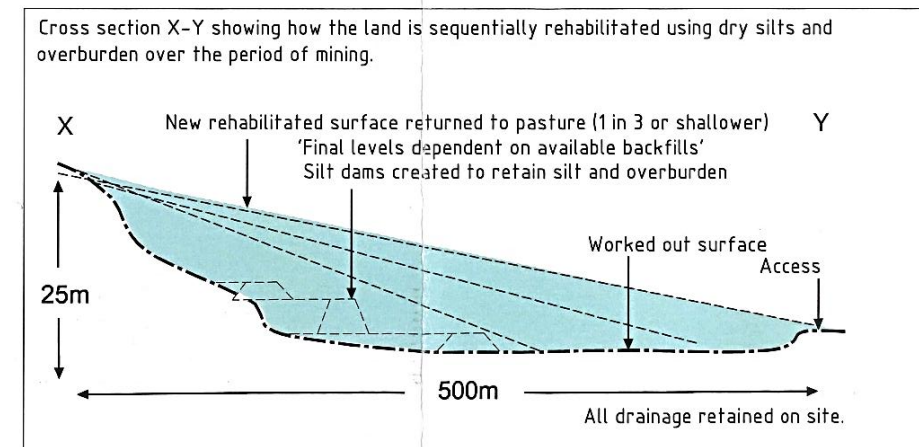
SCHEMATIC REHABILITATION SECTION

Progressive Rehabilitation design method using dried silt and overburden:

The northern side of each mined out stage can be progressively rehabilitated from the top to three quarter way down the slope, leaving a bund wall near the bottom to hold loose material and minimise contamination of the mined product.

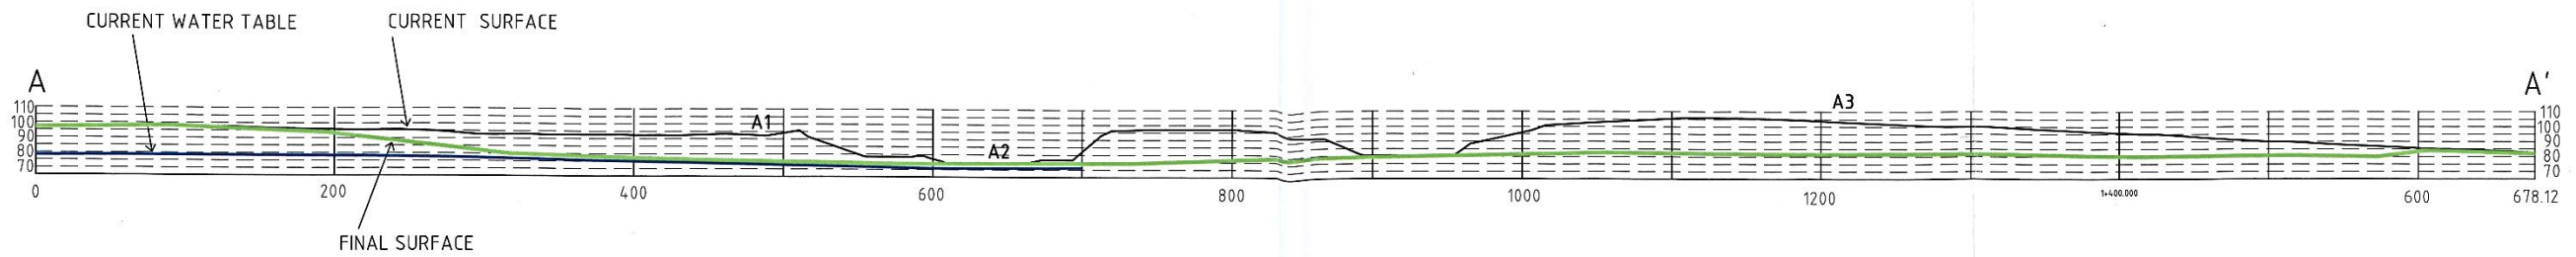
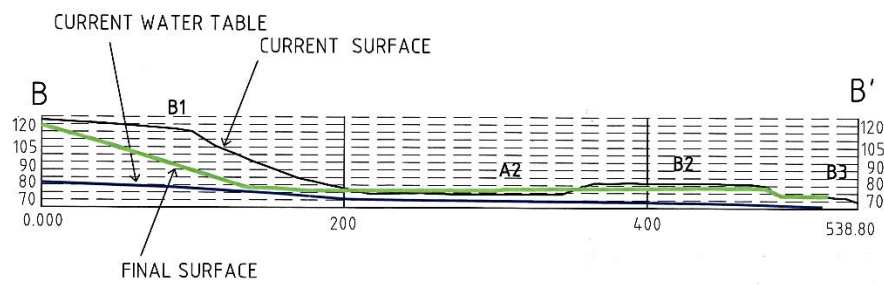
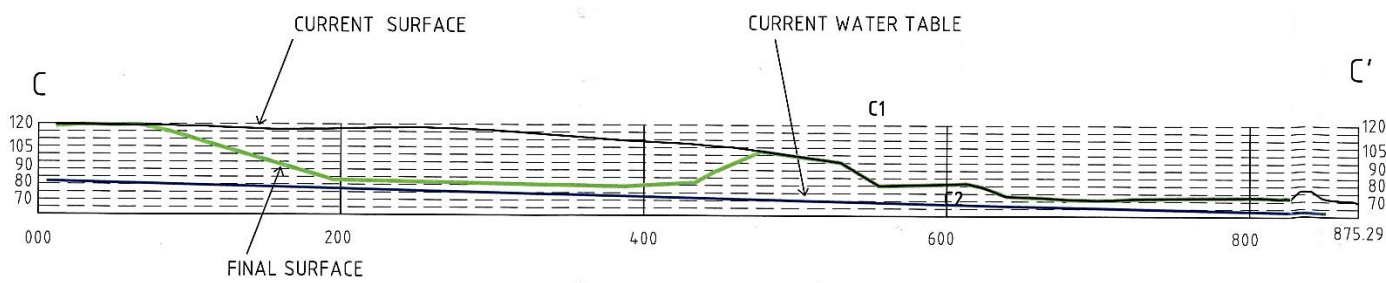
Drawing Number 8

FINAL SURFACE CROSS SECTIONS

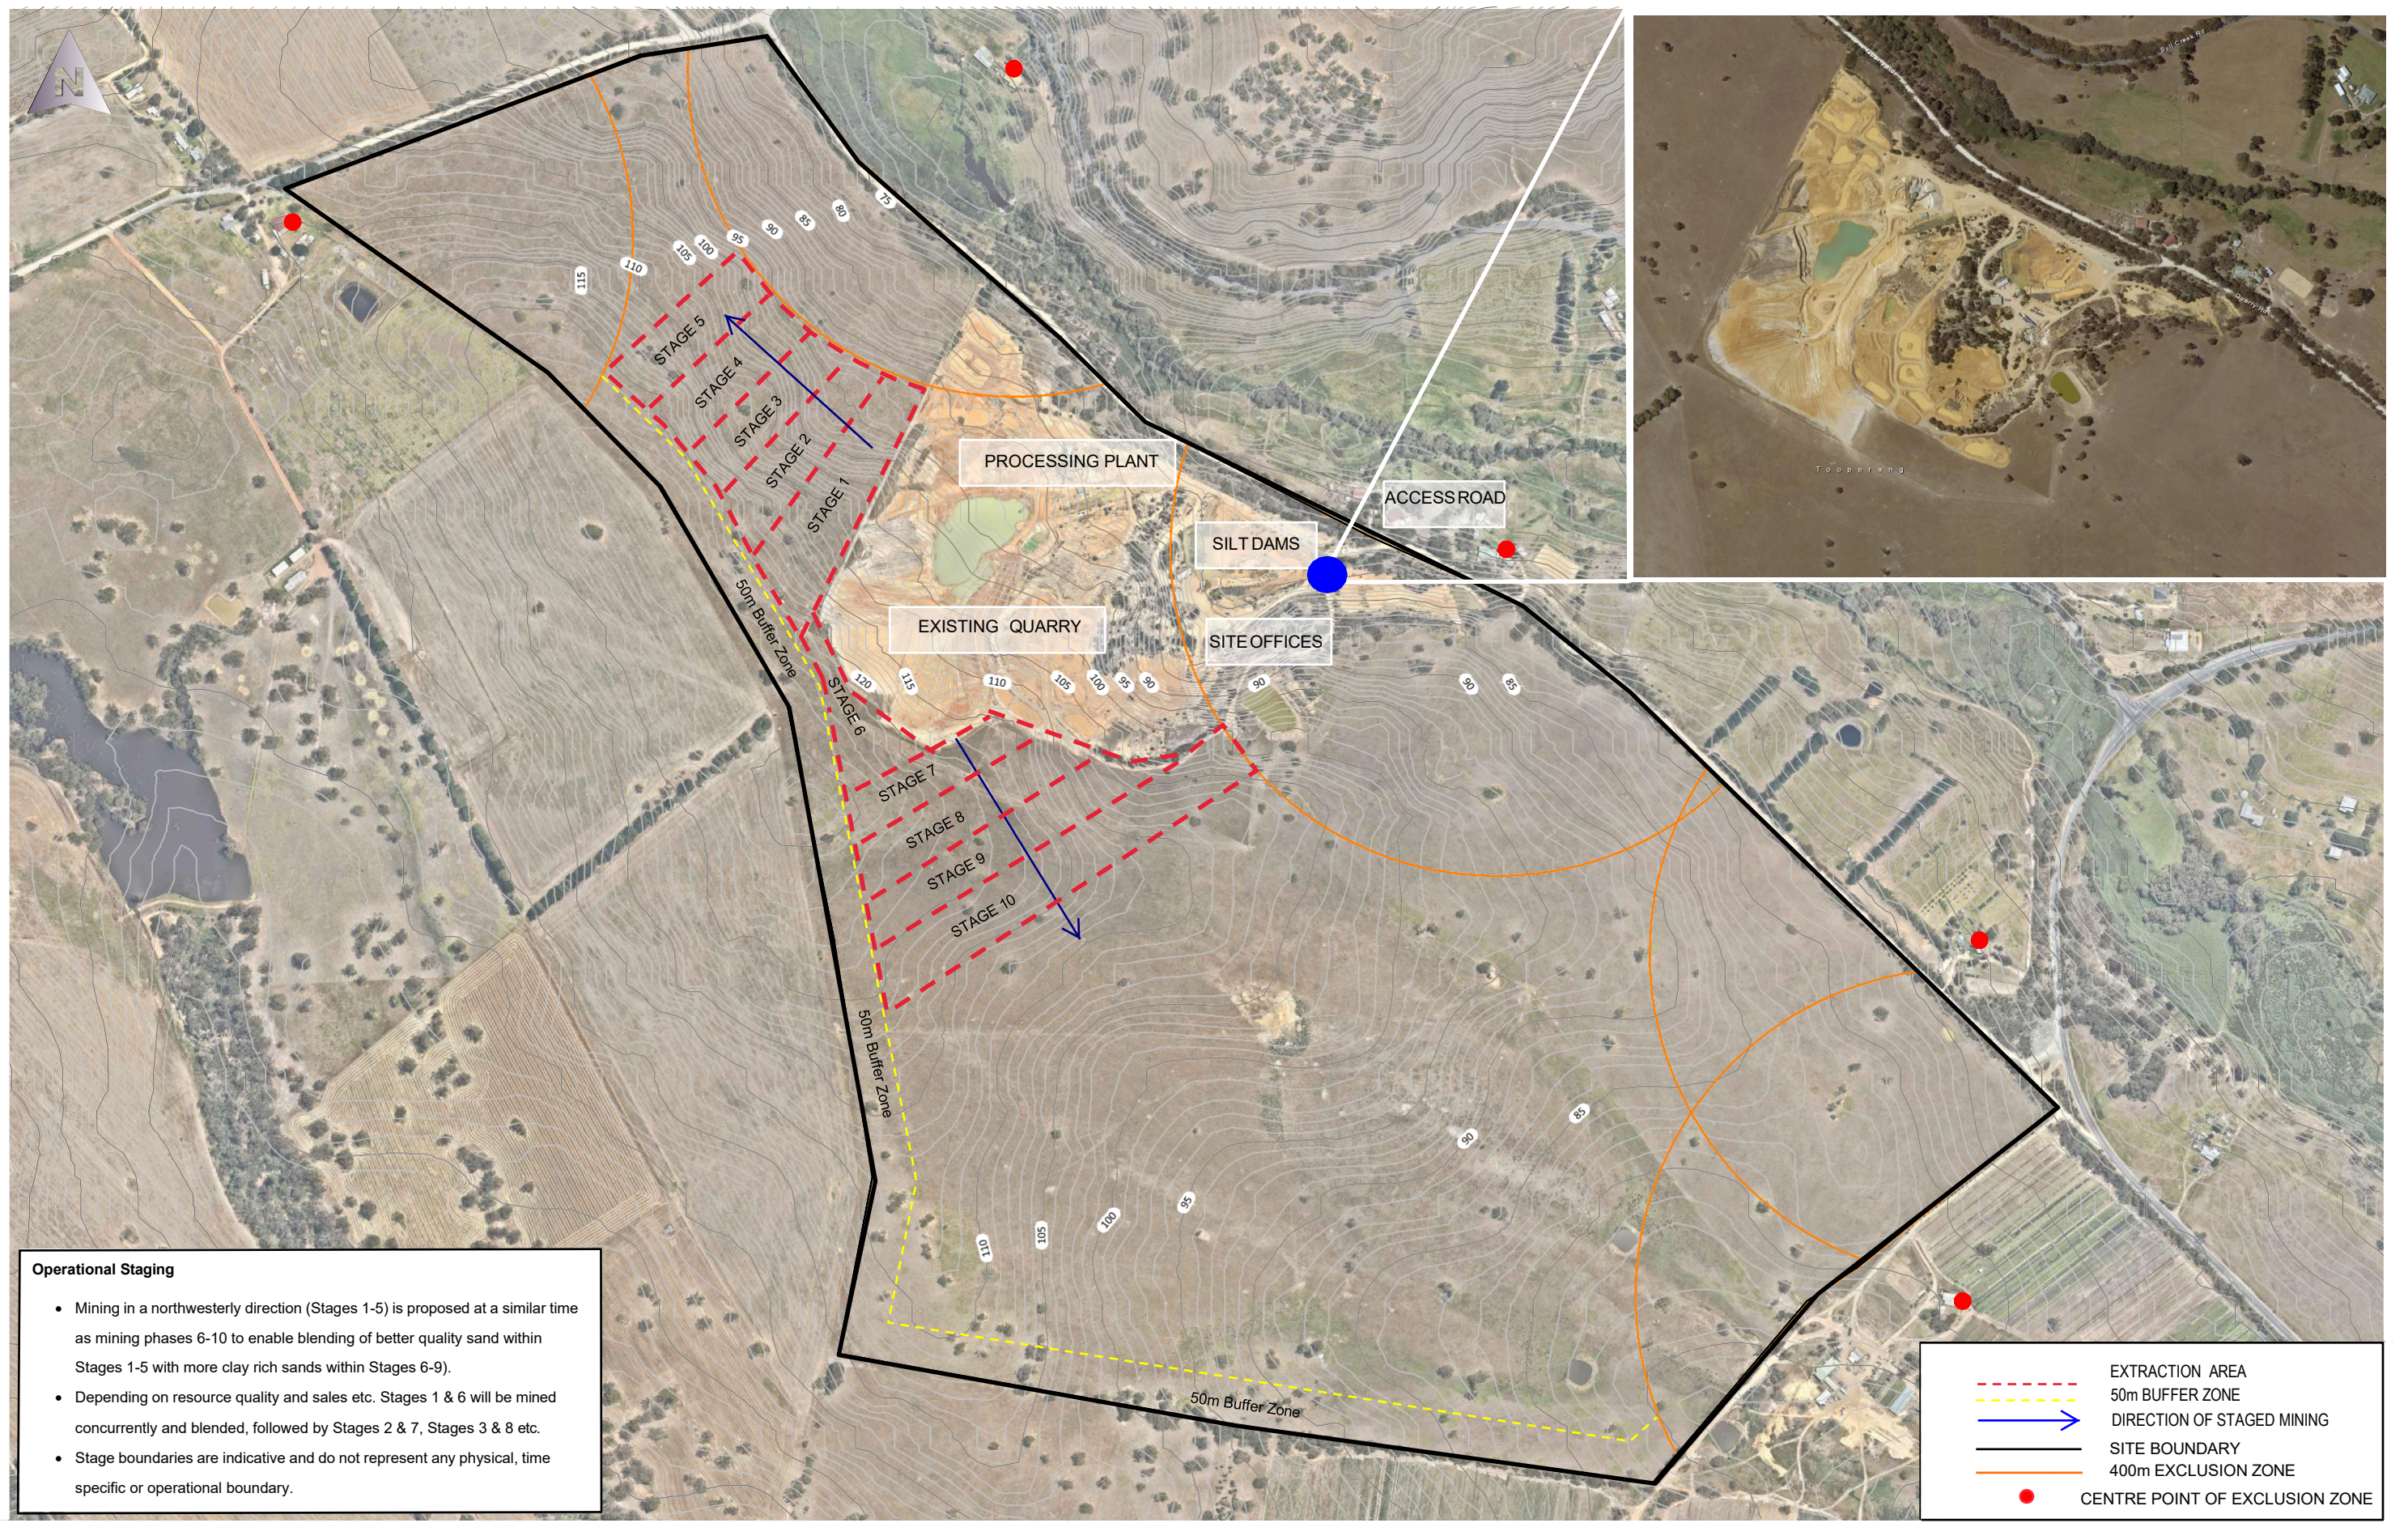
DRAWING	DATE	SHEET	REV.
2974MN01	23/12/2015	2 OF 2	2.30

Tooperang Quarry
WARWICK STEEN MAYER
CONCEPTUAL CLOSURE PLAN
EML5331, EML5864 & EML6449
TOOPERANG
