# Alexandrina Quarry (ML 6563)

## Program for Environment Protection and Rehabilitation (PEPR)

### HP Resources SA Pty Ltd

Revision: 7.0

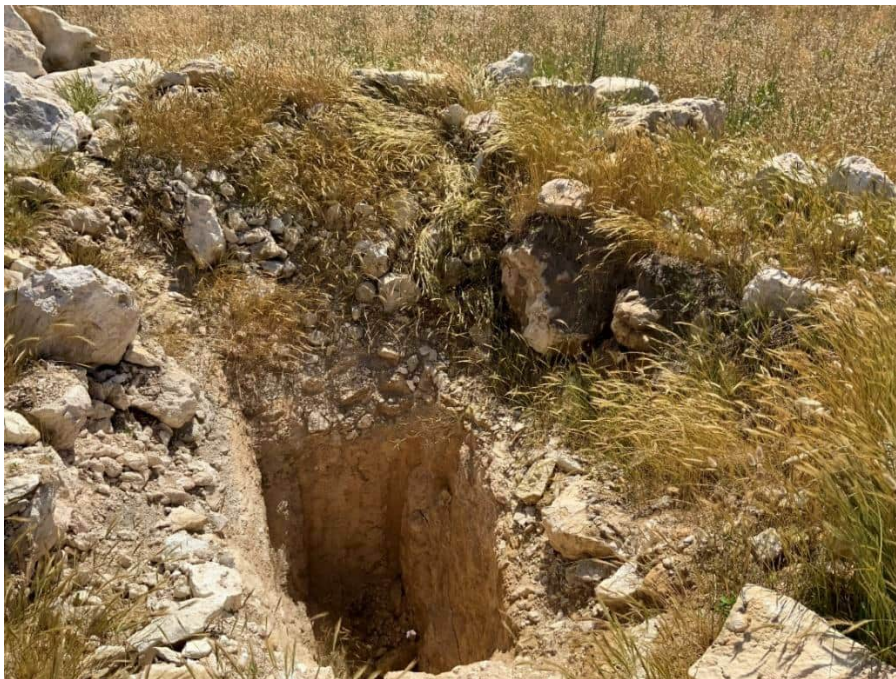
**Photo 1 – Site Geology Observation**

Review of historical (DEM) drilling logs approximately 180 m north east of the Site, indicate that sand is approximately 300 mm thick and underlain by undifferentiated Pleistocene calcrete approximately 300 mm thick at the drilling location. An inspection of excavations within the Site undertaken by the landowner confirmed the regional geology of the Site is consistent with the mapped regional geology, however, the layer of calcrete is thicker than the adjacent drill hole and is estimated to be up to 2.7 m deep within the Site, refer to Photo 1. Based upon review of the historical drilling logs and observations of excavations within the Site, a representative geological cross section has been derived for the Site within Drawing No. 5042.DRG.013 within Appendix A.

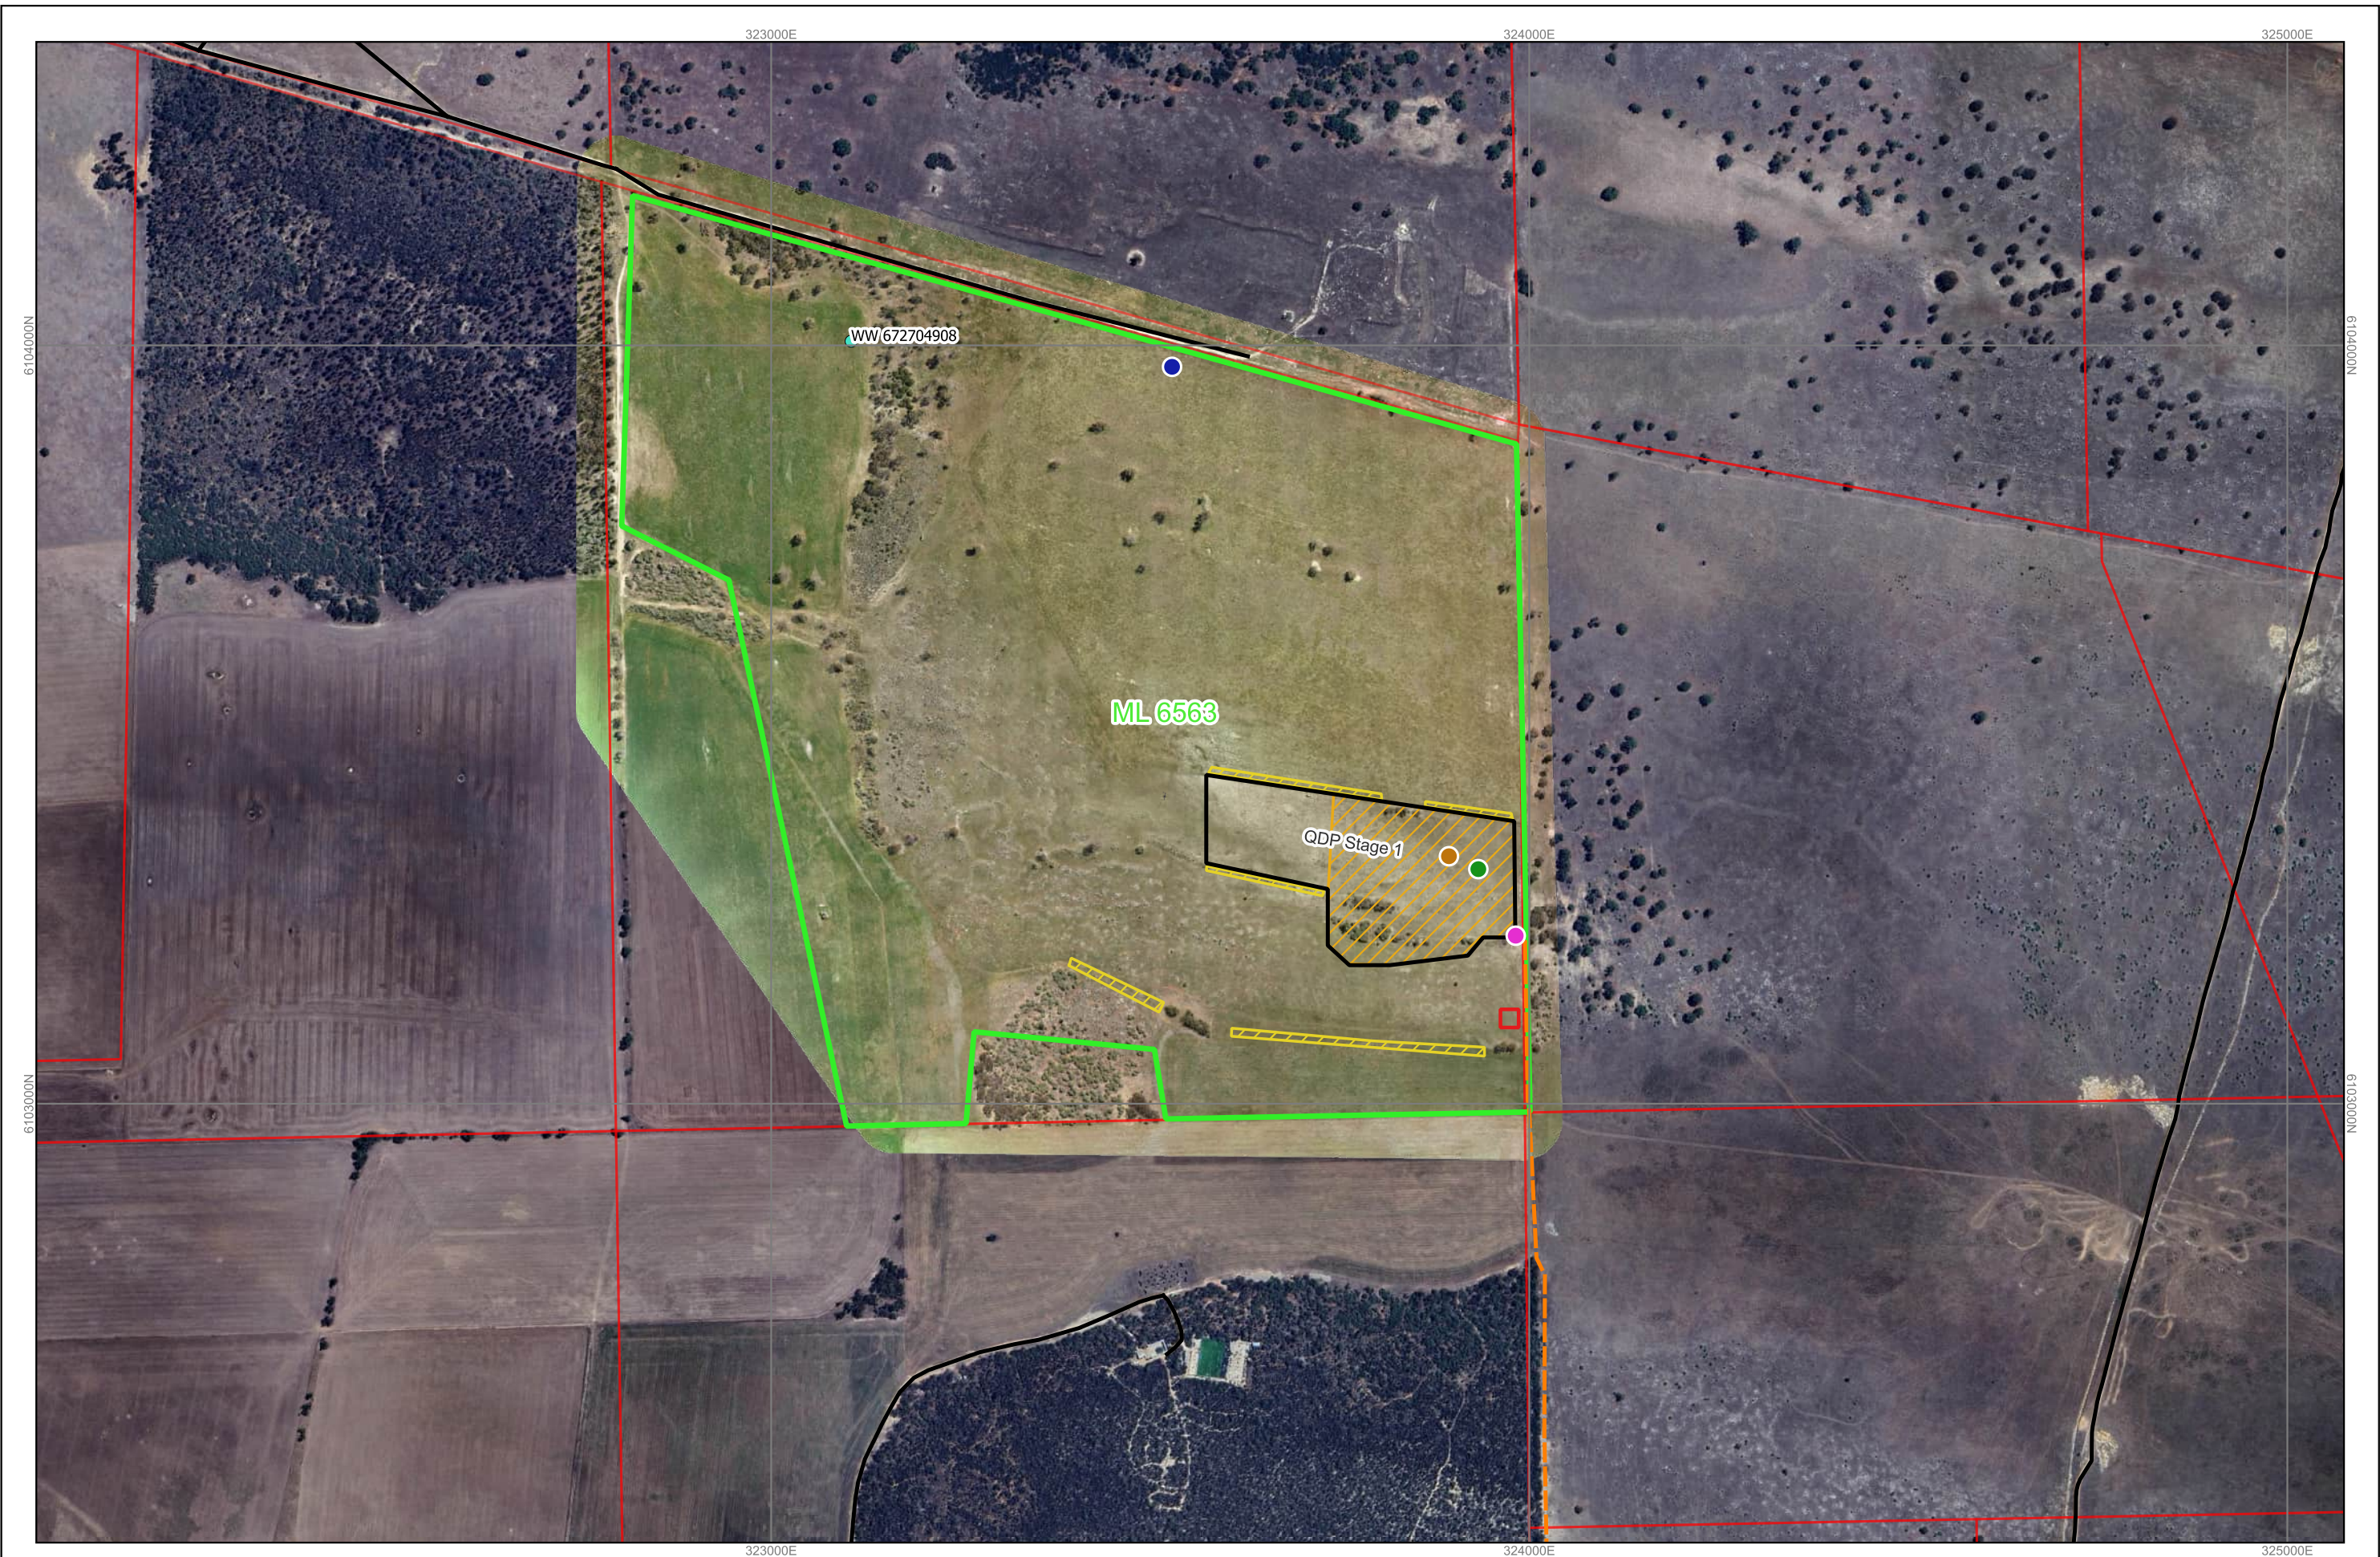
Legend:	
	Site Office & Amenity Facilities
	Initial Extraction Area
	Water Storage Tanks
	Cadastral Boundaries
	Water Well
	Topsoil Stockpile
	Site Entry and Exit
	Access Road
	QDP Stage 1
	Haul Road
	All Roads
	Long term Staging & Operational Area
	C & D Stockpiles and Processing

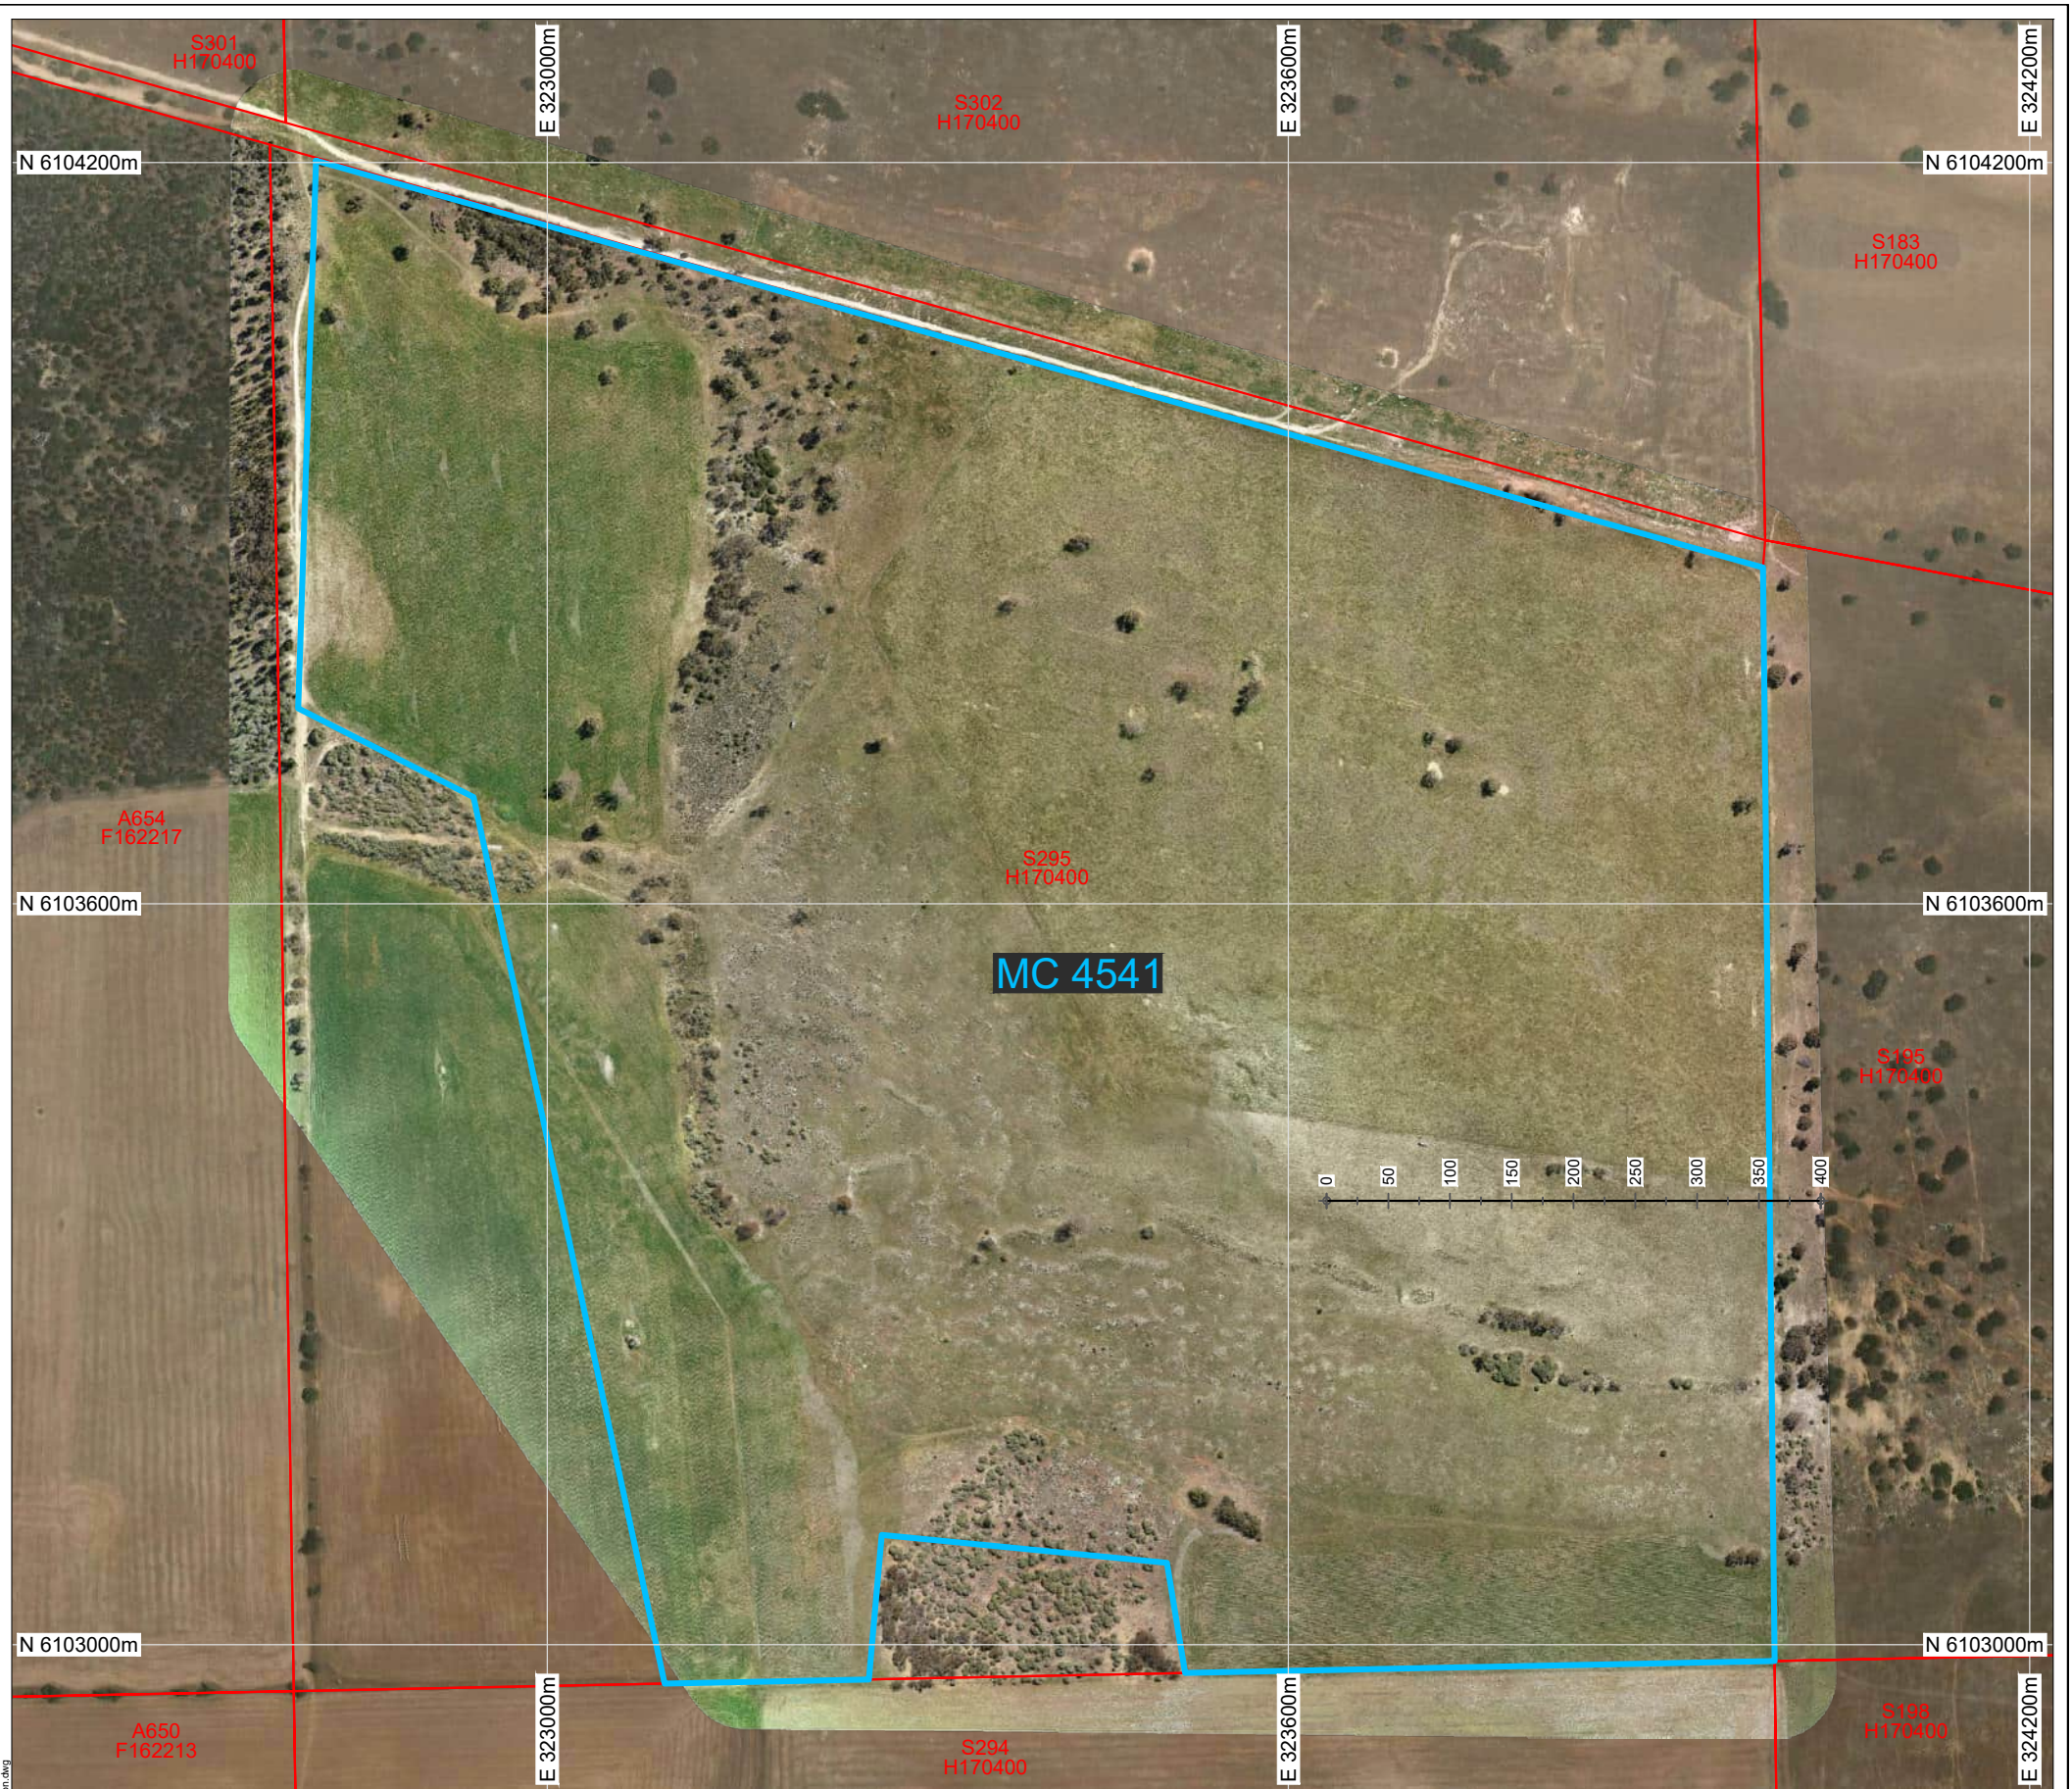
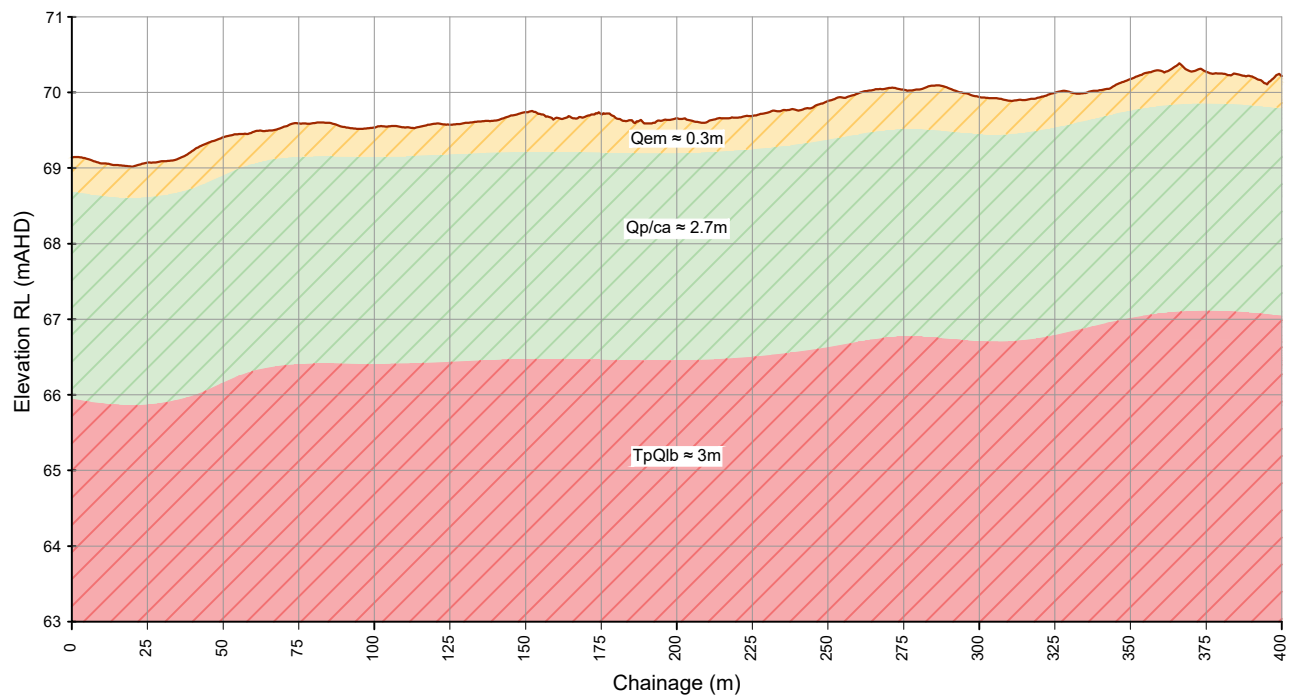
Geological Cross Section  
 SCALES: HORIZONTAL 1:2500 VERTICAL 1:100

- Topsoil
- Qem: Sand, pale yellow, fine to medium-grained quartzose
- Qp/ca: Undifferentiated Pleistocene Calcrete
- TpQlb: Clay, greenish grey, sandy; limestone, thin; and quartz sand; clay, green-grey, mottled, sandy

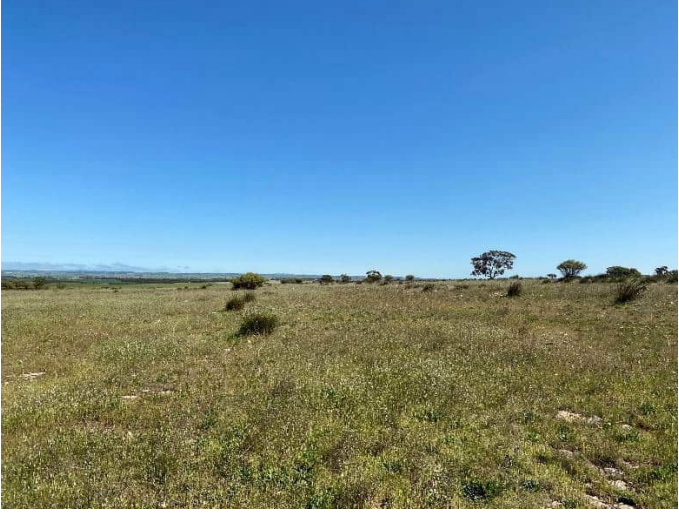
**Table 1 – Vegetation Association A – Stage 2**

<p data-bbox="675 898 957 996"><b>Direction of Photo: West</b>  <b>Easting: 323631.47</b>  <b>Northing: 6130264.33</b></p>					
General Description	The Site comprised of +/- <i>Chrysocephalum apiculatum</i> (Common Everlasting) +/- <i>Austrostipa</i> sp. (Spear-grass) +/- <i>Gahnia deusta</i> (Limestone Saw-sedge) +/- <i>Gahnia lanigera</i> (Black Grass Saw-sedge). Weed disturbance is present within the Site, additional species comprised of <i>Scabiosa atropurpurea</i> (Pincushion) +/- <i>Marrubium vulgare</i> (Horehound) +/- <i>Echium plantagineum</i> (Salvation Jane) +/- <i>Lagurus ovatus</i> (Hare's Tail Grass) +/- <i>Arctotheca calendula</i> (Cape Weed) +/- <i>Avena</i> sp. (Oat).				
Threatened Species or Community	One listed threatened flora species was observed within the Site, <i>Eucalyptus fasciculosa</i> (Pink Gum), with a state rating of Rare. This species will be retained with a five (5) m buffer and will not be required for removal.

Landscape Context Score	1.11	Vegetation Condition Score	9.80	Conservation Significance Score	1.10
Unit Biodiversity Score	11.97	Area (ha)	6.55	Total Biodiversity Score	78.40

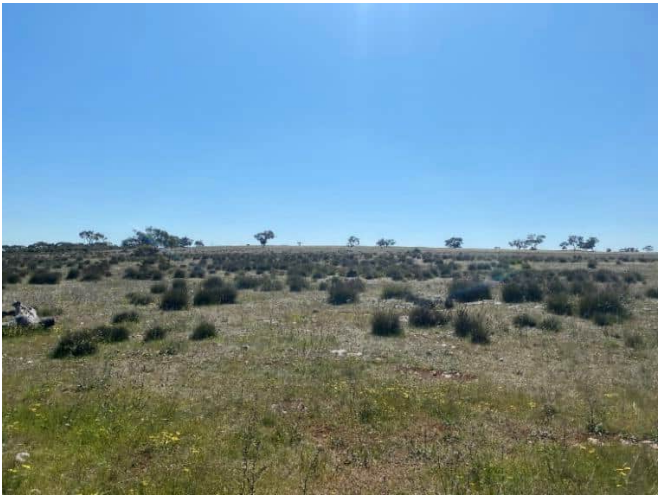
**Table 2 – Vegetation Association A – Stage 3**

<p><b>Direction of Photo:</b> North East  <b>Easting:</b> 323208.81  <b>Northing:</b> 6103426.84</p>					
General Description	The Site comprised of +/- <i>Chrysocephalum apiculatum</i> (Common Everlasting) +/- <i>Austrostipa</i> sp. (Spear-grass) +/- <i>Gahnia deusta</i> (Limestone Saw-sedge) +/- <i>Gahnia lanigera</i> (Black Grass Saw-sedge). Weed disturbance is present within the Site, additional species comprised of <i>Scabiosa atropurpurea</i> (Pincushion) +/- <i>Marrubium vulgare</i> (Horehound) +/- <i>Echium plantagineum</i> (Salvation Jane) +/- <i>Largurus ovatus</i> (Hare's Tail Grass) +/- <i>Arctotheca calendula</i> (Cape Weed) +/- <i>Avena</i> sp. (Oat).				
Threatened Species or Community	One (1) listed threatened flora species was observed within the Site, <i>Eucalyptus fasciculosa</i> (Pink Gum), with a state rating of Rare. This species will be retained with a five (5) m buffer and will not be required for removal.

Landscape Context score	1.12	Vegetation Condition Score	9.80	Conservation Significance Score	1.10
Unit Biodiversity Score	12.07	Area (ha)	8.61	Total Biodiversity Score	103.92

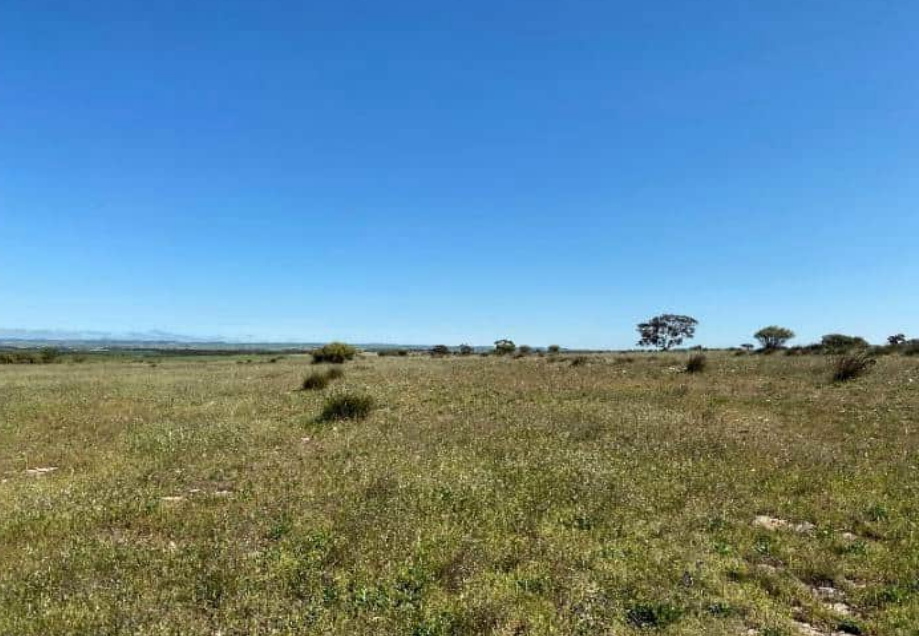
West
	<b>GPS Reference</b>
	Datum GDA94
	Zone (52, 53 or 54) 54
	Easting (6 digits) 351153.31
	Northing (7 digits) 139345.62
	<b>Description</b>
Scattered Callitris gracilis (Southern Cypress Pine) +/- Acacia victoriae ssp. (Elegant Wattle) +/- Melaleuca lanceolata (Dryland Tea-tree) +/- Chrysocephalum apiculatum (Common Everlasting) +/- Lomandra longifolia (Spiny-headed Mat-rush)

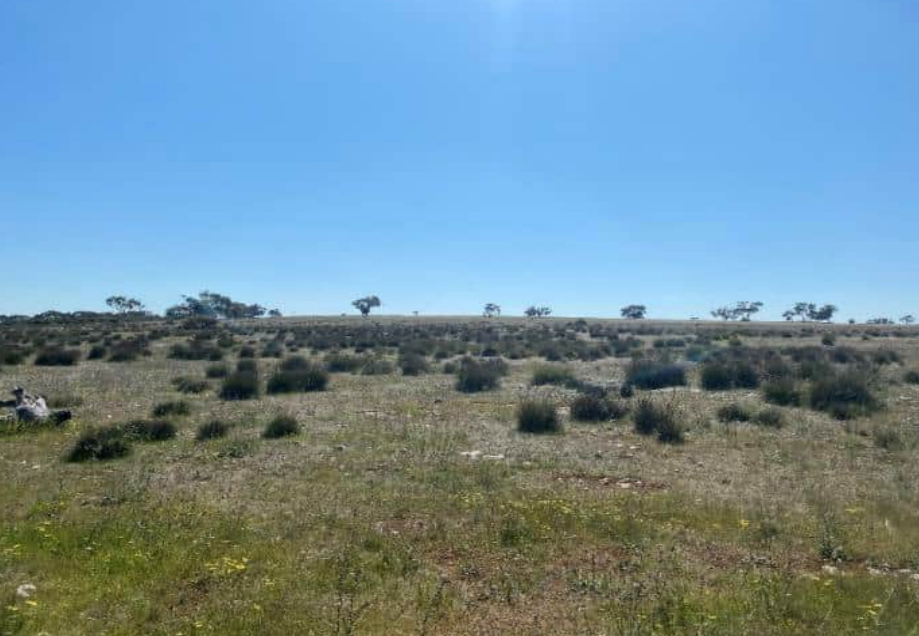
North East	
	<b>GPS Reference</b>	
	Datum	GDA94
	Zone (52, 53 or 54)	54
	Easting (6 digits)	351147.77
	Northing (7 digits)	139329.04
	<b>Description</b>	
	Scattered <i>Callitris gracilis</i> (Southern Cypress Pine) +/- <i>Acacia victoriae</i> ssp. (Elegant Wattle) +/- <i>Melaleuca lanceolata</i> (Dryland Tea-tree) +/- <i>Chrysocephalum apiculatum</i> (Common Everlasting) +/- <i>Lomandra longifolia</i> (Spiny-headed Mat-rush)

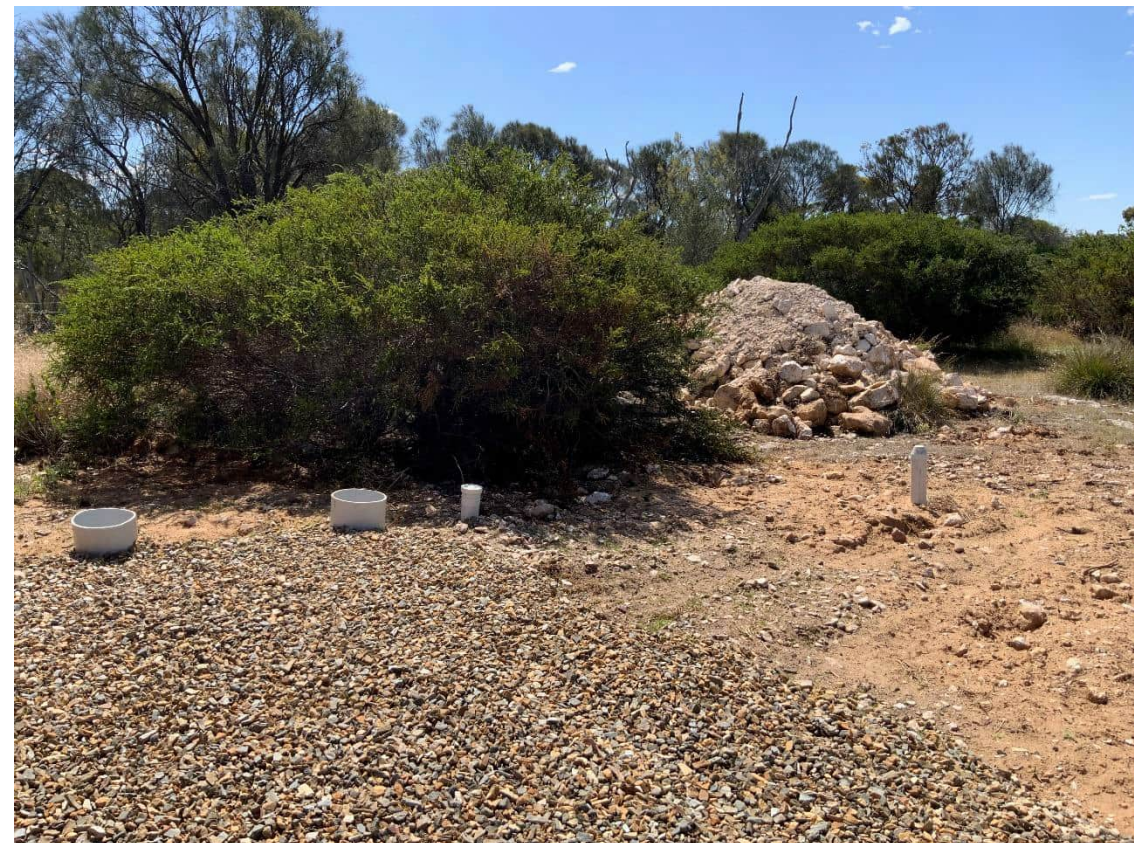
**Photo 15:** Photo – Septic tank installed

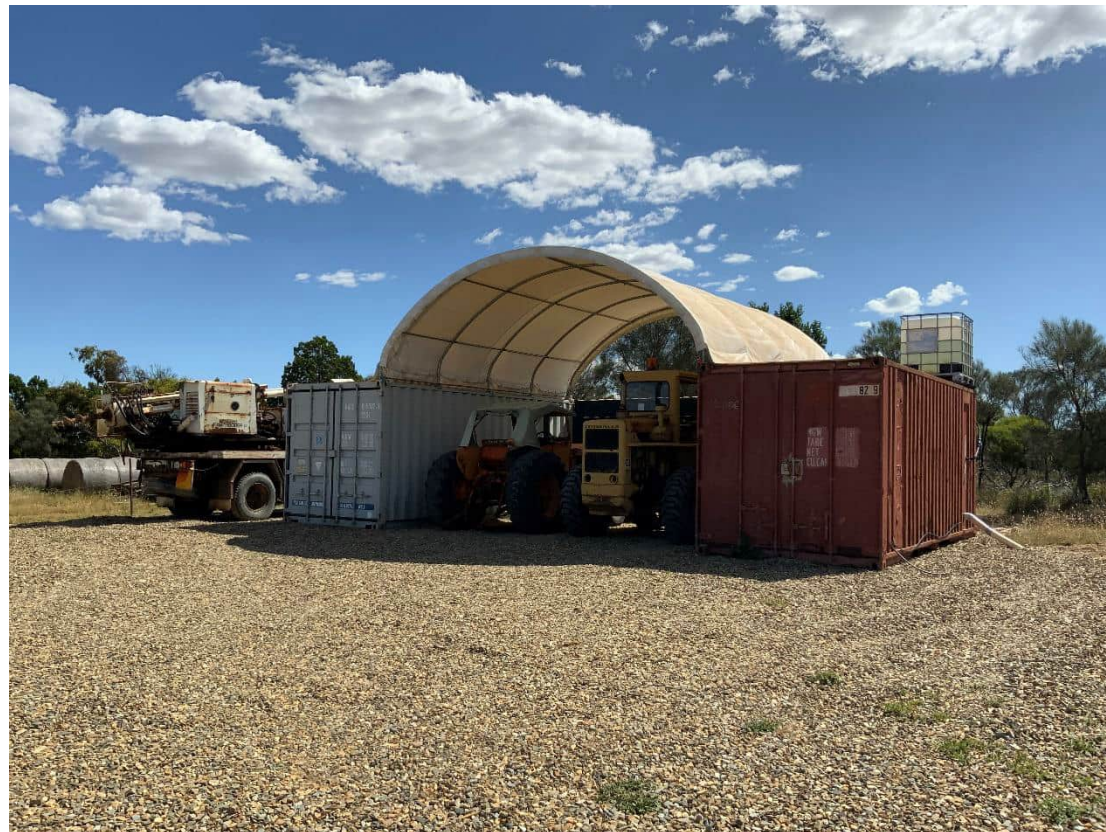
Photo 16: Photo – Septic tank installed

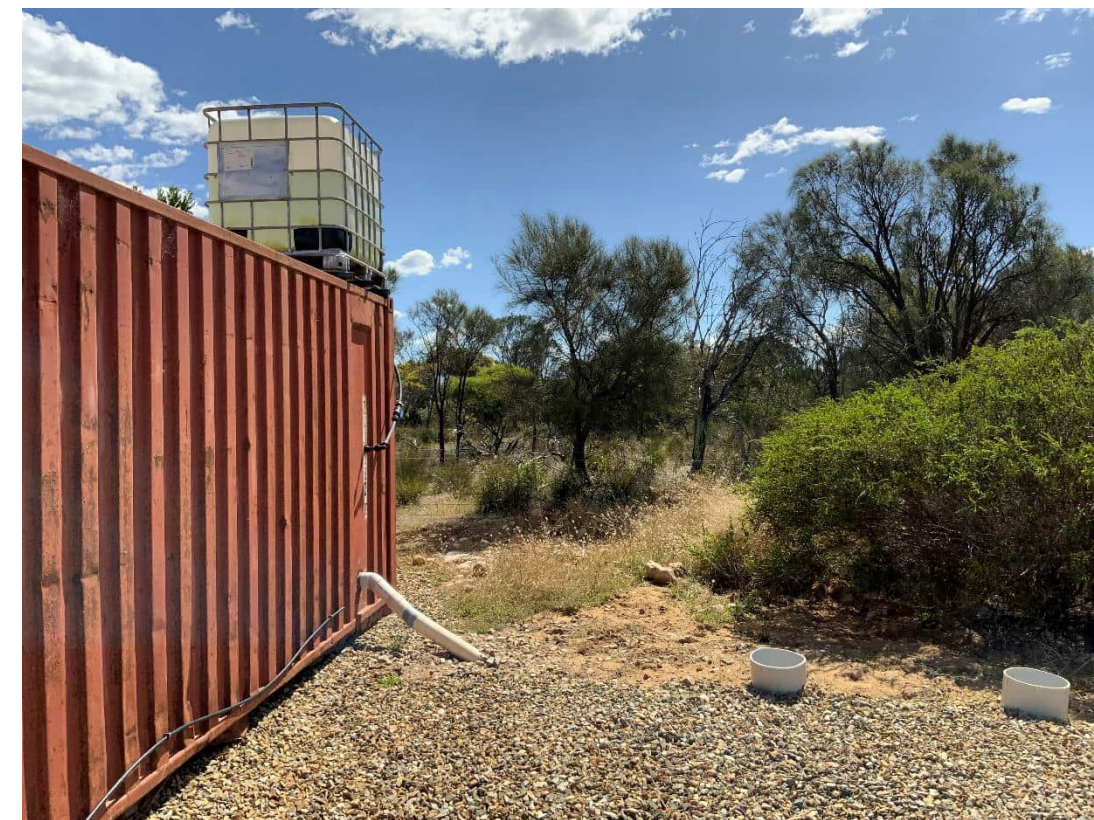
Photo 17: Photo - Septic tank installed

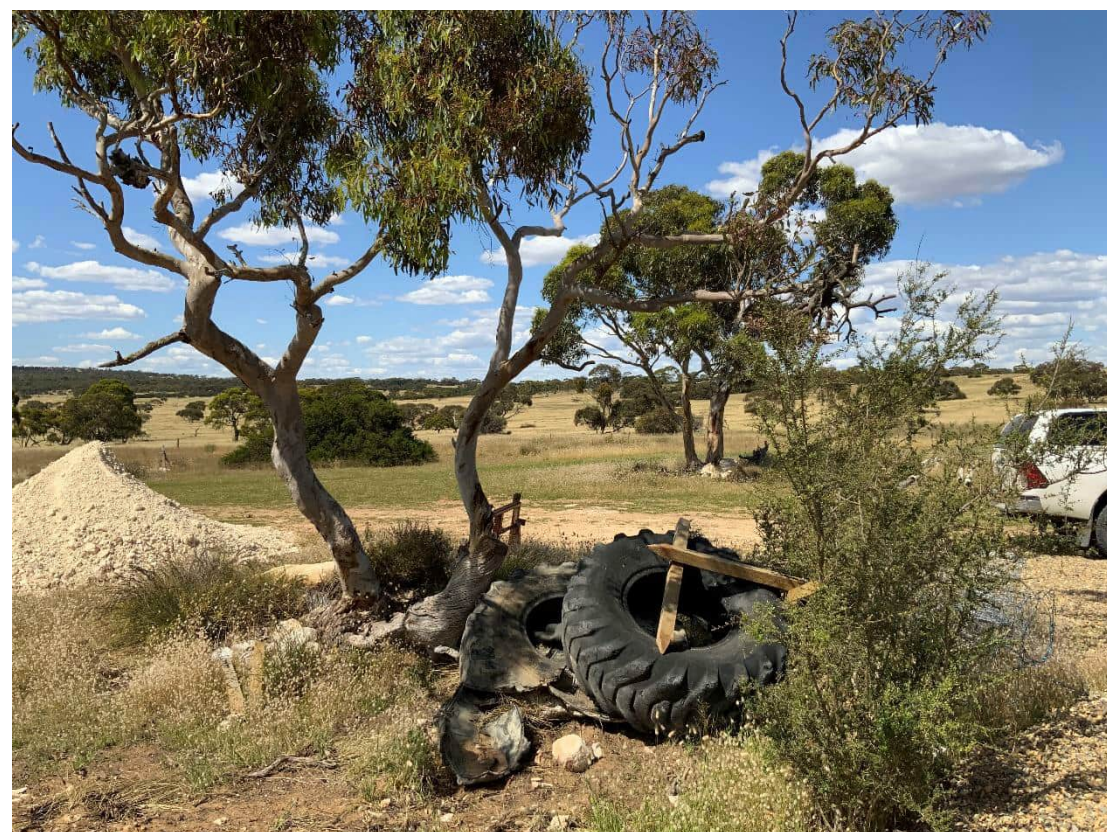
Photo 18: Photo – Rubbish within MC area
