Whittlesea Quarry
Mineral Claim 4569

Mining Proposal

Craig Haywood

January 2025

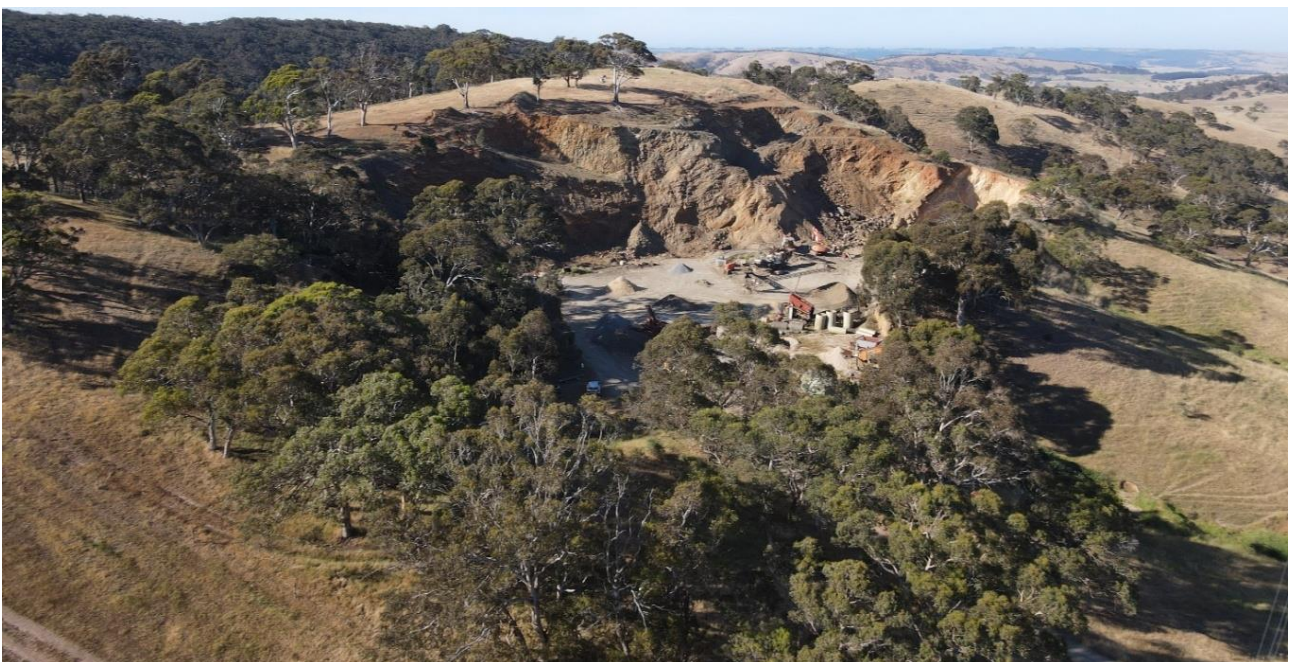
Plate 1 – The local topography and landscape surrounding MC 4569 to the south

The Site is located in the hilly Mount Lofty Ranges landscape (**Plate 1**). The Site includes mildly steep topography that slopes generally downhill from south-east to north-west.

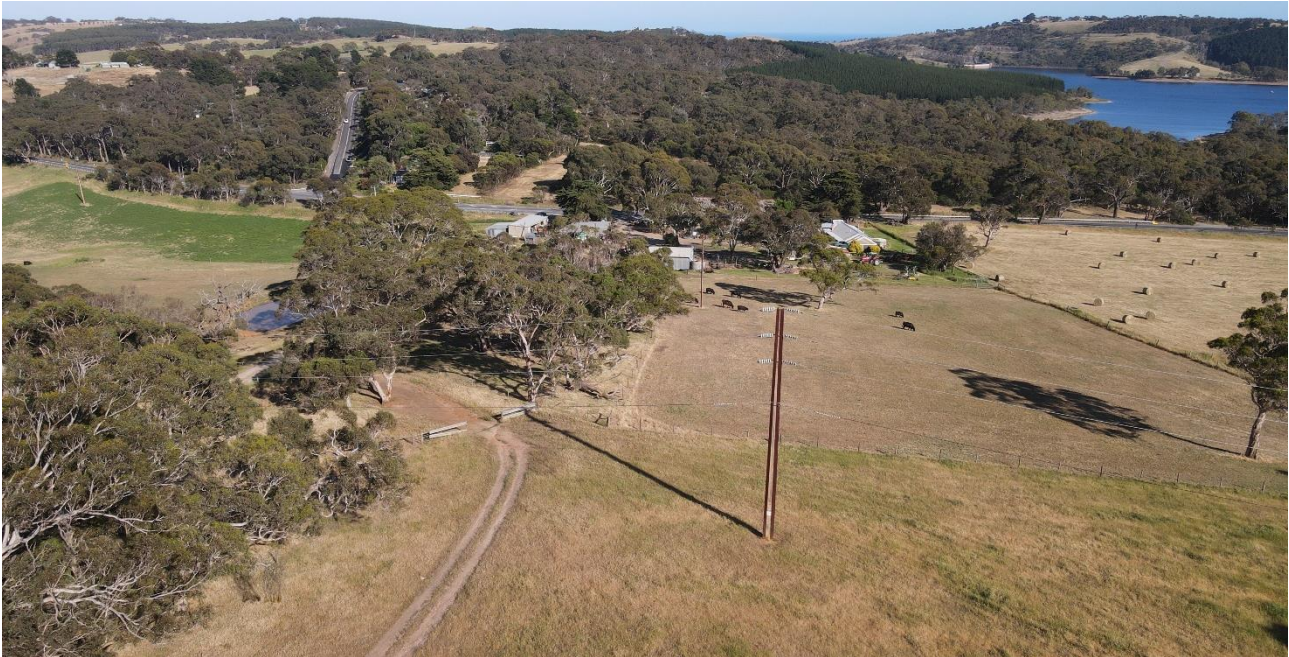
Plate 2 – The local topography and landscape surrounding MC 4569 to the north

The Myponga Reservoir and Main South Road are also predominant features of the landscape (**Plate 2**).

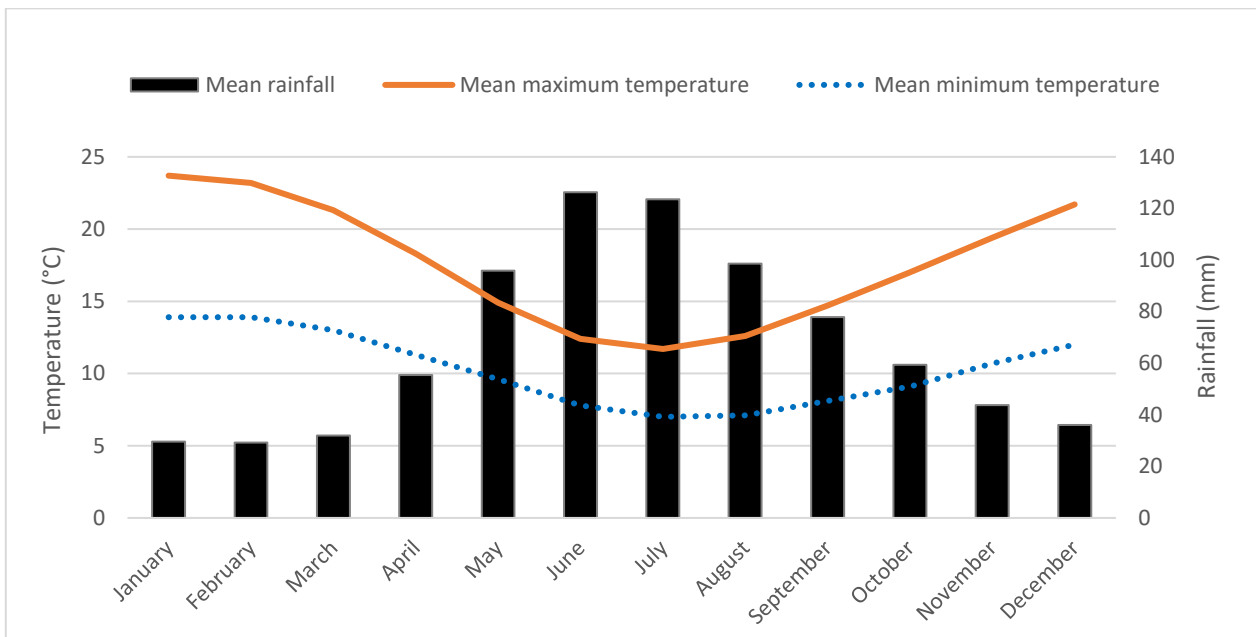
Figure 1 – Mean temperature and rainfall data from Parawa BOM Station (023875)

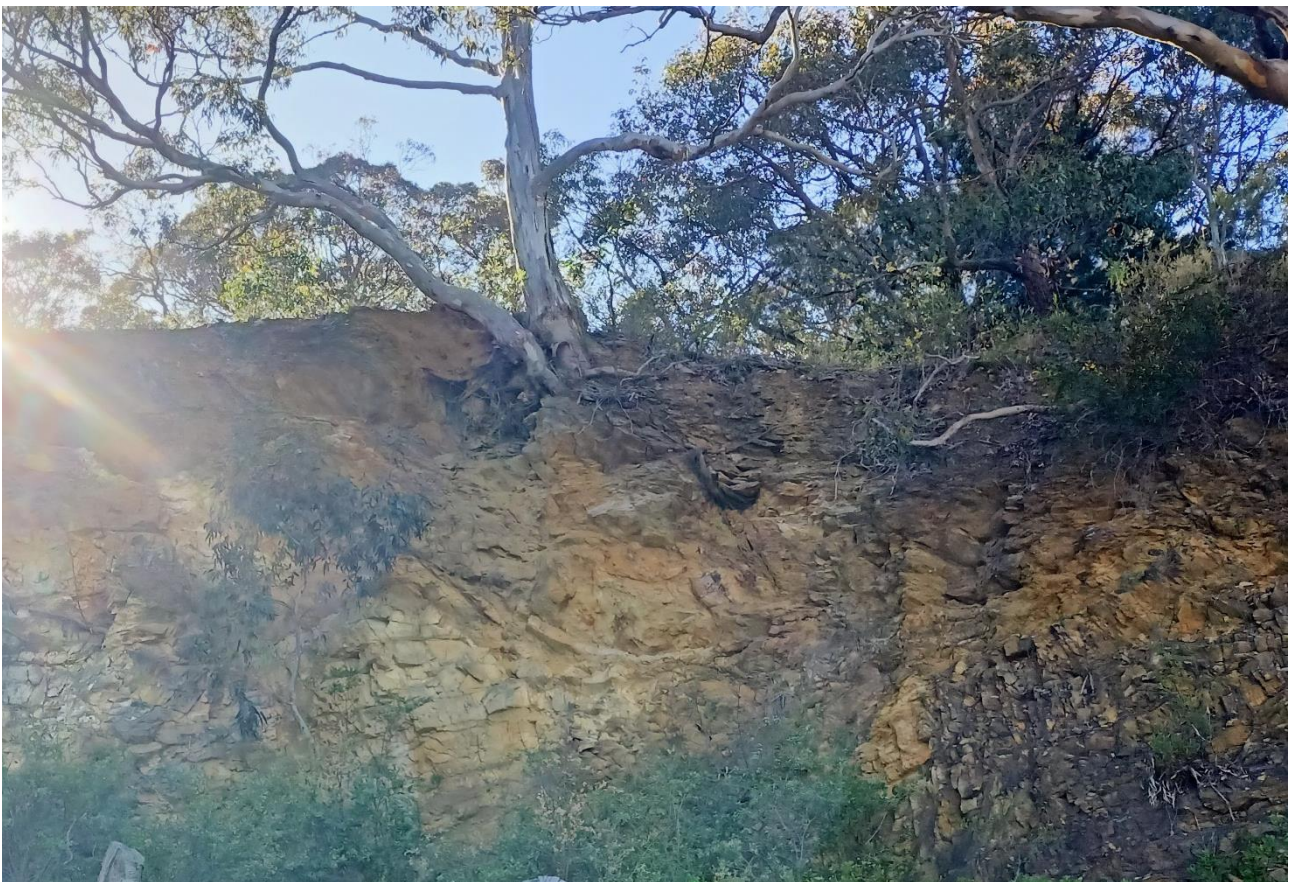
Plate 3 – The soil profile viewed into a pre-existing cut into the hill face on MC 4569

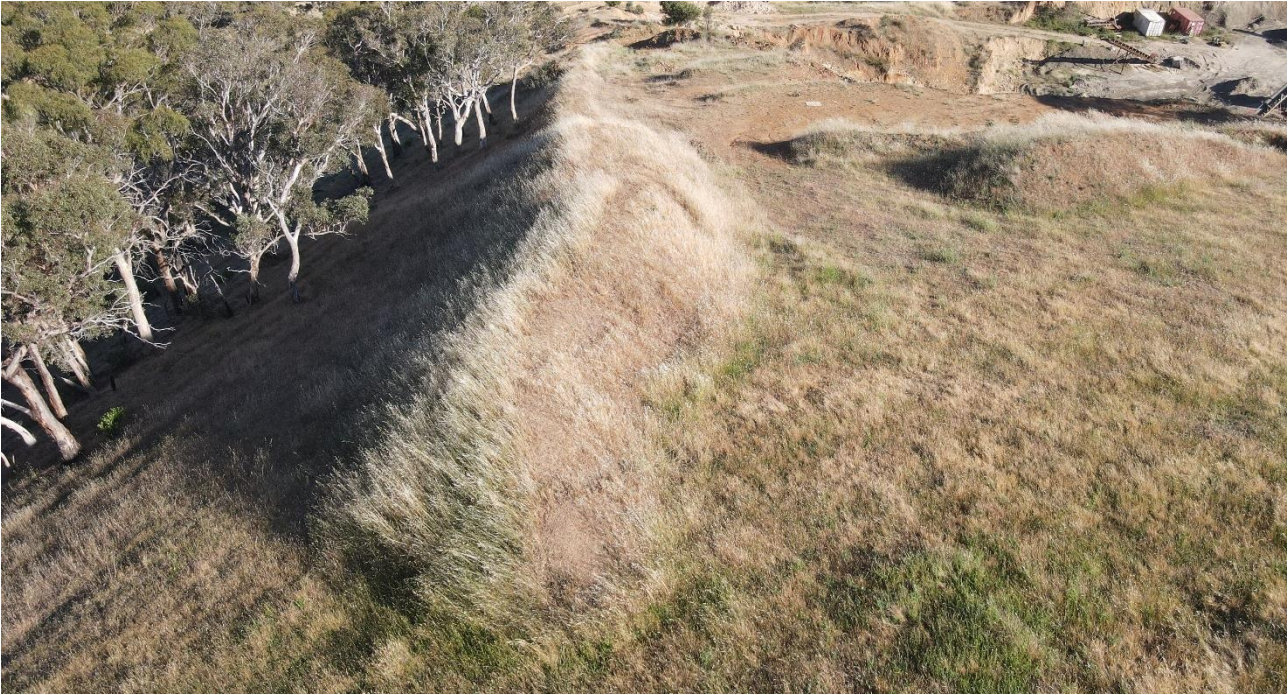
Plate 4 – Soil windrow along the EML 5542 western boundary

The total length of the windrows at the Site is approximately 211m and the volume of soil currently stockpiled on the Site is therefore approximately 1,108m³.

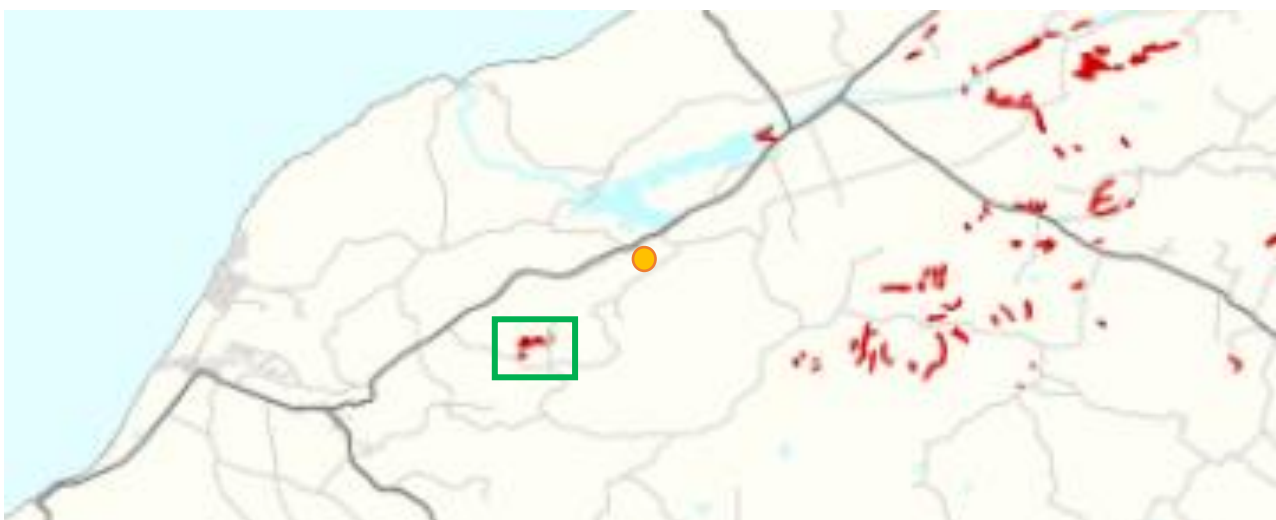
Figure 3 – SFP TEC location (green box) in reference to the Site (orange dot)

A map showing the location of the SFP TECs from the *Environment Australia’s Communities of National Environmental Significance database* shows that the nearest SFP TEC is located approximately 2.5km south-west of the Site (**Figure 3**).

A review of the surface water network identified that the nearby TEC is within the Carrickalinga Creek but not hydrologically connected to the Site. The Site is located at the headwaters of a drainage line that follows Main South Road that feeds into Carrickalinga Creek approximately 1.5km downstream of the SFP TEC location. Therefore, there is no surface water pathway between the Site and the nearby SFP TEC.

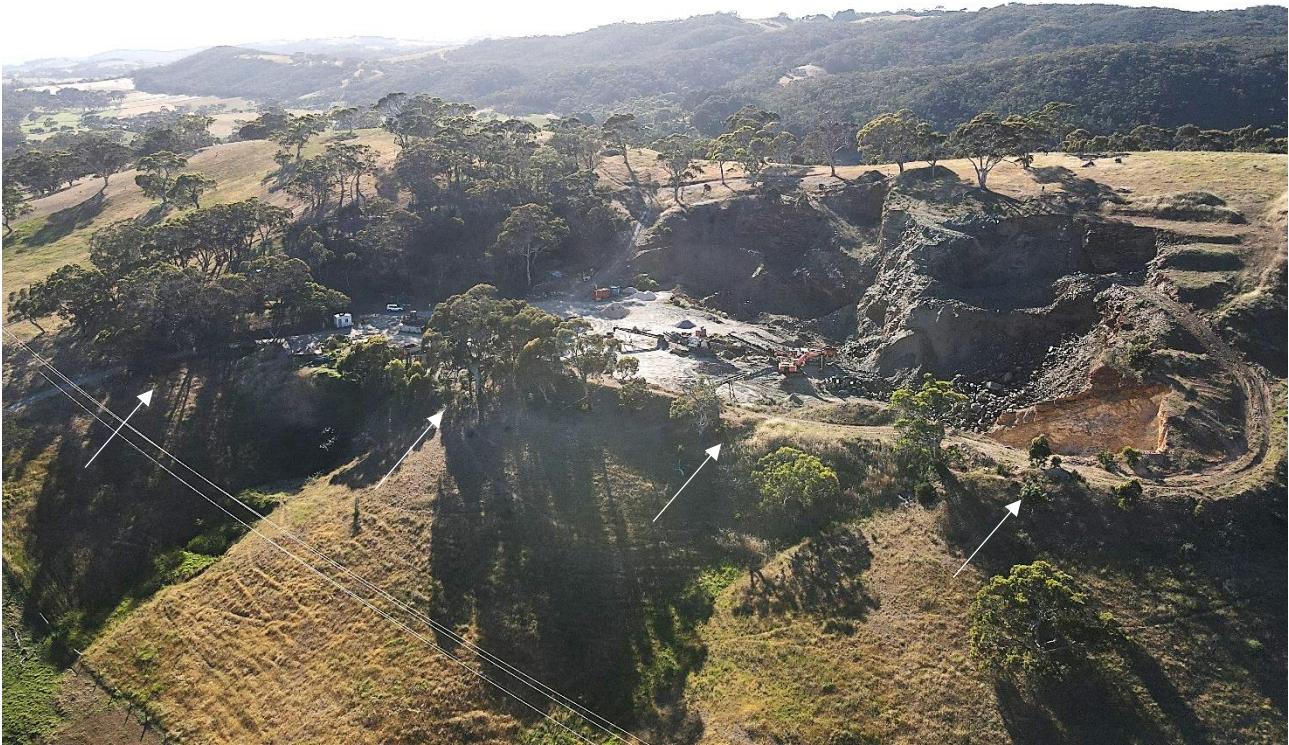
Plate 5 – The partial tree screen along the northern side of quarry

The existing quarry is visible from Main South Road. The Site has partial tree screening by a row of trees adjacent to Main South Road, and from a partially vegetated bund established at the northern side of the Site (**Plate 5**).

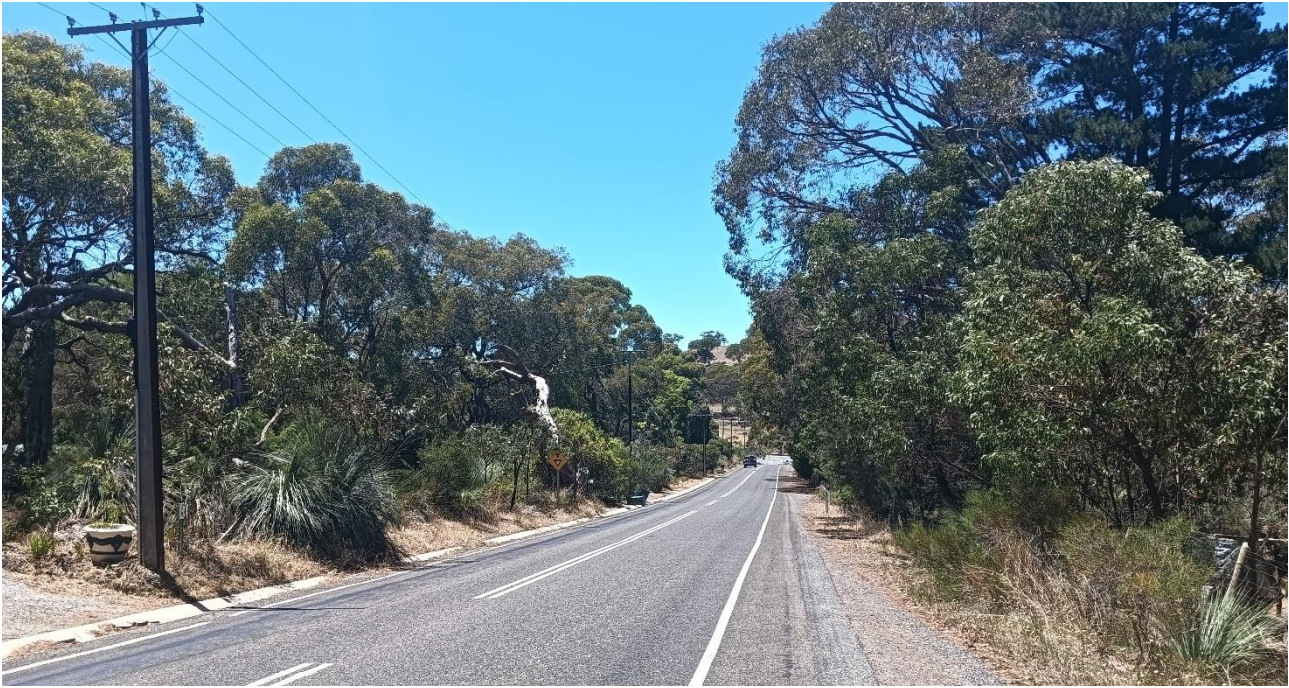
Plate 6 – The view towards MC 4569 from Forktree Road

An inspection of the area where SR7 – SR13 are located along Forktree Road identified that thick vegetation is likely to screen any views of MC 4569 (**Plate 6**).

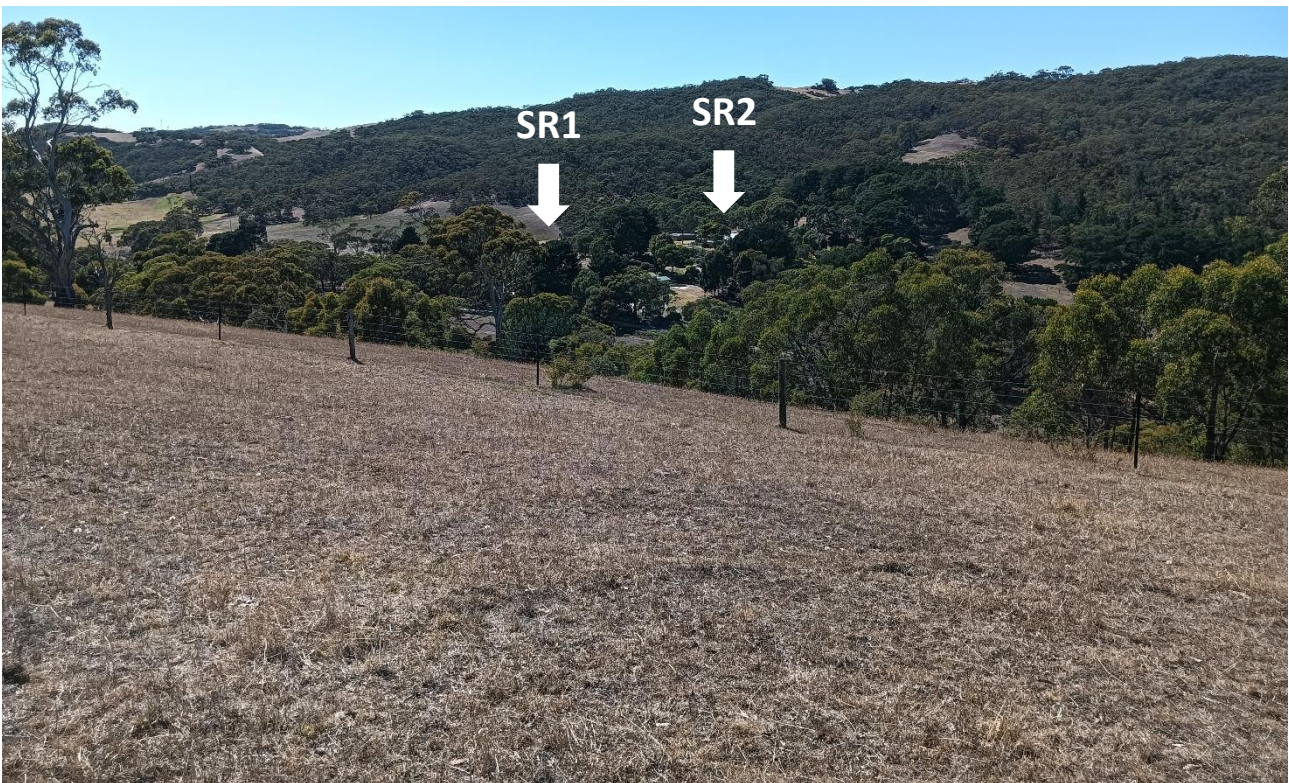
Plate 7 – The view towards SR1 and SR2 from the southern boundary of the East Pit

An inspection from the East Pit area confirmed that the top of the hill (Stage 2) will be visible from SR1 and SR2 (**Plate 7**) but that the view of the East Pit from SR4 to SR13 will be predominantly screened by the existing vegetation (**Plate 8**).

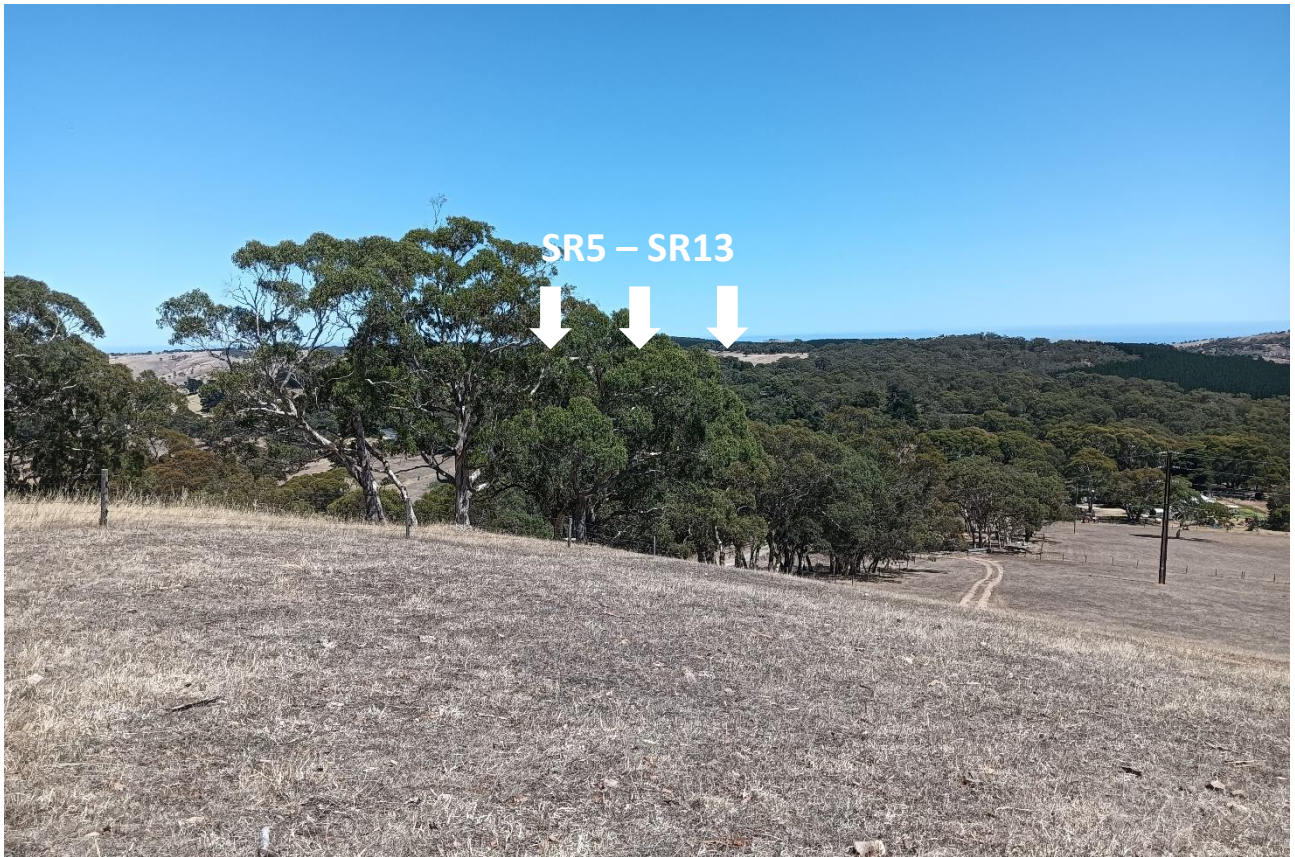
Plate 8 – The view from the East Pit towards Forktree Rd

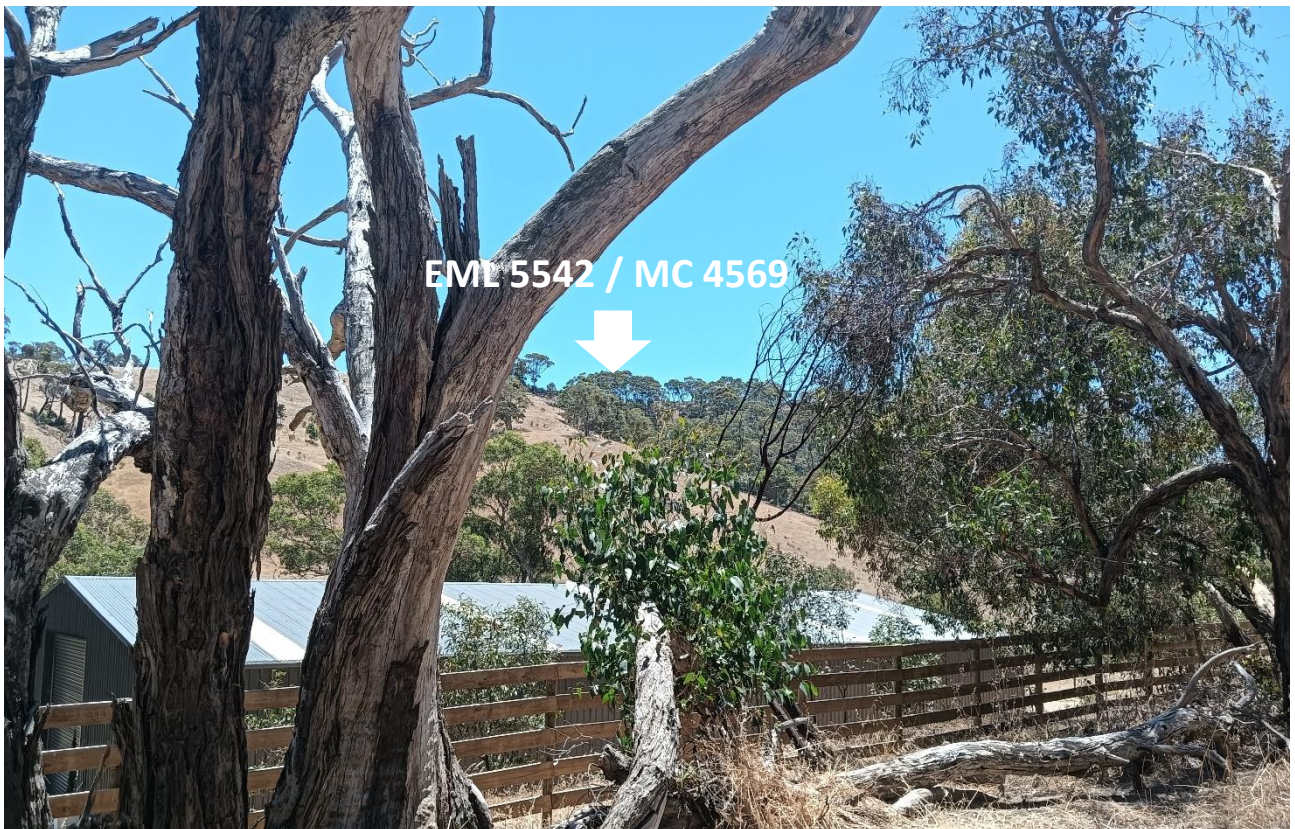
Plate 9 – The view from SR3 on Nunn Road

An inspection of the view from the south along Nunns Road confirmed that the Site will not be visible from SR3 (**Plate 9**) and activity at the top of the hill in Stage 2 may be visible from SR14.

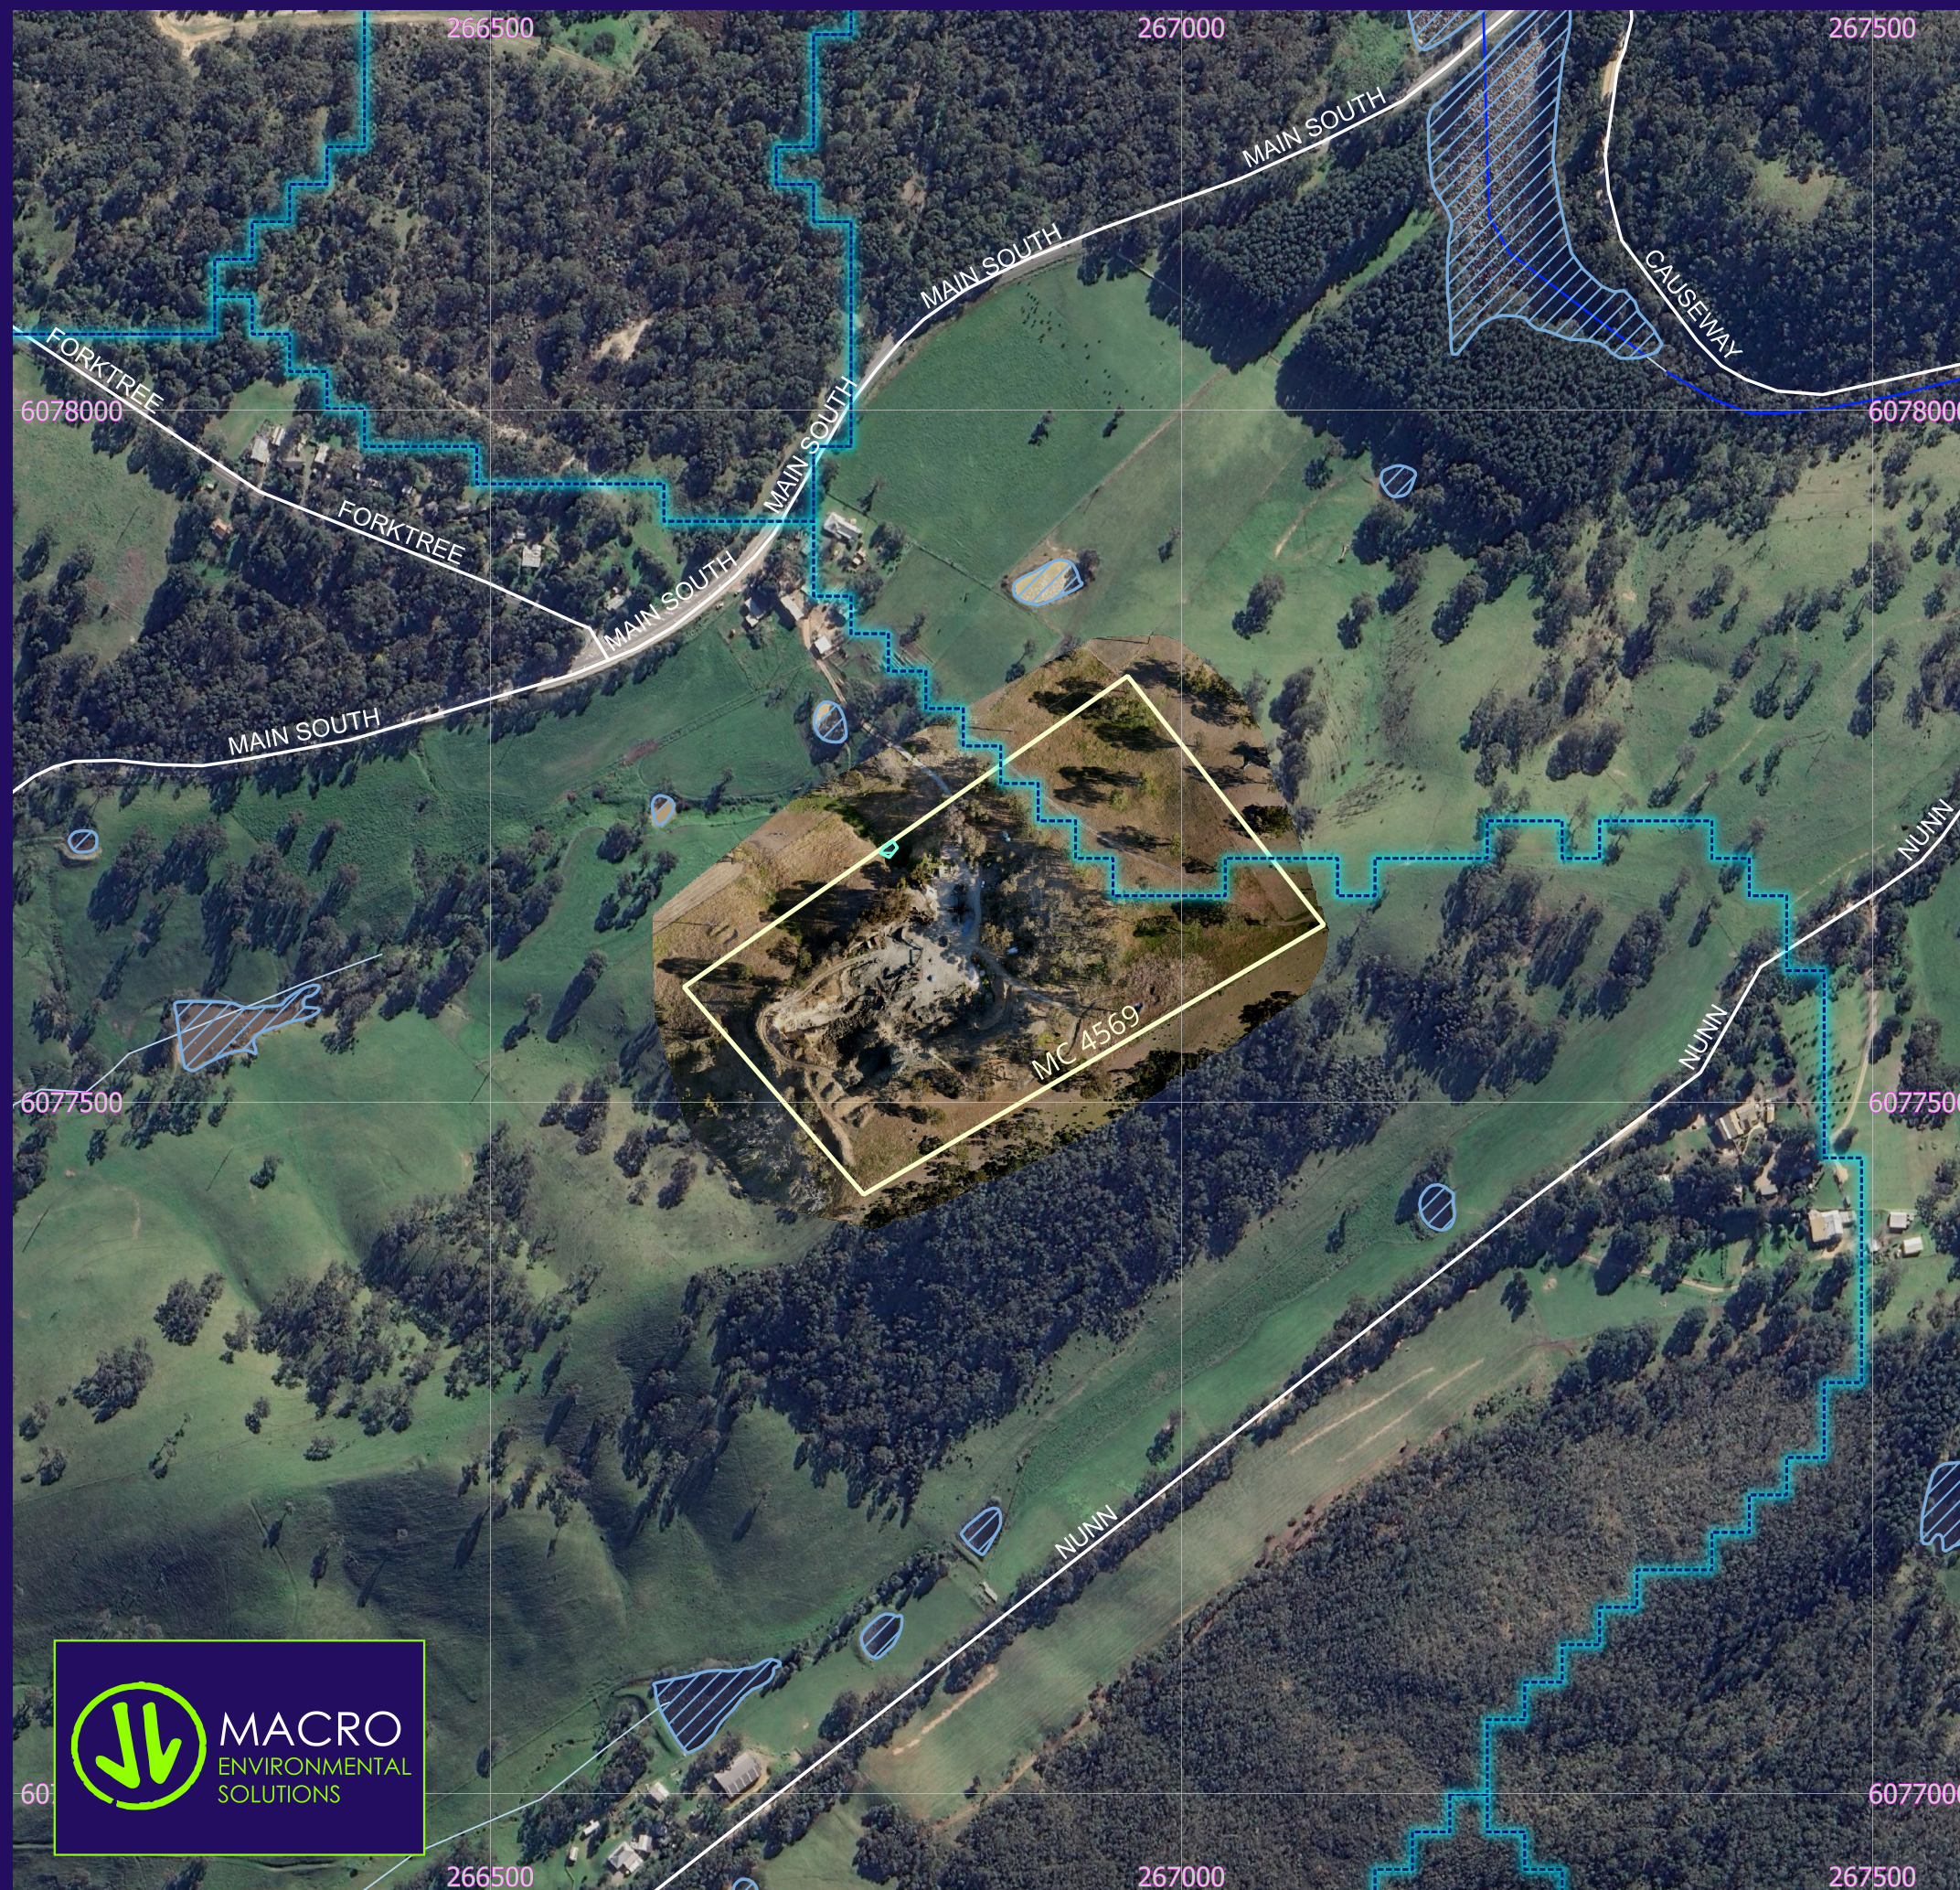
MP Drawing 8 Local hydrology map

- Mineral Claim 4569
- Sediment retention dam
- Waterbodies (Enviro Data SA)
- Watercourses (Enviro Data SA)
 - Stream Order 1
 - Stream Order 2
 - Stream Order 3
- Watershed basin boundary

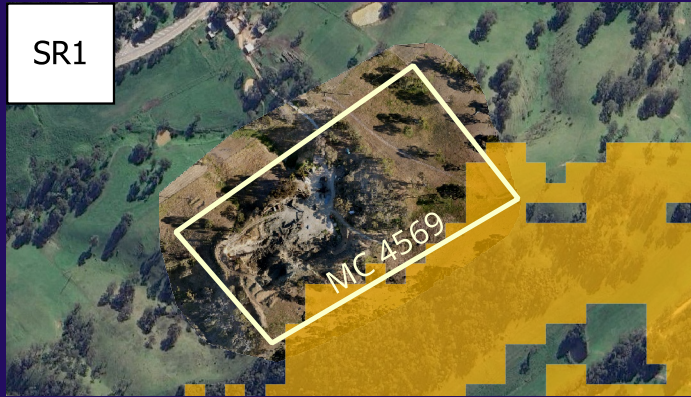
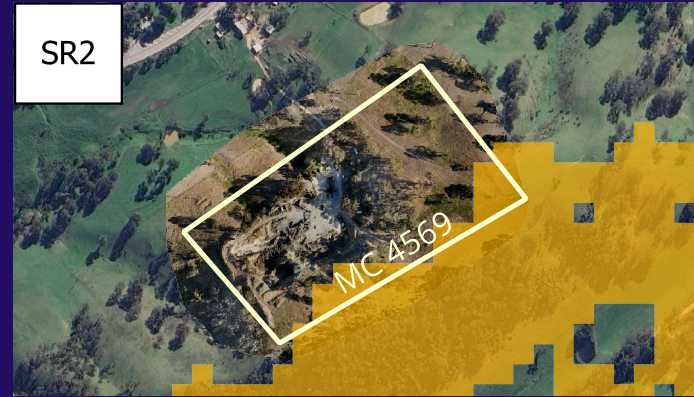
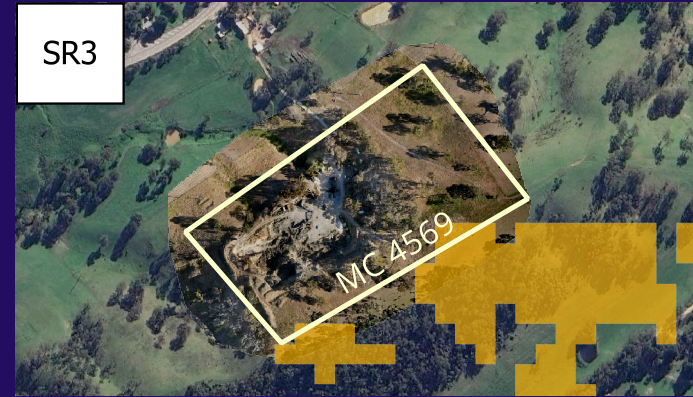
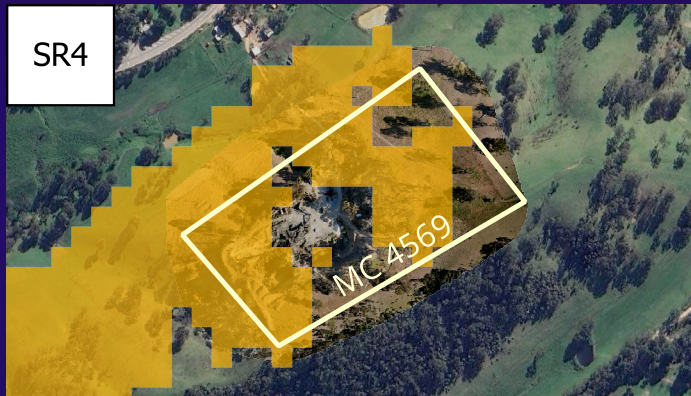
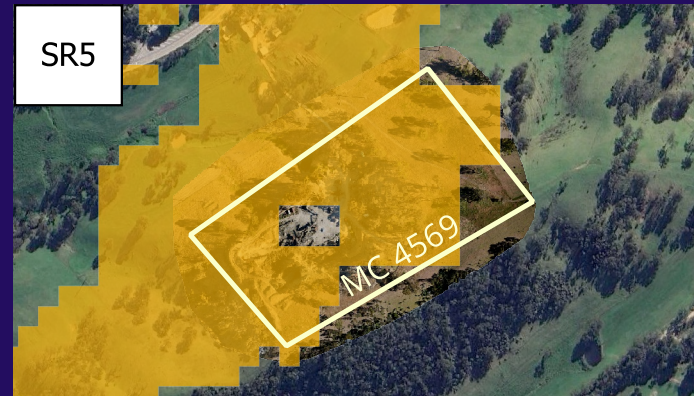
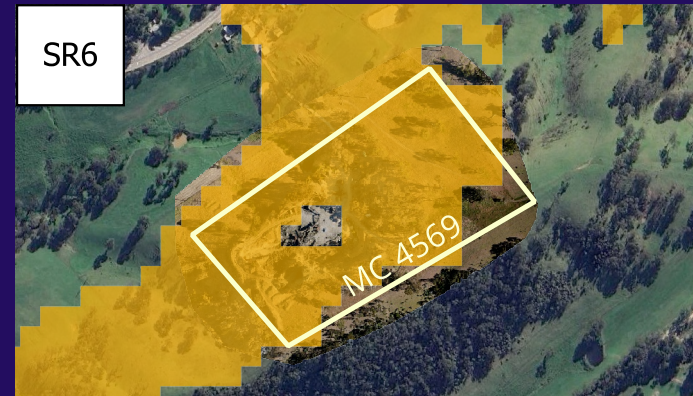
MP Drawing 15

Viewshed analysis results

An assessment of the visibility of the MC 4569 was undertaken through conducting a ‘Viewshed Analysis’ for all sensitive receptor locations within 1km of the MC 4569 boundary.

The ‘Viewshed Analysis’ is based on the view from each dwellings location at 2.0m from the ground. The software then utilises a Digital Elevation Model obtained from the Elevation and Depth - Foundation Spatial Data (ELVIS) platform to identify sections of the surface that are visible from the viewers location.

It should be noted that the results do not incorporate trees as an obstacle to view.
