CARRARA MARBLE QUARRY (ML 6556, PM 111)
MINE OPERATIONS PLAN (MOP) AND
PROGRAM FOR ENVIRONMENTAL
PROTECTION AND REHABILITATION (PEPR)

Prepared for:
Amulet Holdings Pty Ltd

Date:
July 2025

File Ref:
2492.610.002V1

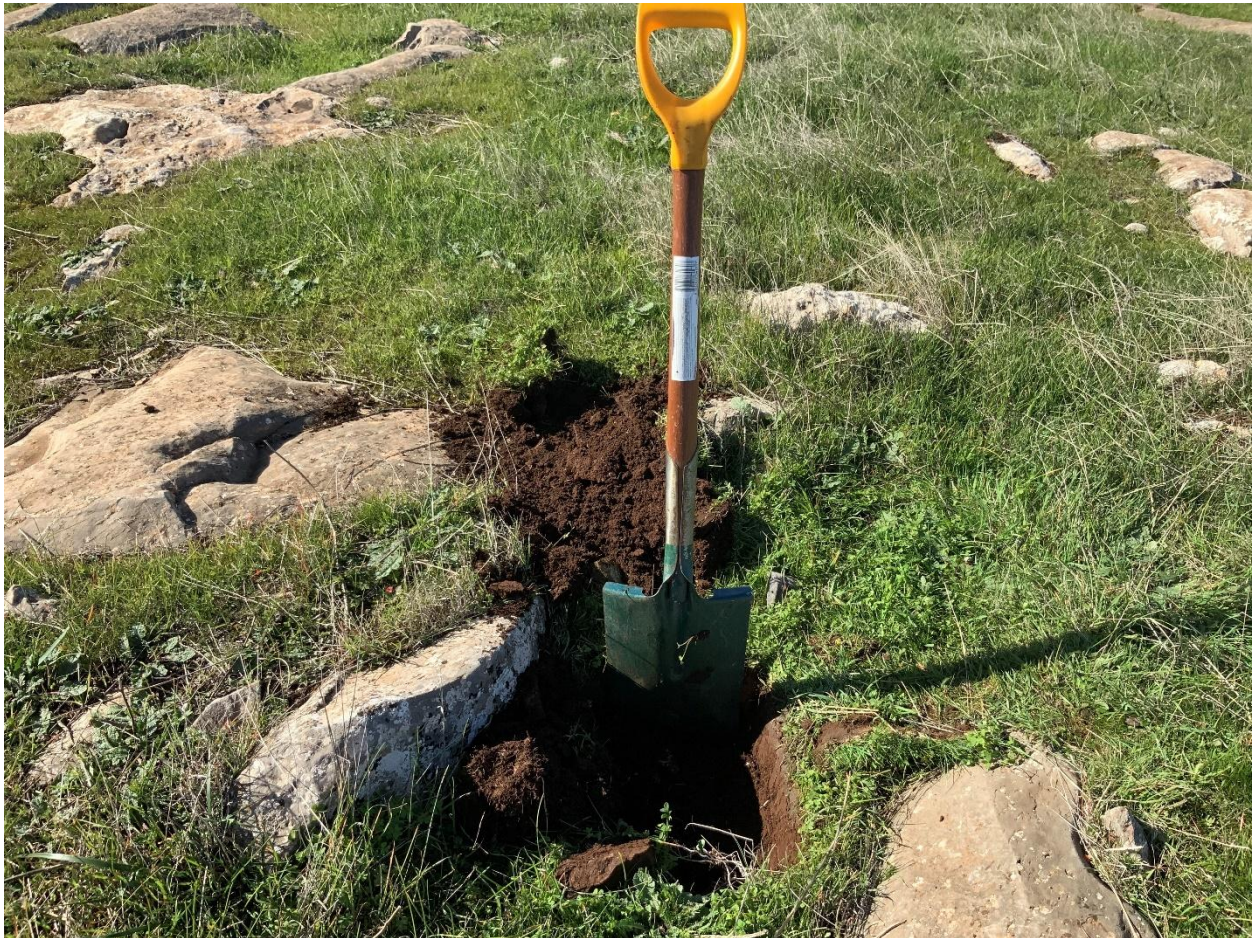
Photo 1 – Topsoil Profile

A Site inspection by Groundwork Plus (SA) Pty Ltd (Groundwork Plus) (September 2020) noted the ML has shallow topsoil (100 – 200 mm) with a rocky outcrop. The western portion of the ML is predominantly rock on the surface while the eastern side is mostly soil and supports cropped land which will remain undisturbed by quarrying. **Photo 1 – Topsoil Profile** demonstrates the depth of topsoil within the ML, integrated between heavy outcropping of Limestone.

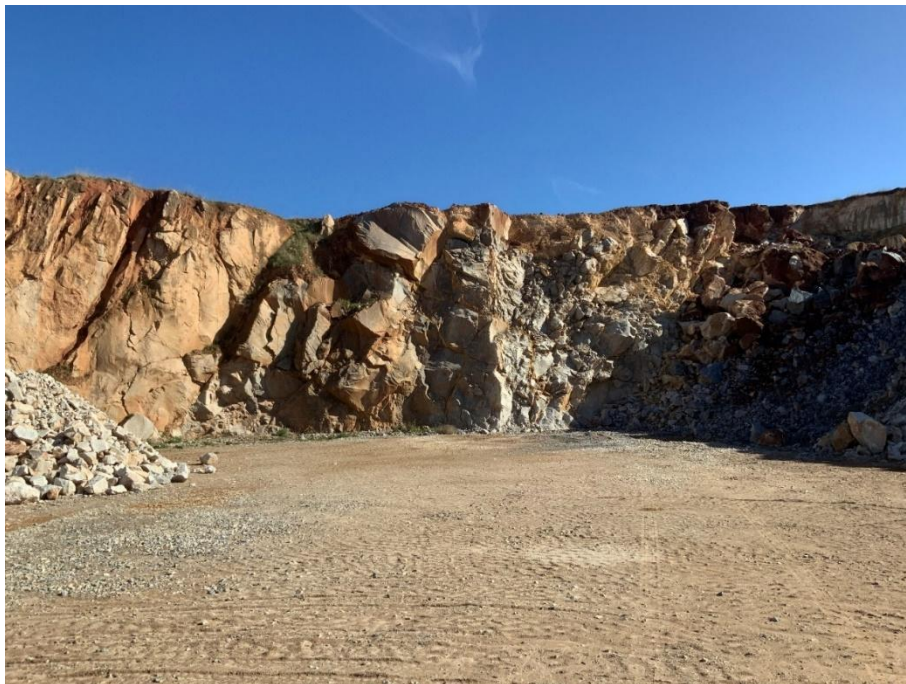
Photo 2 –PM 111 Marble

Photo 2 – PM 111 Marble highlights a sample of the marble along the northern wall face of PM 111.

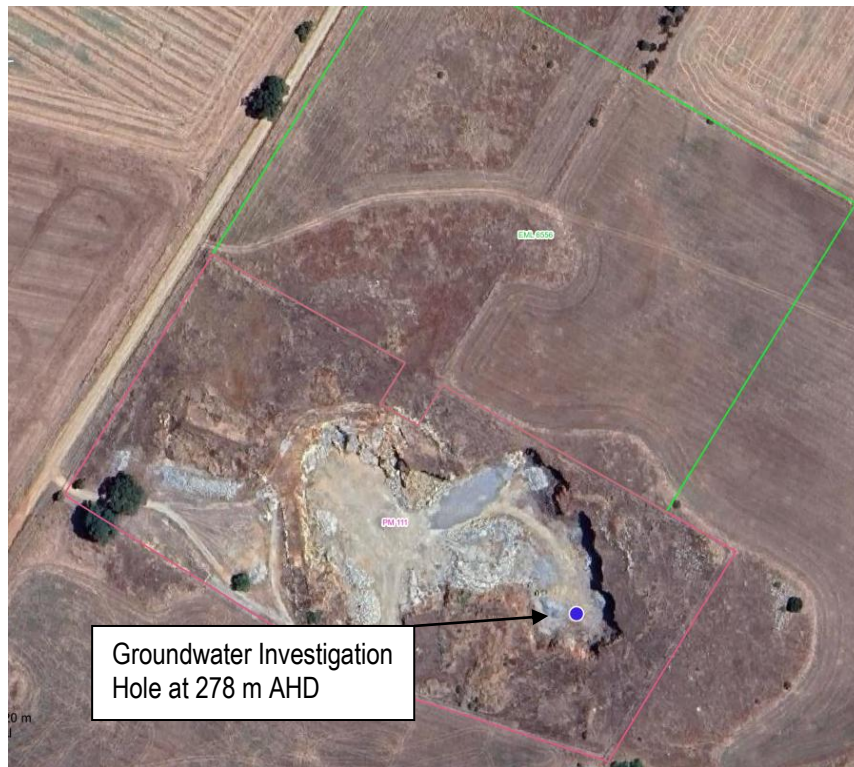
Diagram 1 – Groundwater Investigation Hole

Additionally in April 2024, one (1) hole was drilled within the current pit floor of PM 111 to determine the depth of groundwater presence (groundwater investigation purposes only). The hole was drilled within the pit floor at the location as shown below in **Diagram 1 – Groundwater Investigation Hole** at the pit floor level of 278 m AHD to a depth of 18 metres to a depth of 260 m AHD of which groundwater was not intersected, drilling remained consistently dry and in the marble resource for the full depth of 18 m. Whilst it is recognised the drill hole was undertaken in Autumn, groundwater variations due to seasonal fluctuations are not anticipated to rise more than 20 m, confirming that the proposed pit floor of 280 m AHD provides a significant buffer above groundwater.

Recommendations for pit design are for depths no greater than 280 m AHD allowing for uncertainty given limited water wells close to the Site.

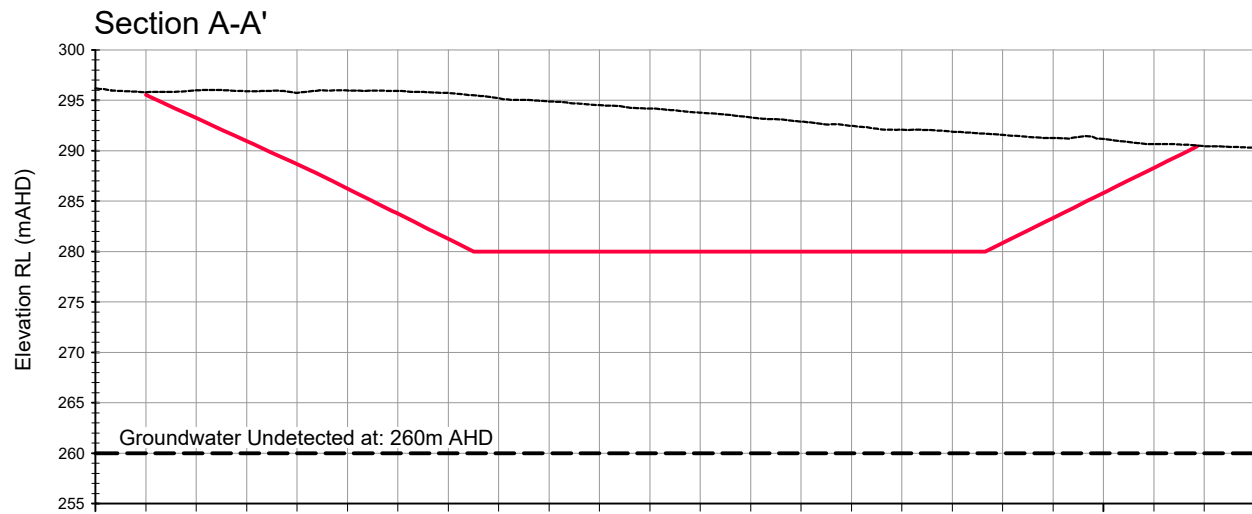
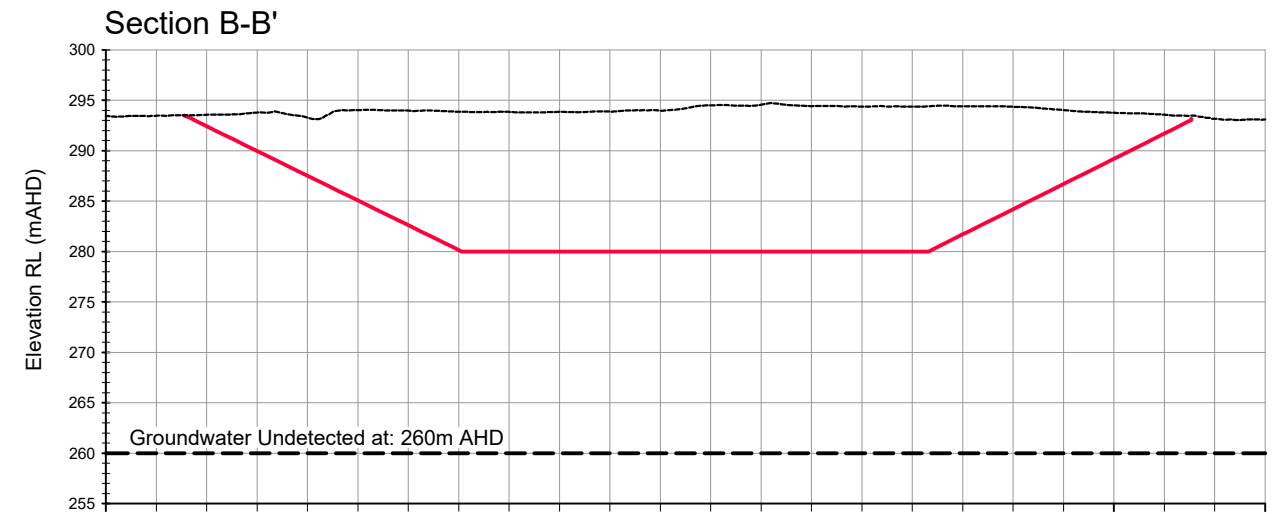
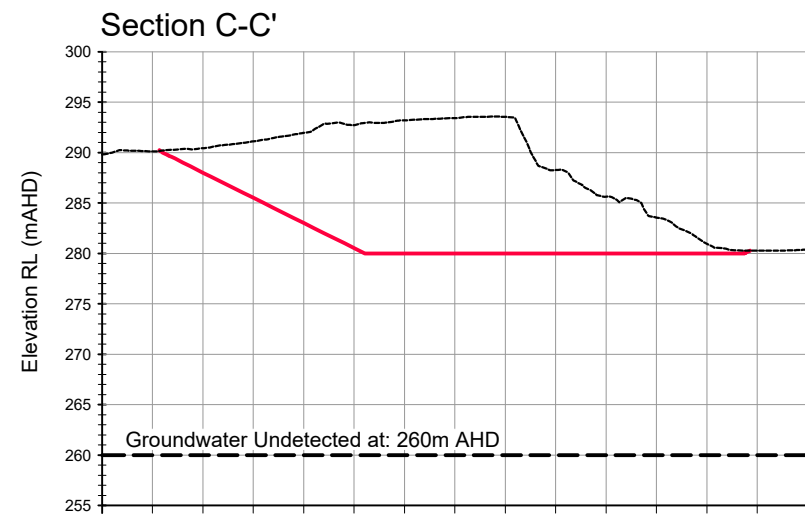
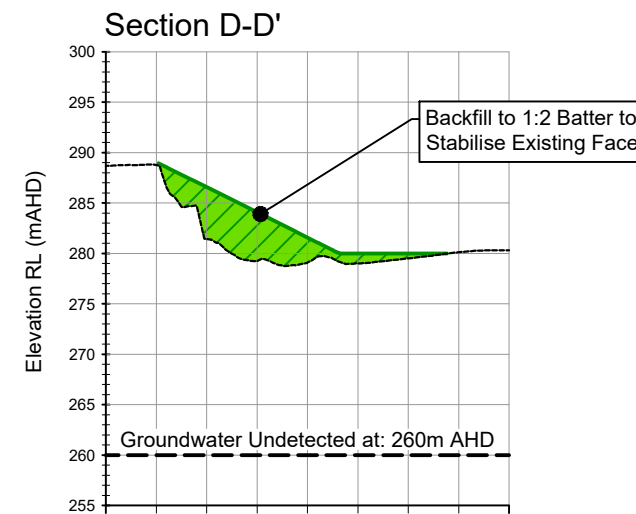
Chainage (m)	5	10	15	20	25	30	35	40	45	50	55	60	65	70	75	80	85	90	95	100	105	110	115
Existing Level (AHD)	295.8	296.0	295.9	295.8	296.0	295.9	295.7	295.2	294.9	294.5	294.2	293.8	293.3	292.9	292.5	292.1	291.9	291.6	291.3	291.2	290.7	290.5	290.3
Design Level (AHD)	295.6	293.2	290.9	288.7	286.2	283.8	281.3	280.0	280.0	280.0	280.0	280.0	280.0	280.0	280.0	280.0	280.0	280.9	283.3	285.8	288.3		
Depth (m)	0.3	2.7	5.0	7.1	9.7	12.2	14.5	15.2	14.9	14.5	14.2	13.8	13.3	12.9	12.5	12.1	11.9	10.7	7.9	5.4	2.4

Chainage (m)	5	10	15	20	25	30	35	40	45	50	55	60	65	70	75	80	85	90	95	100	105	110	115
Existing Level (AHD)	293.5	293.6	293.8	293.3	294.0	294.0	293.9	293.9	293.9	293.9	294.0	294.5	294.6	294.4	294.4	294.4	294.4	294.4	294.0	293.8	293.6	293.2	293.1
Design Level (AHD)		292.4	290.0	287.5	285.1	282.6	280.2	280.0	280.0	280.0	280.0	280.0	280.0	280.0	280.0	280.0	281.7	284.2	286.7	289.2	291.7		
Depth (m)		1.1	3.8	5.8	9.0	11.4	13.7	13.9	13.9	13.9	14.0	14.5	14.6	14.4	14.4	14.4	12.7	10.2	7.3	4.6	1.9

Chainage (m)	5	10	15	20	25	30	35	40	45	50	55	60	65	70
Existing Level (AHD)	290.1	290.4	291.1	292.0	292.7	293.2	293.4	293.5	288.3	285.6	283.5	281.0	280.3	280.4
Design Level (AHD)		288.0	285.5	283.0	280.5	280.0	280.0	280.0	280.0	280.0	280.0	280.0		
Depth (m)		2.4	5.6	8.9	12.2	13.2	13.4	13.5	8.3	5.6	3.5	1.0

Chainage (m)	5	10	15	20	25	30	35	40
Existing Level (AHD)	288.8	281.4	279.2	279.1	279.0	279.5	280.1	280.3
Design Level (AHD)		286.6	284.1	281.6	280.0	280.0

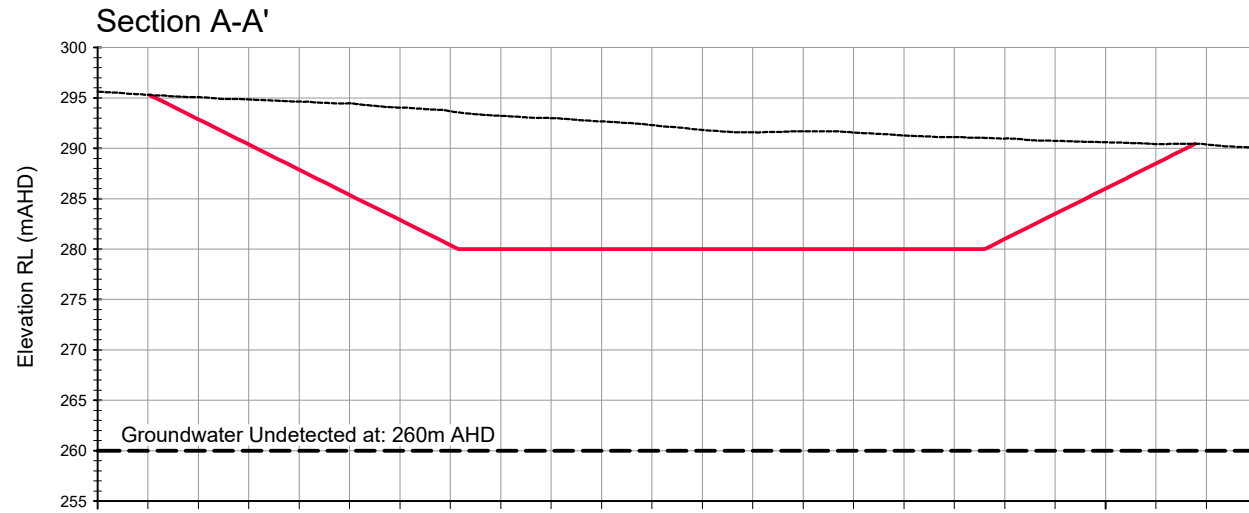
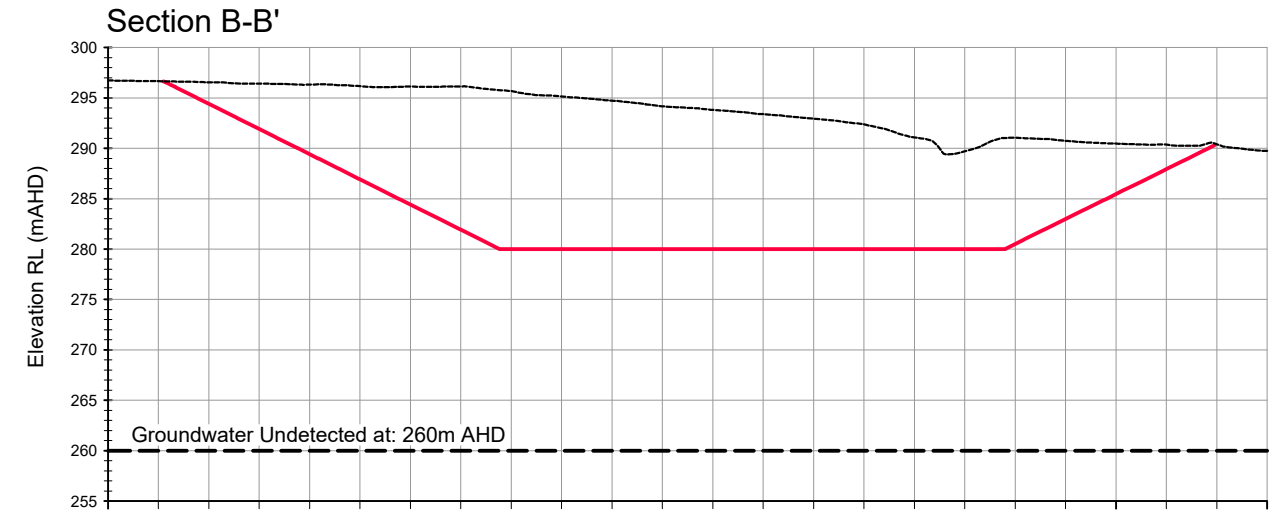
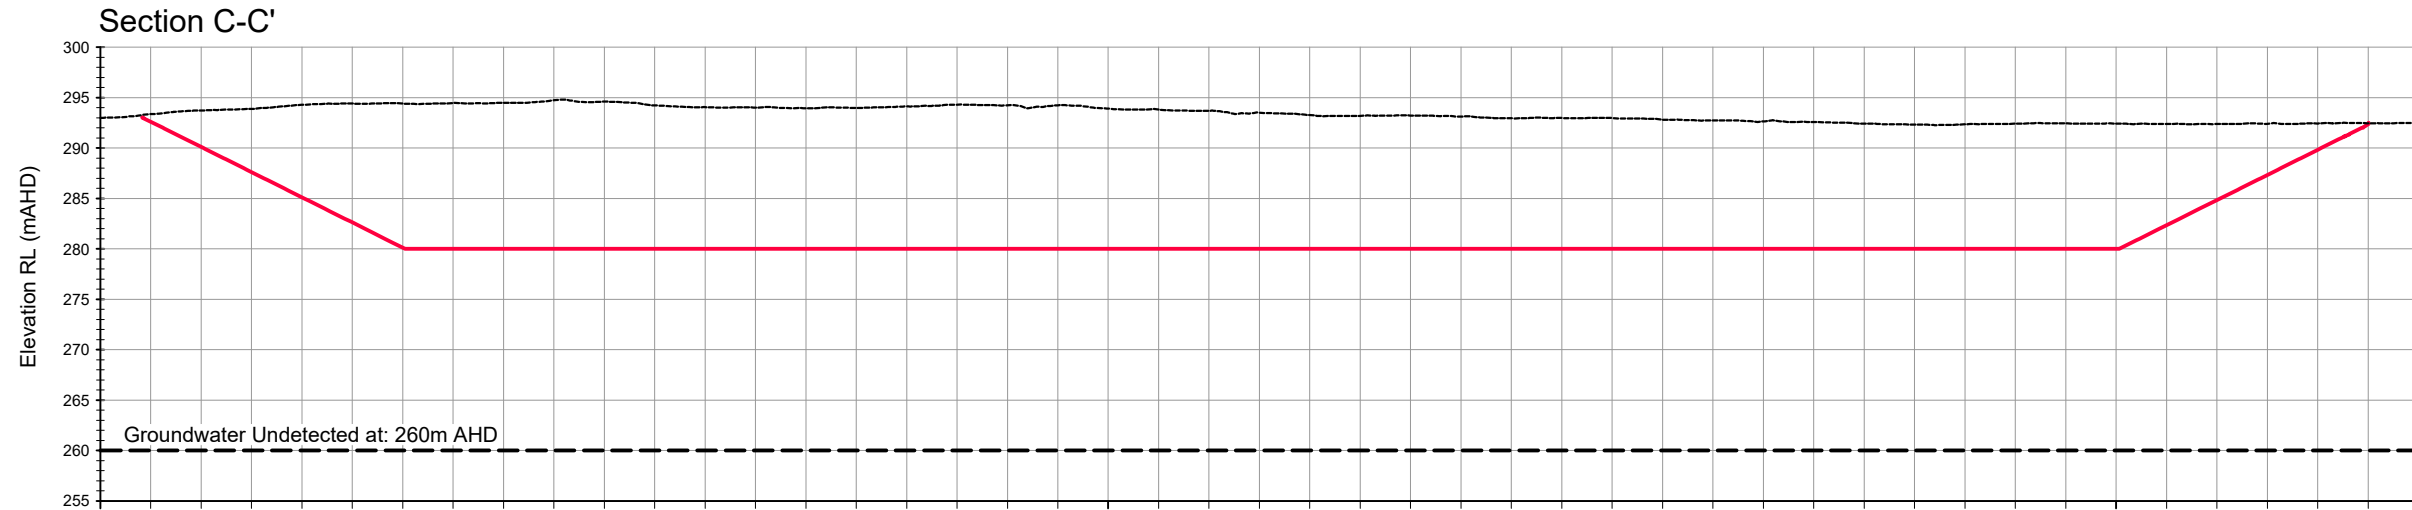
Chainage (m)	5	10	15	20	25	30	35	40	45	50	55	60	65	70	75	80	85	90	95	100	105	110	115
Existing Level (AHD)	295.3	295.1	294.8	294.6	294.5	294.0	293.7	293.2	293.0	292.7	292.3	291.8	291.6	291.7	291.6	291.3	291.1	291.0	290.7	290.6	290.4	290.4	290.1
Design Level (AHD)		292.9	290.4	287.9	285.4	282.9	280.4	280.0	280.0	280.0	280.0	280.0	280.0	280.0	280.0	280.0	280.0	281.0	283.5	286.0	288.5		
Depth (m)		2.2	4.5	6.7	9.1	11.1	13.3	13.2	13.0	12.7	12.3	11.8	11.6	11.7	11.6	11.3	11.1	10.0	7.2	4.6	1.9

Chainage (m)	5	10	15	20	25	30	35	40	45	50	55	60	65	70	75	80	85	90	95	100	105	110	115
Existing Level (AHD)	296.7	296.5	296.4	296.3	296.2	296.1	296.1	295.7	295.1	294.7	294.2	293.8	293.4	292.9	292.4	291.1	289.7	291.0	290.7	290.5	290.4	290.4	289.7
Design Level (AHD)		294.4	291.9	289.4	286.9	284.4	281.9	280.0	280.0	280.0	280.0	280.0	280.0	280.0	280.0	280.0	280.0	280.5	283.0	286.0	288.5		
Depth (m)		2.1	4.5	6.9	9.2	11.7	14.2	15.7	15.1	14.7	14.2	13.8	13.4	12.9	12.4	11.1	9.7	10.5	7.8	5.0	2.4

Chainage (m)	5	10	15	20	25	30	35	40	45	50	55	60	65	70	75	80	85	90	95	100	105	110	115	120	125	130	135	140	145	150	155	160	165	170	175	180	185	190	195	200	205	210	215	220	225	230
Existing Level (AHD)	293.4	293.7	293.9	294.3	294.4	294.4	294.5	294.5	294.7	294.6	294.2	294.1	294.0	293.9	294.0	294.1	294.3	294.2	294.2	293.9	293.8	293.7	293.5	293.3	293.2	293.2	293.1	292.9	293.0	292.8	292.7	292.6	292.6	292.4	292.3	292.3	292.4	292.4	292.4	292.4	292.4	292.4	292.4	292.5		
Design Level (AHD)	292.6	290.1	287.6	285.1	282.6	280.1	280.0	280.0	280.0	280.0	280.0	280.0	280.0	280.0	280.0	280.0	280.0	280.0	280.0	280.0	280.0	280.0	280.0	280.0	280.0	280.0	280.0	280.0	280.0	280.0	280.0	280.0	280.0	280.0	280.0	280.0	280.0	280.0	280.0	280.0	280.0	280.0	280.0	280.0		
Depth (m)	0.8	3.6	6.3	9.2	11.8	14.3	14.5	14.5	14.7	14.6	14.2	14.1	14.0	13.9	14.0	14.1	14.3	14.2	14.2	13.9	13.8	13.7	13.5	13.3	13.2	13.2	13.1	12.9	13.0	12.8	12.7	12.6	12.6	12.4	12.3	12.3	12.4	12.4	12.4	12.4	12.4	12.4	12.4	12.4

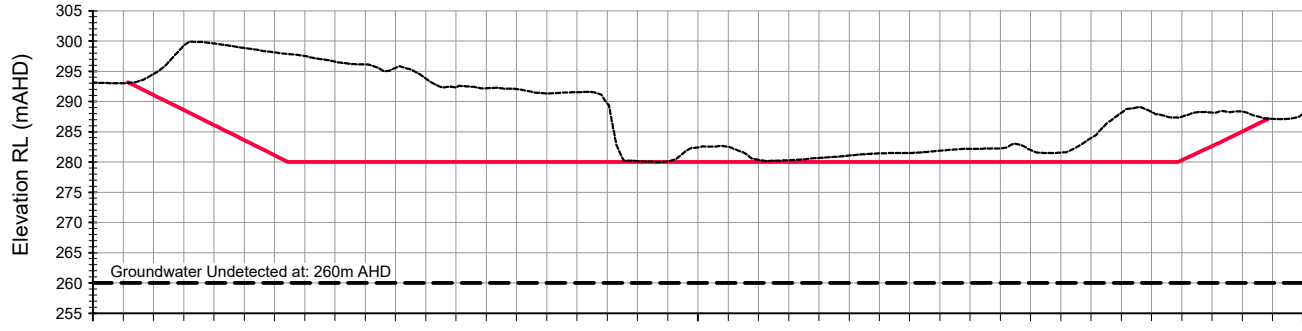
Section A-A'

Chainage (m)	Existing Level (AHD)	Design Level (AHD)	Depth (m)
5	293.0		
10	294.5	291.1	3.5
15	299.2	288.6	10.6
20	299.6	286.1	13.5
25	298.9	283.6	15.3
30	298.1	281.1	17.0
35	297.5	280.0	17.5
40	296.6	280.0	16.6
45	296.1	280.0	16.1
50	295.5	280.0	15.5
55	293.8	280.0	13.8
60	292.3	280.0	12.3
65	292.2	280.0	12.2
70	292.0	280.0	12.0
75	291.3	280.0	11.3
80	291.5	280.0	11.5
85	289.7	280.0	9.7
90	280.1	280.0	0.1
95	280.1	280.0	0.1
100	282.4	280.0	2.4
105	282.5	280.0	2.5
110	280.4	280.0	0.4
115	280.3	280.0	0.3
120	280.7	280.0	0.7
125	281.1	280.0	1.1
130	281.4	280.0	1.4
135	281.5	280.0	1.5
140	281.9	280.0	1.9
145	282.2	280.0	2.2
150	282.3	280.0	2.3
155	282.0	280.0	2.0
160	281.6	280.0	1.6
165	284.0	280.0	4.0
170	288.1	280.0	8.1
175	286.3	280.0	6.3
180	287.5	280.0	7.5
185	288.2	280.0	8.2
190	288.3	280.0	8.3
195	287.1	280.0	7.1
200	287.9	280.0	7.9

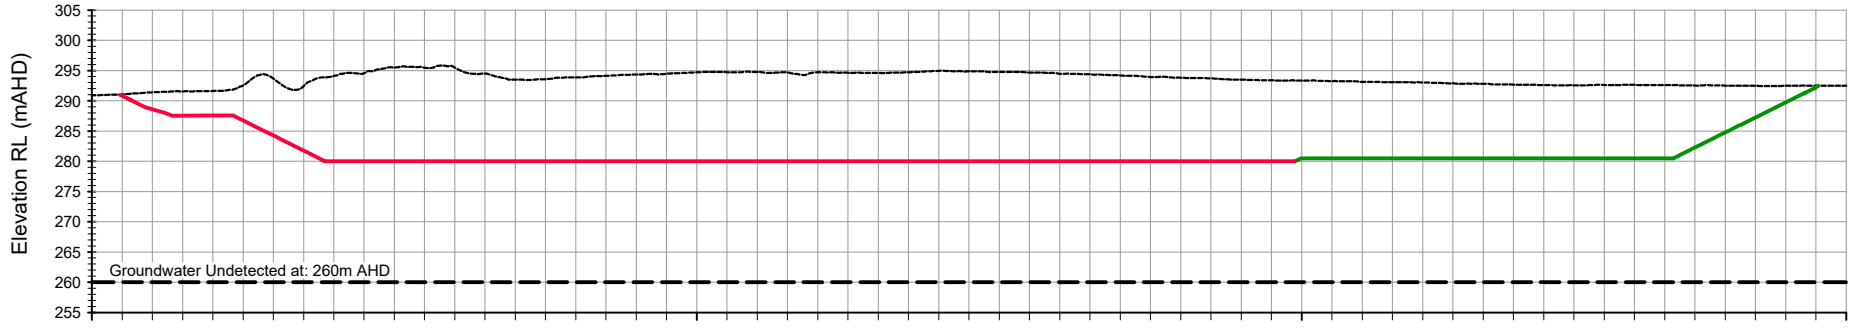
Section B-B'

Chainage (m)	Existing Level (AHD)	Design Level (AHD)	Depth (m)
5	291.0	290.8	0.2
10	291.4	288.6	2.8
15	291.6	287.5	4.1
20	291.6	287.6	4.0
25	292.5	286.8	5.7
30	293.7	284.3	9.4
35	292.4	281.8	10.6
40	294.1	280.0	14.1
45	294.6	280.0	14.6
50	295.5	280.0	15.5
55	295.5	280.0	15.5
60	295.5	280.0	15.5
65	294.5	280.0	14.5
70	293.5	280.0	13.5
75	293.6	280.0	13.6
80	293.9	280.0	13.9
85	294.1	280.0	14.1
90	294.3	280.0	14.3
95	294.5	280.0	14.5
100	294.7	280.0	14.7
105	294.7	280.0	14.7
110	294.8	280.0	14.8
115	294.7	280.0	14.7
120	294.7	280.0	14.7
125	294.6	280.0	14.6
130	294.6	280.0	14.6
135	294.7	280.0	14.7
140	295.0	280.0	15.0
145	294.9	280.0	14.9
150	294.7	280.0	14.7
155	294.7	280.0	14.7
160	294.5	280.0	14.5
165	294.4	280.0	14.4
170	294.2	280.0	14.2
175	293.9	280.0	13.9
180	293.8	280.0	13.8
185	293.7	280.0	13.7
190	293.5	280.0	13.5
195	293.4	280.0	13.4
200	293.3	280.0	13.3
205	293.2	280.0	13.2
210	293.1	280.0	13.1
215	293.1	280.0	13.1
220	293.0	280.0	13.0

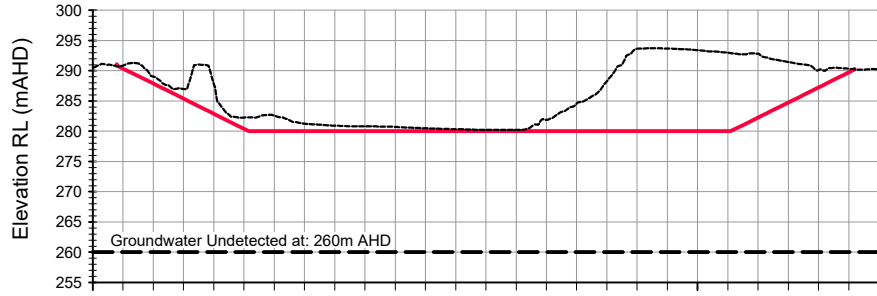
Section C-C'

Chainage (m)	Existing Level (AHD)	Design Level (AHD)	Depth (m)
5	290.8	290.4	0.5
10	289.0	287.9	1.1
15	287.0	285.4	1.6
20	287.9	282.9	5.0
25	282.3	280.4	1.9
30	282.6	280.0	2.6
35	281.3	280.0	1.3
40	280.9	280.0	0.9
45	280.8	280.0	0.8
50	280.7	280.0	0.7
55	280.5	280.0	0.5
60	280.3	280.0	0.3
65	280.2	280.0	0.2
70	280.2	280.0	0.2
75	281.9	280.0	1.9
80	284.6	280.0	4.6
85	288.3	280.0	8.3
90	293.6	280.0	13.6
95	293.7	280.0	13.7
100	293.4	280.0	13.4
105	293.0	280.0	13.0
110	292.8	280.0	12.8
115	291.4	280.0	11.4
120	290.1	280.0	10.1
125	290.3	280.0	10.3
130	290.2	280.0	10.2

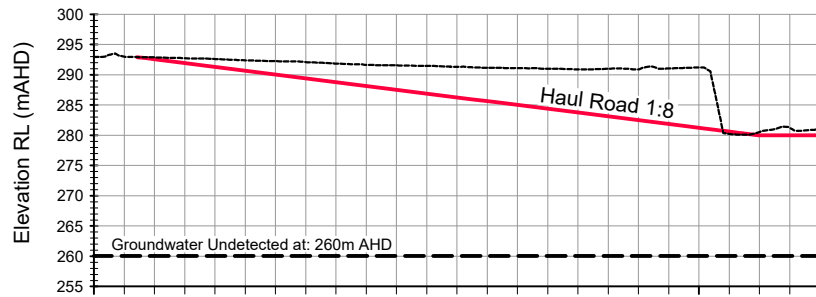
Section D-D'

Chainage (m)	Existing Level (AHD)	Design Level (AHD)	Depth (m)
5	293.0	293.0	0.0
10	292.9	292.6	0.3
15	292.8	292.1	0.8
20	292.6	291.3	1.3
25	292.4	290.7	1.7
30	292.3	290.0	2.3
35	292.1	289.4	2.7
40	291.9	288.8	3.1
45	291.6	288.2	3.5
50	291.6	287.5	4.0
55	291.5	286.9	4.6
60	291.3	286.3	5.0
65	291.2	285.6	5.5
70	291.1	285.0	6.1
75	291.0	284.4	6.6
80	290.9	283.8	7.1
85	291.0	283.1	7.9
90	290.9	282.5	8.4
95	291.0	281.9	9.2
100	291.2	281.2	10.0
105	280.2	280.6	-0.4
110	280.5	280.0	0.5
115	281.2	280.0	1.2
120	281.0	280.0	1.0

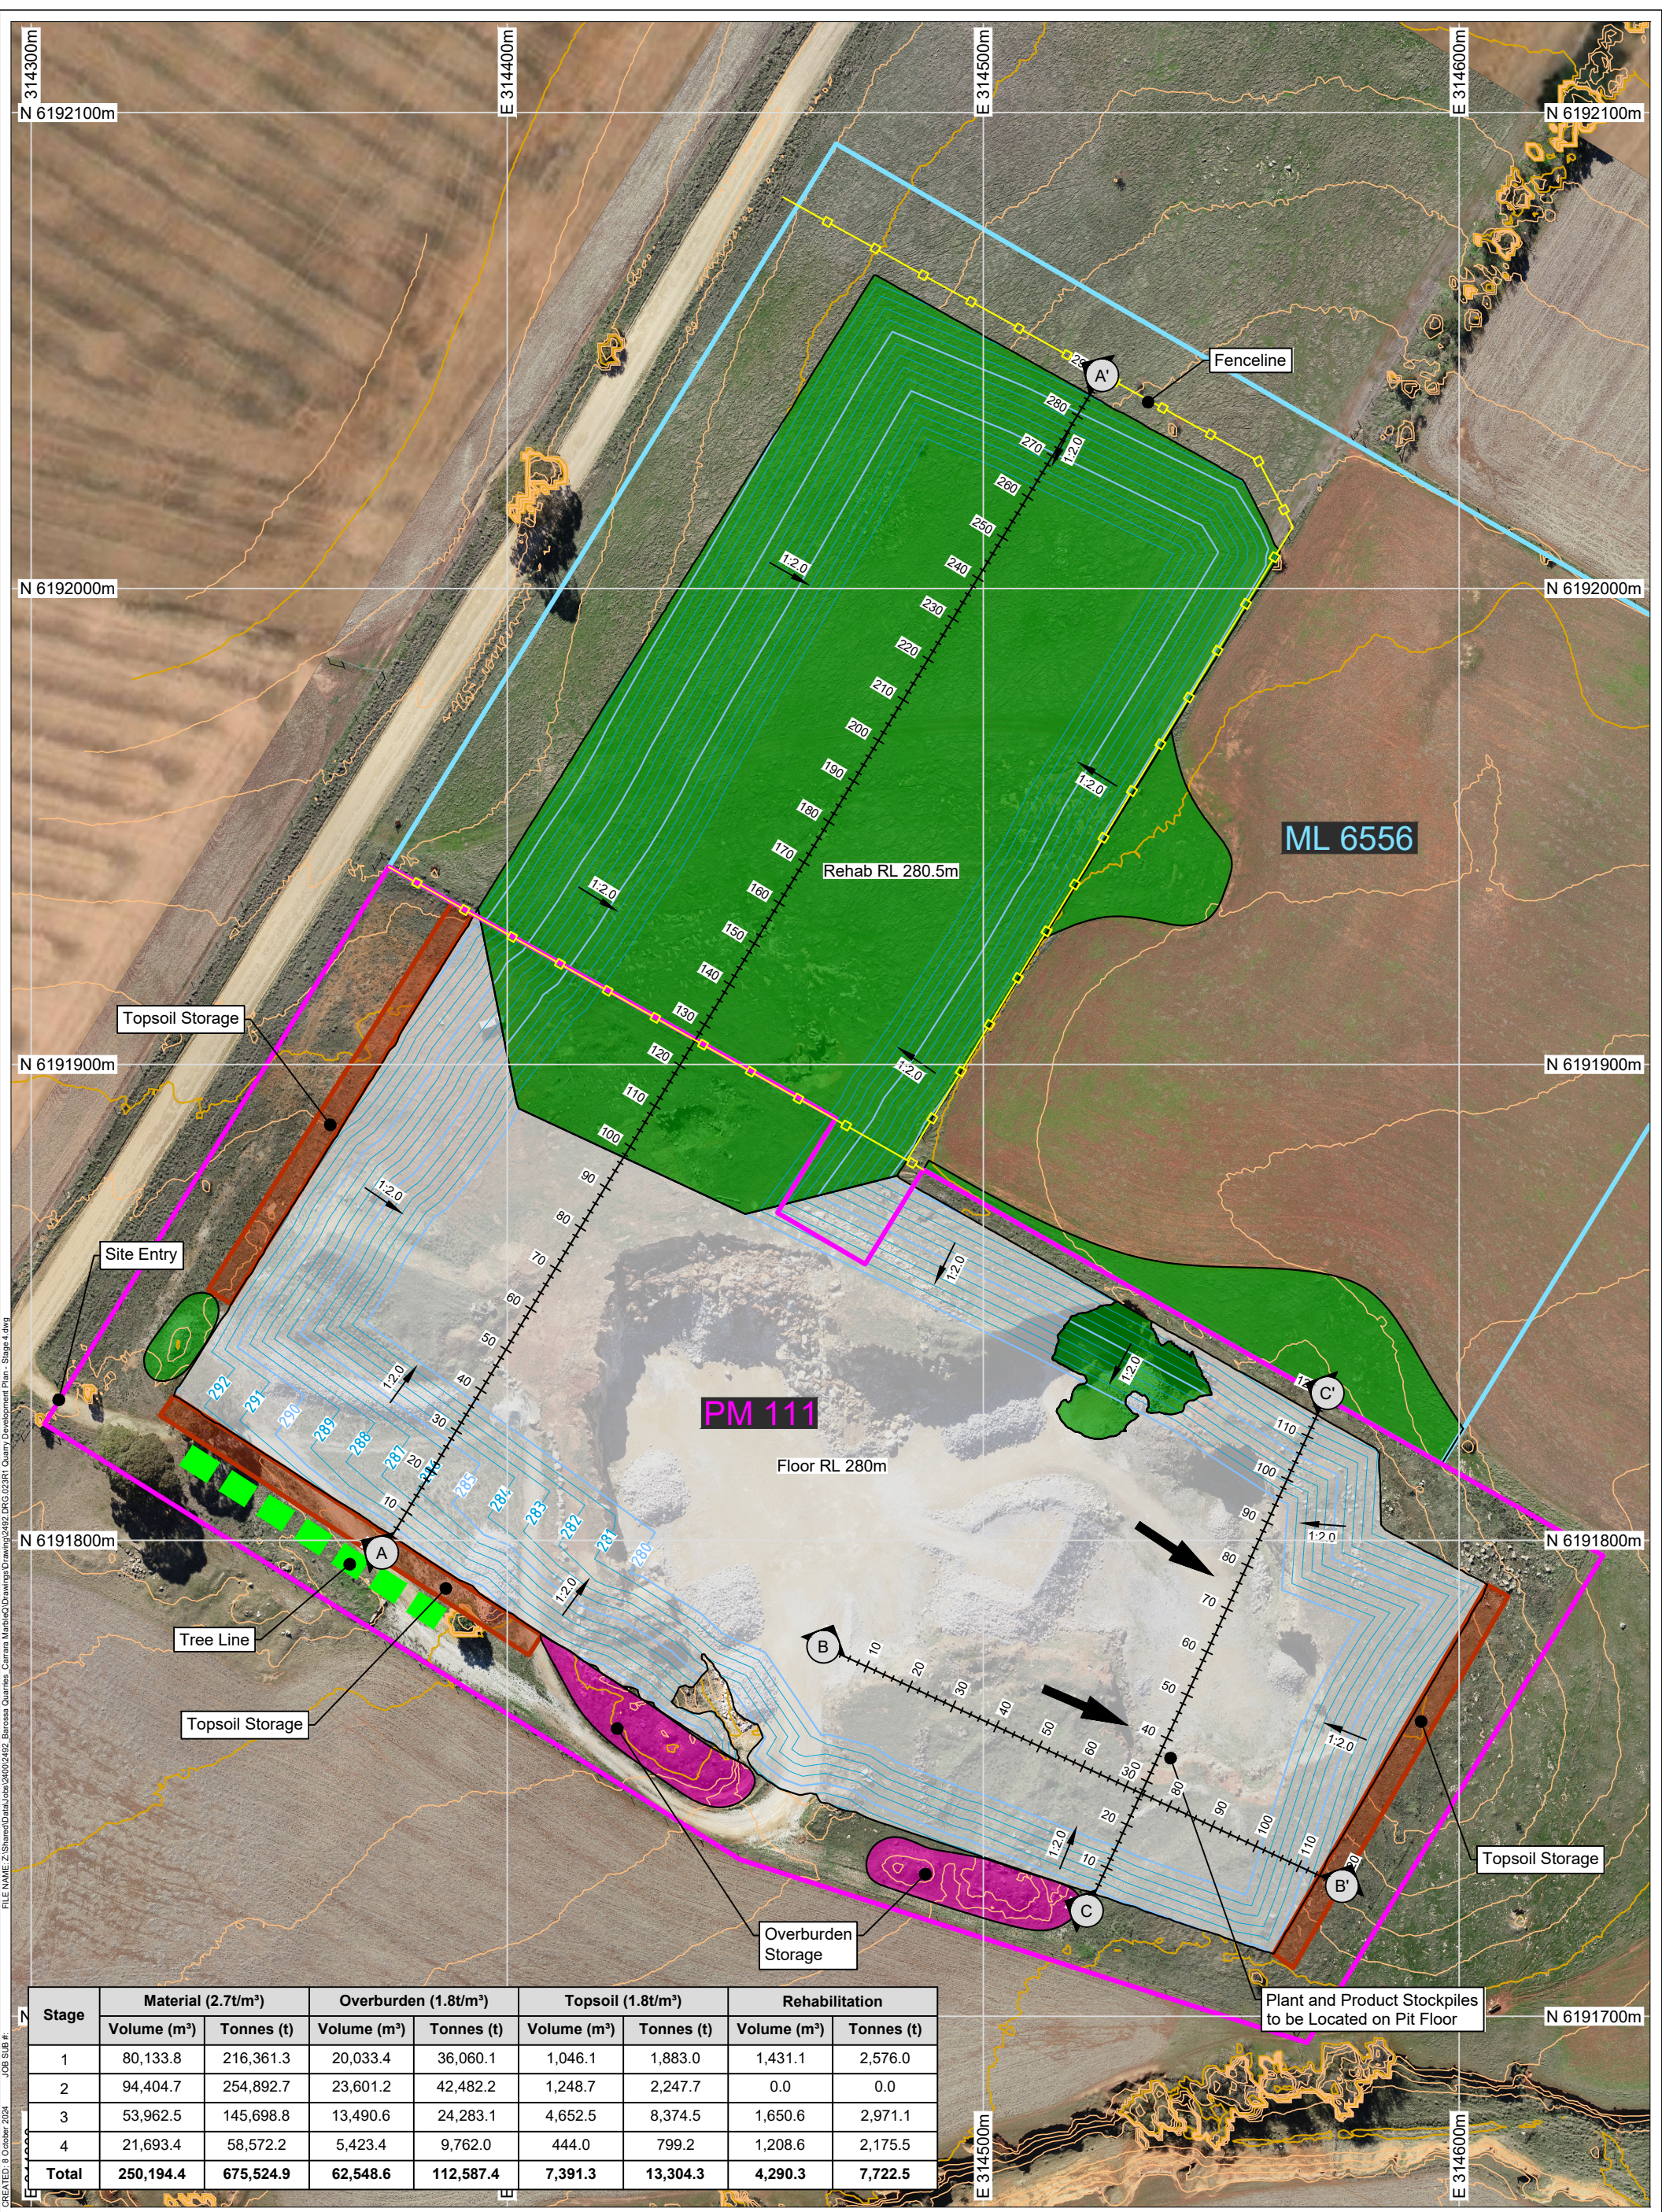
Stage	Material (2.7t/m³)		Overburden (1.8t/m³)		Topsoil (1.8t/m³)		Rehabilitation	
	Volume (m³)	Tonnes (t)	Volume (m³)	Tonnes (t)	Volume (m³)	Tonnes (t)	Volume (m³)	Tonnes (t)
1	80,133.8	216,361.3	20,033.4	36,060.1	1,046.1	1,883.0	1,431.1	2,576.0
2	94,404.7	254,892.7	23,601.2	42,482.2	1,248.7	2,247.7	0.0	0.0
3	53,962.5	145,698.8	13,490.6	24,283.1	4,652.5	8,374.5	1,650.6	2,971.1
4	21,693.4	58,572.2	5,423.4	9,762.0	444.0	799.2	1,208.6	2,175.5
Total	250,194.4	675,524.9	62,548.6	112,587.4	7,391.3	13,304.3	4,290.3	7,722.5

<p>REV 1: Topsoil storage and fence added</p> <p>DATE: 08/10/2024</p> <p>BY: GL</p>	<p>Legend:</p> <ul style="list-style-type: none"> Mining Lease Private Mine Extraction Area (2.71ha) Rehabilitation Area (2.27ha) 	<p>PROJECT: Carrara Marble Quarry</p> <p>CLIENT: Barossa Quarries</p>	<p>TITLE: Quarry Development Plan - Stage 4</p> <p>SCALE: 1:1,250</p> <p>0 25m</p> <p>DRAWING NUMBER: 2492.DRG.023A</p> <p>REVISION: 1</p> <p>DATE: 8 October 2024</p> <p>PRINTED: 8 October 2024</p>	<p>PHOTOGRAPHY: Groundwork part of SLR Pty Ltd UAV Survey, Captured 2020/05/05</p> <p>TOPOGRAPHY: Groundwork part of SLR Pty Ltd UAV Survey, Captured 2020/05/05, DSM 1m</p> <p>CADASTRE: Ecosystem:</p> <p>Other: © 2024 Microsoft Corporation, © 2024 Maxar, © CNES (2024) Distribution Airbus DS</p> <p>THESE DESIGNS AND PLANS ARE COPYRIGHT AND ARE NOT TO BE USED OR REPRODUCED WHOLLY OR IN PART OR TO BE USED ON ANY PROJECT WITHOUT THE WRITTEN PERMISSION OF GROUNDWORK PART OF SLR. ABN: 13 609 422 791</p>

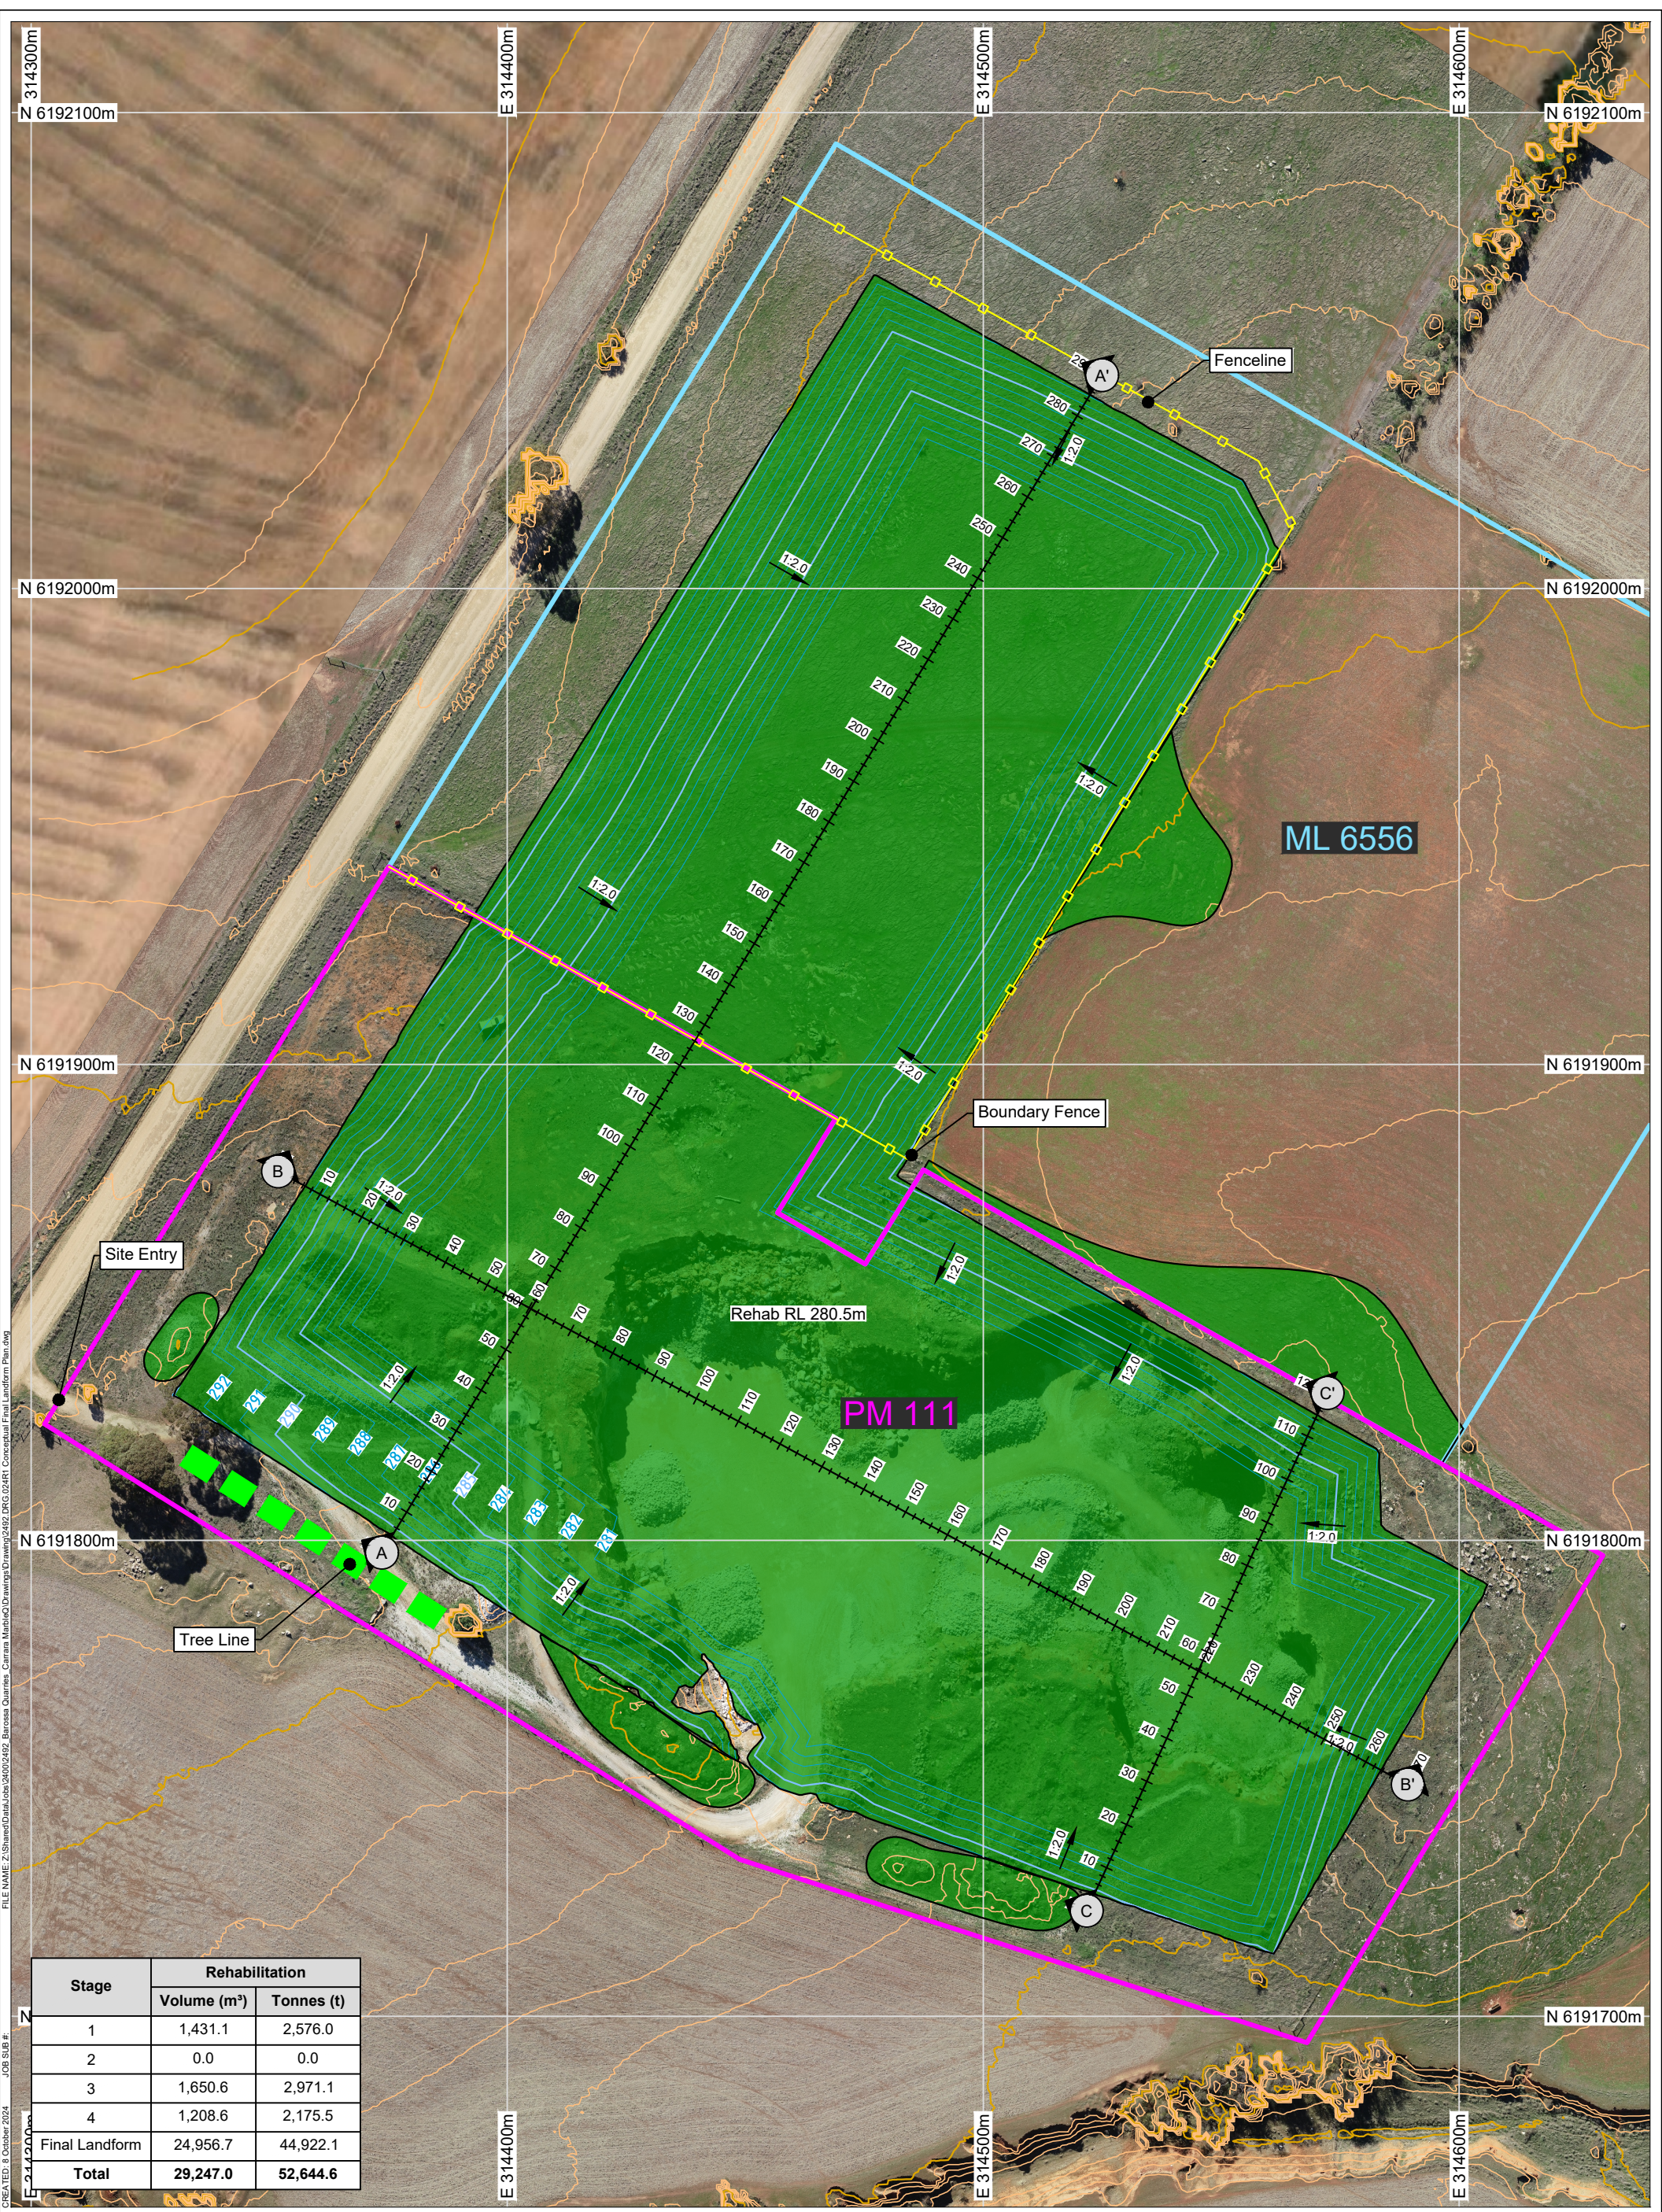
Stage	Rehabilitation	
	Volume (m³)	Tonnes (t)
1	1,431.1	2,576.0
2	0.0	0.0
3	1,650.6	2,971.1
4	1,208.6	2,175.5
Final Landform	24,956.7	44,922.1
Total	29,247.0	52,644.6

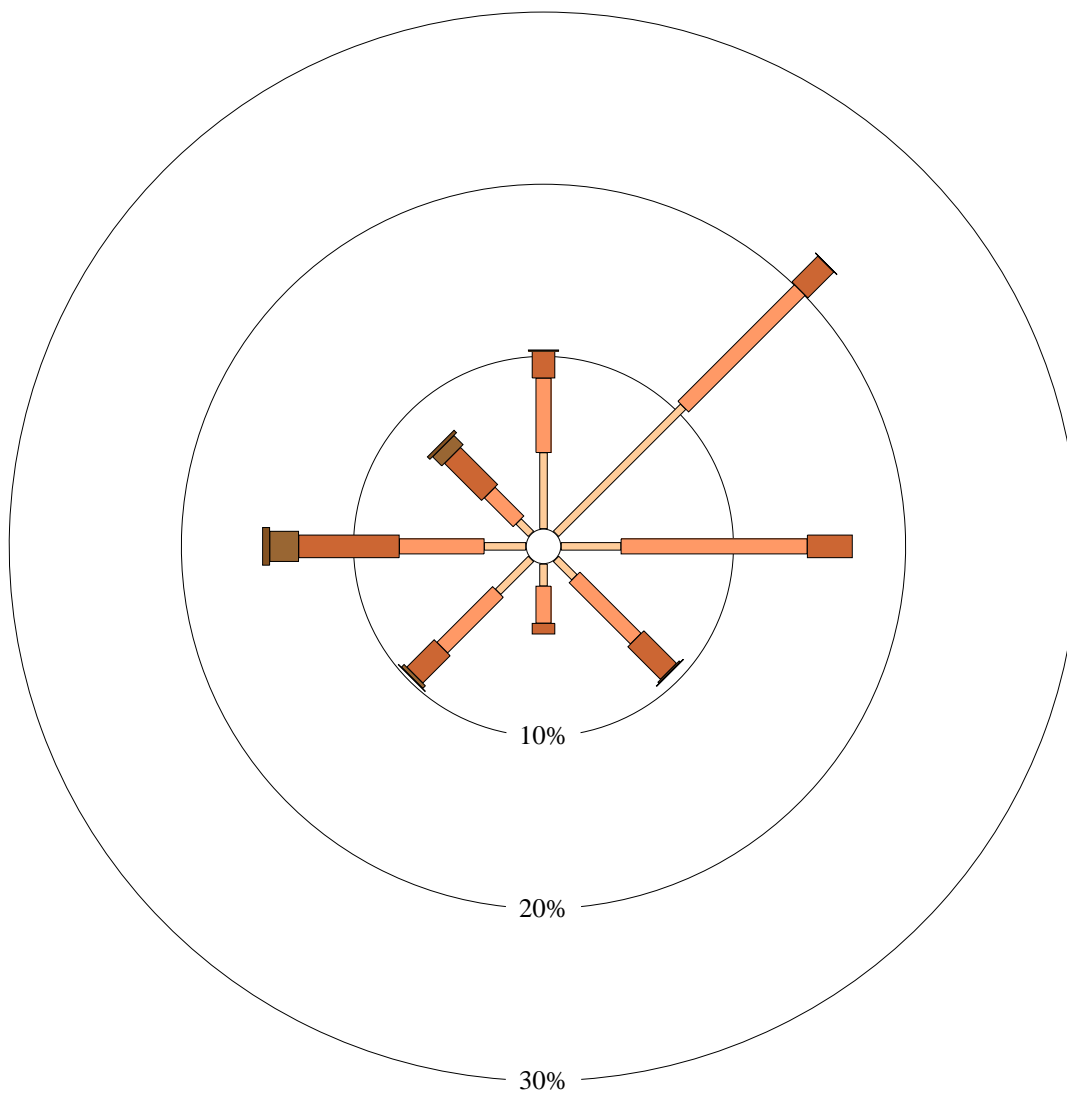
Rose of Wind direction versus Wind speed in km/h (28 Aug 1996 to 10 Aug 2024)

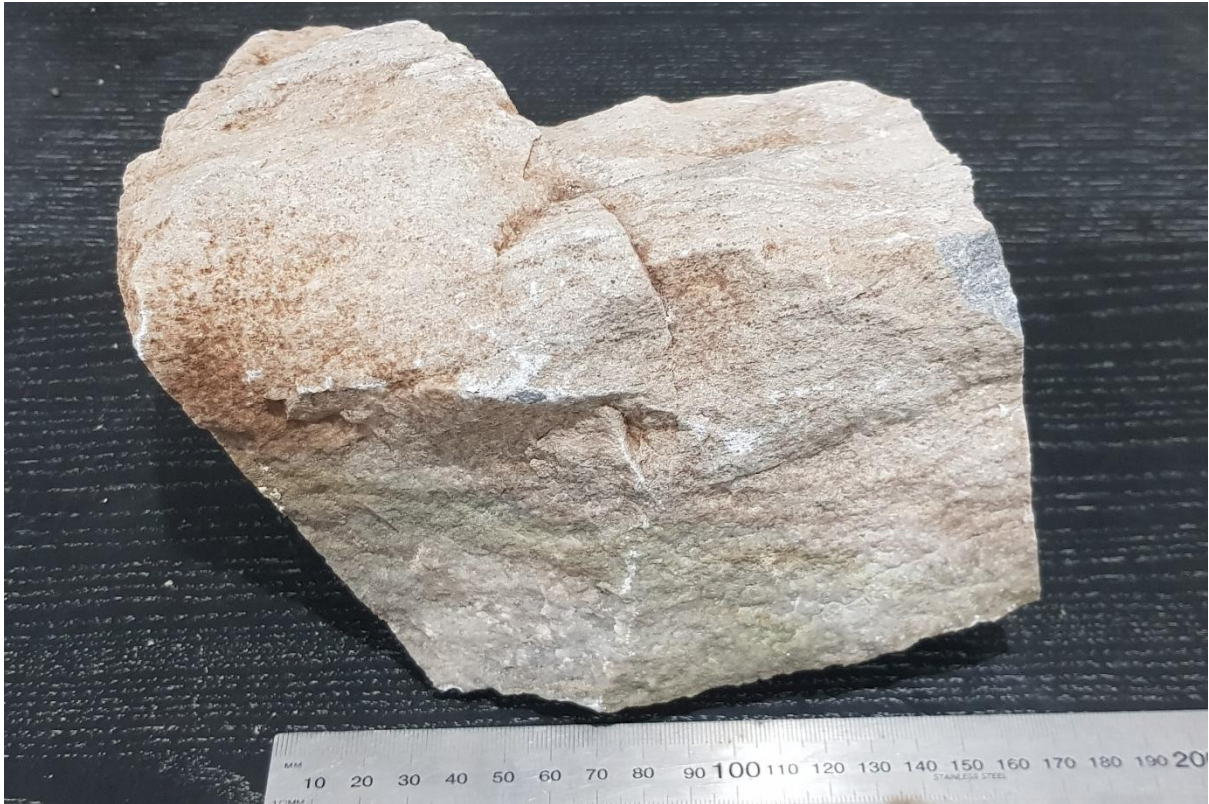
The supplied sample is approximately 15cm in diameter and is slightly weathered, with minor goethitic staining on the exterior of the spall. The sample consists of medium grained white crystalline and tightly interlocking calcite crystals. The cut face of the spall shows thin grey veining, which represents primary clay-rich sedimentary layers. Minor white veining is present crosscuts the grey layering observed and is composed of micritic calcite. The sample is regarded as hard, strong, and durable. Minor pyrite is observed in hand specimen, and the sample is non-magnetic.

Plate 1: Photograph of the sample as provided, showing the medium grain size and weathered exterior of the spall.

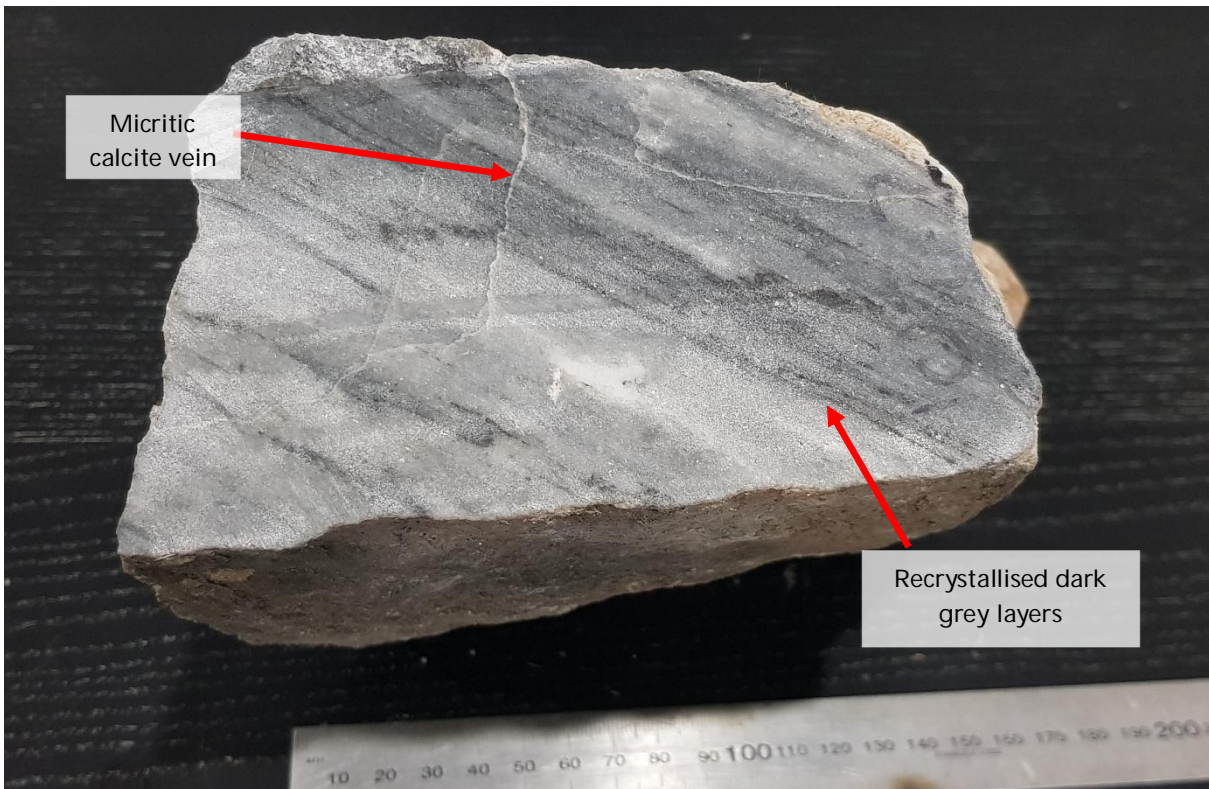
Plate 2: Photograph of the washed sample, showing the occurrence of deformed clay-rich primary layers and minor white veining.
