CARRARA MARBLE QUARRY (ML 6556, PM 111)
MINE OPERATIONS PLAN (MOP) AND
PROGRAM FOR ENVIRONMENTAL
PROTECTION AND REHABILITATION (PEPR)

Prepared for:
Amulet Holdings Pty Ltd

Date:
July 2025

File Ref:
2492.610.002V1

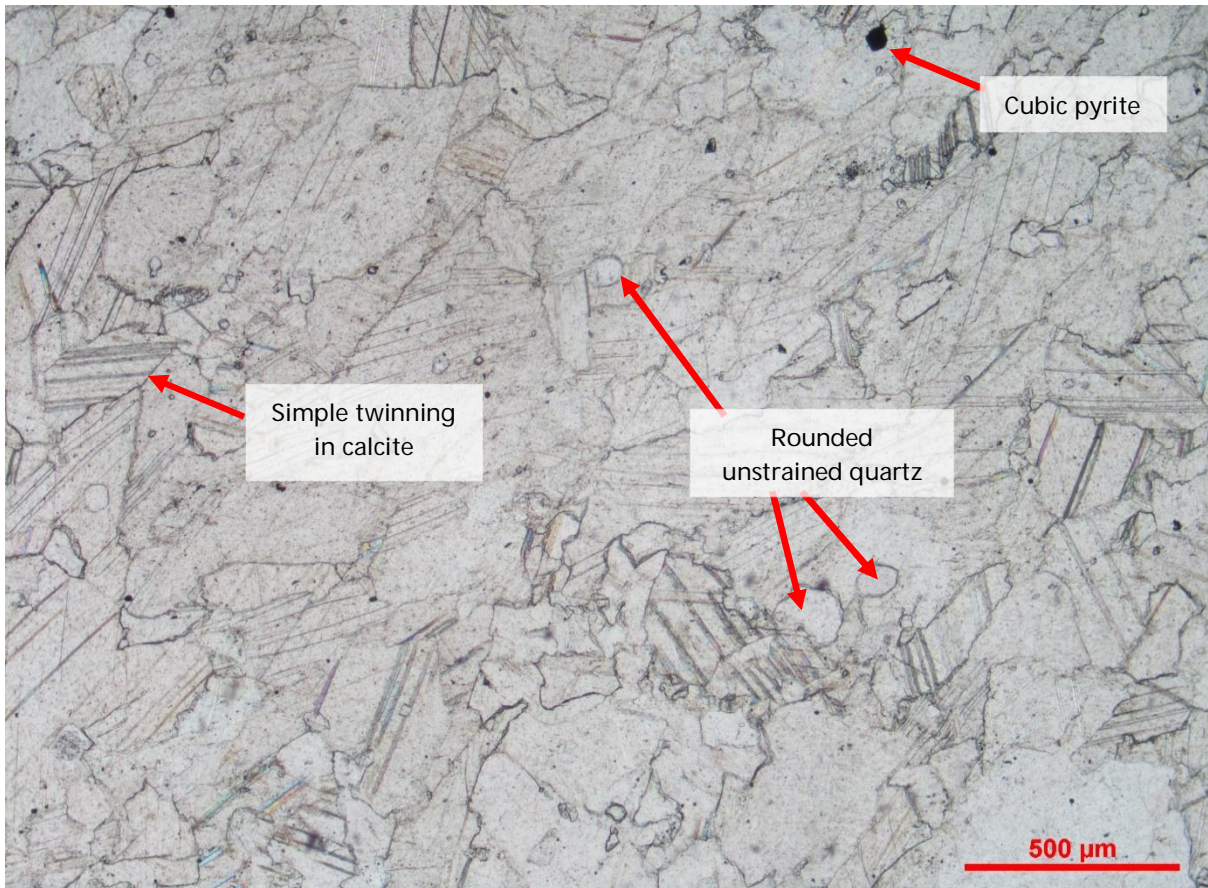
Plate 3: Microphotograph of the sample, showing the occurrence of abundant variably sized sparry calcite, with minor quartz and pyrite. Image shown in plane polarised light. Scale = 500µm x 40 magnification. F.O.V. 5.2mm.

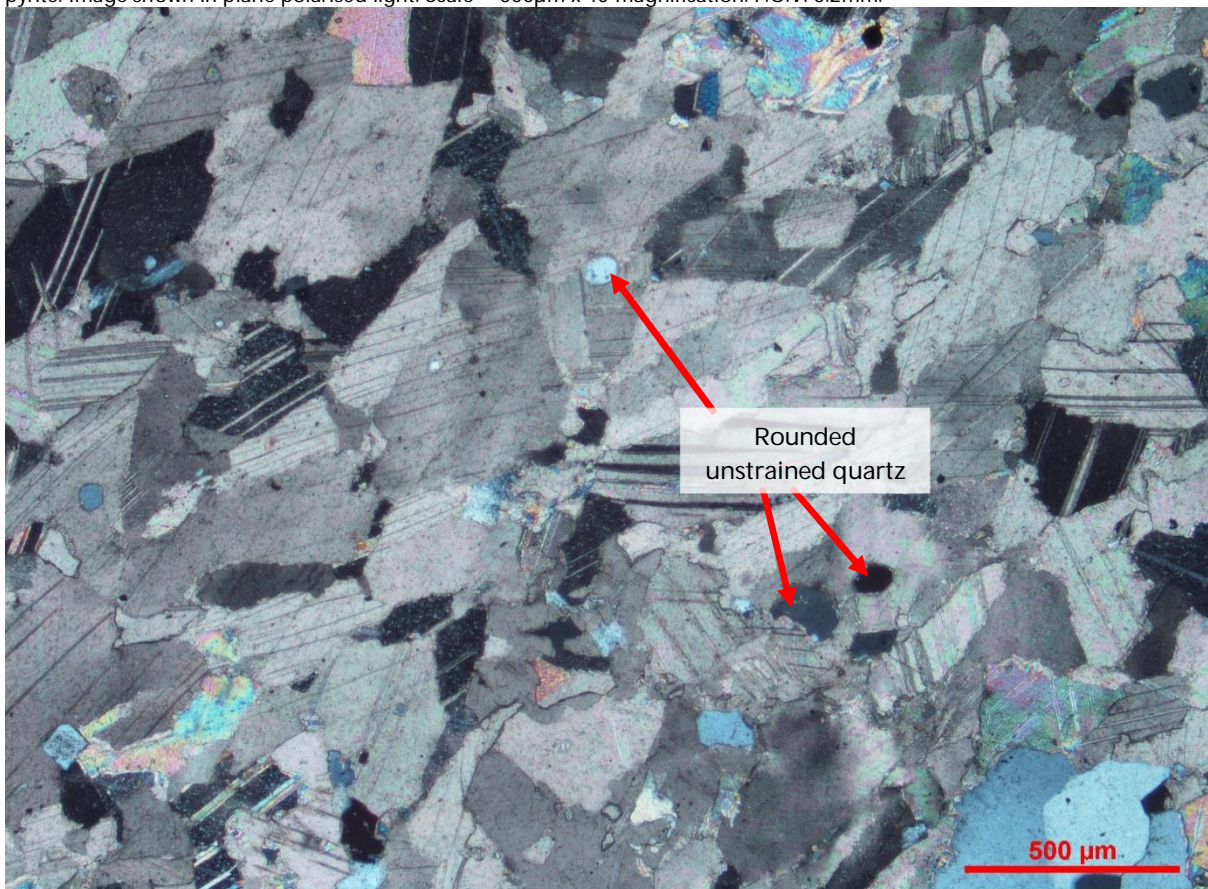
Plate 4: The same image from Plate 3 under crossed polarised light. Scale = 500µm x 40 magnification. F.O.V. 5.2mm.

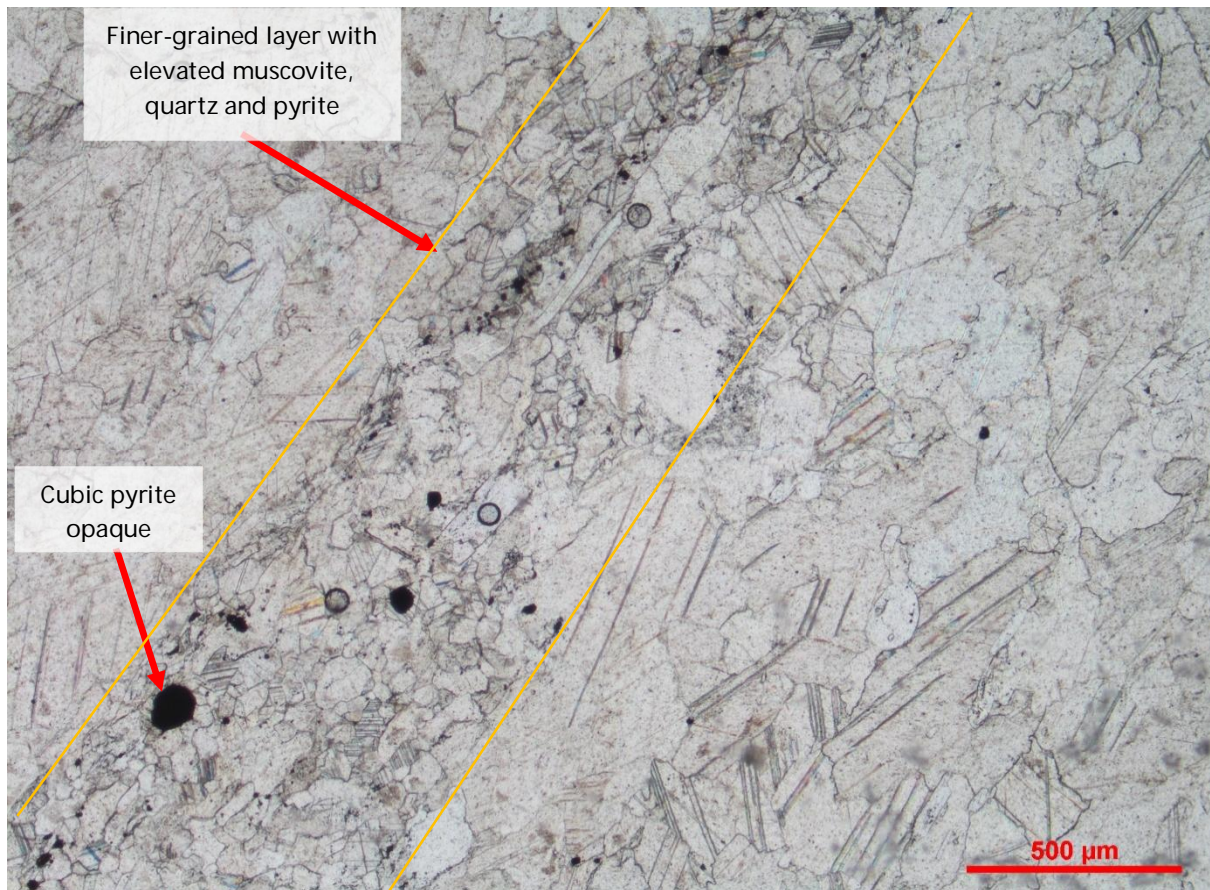
Plate 5: Microphotograph of the sample, showing the occurrence of a finer-grained layer with elevated muscovite, pyrite and quartz. Image shown in plane polarised light. Scale = 500µm x 40 magnification. F.O.V. 5.2mm.

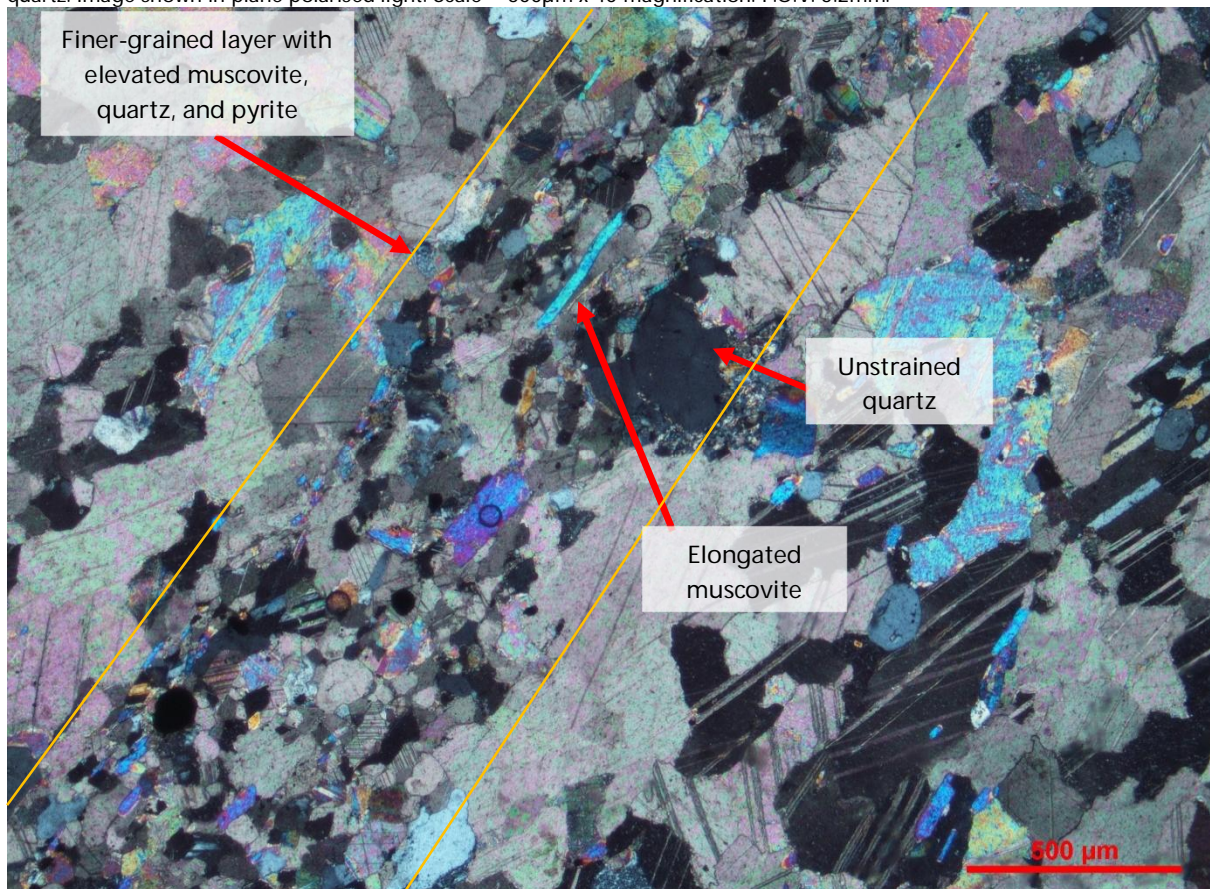
Plate 6: The same image from Plate 5 under crossed polarised light. Scale = 500µm x 40 magnification. F.O.V. 5.2mm.

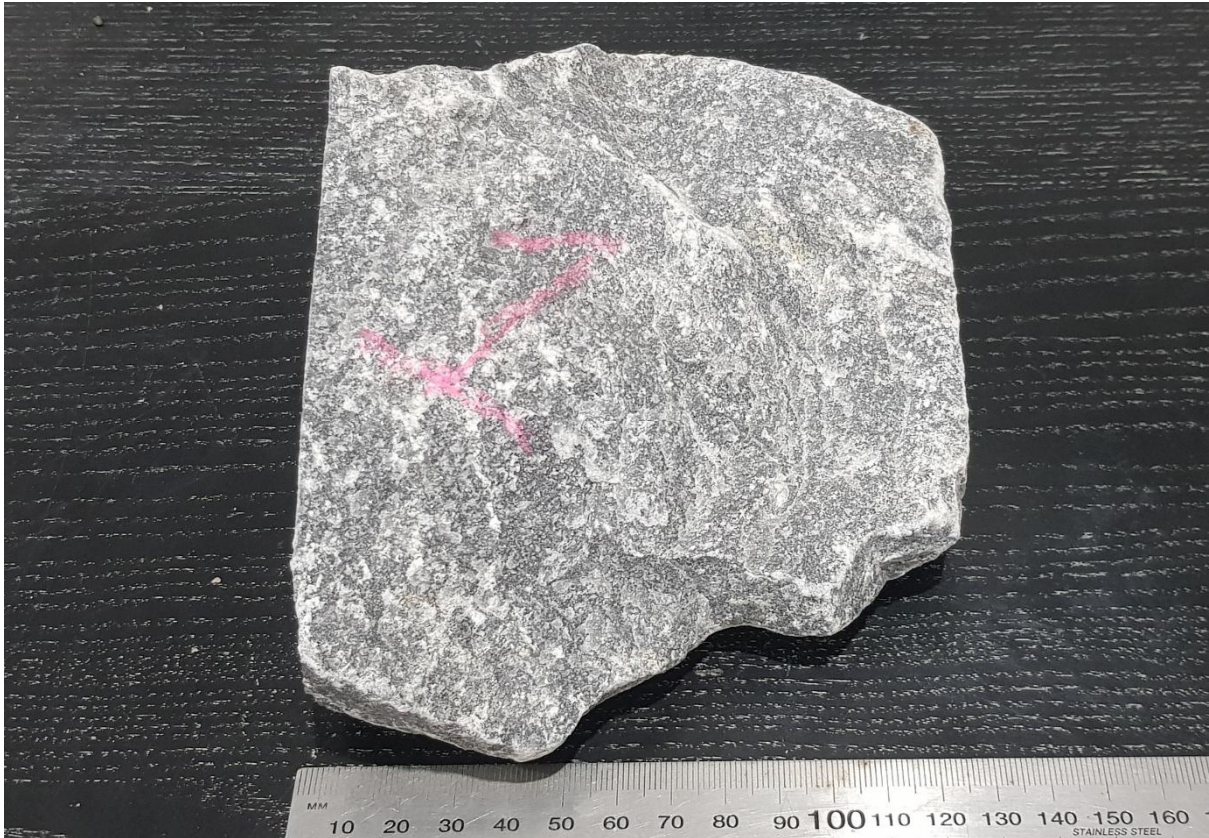
Plate 1: Photograph of the sample as provided, showing the sample's crystalline nature and uniformly grey colour.

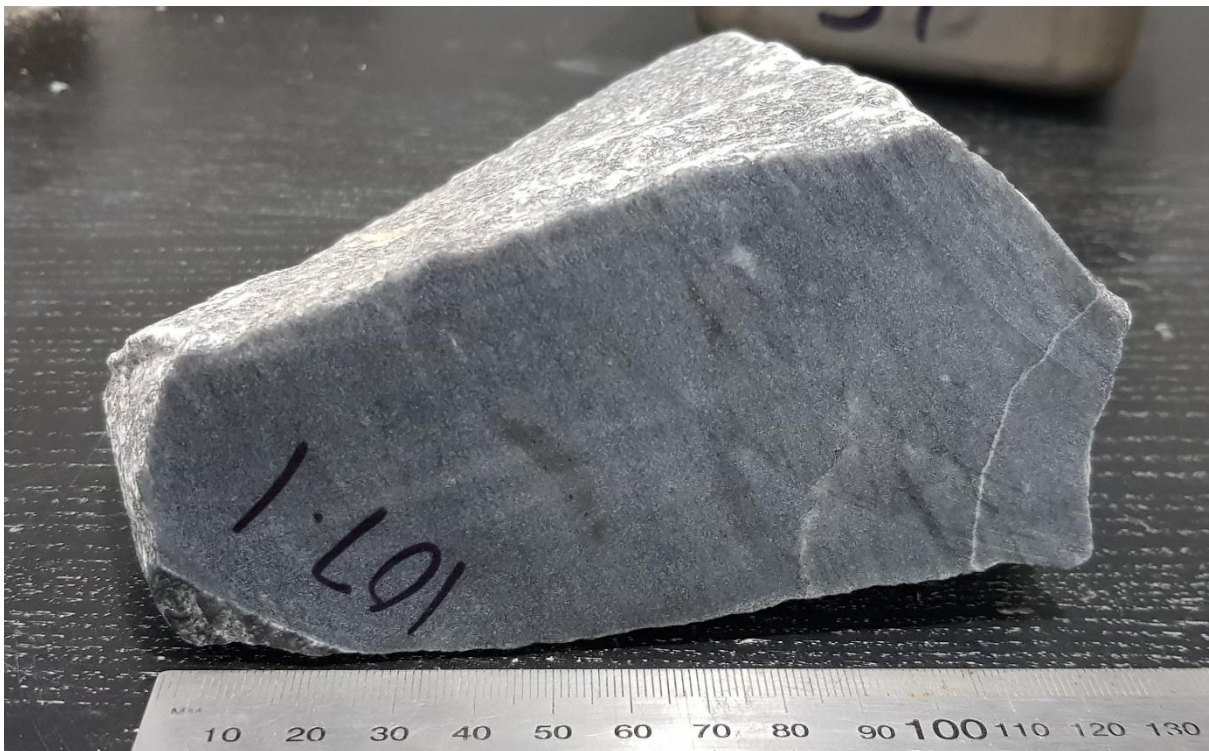
Plate 2: Photograph showing the cut face of the sample, which displays the grey colour and medium-grained nature, as well as micritic white calcite veining.

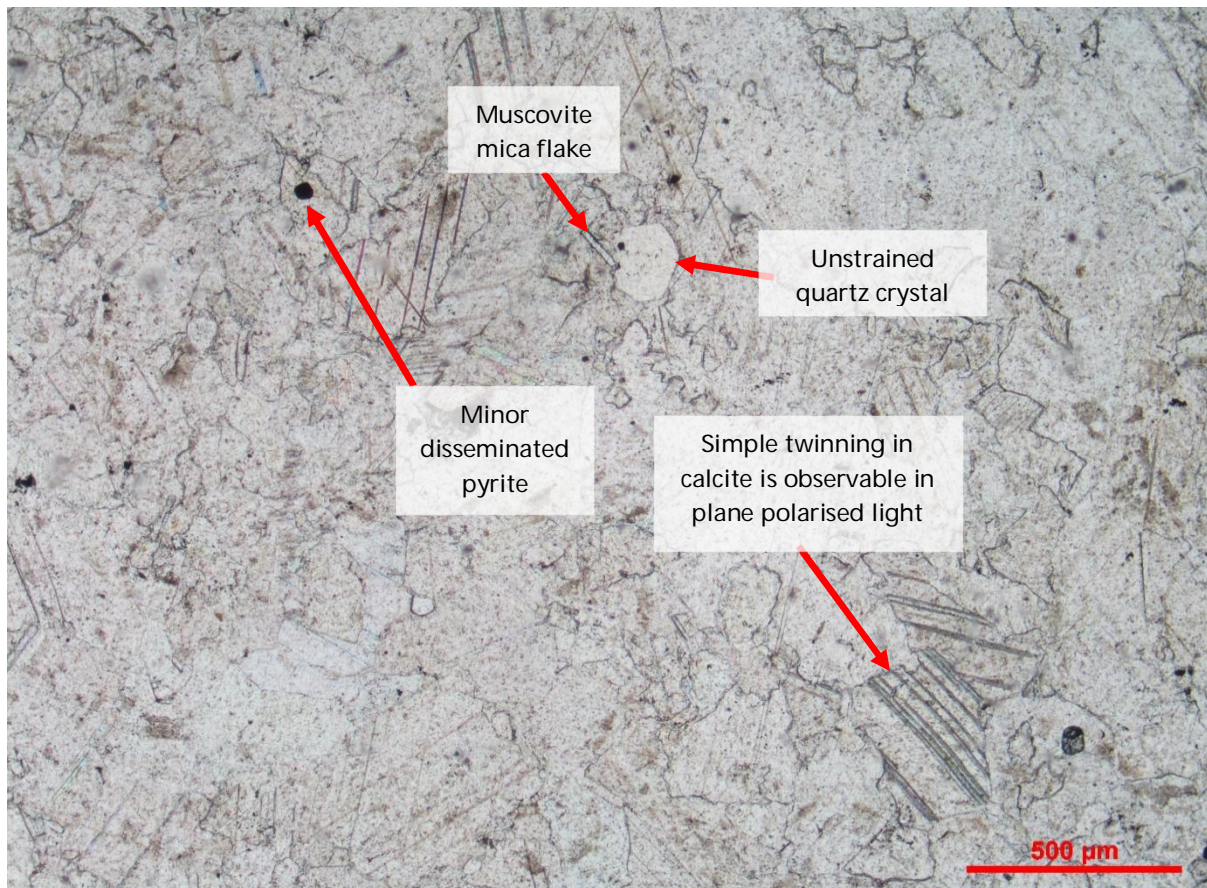
Plate 3: Microphotograph of the sample, showing the occurrence of abundant variably sized recrystallised calcite, with minor accessory phases. Image shown in plane polarised light. Scale = 500µm x 40 magnification. F.O.V. 5.2mm.

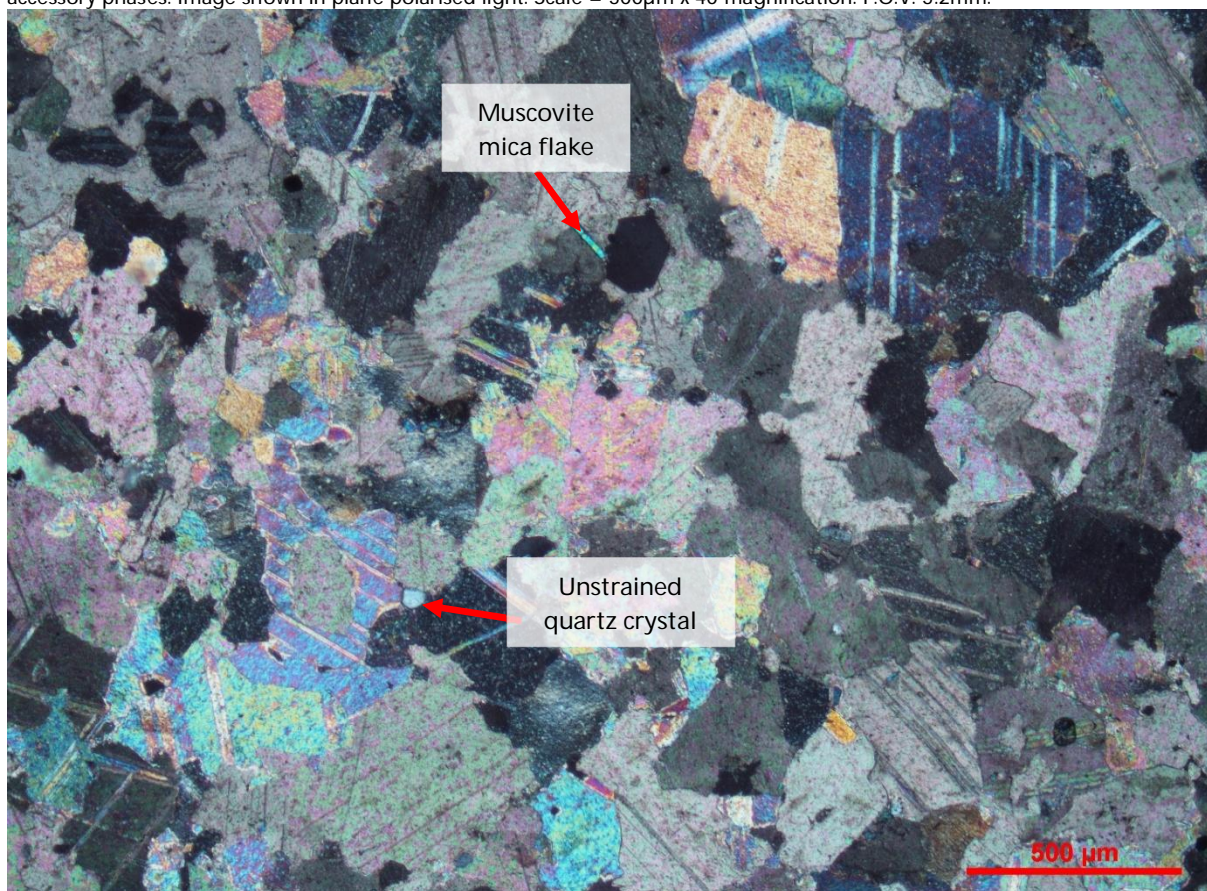
Plate 4: The same image from Plate 3 under crossed polarised light. Scale = 500µm x 40 magnification. F.O.V. 5.2mm.

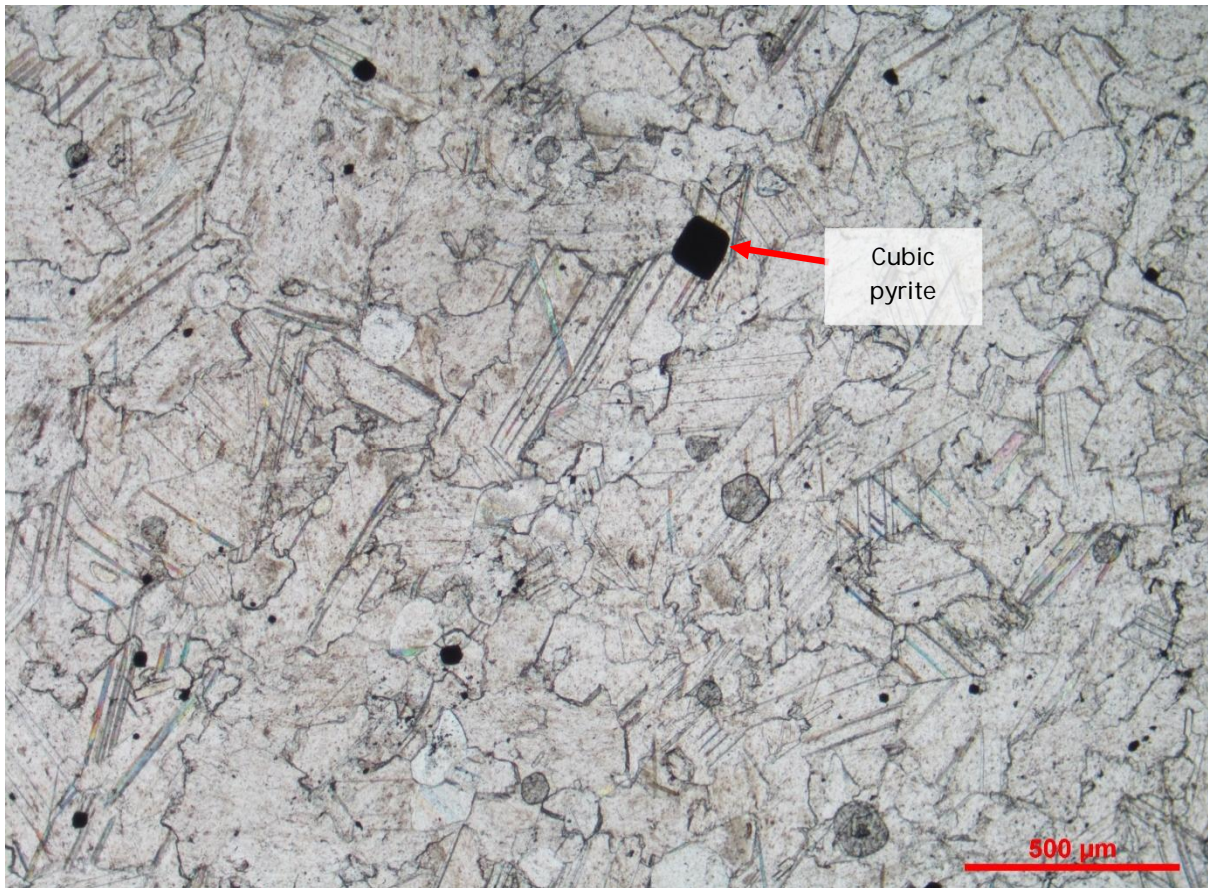
Plate 5: Microphotograph of the sample, showing disseminated pyrite, with accessory muscovite, diopside and minor quartz crystals. Image shown in plane polarised light. Scale = 500µm x 40 magnification. F.O.V. 5.2mm.

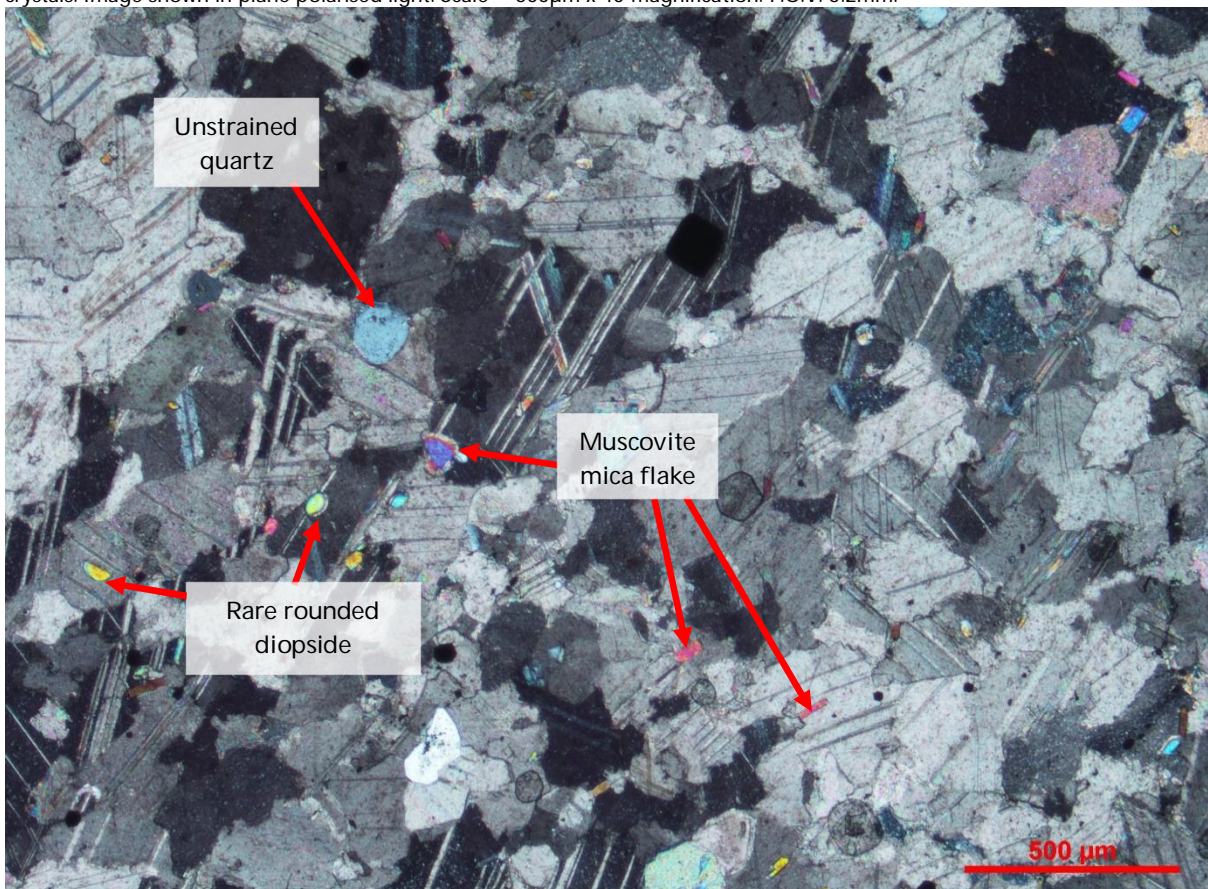
Plate 6: The same image from Plate 5 under crossed polarised light. Scale = 500µm x 40 magnification. F.O.V. 5.2mm.

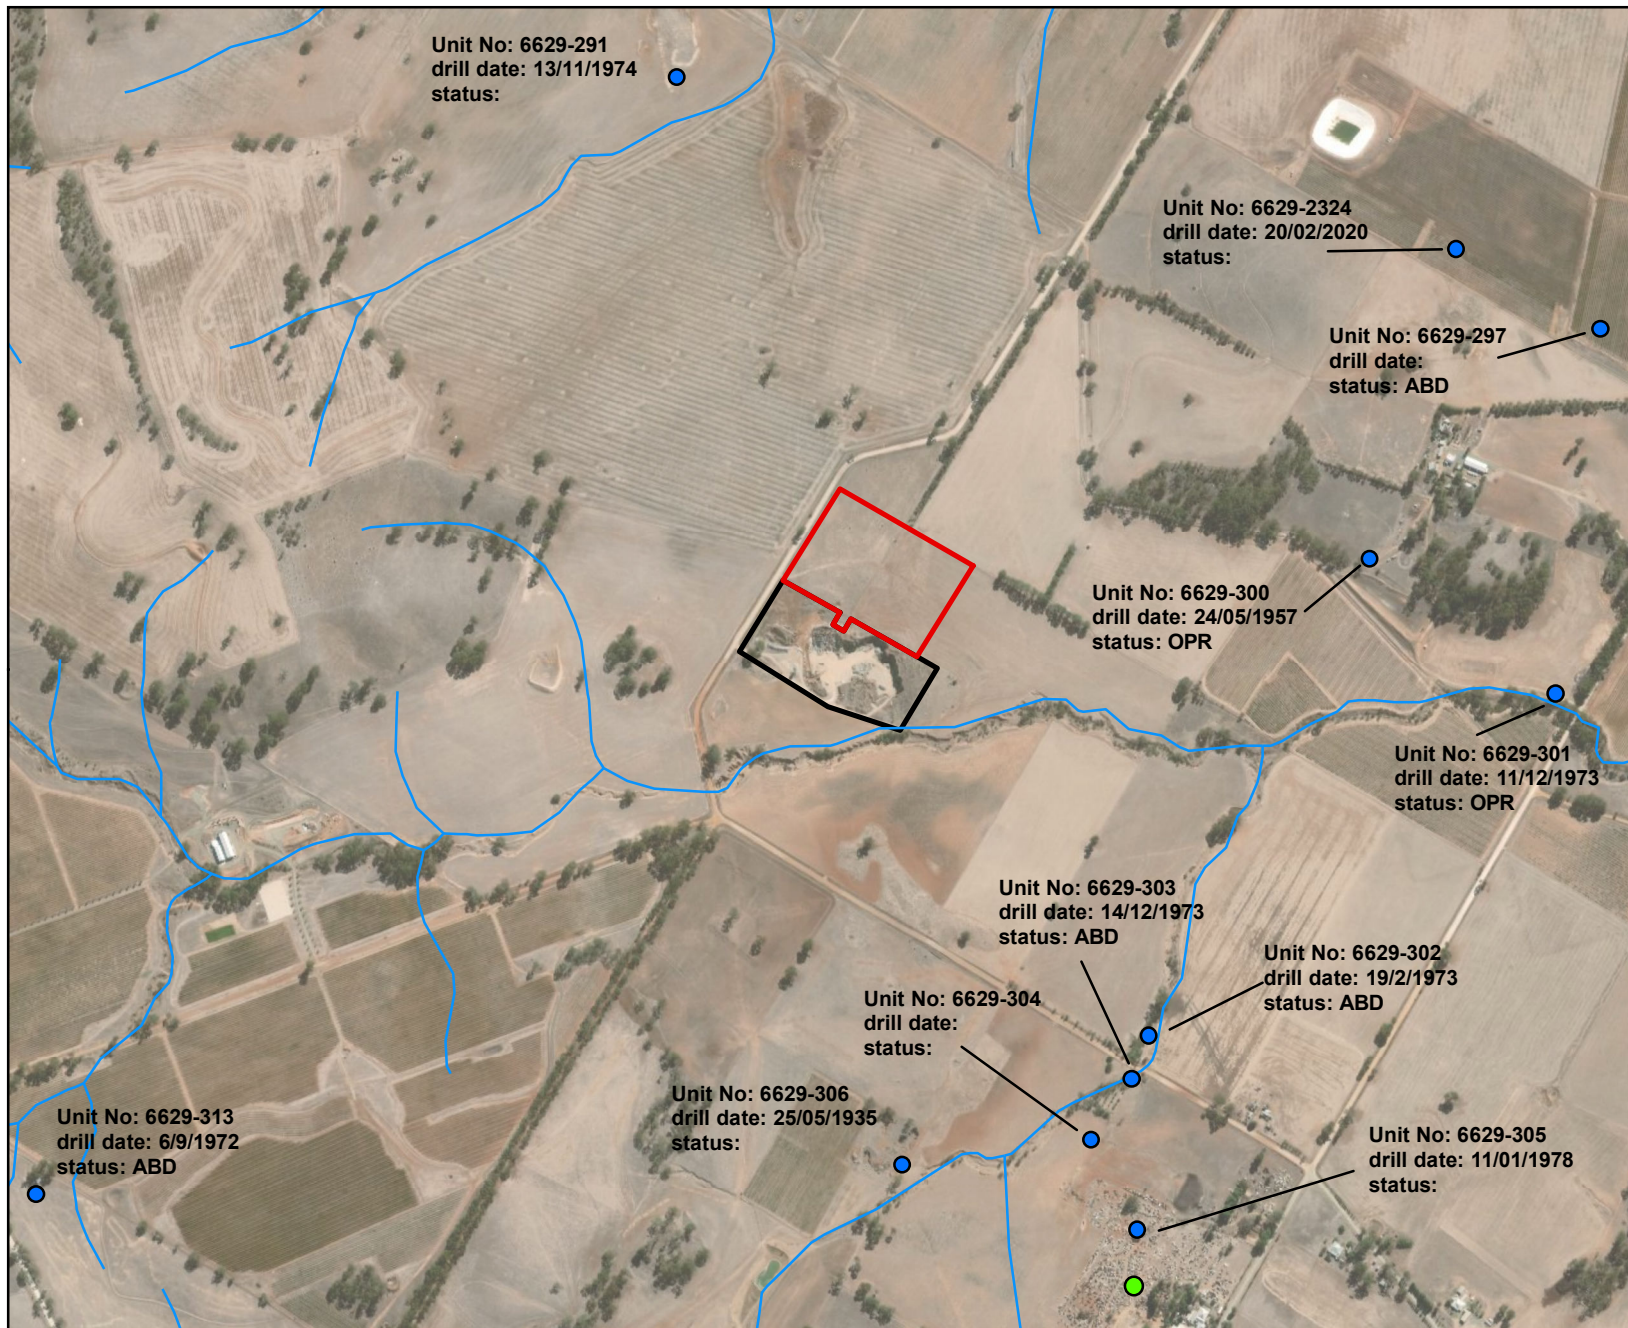
Nearby wells labelled by unit number, drill date and status.

Figure 3 reports water wells labelled by unit number, drill date and status. The map indicates that no water well exists at the Site. The nearest well is located 660 m to the east (unit no 6629-300).

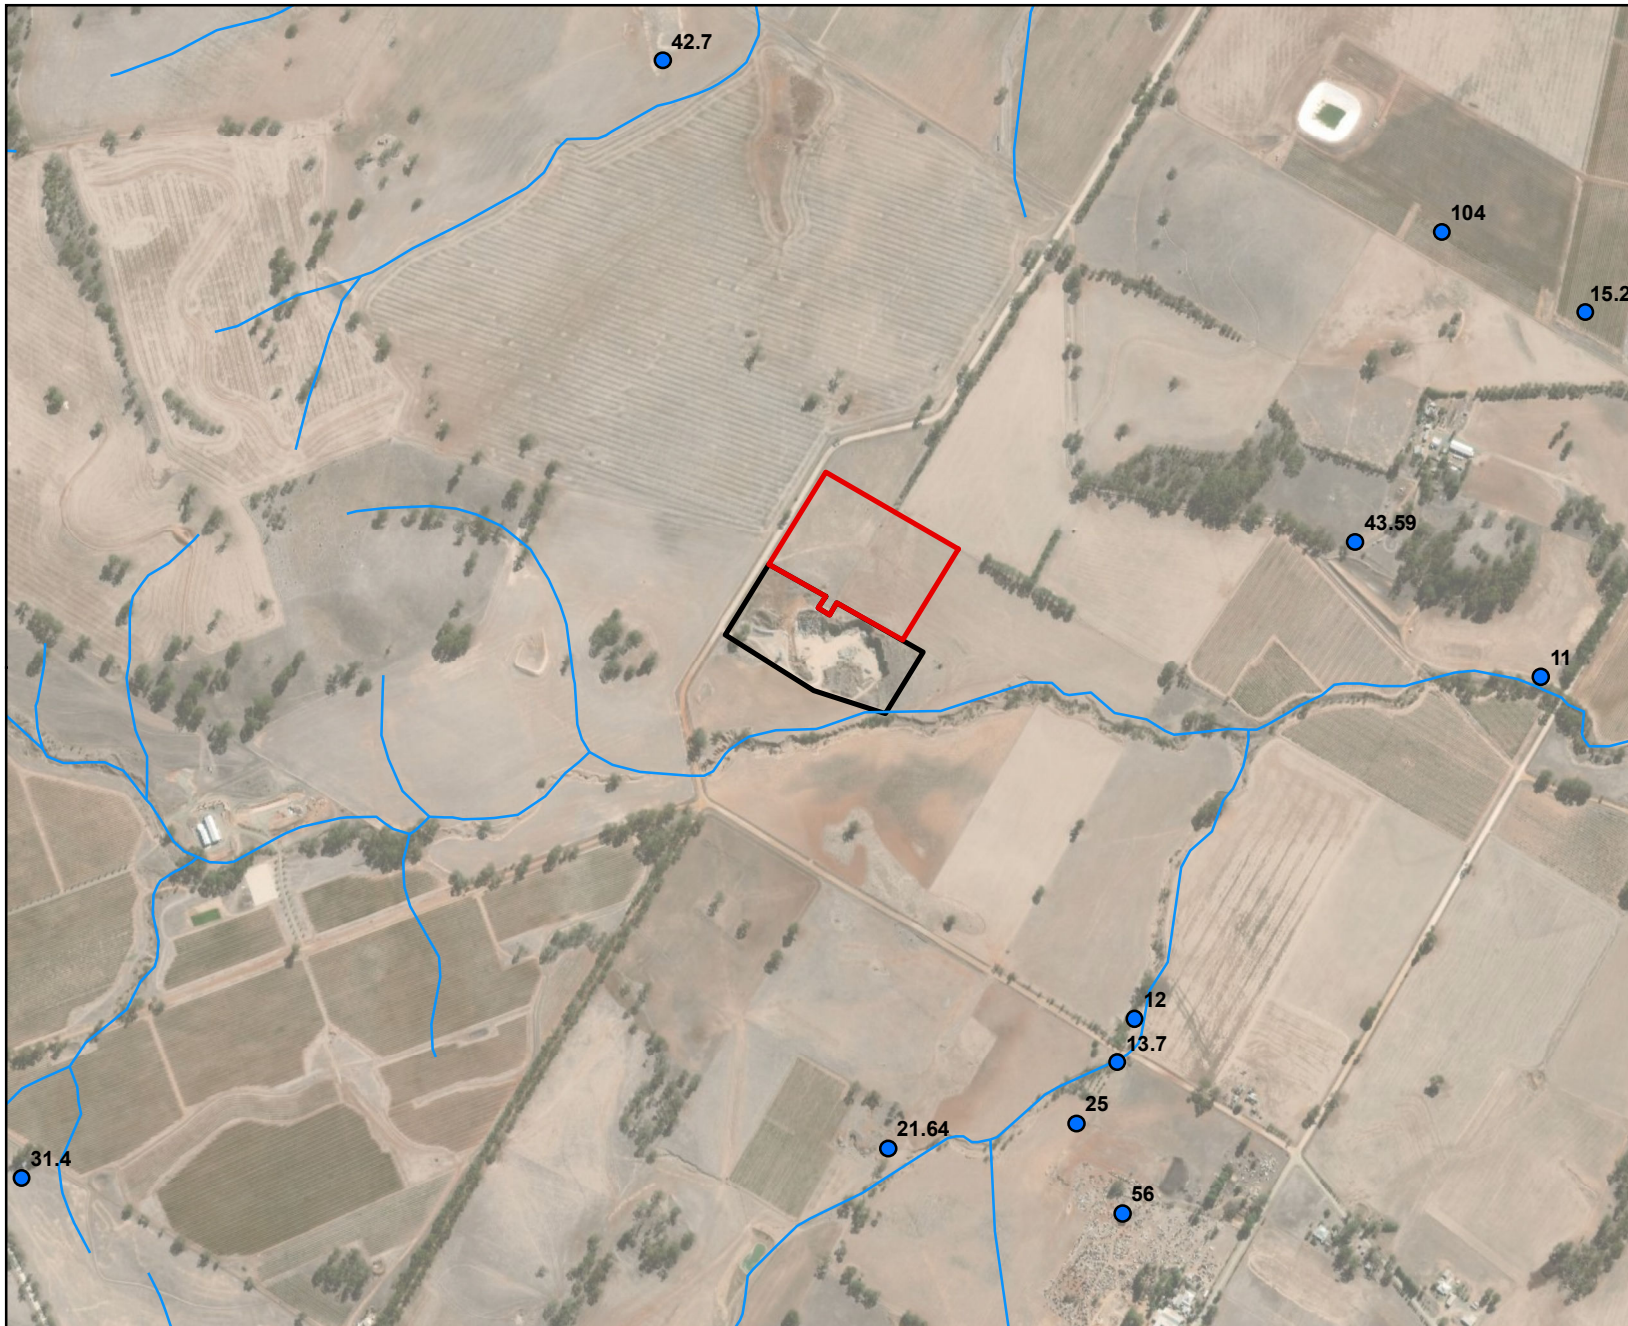
Figure 4

Well Depths (m below ground)

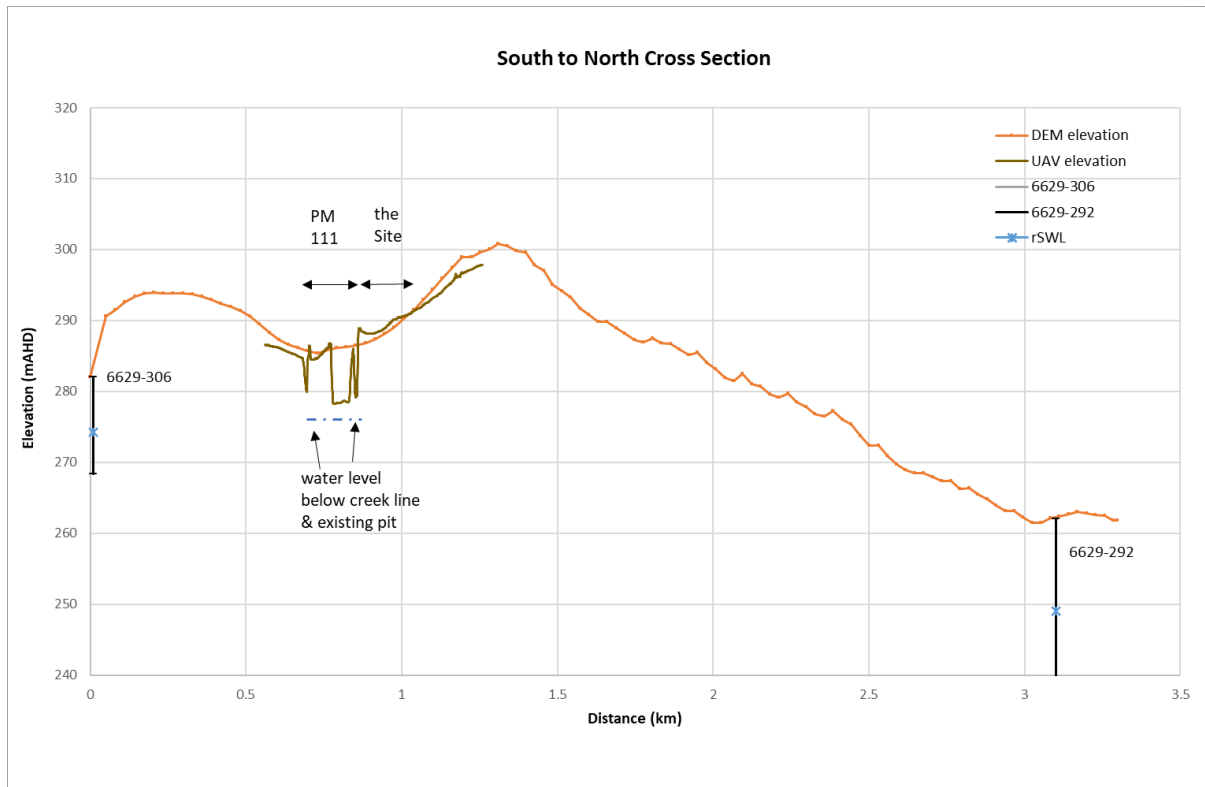
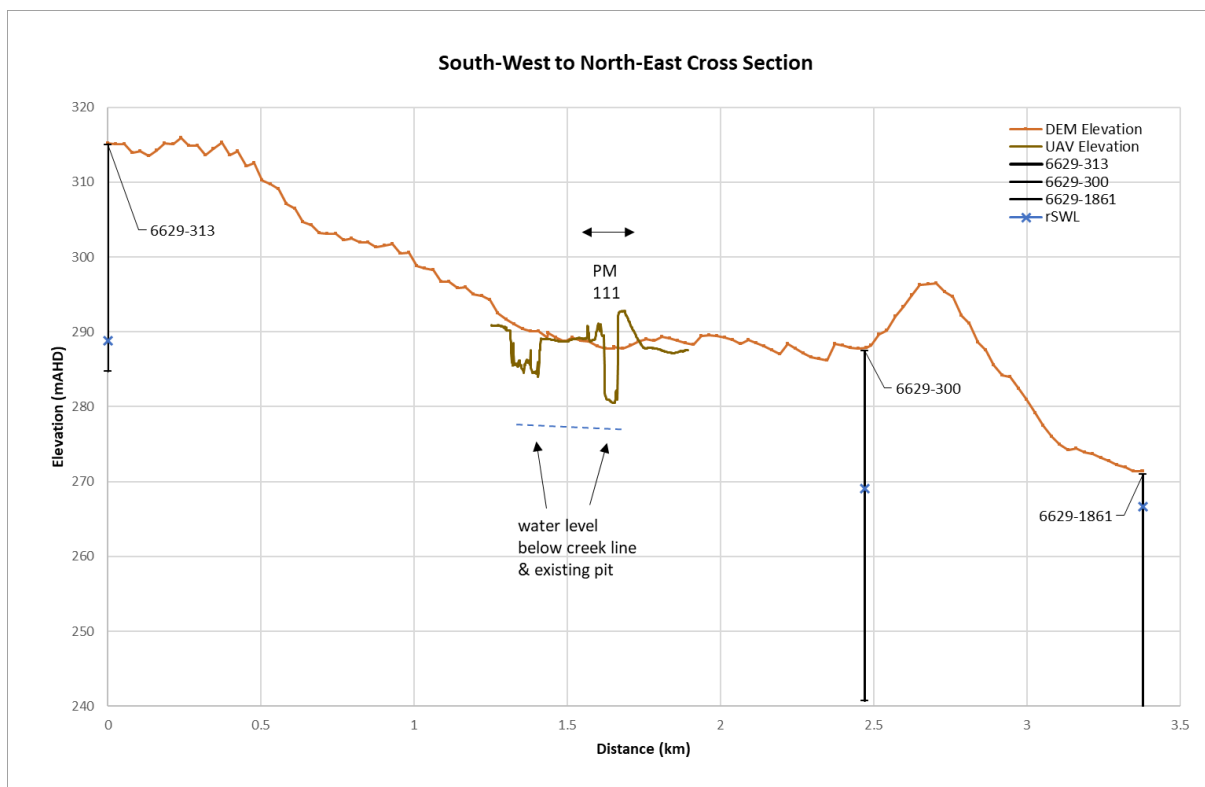
Figure 7. Hydrogeological Cross Sections (see Figure 6 for Cross Section lines).

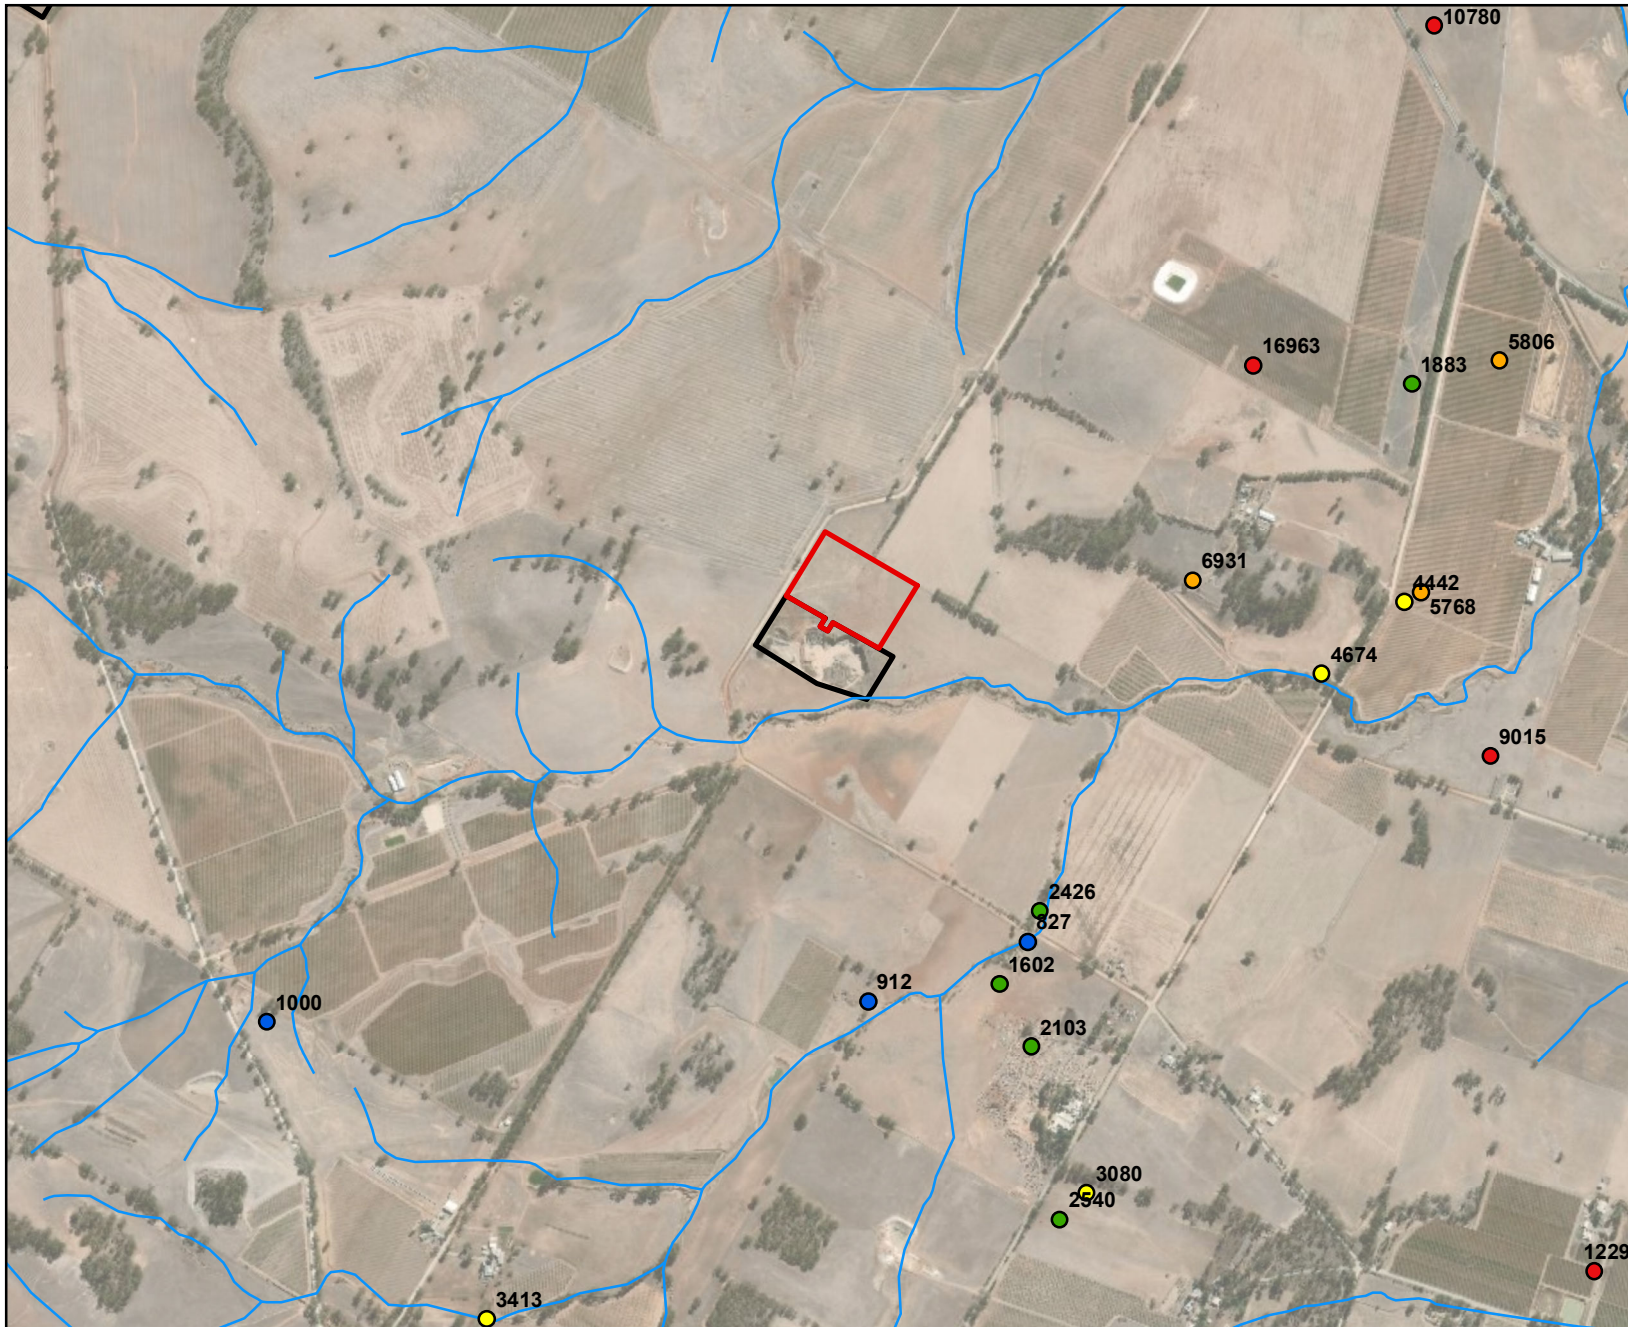
Salinity (mg/L)

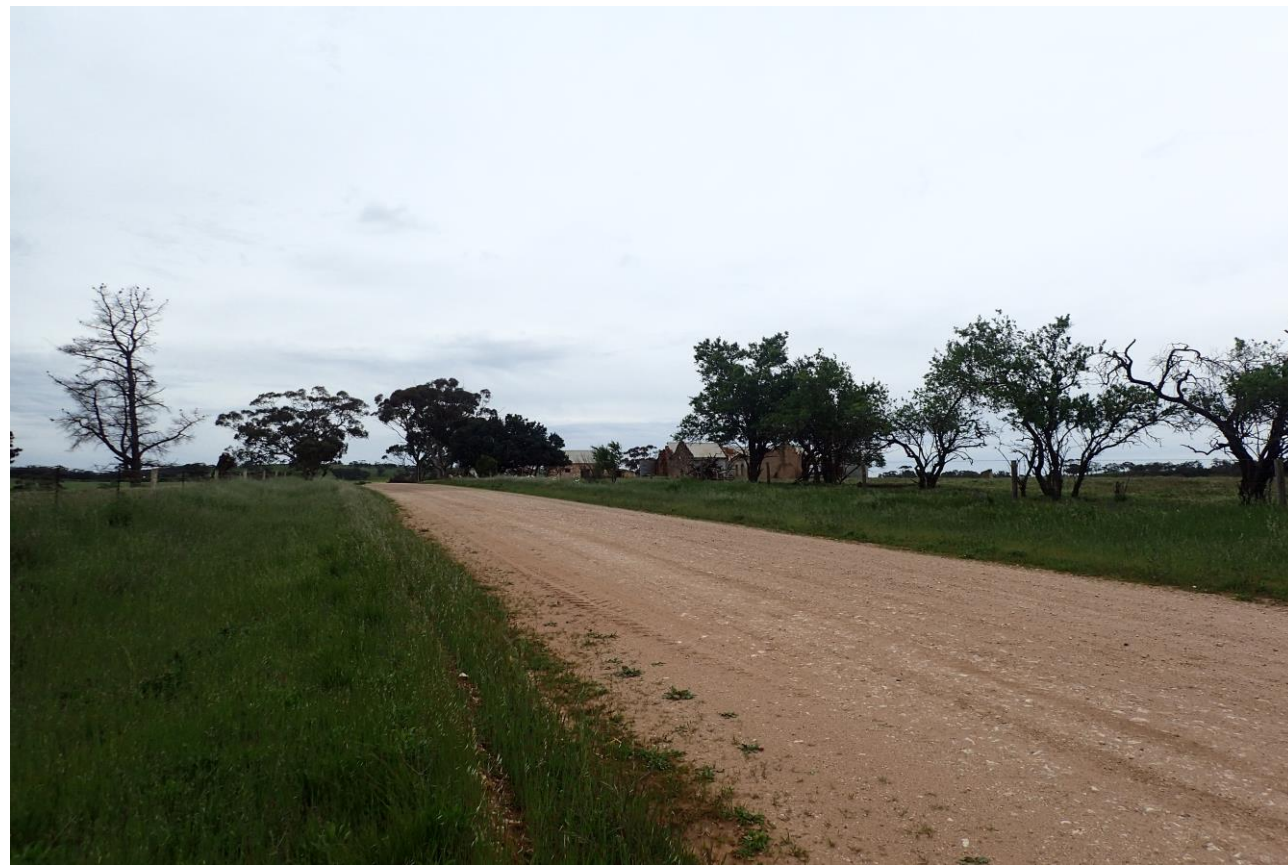
Photo Plate 1: Photo from corner of Schrapel Road and Heinze Road towards MC area. No view experienced due to topography, buildings and tree screening.

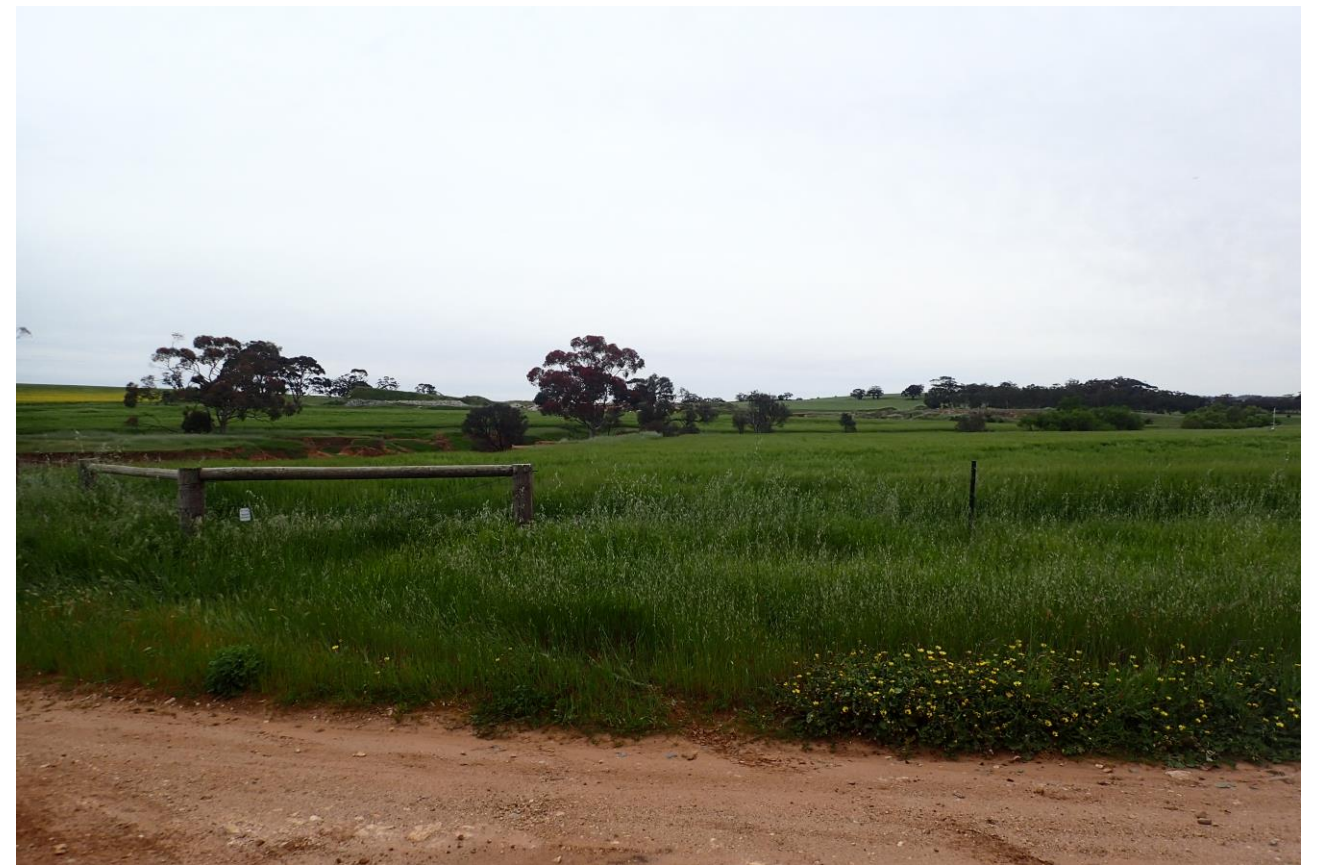
Photo Plate 2: View from Corner of Schrapel Road and Marble Quarry Road. Looking into PM 111 and MC area. Views of the existing quarry experienced. No views of the MC area due to overburden mound and tree screening.

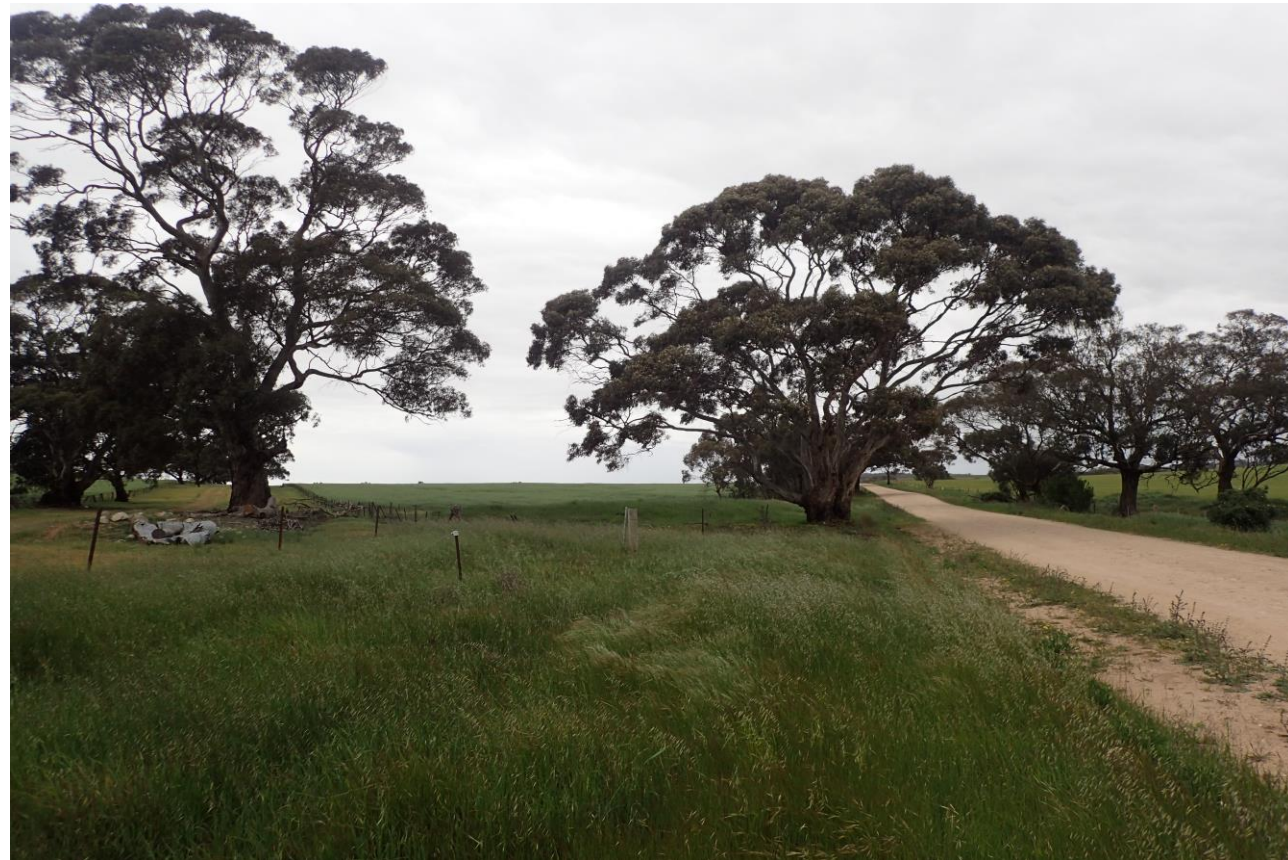
Photo Plate 3: View from north of Marble Quarry Road taken at private access track entry / exit point for landowner (Saegenschnitter). No view due to topography of the area.
