CARRARA MARBLE QUARRY (ML 6556, PM 111)
MINE OPERATIONS PLAN (MOP) AND
PROGRAM FOR ENVIRONMENTAL
PROTECTION AND REHABILITATION (PEPR)

Prepared for:
Amulet Holdings Pty Ltd

Date:
July 2025

File Ref:
2492.610.002V1

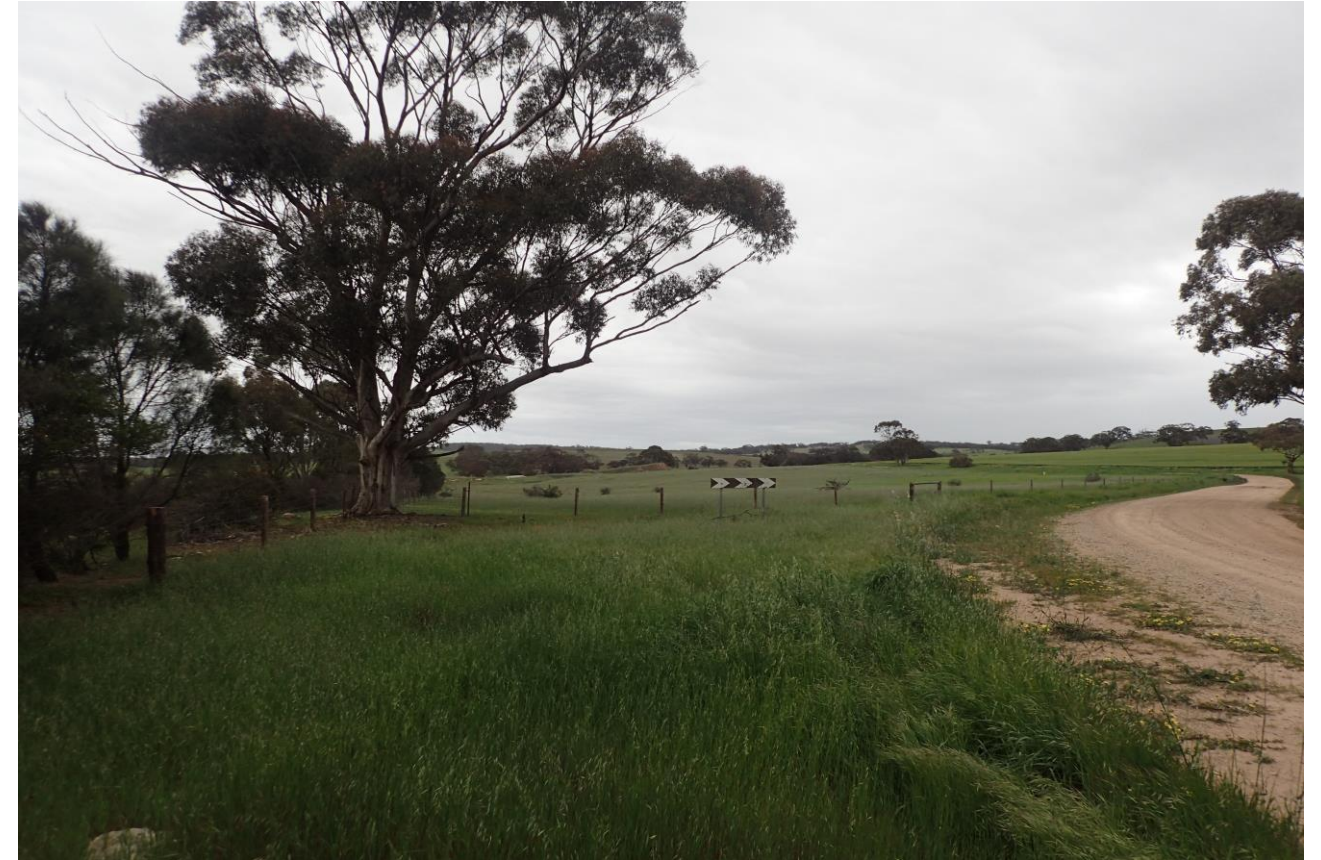
Photo Plate 4: View from Marble quarry Road, north of MC area. Views of MC area experienced, white peg of MC shown in distance. Views of PM 111 Overburden mound also experienced.

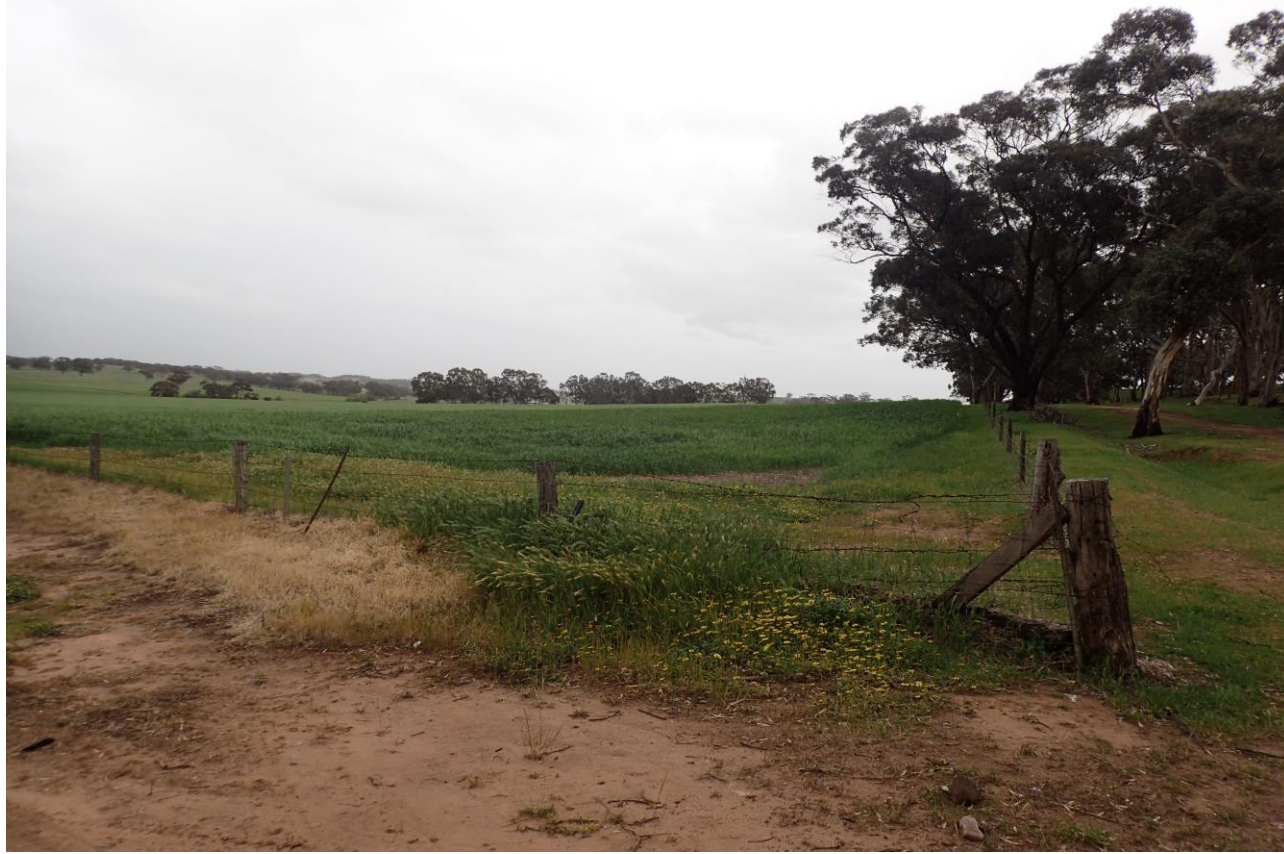
Photo Plate 5: View taken along private access track south of the Saegenschnitter property. Vineyards located just of view to the left of photo. No views of MC area experienced due to topography and tree screening.

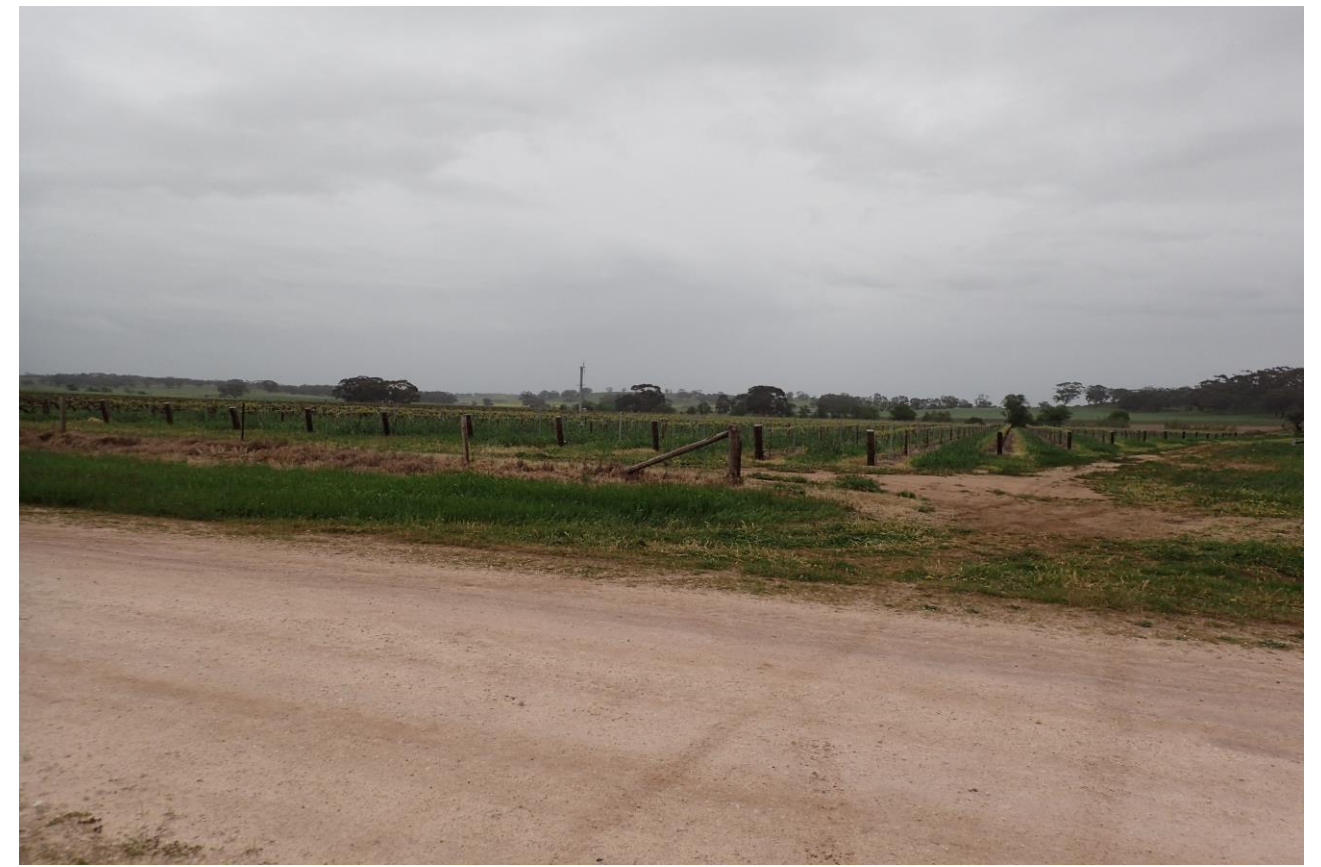
Photo Plate 6: View from corner of Heinze Road and Neukirch Road towards PM and MC area. Distant views of PM Overburden mound but no views of MC area due to topography and tree screening.

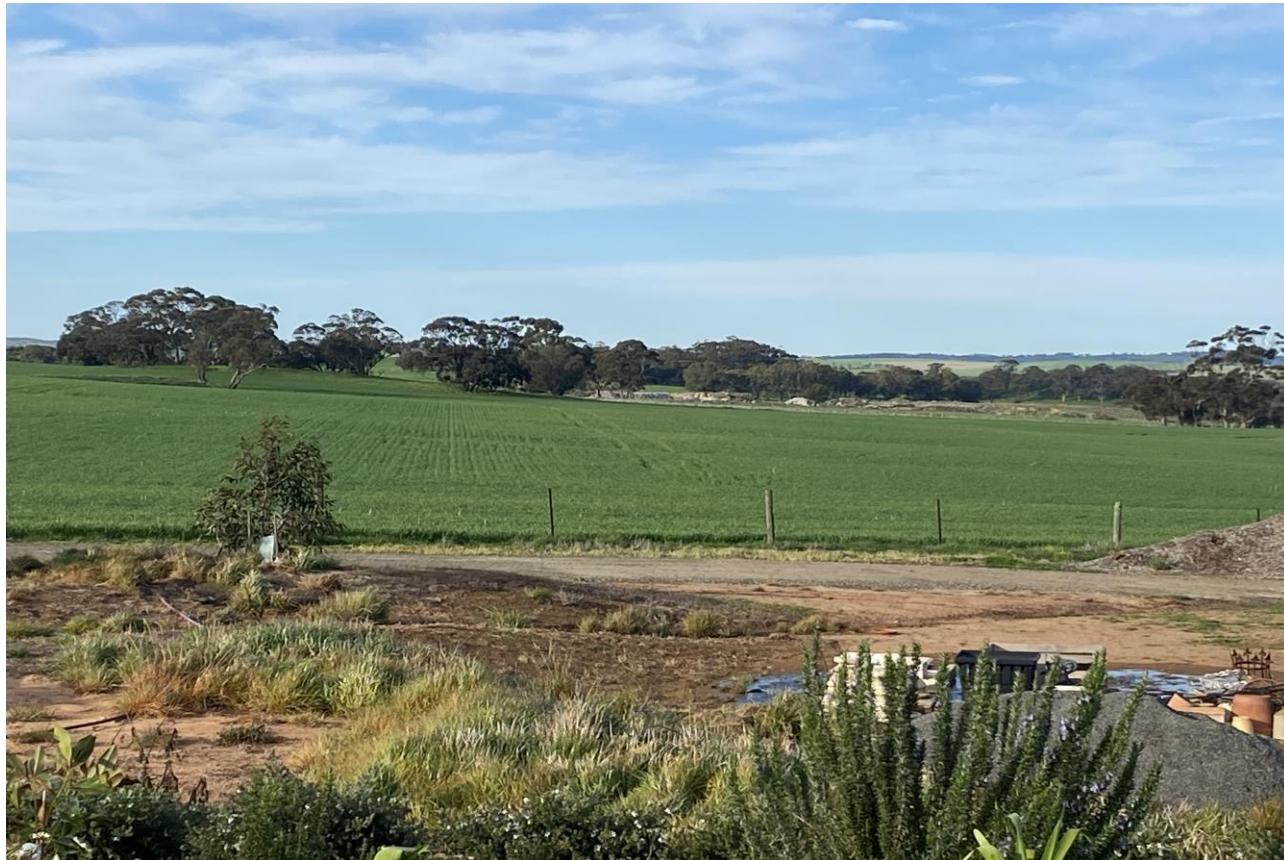
Photo Plate 7: View from the residence located south west of the Site shows limited views of the MC area are experienced due to topography and vegetation screening, and views are predominately of the adjacent PM.
