Kanmantoo Copper Project Mining Lease Proposal

Kanmantoo Copper Project Integrated Waste Landform Design

**INTEGRATED WASTE LANDFORM (IWL)
DESIGN DOCUMENT
KANMANTOO PROJECT,
SOUTH AUSTRALIA**

MWP00335AA-A -IWL Design Report Rev 2

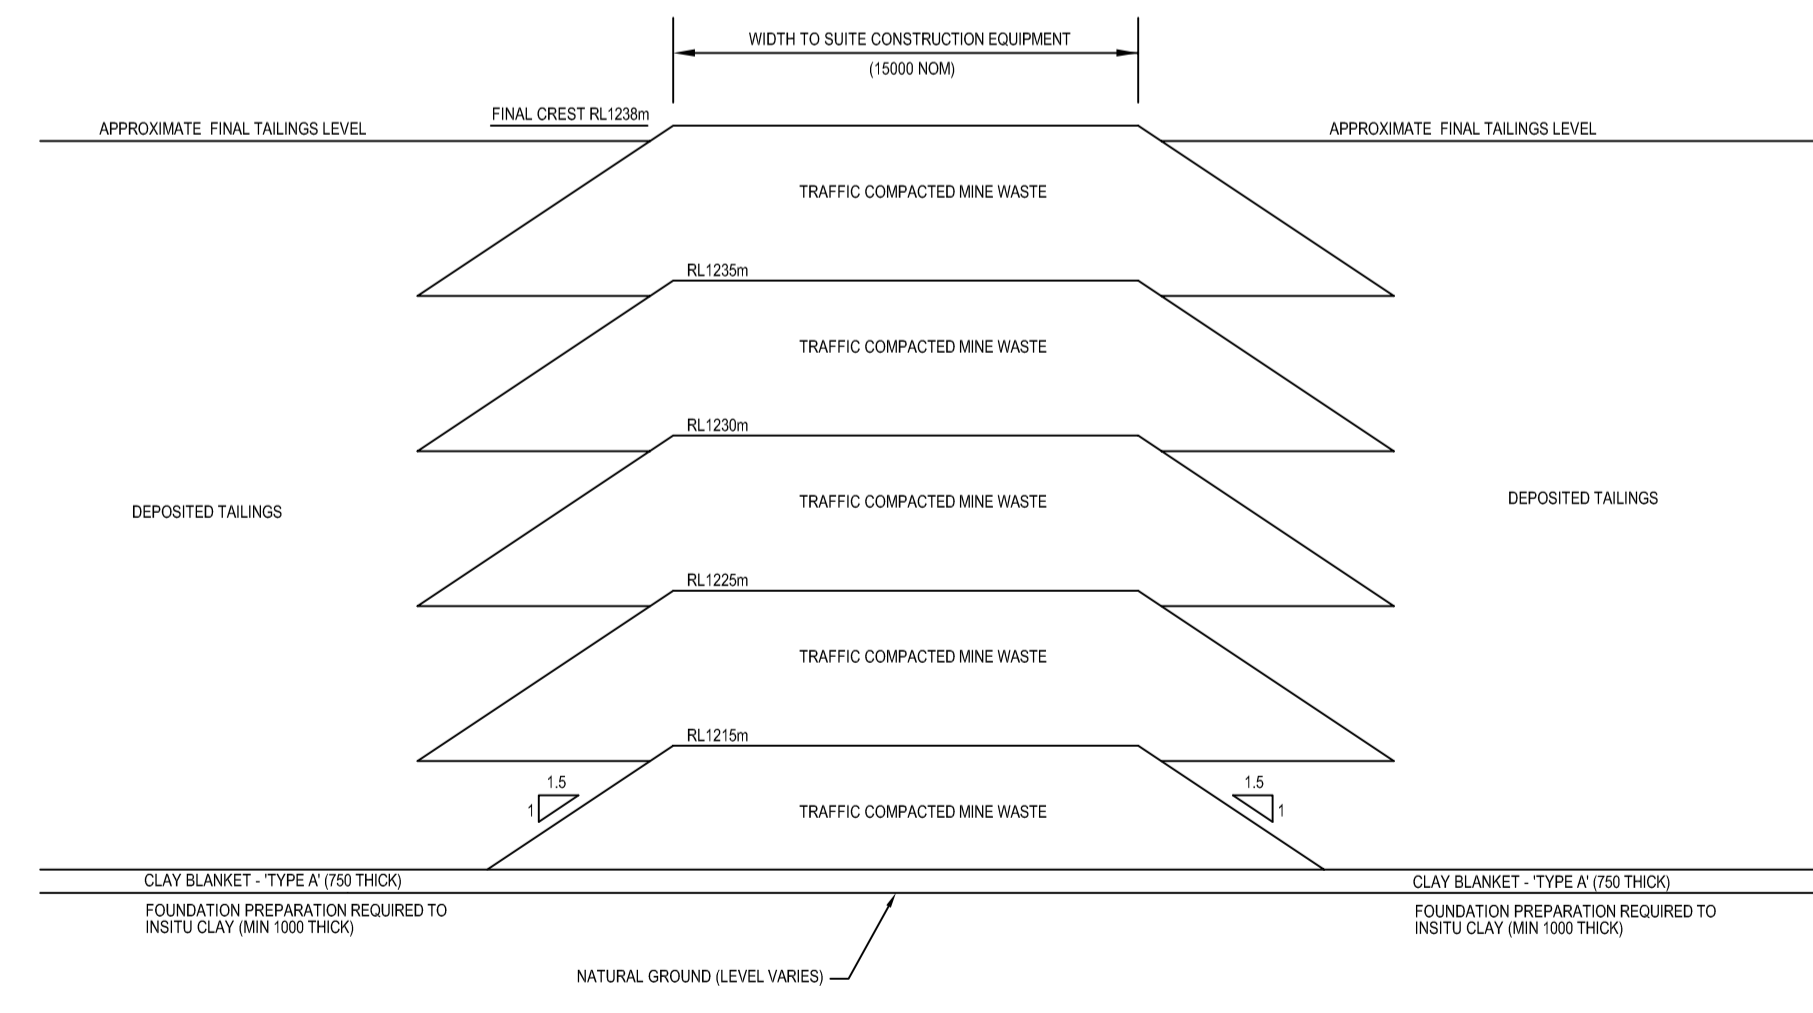
DECANT ACCESSWAY - FINAL
TYPICAL SECTION
SCALE 1:250

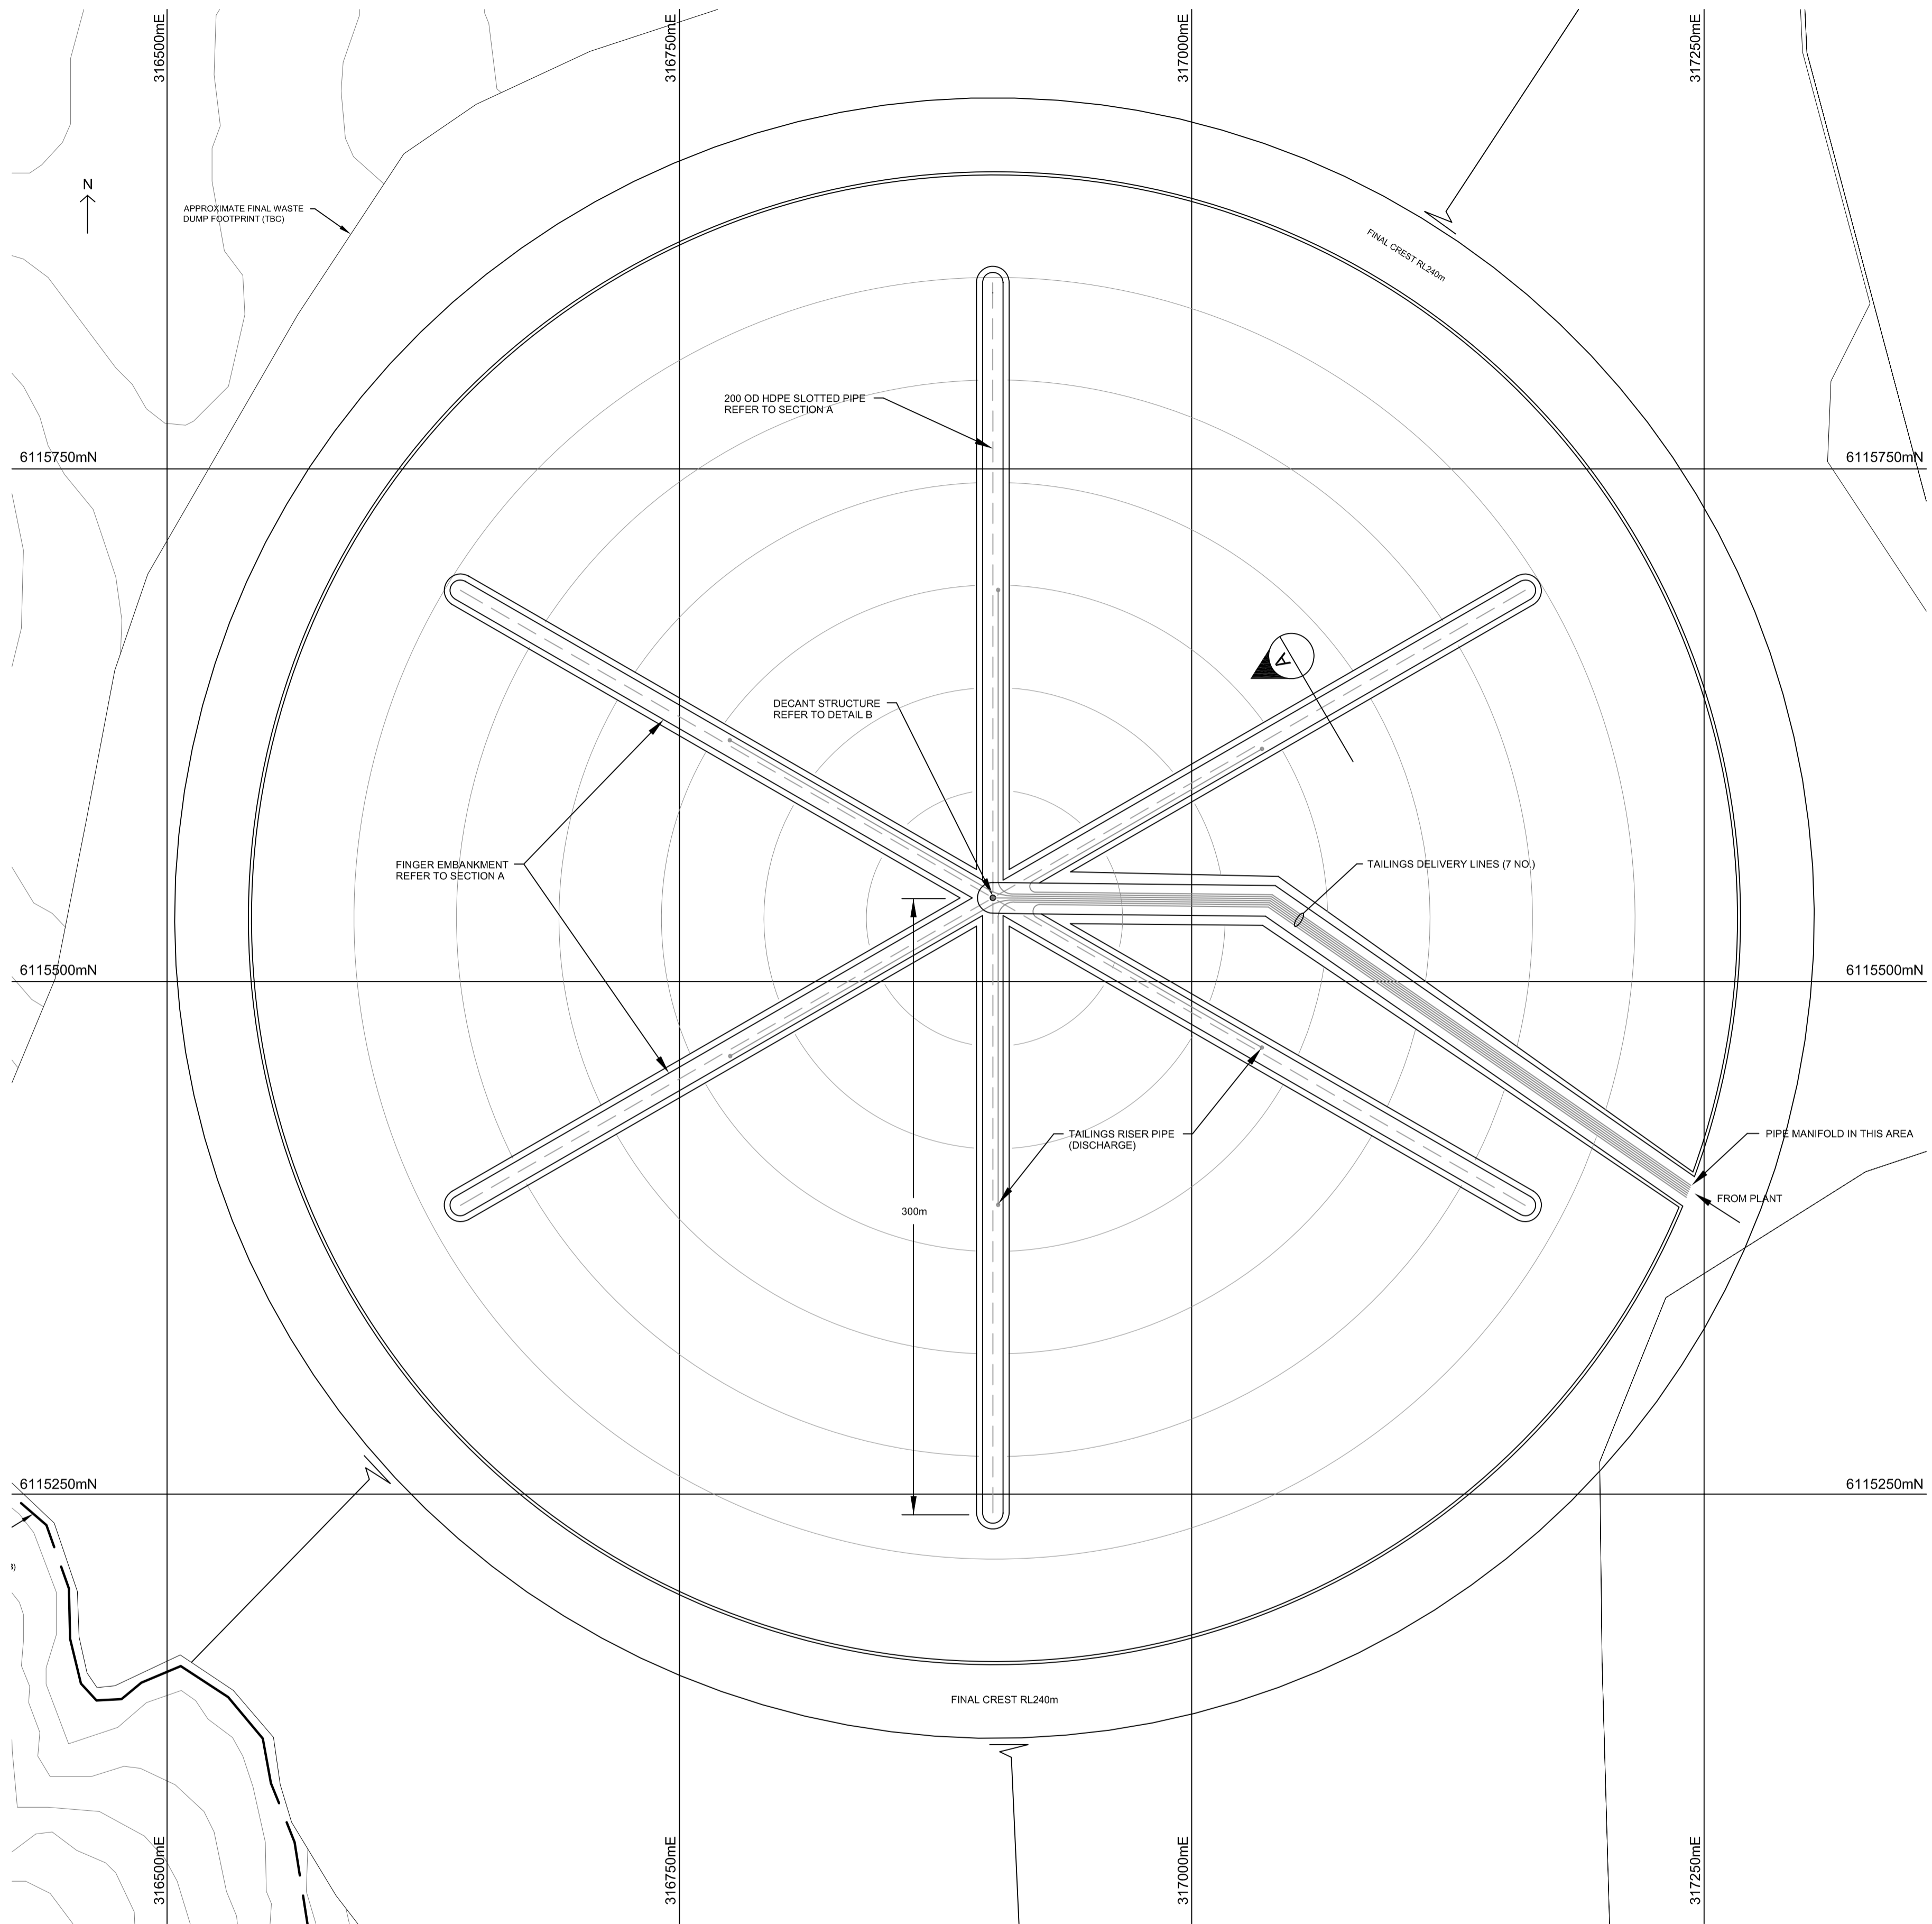
STAGE 7 - FINAL DEPOSITION
PLAN
SCALE 1:2000

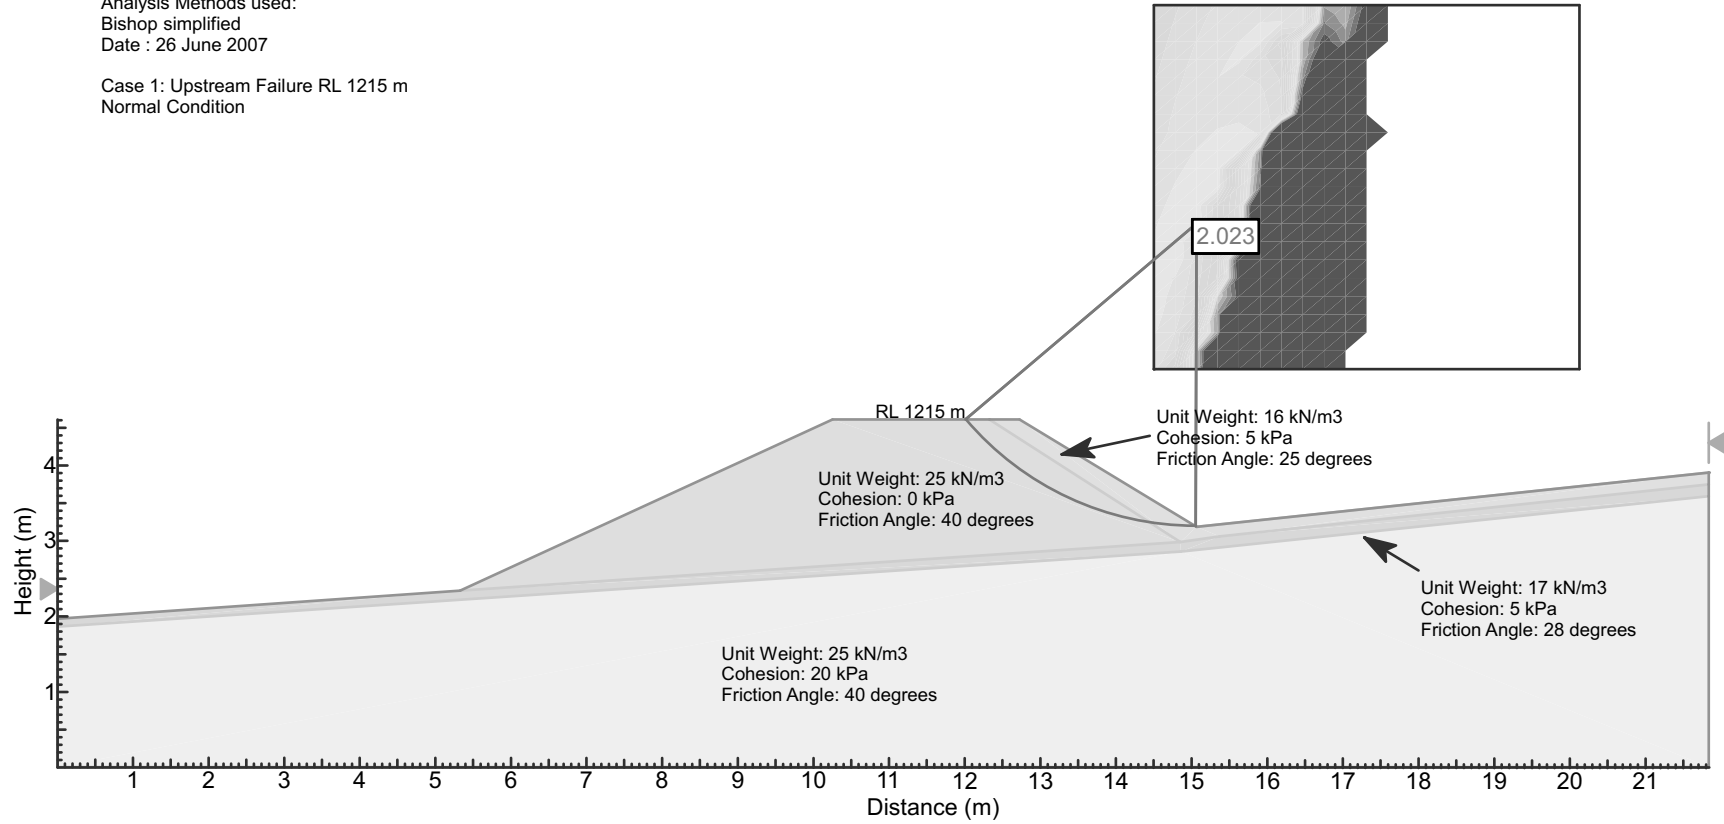
SPECIALISTS FROM BOARDROOM TO MINE FACE	Drawn	FAC	HILLGROVE COPPER PTY LTD COMPANY KANMANTOO TAILINGS STORAGE FACILITY CASE 1 UPSTREAM FAILURE RL 1215m NORMAL CONDITION	Original Size	A4
	Approved	CL		Project no:	MH00335AA
	Date	19/09/2007		Figure	F3
	Scale	AS SHOWN

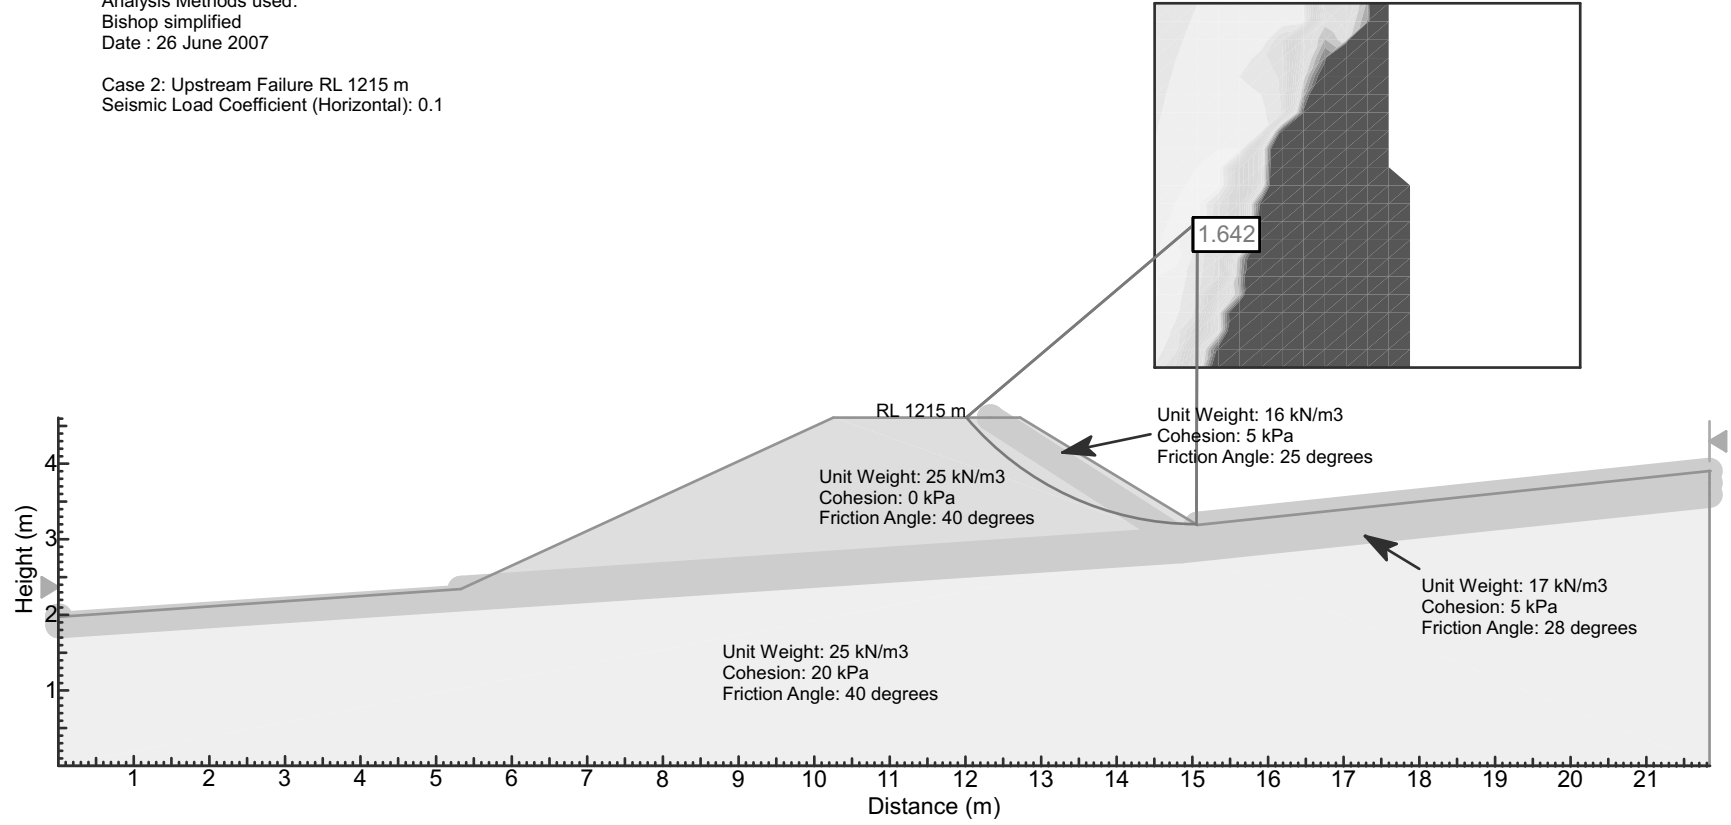
SPECIALISTS FROM BOARDROOM TO MINE FACE	Drawn	FAC	HILLGROVE COPPER PTY LTD COMPANY KANMANTOO TAILINGS STORAGE FACILITY CASE 2 UPSTREAM FAILURE RL 1215m SEISMIC LOAD COEFFICIENT (HORIZONTAL) 0.1	Original Size	A4
	Approved	CL		Project no:	MH00335AA
	Date	19/09/2007		Figure	F4
	Scale	AS SHOWN

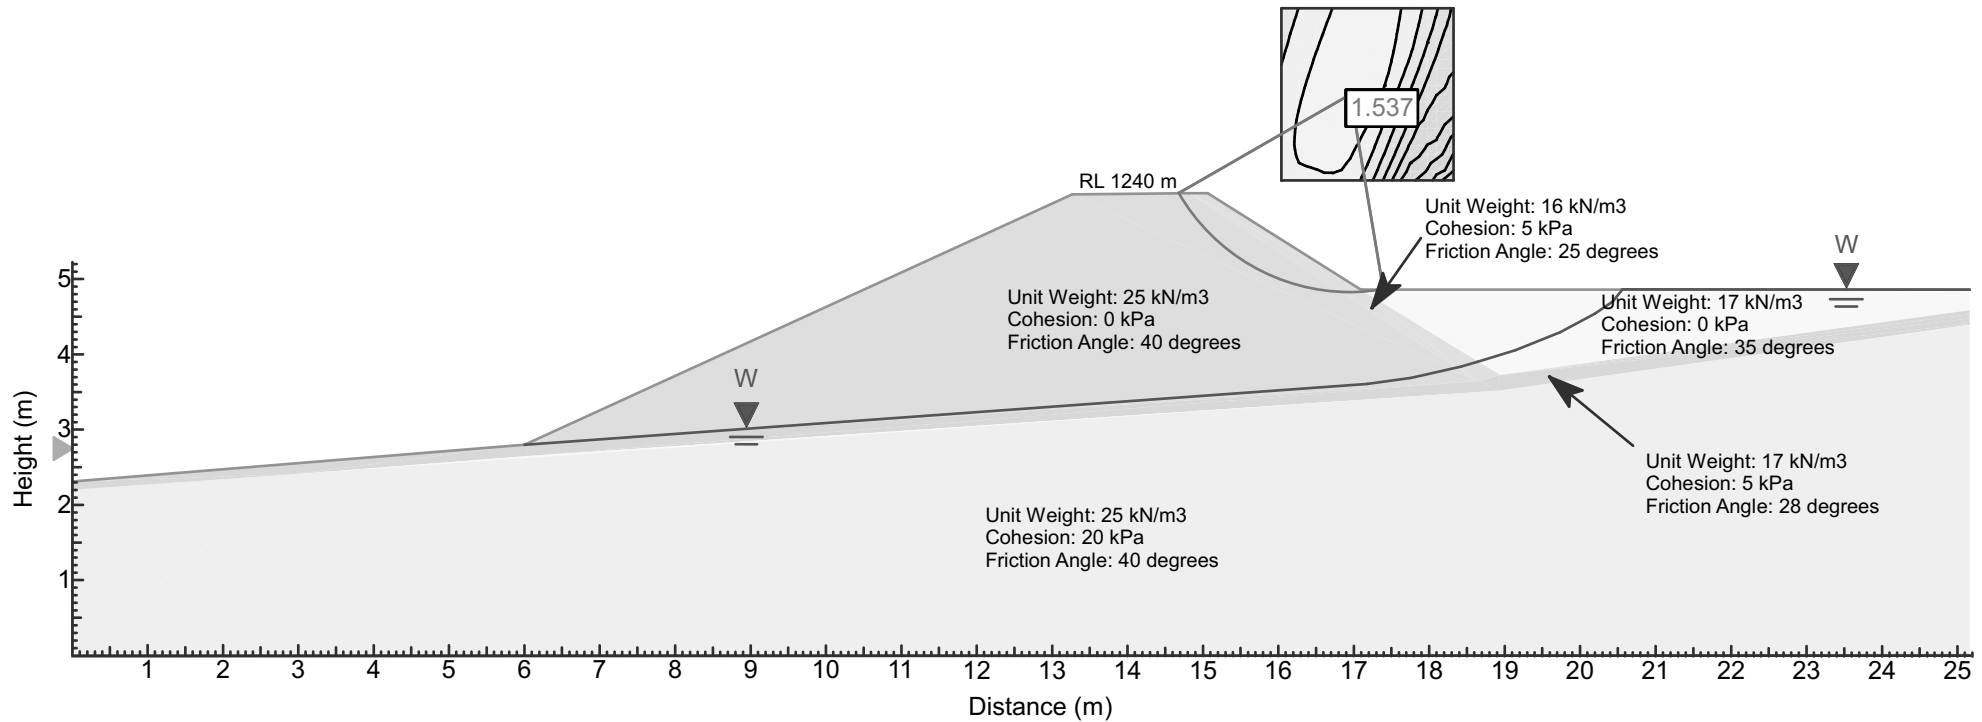
SPECIALISTS FROM BOARDROOM TO MINE FACE	Drawn	FAC	HILLGROVE COPPER PTY LTD COMPANY KANMANTOO TAILINGS STORAGE FACILITY CASE 4 UPSTREAM FAILURE RL 1240m SEISMIC LOAD COEFFICIENT (HORIZONTAL) 0.1	Original Size	A4
	Approved	CL		Project no:	MH00335AA
	Date	19/09/2007		Figure	F8
	Scale	AS SHOWN
