EXTRACTIVE MINERAL LEASE PROPOSAL

Mineral Claim (MC) 3828

“Deep Well”

Submitted by Kalkaroo Copper Pty Limited

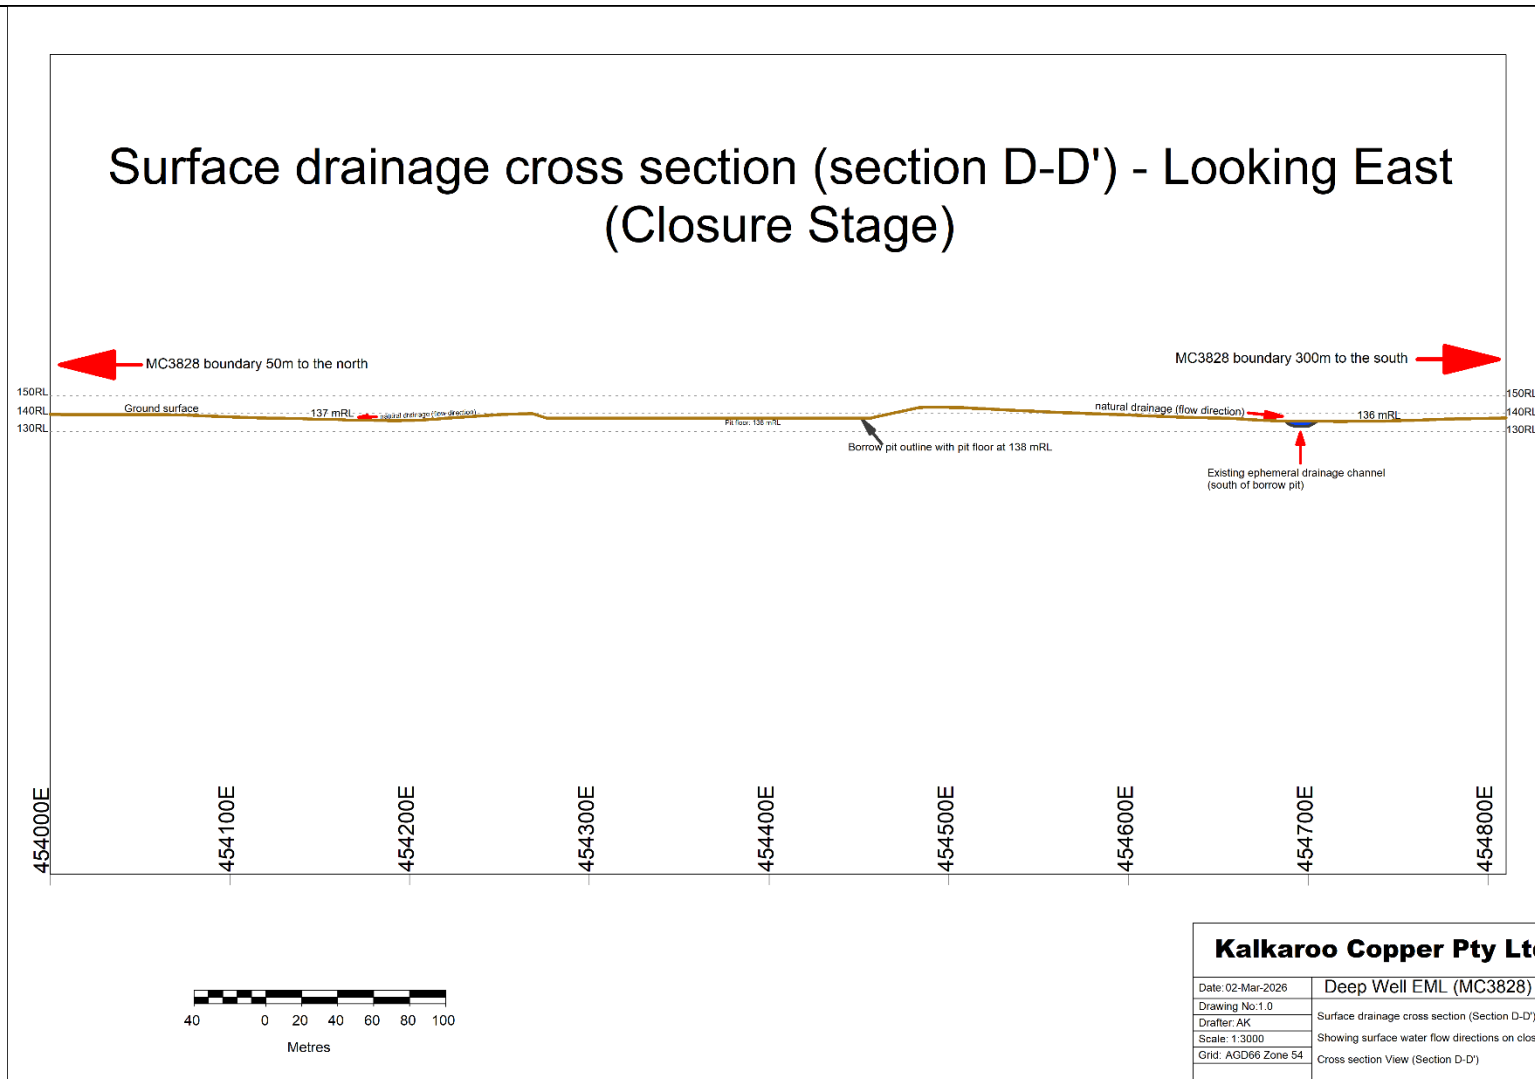
Figure 7 Crossover D-D' looking North through MC3828 showing RL of borrow pit to adjacent drainage

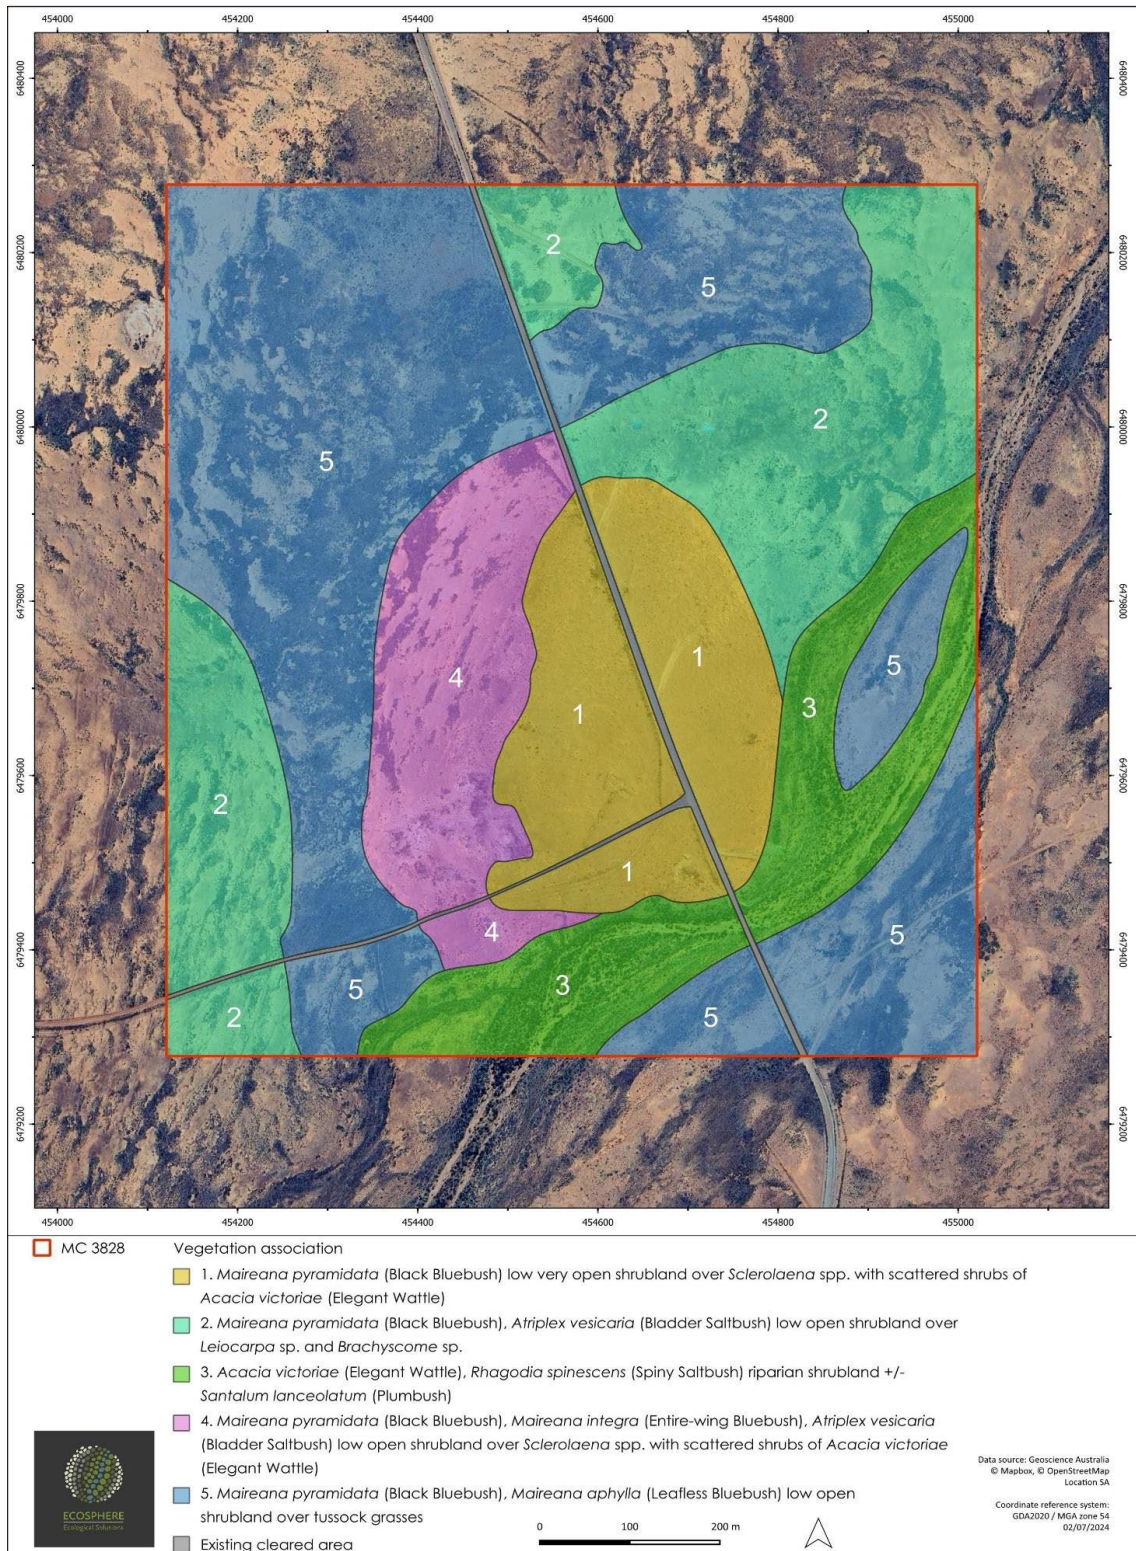
Figure 11 Vegetation Map of the Mineral Claim disturbance area.

A vegetation survey map of the Mineral Claim area is shown in Figure 11.

Three vegetation associations were recorded within the Project area covering an area of 10.5 ha representing the total Vegetation Clearance area proposed within the Mineral Claim. Refer to Figure 11 and Table 5 Vegetation association summary.

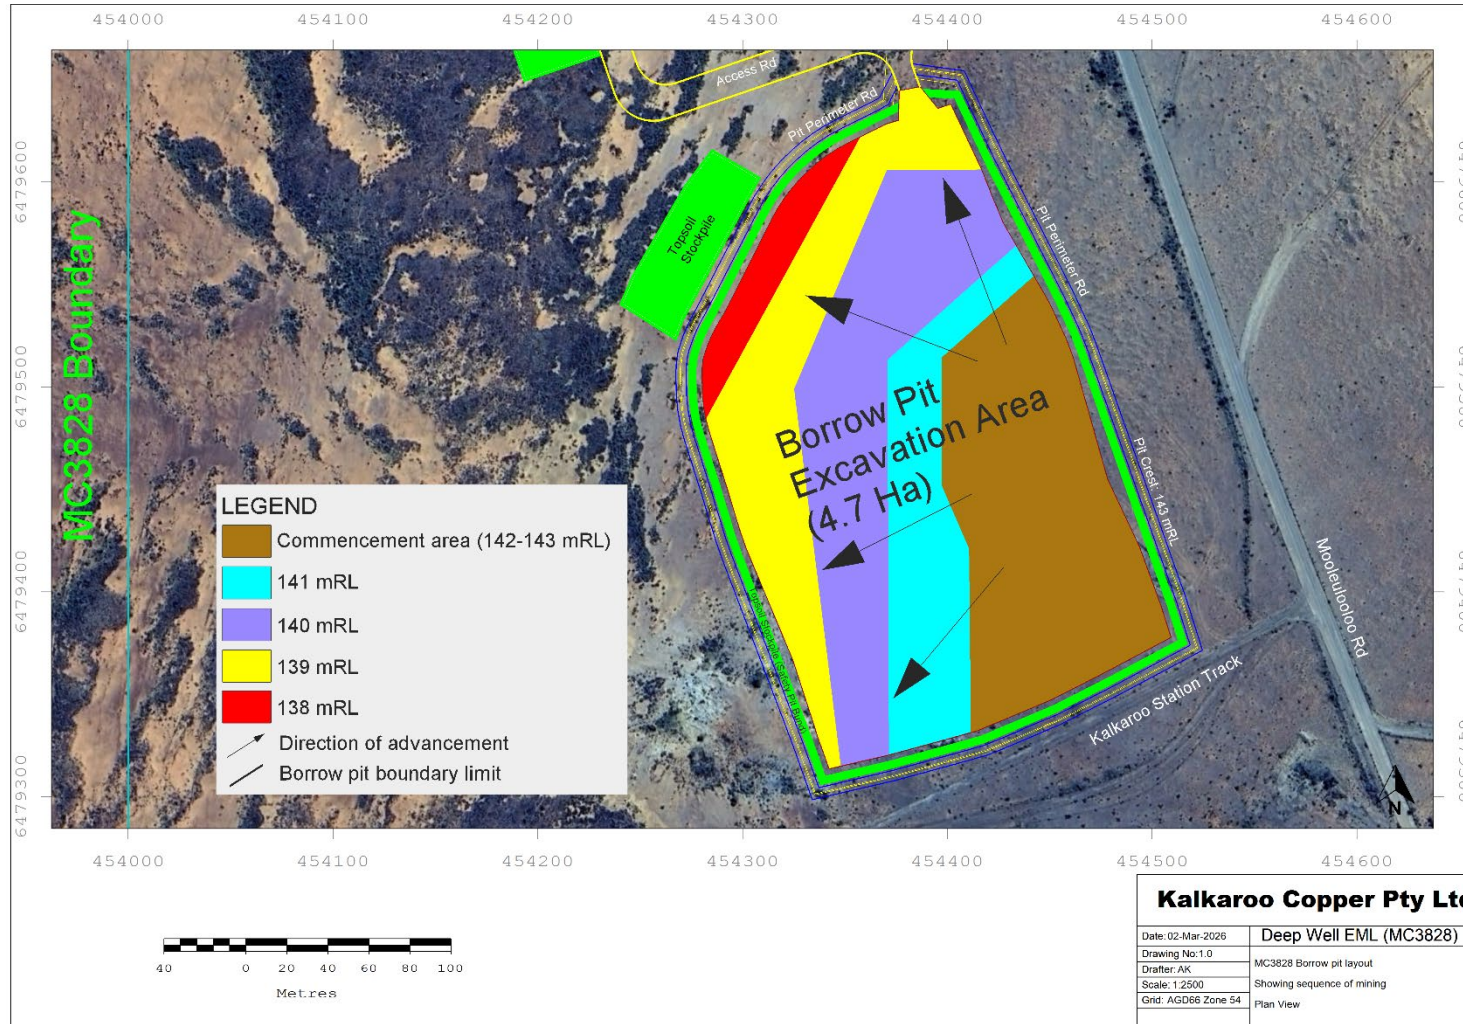
Figure 23 Sequence of mining operations

- Progressively batter walls of the borrow pit during the proposed mining sequence of operation to achieve design for closure.
- Profile walls and floor of the pit to achieve design for closure during the proposed mining sequence of operation
- Removal of remaining stockpiles of material from the pit floor and profiling the pit floor to achieve design for closure.
- Removal of all remaining stockpiled material from the Mineral Claim during the proposed mining sequence of operation.

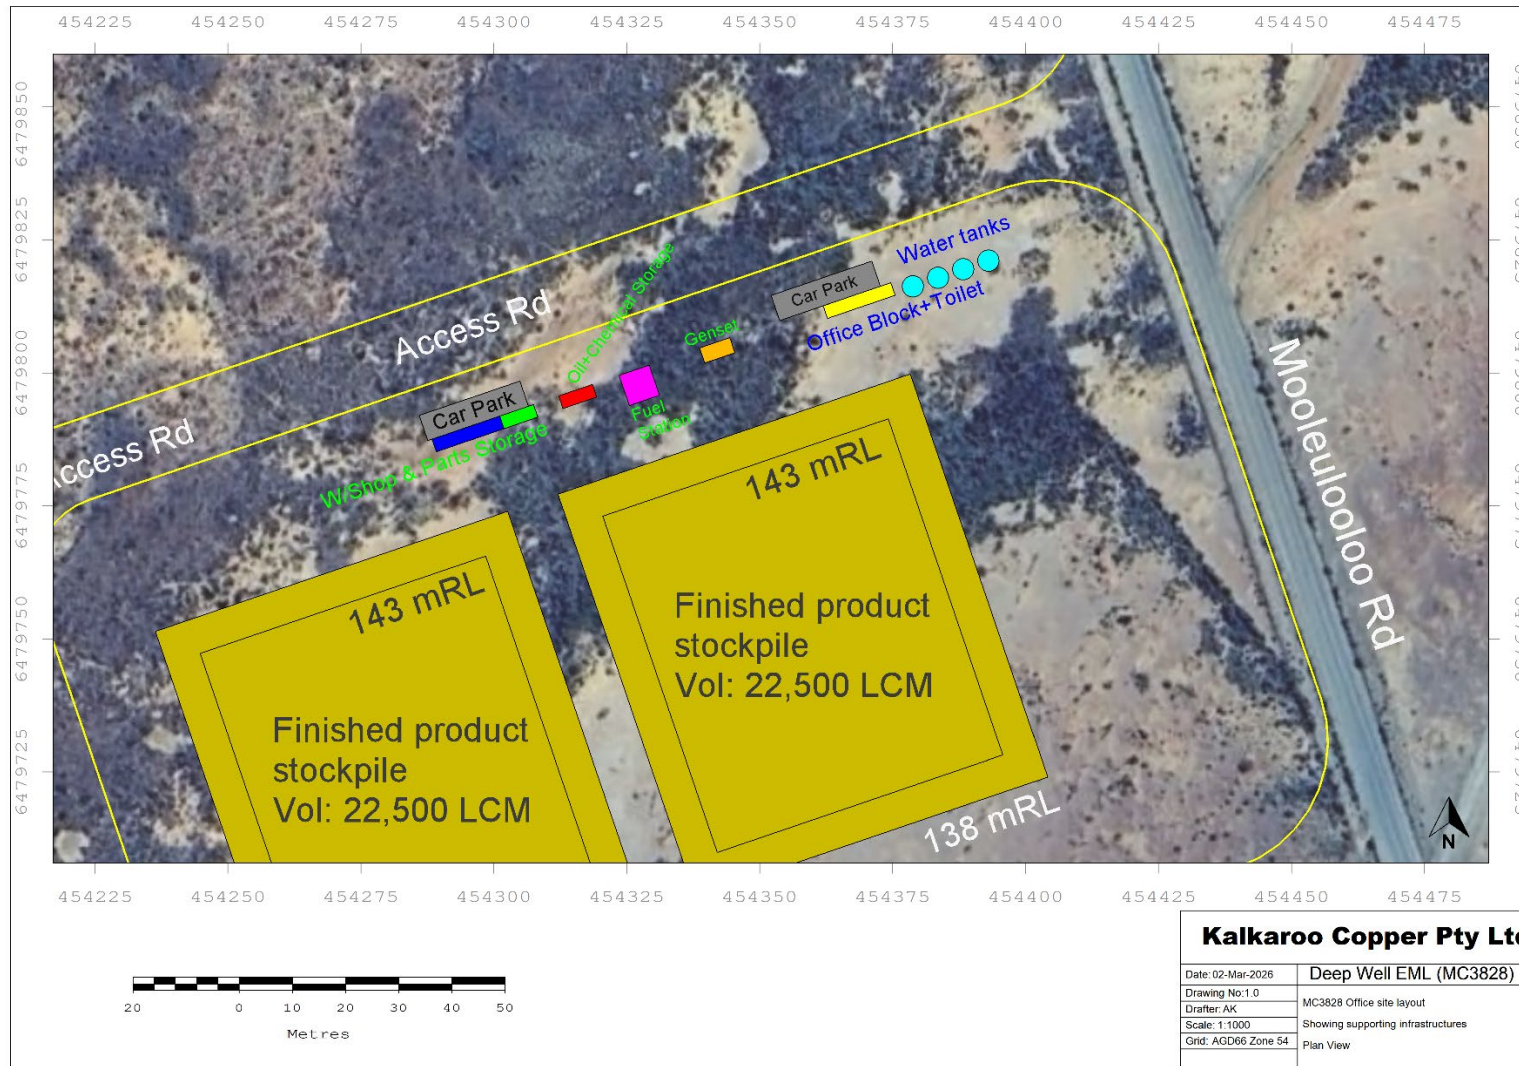
Figure 26 Location of Ancillary infrastructure and services on the Mineral Claim

There will be a small demountable lunch/meeting/first aid room on the site which will contain handwashing and ablution facilities. Septic facilities will comply with Department of Health requirements and shall be installed by a qualified and registered plumber in the state of South Australia. Power to these facilities will be provided by a small portable onsite generator. Potable water will be provided by rain water harvesting from the roof of the building and topped up with potable water supplied from the Kalkaroo Project. All water will be stored in poly tanks. Refer to Figure 26.

Oils will be stored in either 1000 Lt IBCs or 200 Lt drums, on bunded pallets or in a purpose-built portable hydrocarbon storage self-bunded container. Approximately 2500 Lt of oils and 60 Kg of grease will be stored on site during mining campaigns.

No chemicals will be stored on site. Refer to Figure 26.

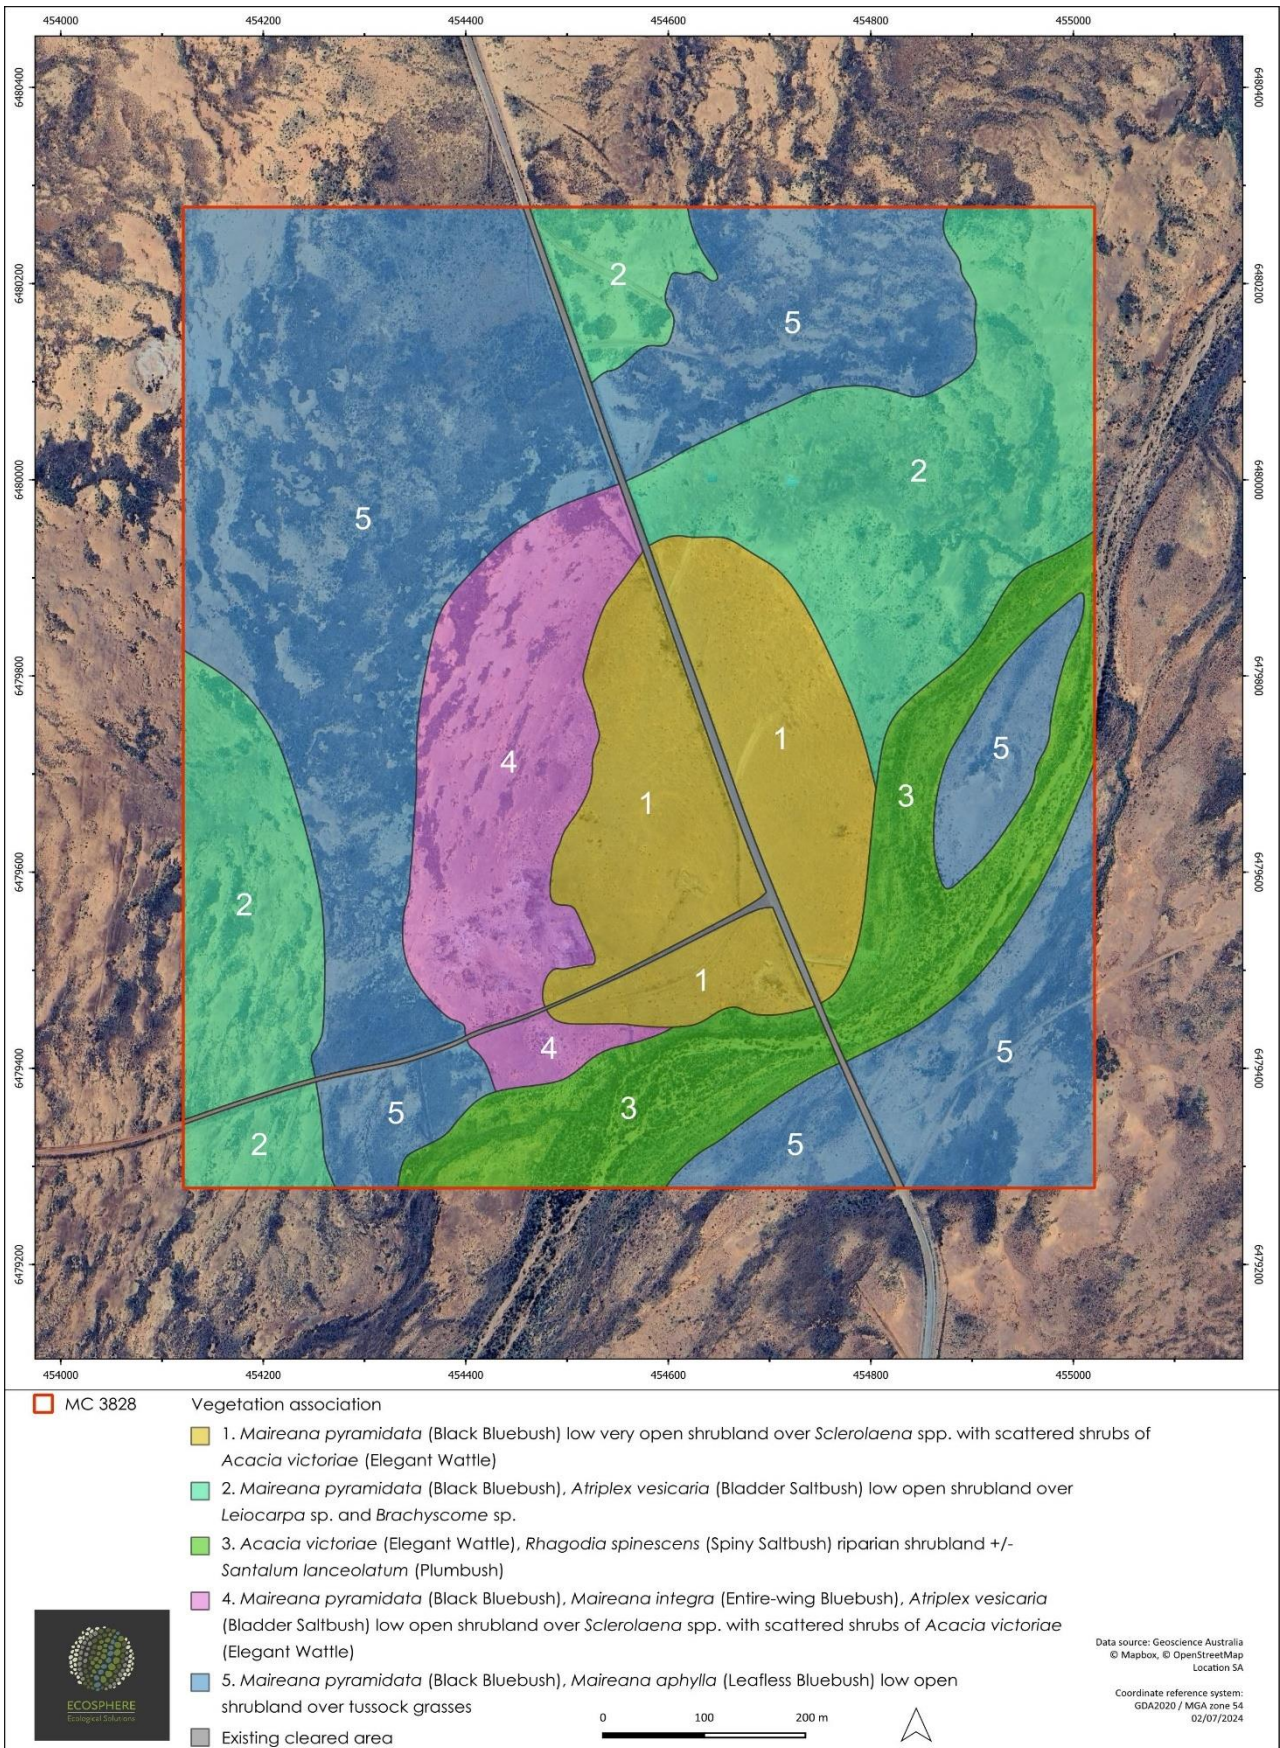
Figure 5. Vegetation mapping for the entirety of MC3828

Five vegetation associations were recorded within MC3828 (Table 5 and Figure 5) covering an area of almost 90 ha. Of this, 10.5 ha comprising of vegetation associations 1, 3 and 5 will be cleared for the construction of the quarry and associated infrastructure (Figure 6).

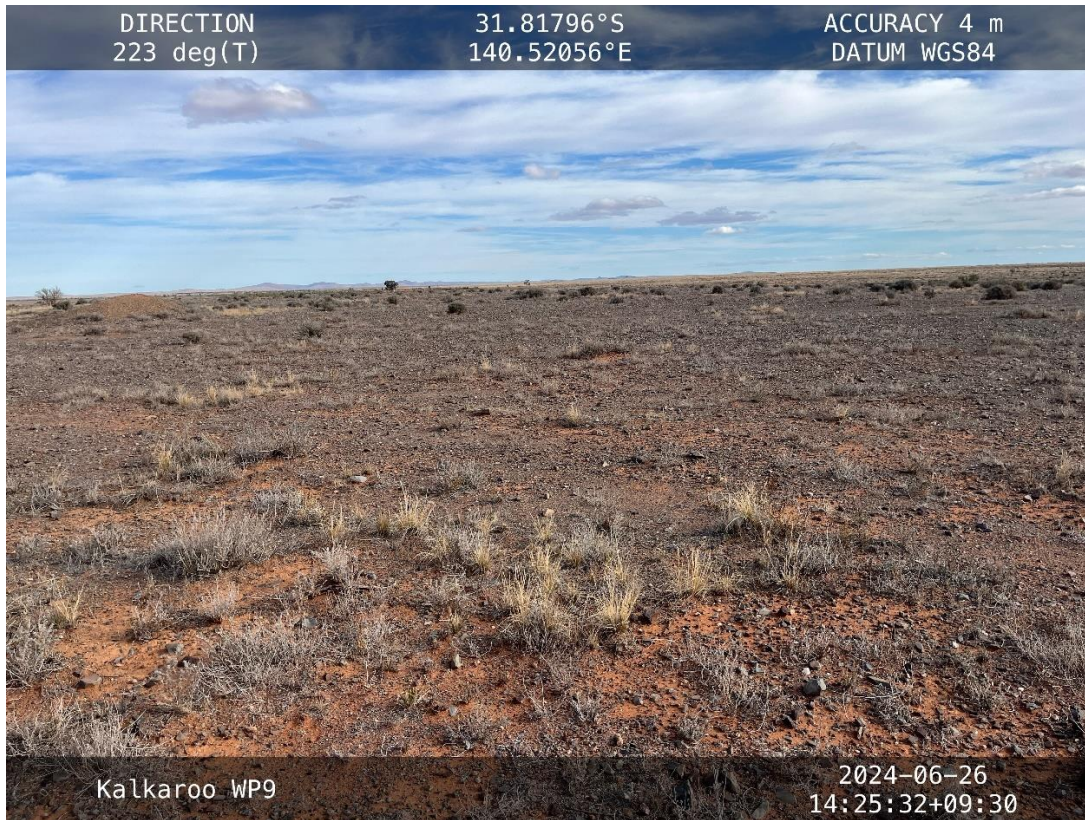
Vegetation Association 1	<i>Maireana pyramidata</i> (Black Bluebush) low very open shrubland over <i>Sclerolaena</i> spp. with scattered shrubs of <i>Acacia victoriae</i> (Elegant Wattle).
---------------------------------	--

General description	Low very open shrubland of <i>Maireana pyramidata</i> (Black Bluebush) over smaller forbs of <i>Sclerolaena obliquicuspis</i> (Oblique-spined Bindyi), <i>Sclerolaena ventricosa</i> (Salt Bindyi), and <i>Sclerolaena intricata</i> (Tangled Bindyi). Young, sub-adult and adult plants of <i>Maireana pyramidata</i> (Black Bluebush) were present, along with scattered adult shrubs of <i>Acacia victoriae</i> (Elegant Wattle) and <i>Ptilotus obovatus</i> (Silver Mulla Mulla). Short-lived annual / perennial tussock grasses occur within the site (e.g., <i>Enneapogon</i> sp. (Bottle-washers / Nineawn)). Vegetation association 1 occurs on the summit of a low hill within the Block, consisting of a stony surface and a thin layer of sandy-clayey soil. Minor physical disturbance from vehicle tracks are present within the site. Plants were observed to be intact with no obvious evidence of grazing impacts.

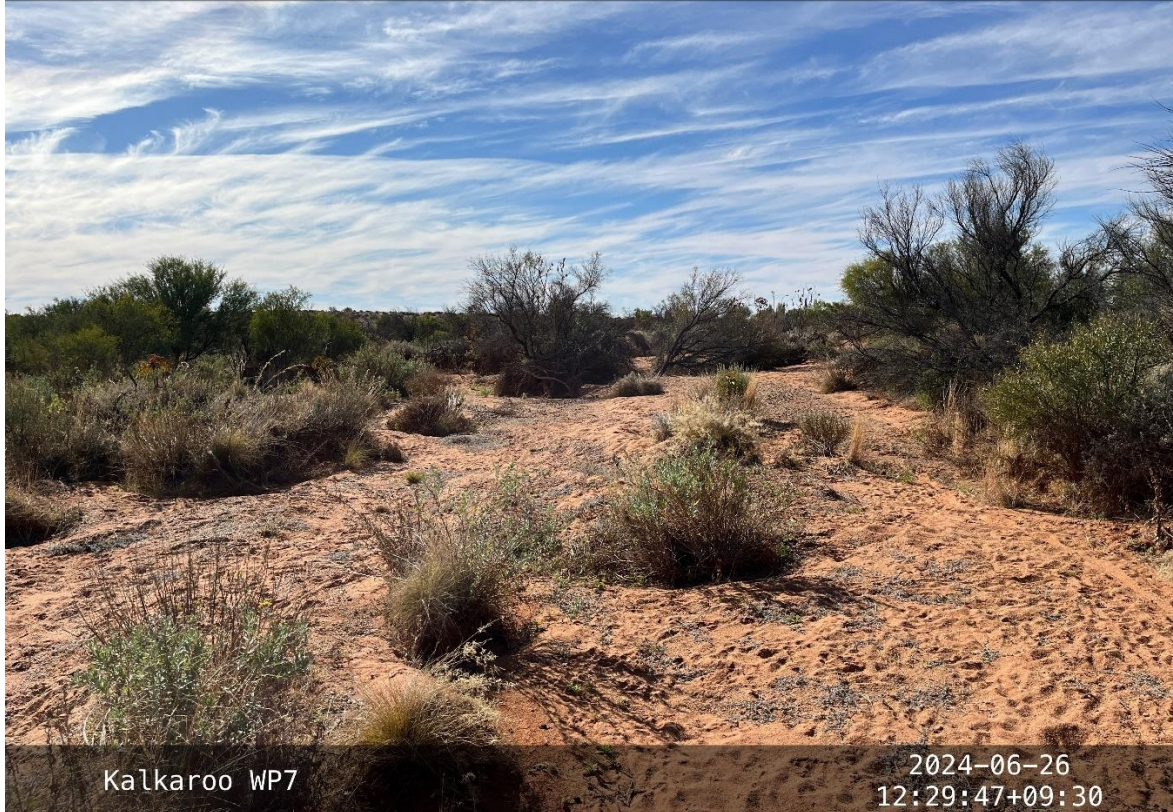
Vegetation Association 3	<i>Acacia victoriae</i> (Elegant Wattle), <i>Rhagodia spinescens</i> (Spiny Saltbush) riparian shrubland +/- <i>Santalum lanceolatum</i> (Plumbush).
---------------------------------	---

DIRECTION 30 deg (T)	31.82097°S 140.51964°E	ACCURACY 5 m DATUM WGS84
-------------------------	---------------------------	-----------------------------

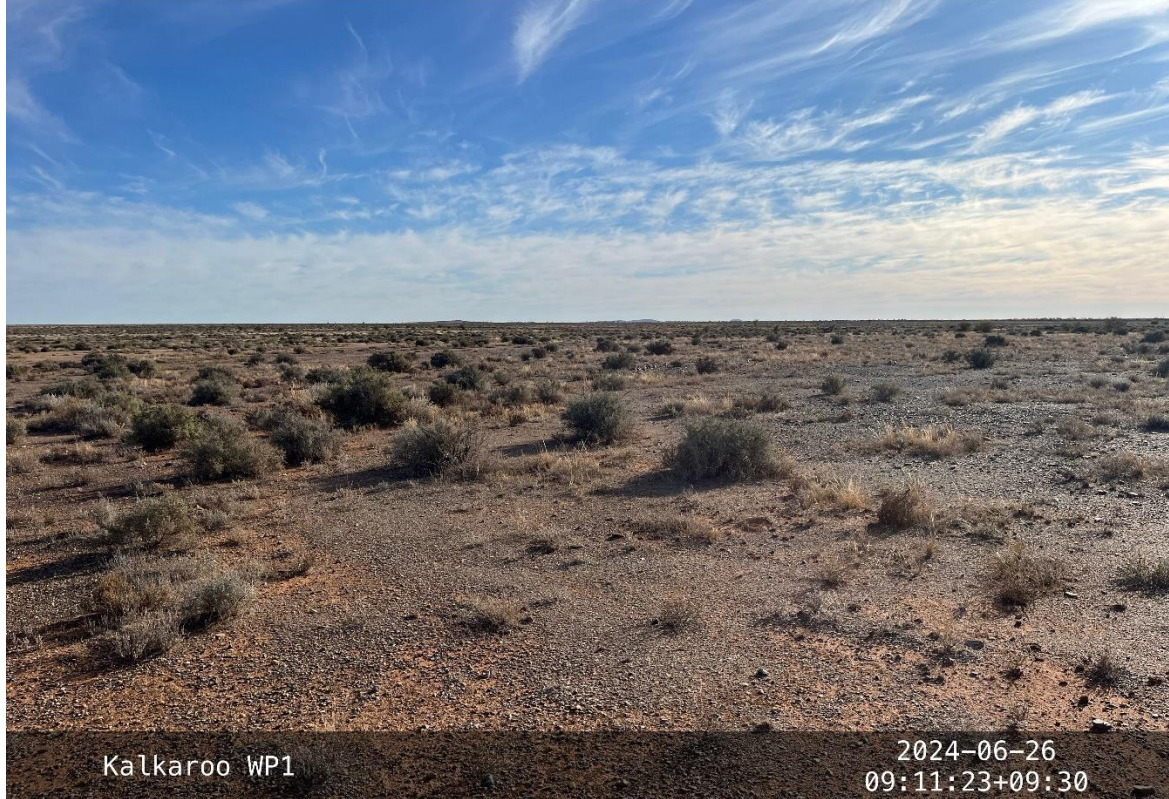
DIRECTION 3 deg (T)	31.81703°S 140.51956°E	ACCURACY 4 m DATUM WGS84
------------------------	---------------------------	-----------------------------

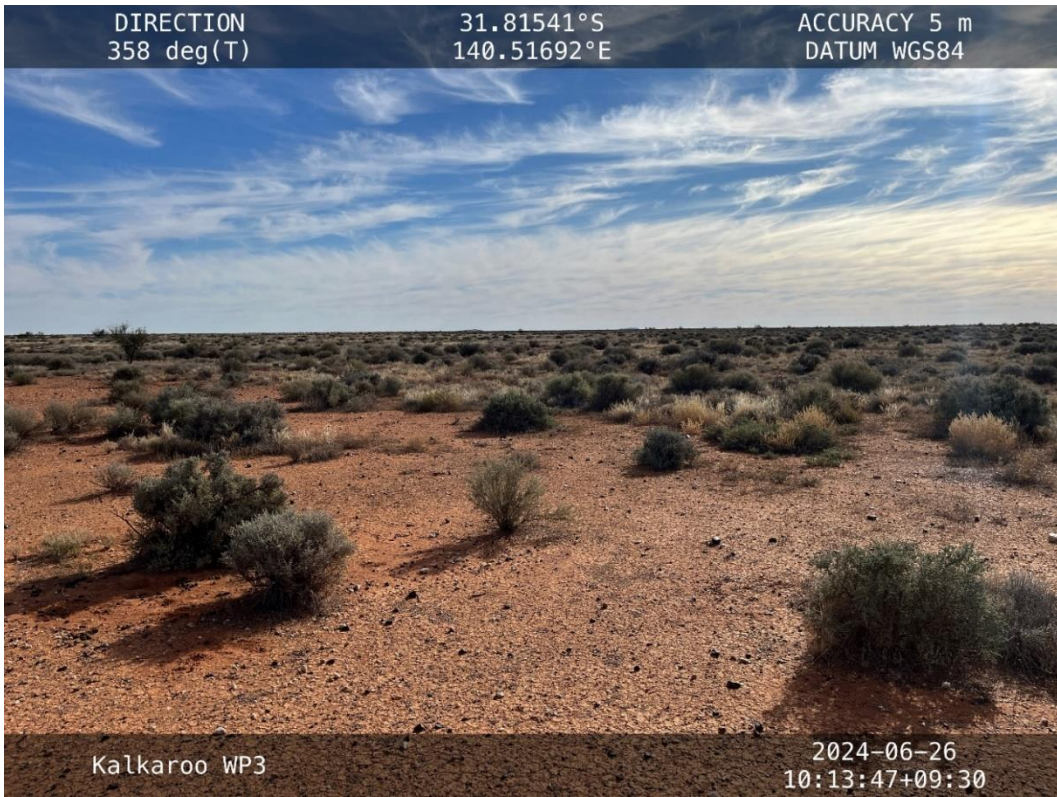
Vegetation Association 5	<i>Maireana pyramidata</i> (Black Bluebush), <i>Maireana aphylla</i> (Leafless Bluebush) low open shrubland over tussock grasses.
--------------------------	--

General description	Low open shrubland of <i>Maireana pyramidata</i> (Black Bluebush) and <i>Maireana aphylla</i> (Leafless Bluebush) over short-lived annual / perennial tussock grasses (e.g., <i>Austrostipa</i> sp. (Spear-grass), <i>Enneapogon</i> sp. (Bottle-washers / Nineawn), and <i>Panicum decompositum</i> var. <i>decompositum</i> (Native Millet)). Forbs present included <i>Atriplex angulata</i> (Fan Saltbush), <i>Atriplex lindleyi</i> ssp. <i>inflata</i> (Corky Saltbush), <i>Dissocarpus paradoxus</i> (Ball Bindyi), <i>Sclerolaena obliquicuspis</i> (Oblique-spined Bindyi), <i>Sclerolaena ventricosa</i> (Salt Bindyi), <i>Sclerolaena intricata</i> (Tangled Bindyi), and <i>Salsola australis</i> (Buckbush). Vegetation association 1 occurs on a mostly level plain within the Project area, consisting of a stony surface and a relatively thicker layer of sandy-clayey soil. In particular, the soils within this vegetation association appear to have a greater capacity for water retention.

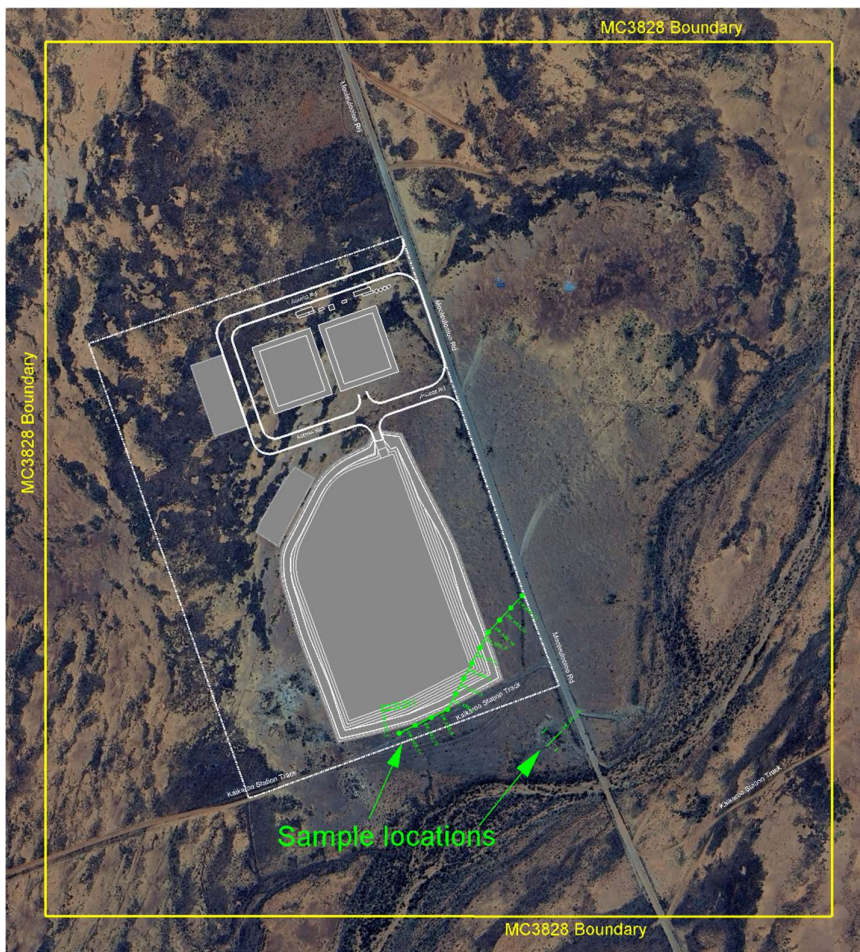
Figure 2: Showing the locations of Surface Rock Samples obtained for testing.

Representative samples of the outcropping waste rock were selected. A plan view of the sample locations is shown in Figure 2.

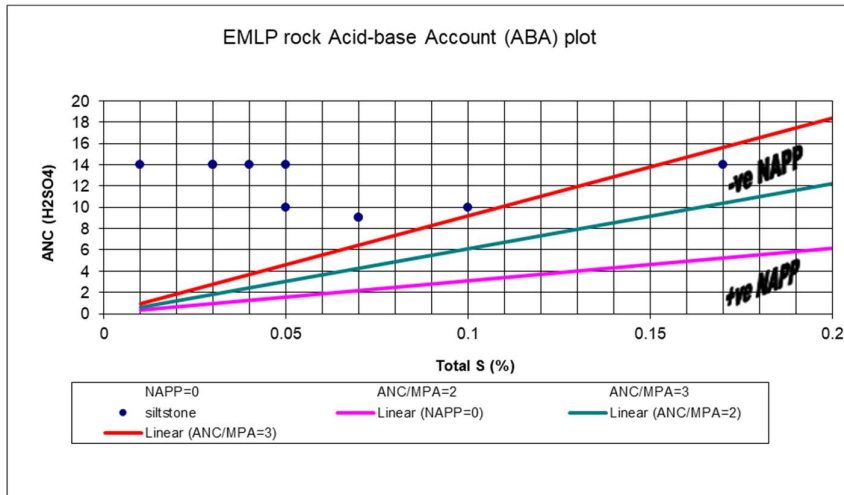
Figure 3: Acid-base account plot of representative rock to be mined from within MC 3828.

Based upon the ABA accounting, all ten samples are classified as Non-Acid Forming.

Figure 3 is an acid-base account plot of ANC versus total S. The NAPP zero line which defines NAPP positive and NAPP negative domains and lines for ANC/MPA ratio values of 2 and 3 are also plotted. The NAPP=0 line is equivalent to an ANC/MPA ratio of 1. The figure shows that all samples had an ANC/MPA ratio above 2.

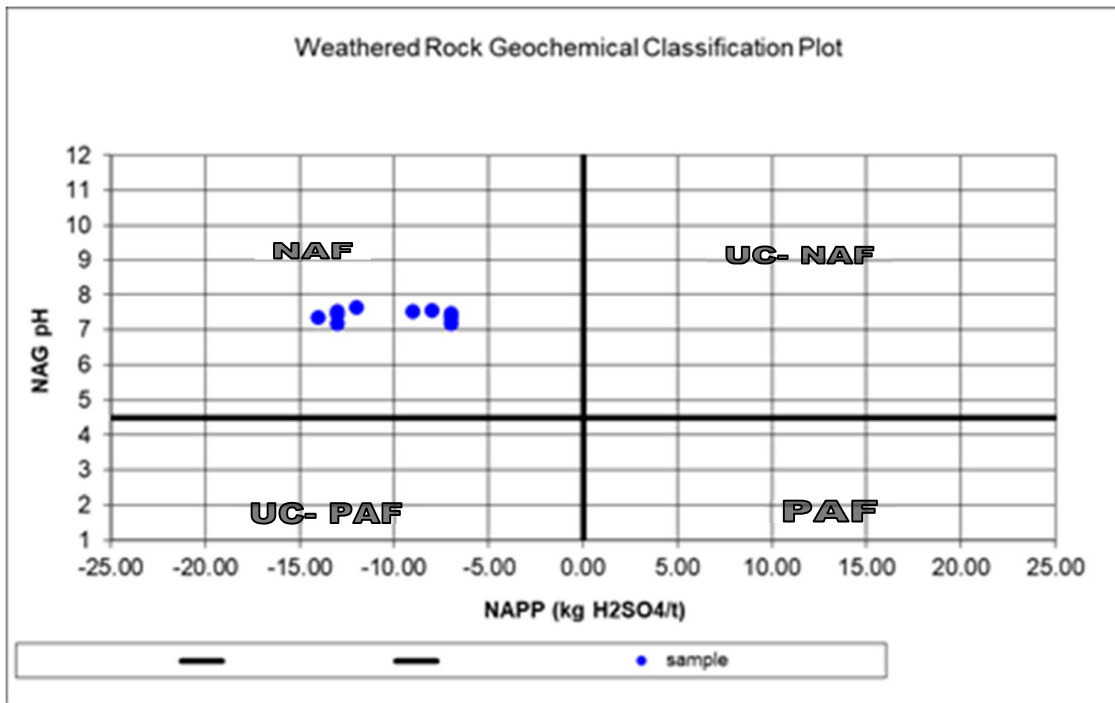
Figure 4: ARD classification plot of the representative rock material to be quarried from the proposed borrow pit on MC3828.

Figure 4 is a typical ARD classification plot showing NAGpH versus NAPP of the representative rock samples taken. The results show that the samples all plot in the NAF domain,
