MINING AND REHABILITATION PROGRAM, BELTANA MINE

Beltana Mine, Beltana, SA

Mining and Rehabilitation Program ML
4371, ML 4370 and ML 4369, and
associated MPL

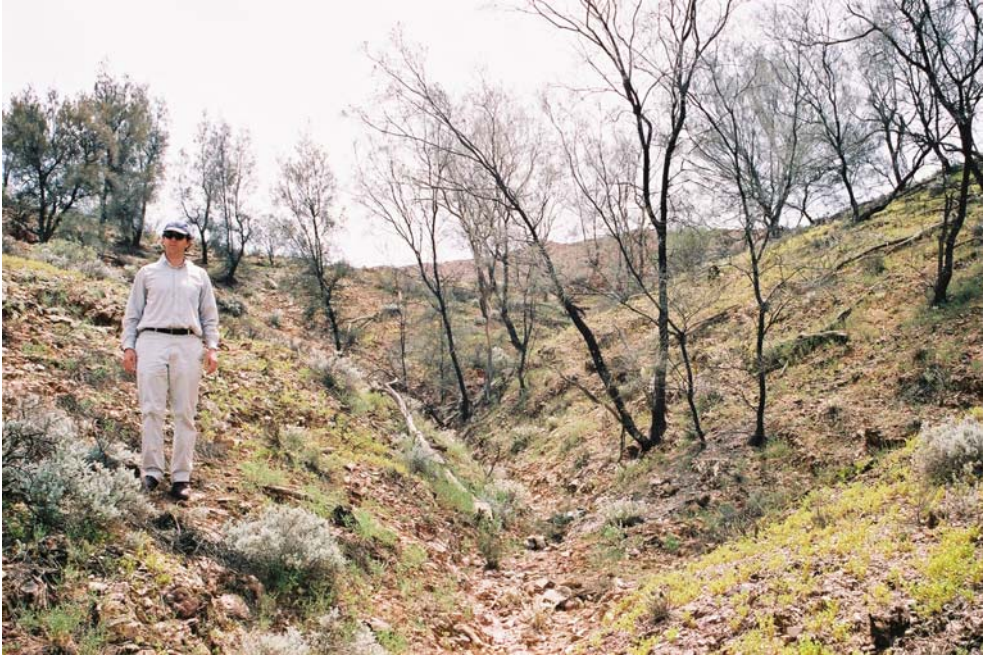
Plate 3.1 Lithosol Exposed In Drainage Channel South Of Evaporation Pond

The typical soils of the area are lithosols and solodic soils. The lithosols are vestigial hematitic and dolomitic sands with a high proportion of rock fragments (Plate 3.1), and occur in areas of greater relief. Down-slope, in areas of gentler topographic relief, the lithosols grade into solodic soils. In drainage channels there is evidence of fine material washed from the stockpiles and the waste rock dump (WRD) (Plate 3.2). Some soils have a fine white efflorescence (Plate 3.3).

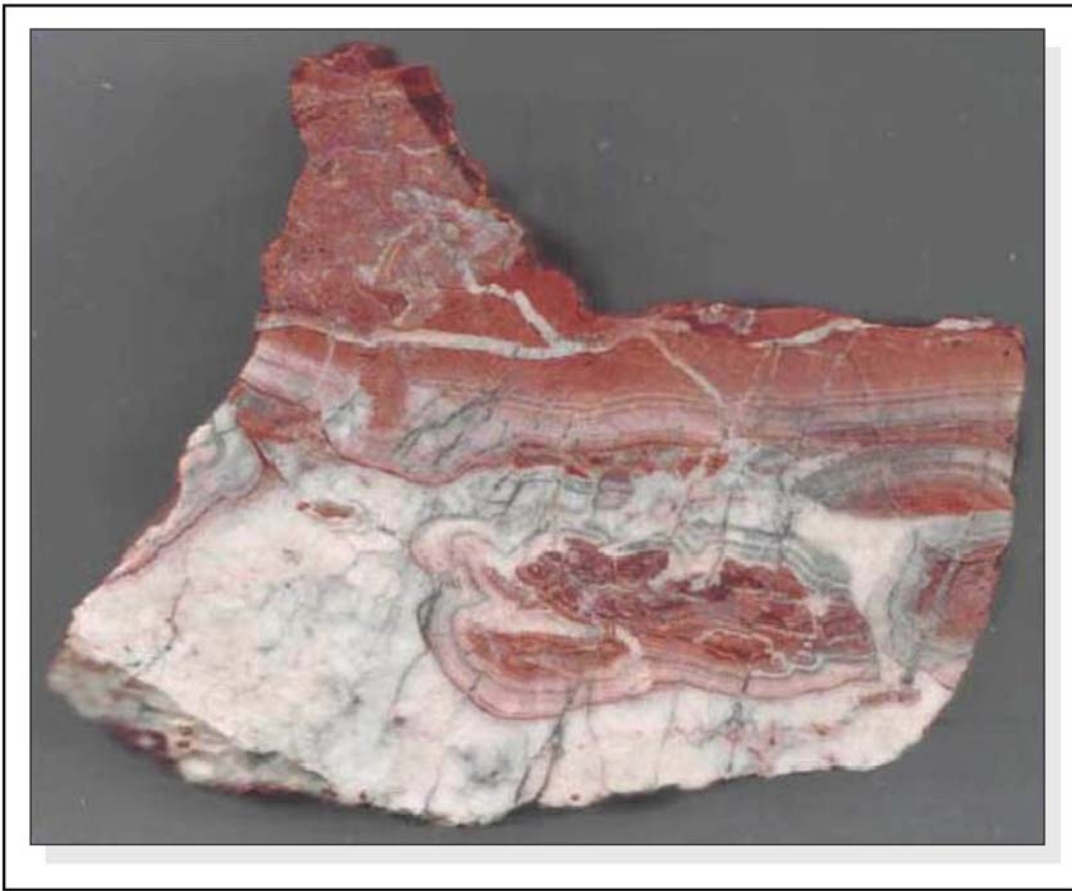
Plate 4.1 Willemite (Zn_2SiO_4) Sample

The ore is predominantly willemite, a zinc silicate. A particular sample of willemite is shown in Plate 4.1. Associated mineralogy includes coronadite (manganese lead oxide), mimetite (lead arsenate), hedyphane (calcium lead arsenate) and smithsonite (zinc carbonate).

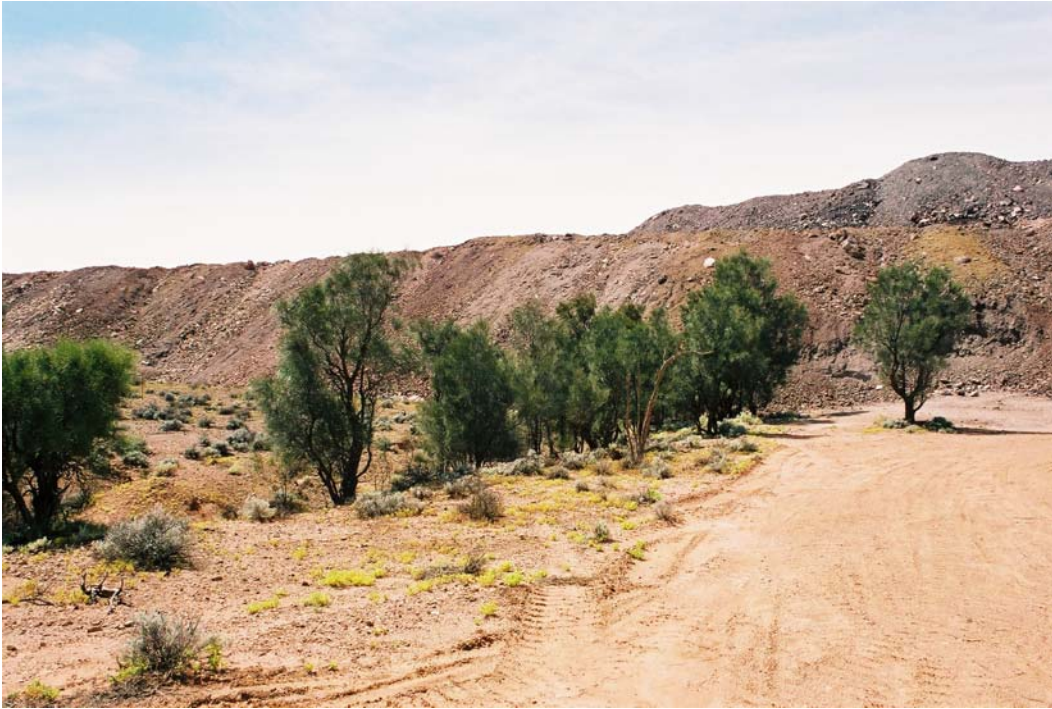
Plate 6.1 Western Face of WRD

The WRD will cover an area of about 19 Ha immediately to the west of the pit and will attain a maximum height of about 15m above the surrounding land surface. It will be flat topped and the sides will be battered to angles of less than 25 degrees. Available topsoil will be placed on the WRD and the final form will be contoured to better resist erosion and retain rainfall to promote the establishment of vegetation. The surface of the WRD will be revegetated using locally derived seed stock.

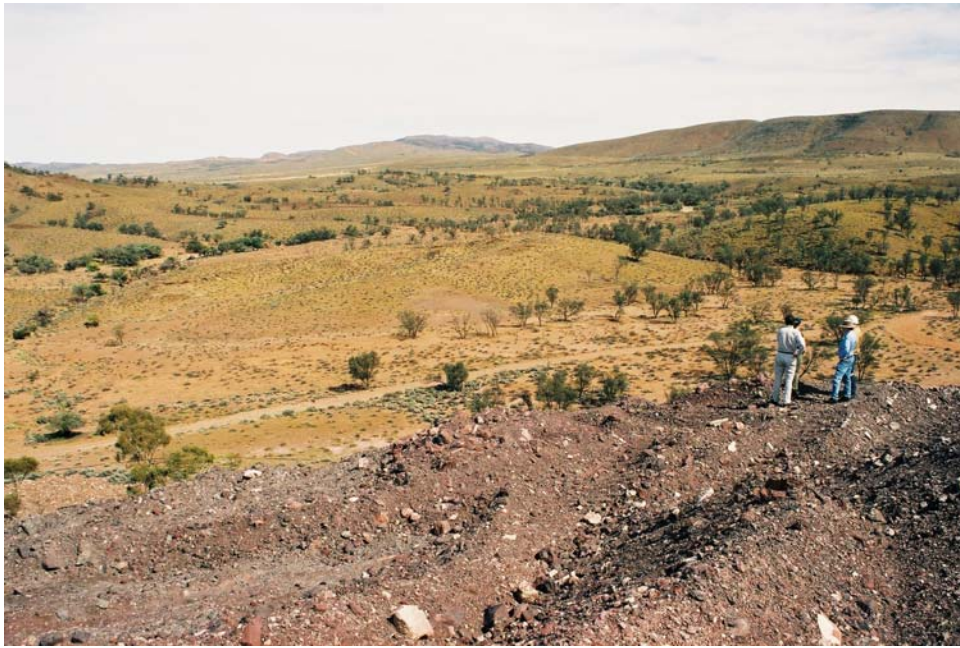
Plate 6.5 Area for Extension of WRD

- Access to the pit will be further restricted by standard station fencing outside the abandonment bund and across the face of the WRD.
- The WRD will be constructed and contoured to minimize visual impact and erosion, with outer slopes not exceeding 25° from the horizontal. Final dozing will shape and sculpt the WRD into the existing topography. As topsoil will be in short supply, it is envisaged that the bulk of recovered weathered dolomite and topsoil will be used on the western face of the WRD, as this face can be seen from the access road. The area of proposed WRD extension is shown in Plate 6.5.

The footprint of the waste rock dump is to be enlarged, as shown in Figure 4.4 (also included as an A3 figure in Appendix I), by extending it to the west and to the south into the area of the recently approved MPL. This will allow the slope of the western face of the WRD less steep than at present (see also Plate 6.1). The profile of the final WRD is shown in Figures 4.5 and 4.6, both of which are presented as A3 sections in Appendix I. This outline is much more sympathetic to the surrounding landforms than using the previous approved waste rock outline, which, having quite a constrained footprint, would result in a high, steep and more visually intrusive landform if used as the repository for additional waste rock from the expanded mining operations.

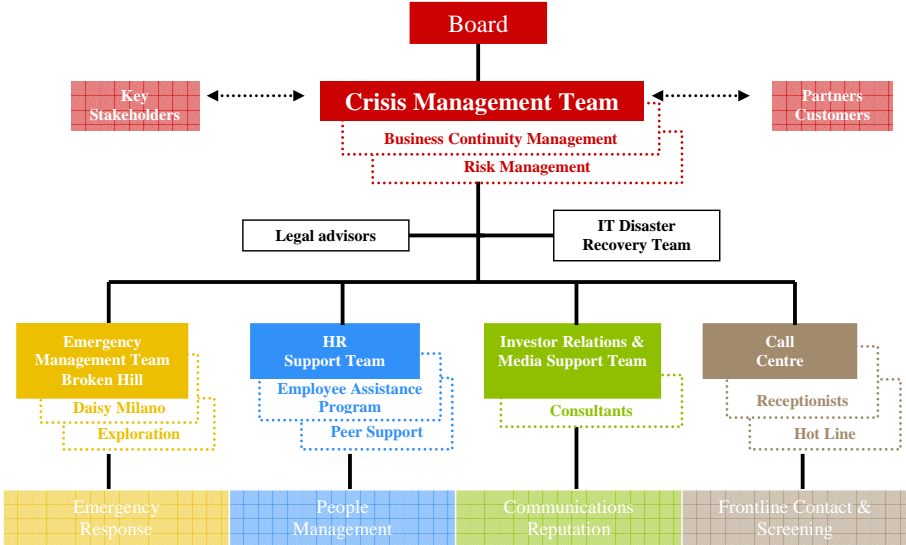
Figure 7.2 Crisis Management System

In addition, Perilya has well developed emergency response teams at Broken Hill that can be contacted in an emergency situation. The company’s emergency response training at Broken Hill is nationally accredited and the teams have significant equipment to draw upon in an emergency situation. A schematic of the crisis management system to be adopted for the Beltana project is presented as Figure 7.2.
