APA Group

2010 ANNUAL REPORT

Pipeline Licence No 16

SESA PIPELINE

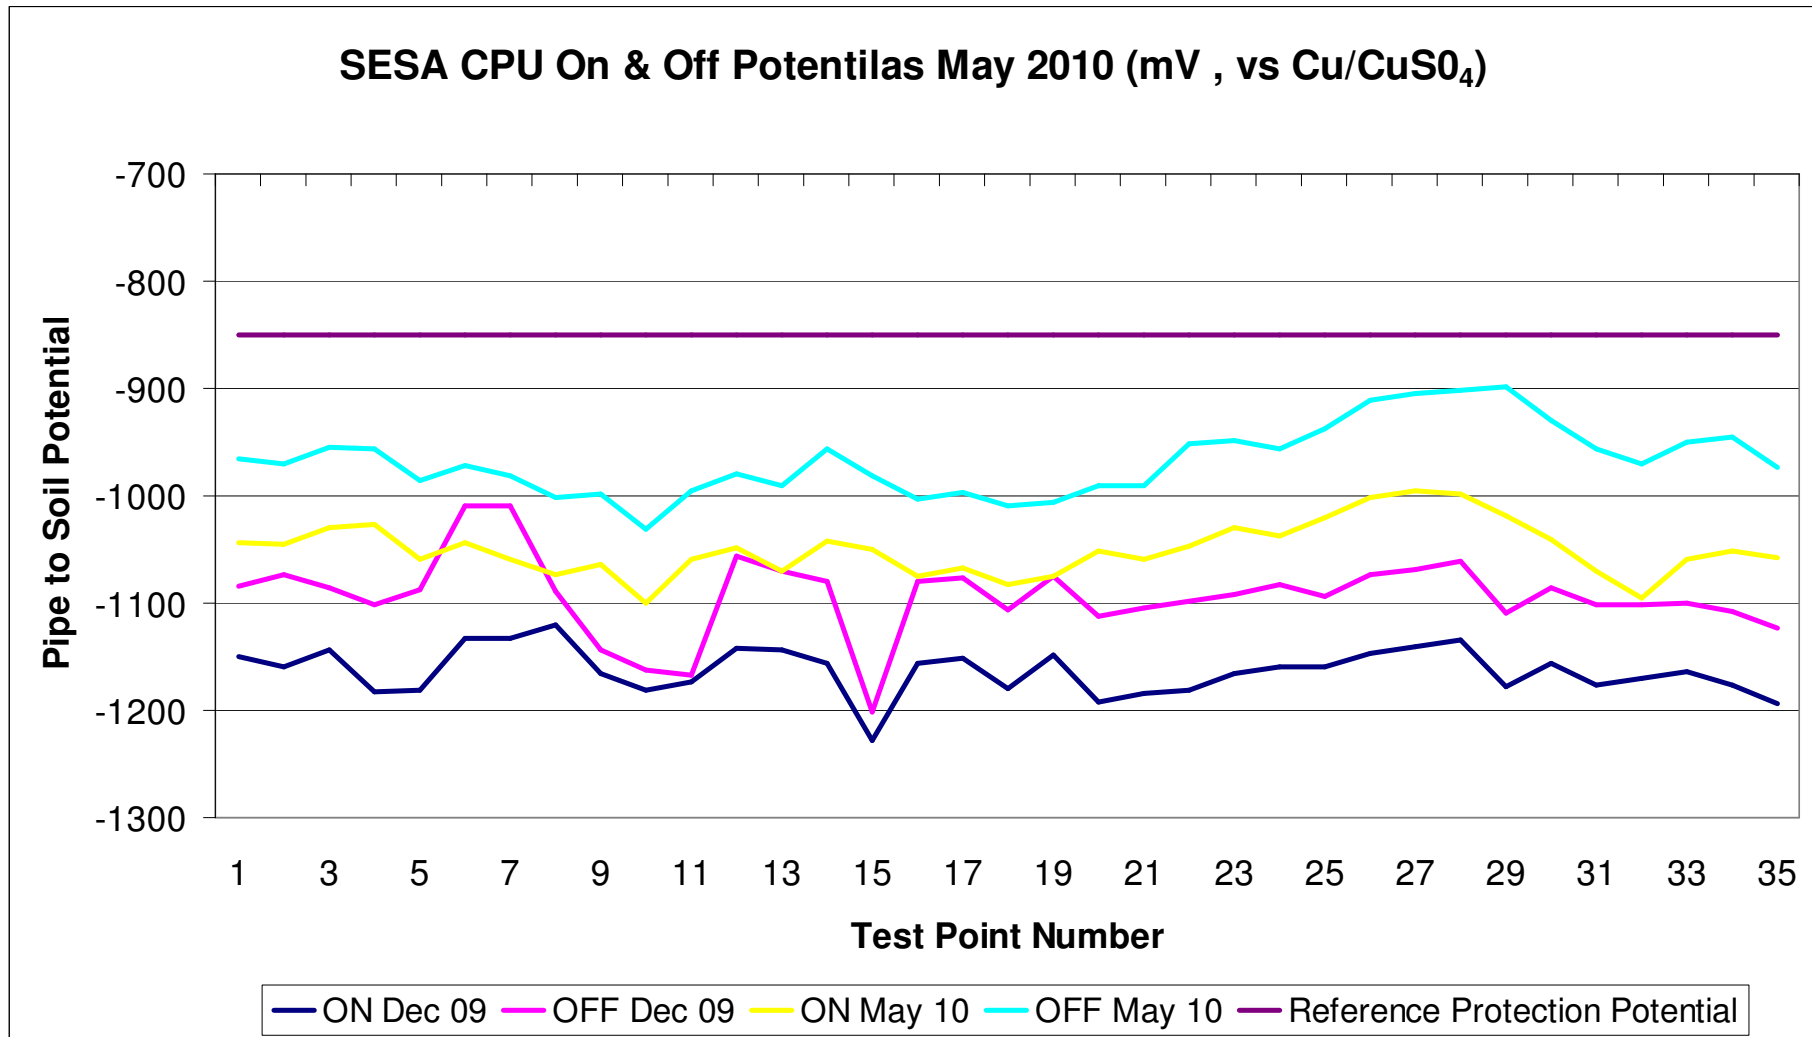
APPENDIX 3: GRAPHICAL RESULTS FROM CATHODIC PROTECTION POTENTIAL SURVEY – MAY 2010

A full line Cathodic Protection Survey was carried out along the SESA Pipeline during May 2010, the survey provided a basic review of the pipeline 'On' and 'Off' potentials. All pipe potentials were measured with respect to a saturated copper/copper sulphate reference electrode. Survey results have been tabulated in Appendix 2 with the associated graphical summary in Appendix 3. There were no abnormalities identified as a result of the spot potential survey.

During the survey, data loggers were set at three locations along the pipeline, TP1, TP15 and TP37. It was noted on the data logger chart at TP37 that anodic excursion occurred at 8:00PM at the Ladbroke grove end of the pipeline. The reason for this hasn't been ascertained. The interference is within the limit of acceptance, indicated in Section 2.2.2.6 of AS2832.1 and will continue to be monitored in future surveys. Other data logger charts demonstrated that the pipeline is protected over 24h period.

Overall the May 2010 CP Survey revealed that the pipeline is protected in accordance with the original design specification and applicable standards, to further improve the integrity of the pipeline the above ground pipework at Poolaijelo is scheduled to be painted during the first quarter of 2011. It was also recommended that the earth bed resistance be measured during the next survey to distinguish the reasons of a substantial increase. A Cathodic Protection Survey is scheduled to occur during the first half of 2011.
