PENRICE QUARRY, ANGASTON (PM 86, PM 120, MPL 75, MPL
118 & ML 6233)

Annual Compliance Report

Prepared for: Adelaide Brighton Cement Limited

Date: 28 February 2025

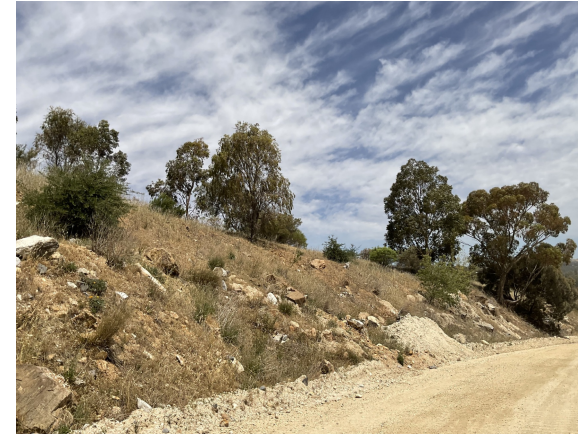
21/11/2024

Weeds and Pests: General views of weeds along safety berm. Generally limited to annual grasses. Planted vegetation within southern portion of PM 120 present.

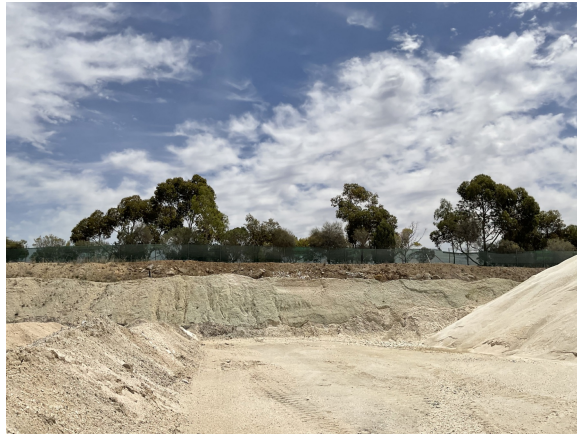
21/11/2024

Public Safety: Public safety fencing with mesh on safety berms along perimeter of Site.

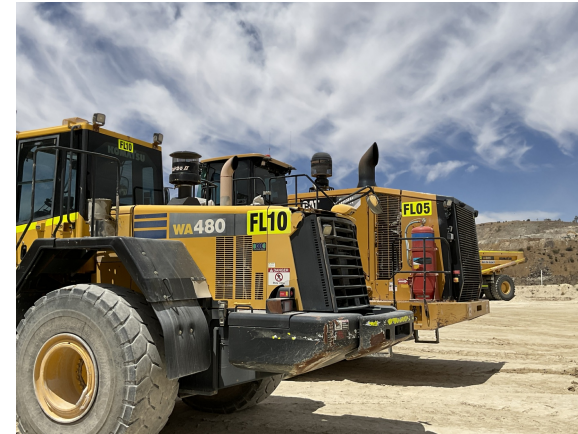
21/11/2024

Public Safety: HME equipment equipped with fire extinguishers.

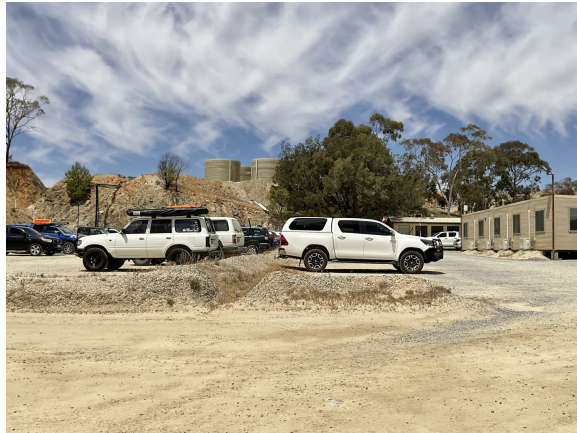
21/11/2024

Public Safety: Site office and light vehicle parking area.

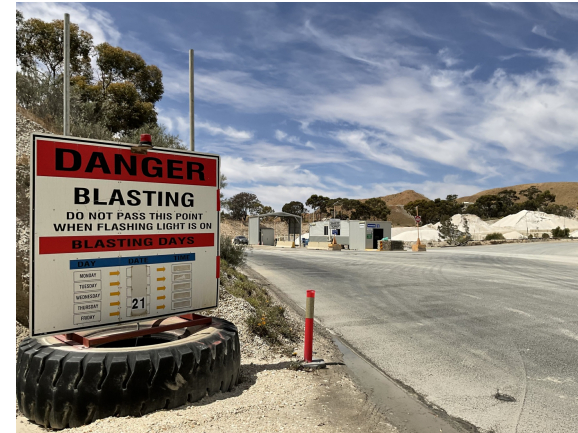
21/11/2024

Public Safety: Public safety signage for blasting. Weighbridge and sales area in background.

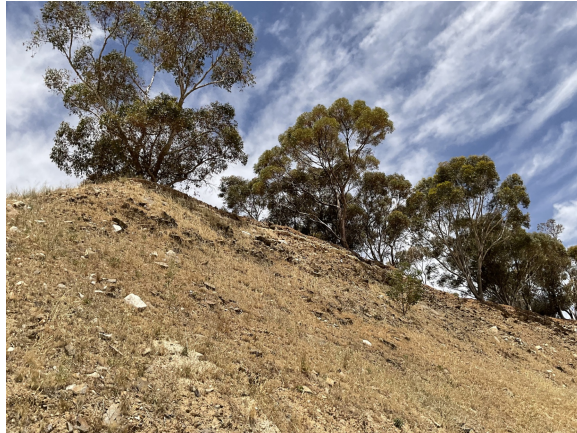
21/11/2024

Native Vegetation: Established vegetation within south eastern portion of Site, within PM 120.

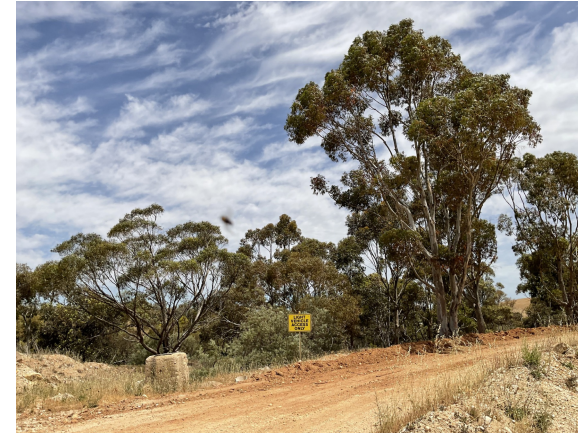
21/11/2024

Native Vegetation: Established native vegetation along southern portion of Site near light vehicle track.

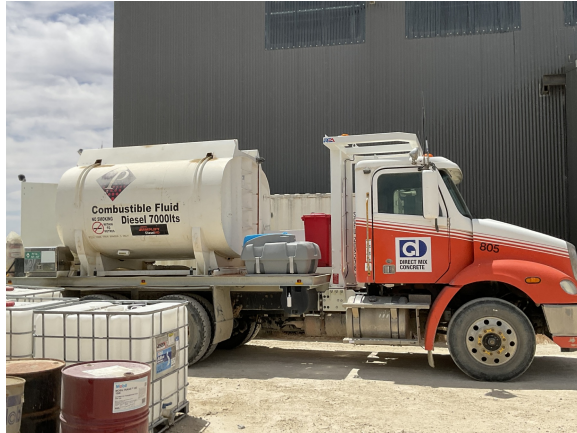
21/11/2024

Hydrocarbons: Mobile diesel truck.

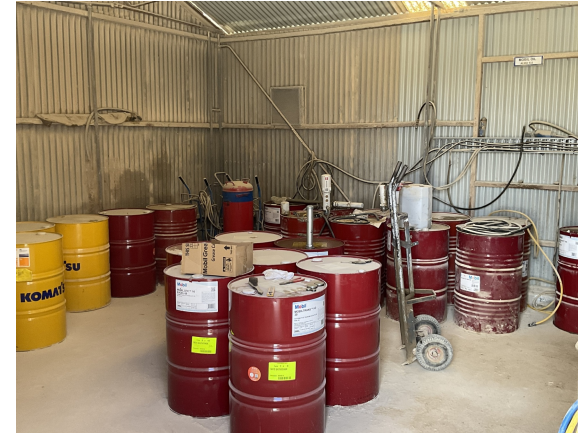
21/11/2024

Hydrocarbons: General views of chemical storage area.

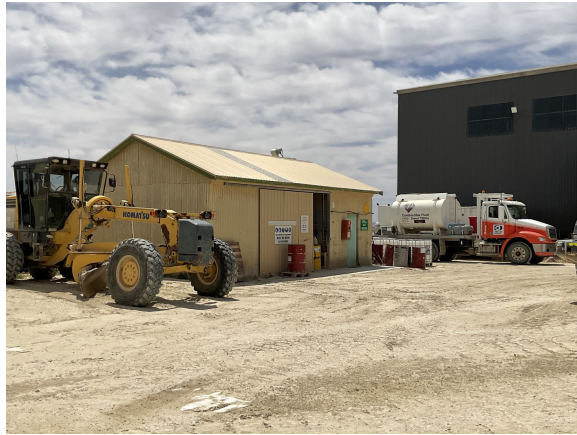
21/11/2024

Hydrocarbons: Workshop area with fire extinguisher and spill kit.

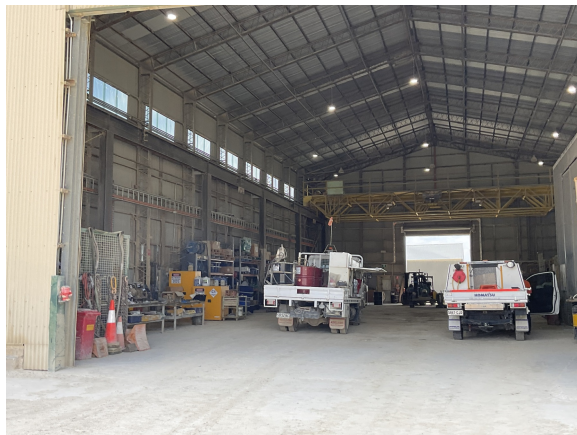
21/11/2024

Hydrocarbons: Views of within workshop area.

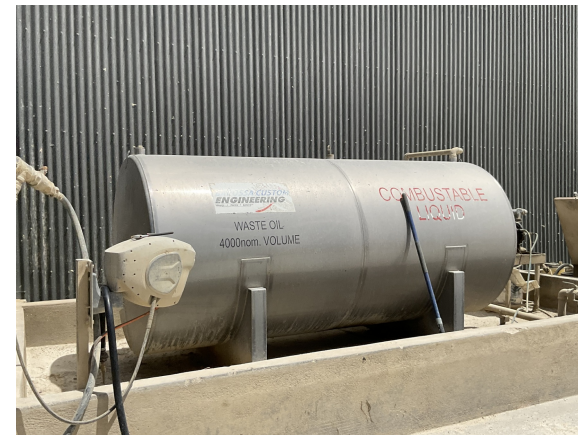
21/11/2024

Hydrocarbons: Oil tank onsite.

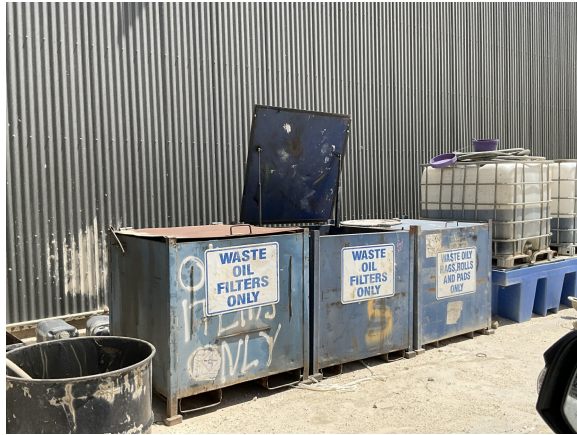
21/11/2024

Hydrocarbons: Waste bins near workshop area with lids.

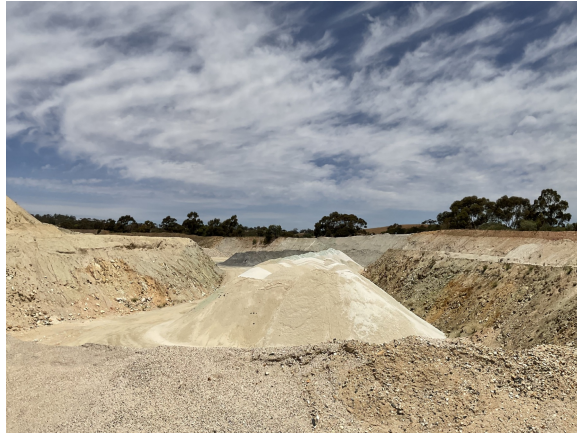
21/11/2024

General Observations / Other: General views of sales / product stockpiling area within PM 86.

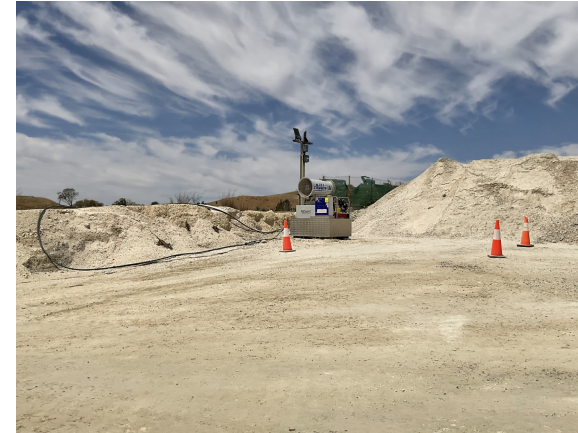
21/11/2024

General Observations / Other: Mist canon within sales area for dust suppression.

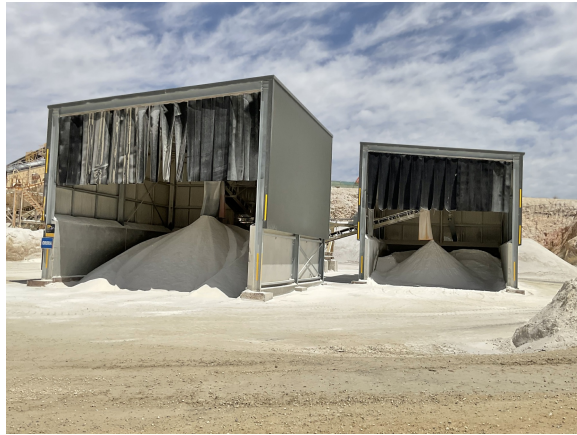
21/11/2024

General Observations / Other: Sheltered plant for dust and noise suppression.

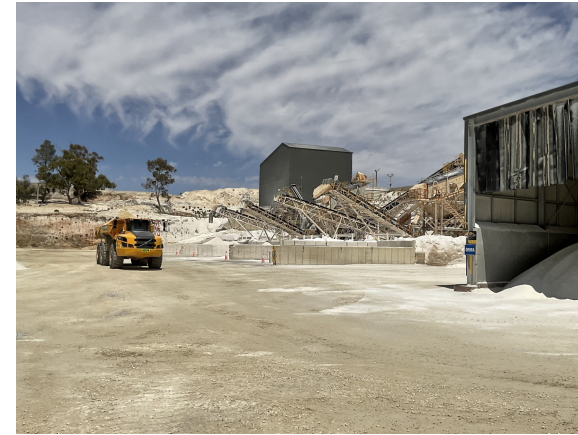
21/11/2024

General Observations / Other: General views of fixed plant area.

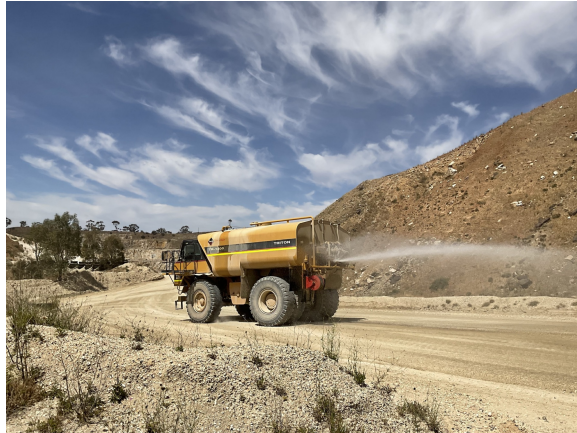
21/11/2024

General Observations / Other: Water truck in operation for dust suppression.

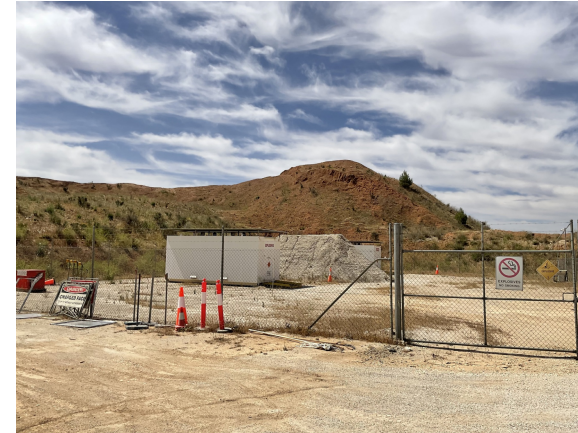
21/11/2024

General Observations / Other: Explosives magazine area with public safety signage and fencing.

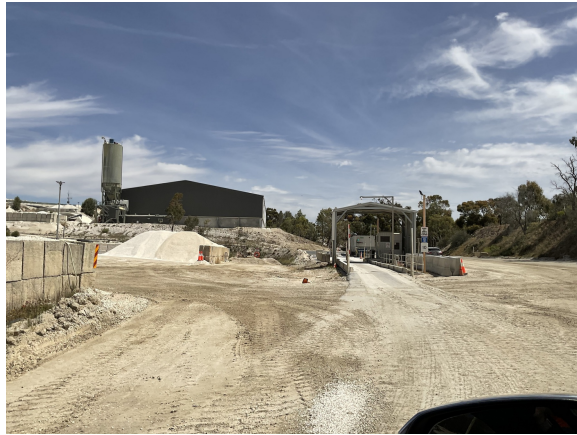
21/11/2024

General Observations / Other: General view of sales and weighbridge area.

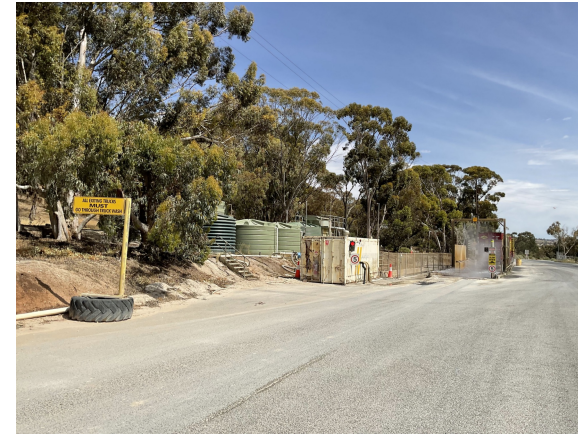
21/11/2024

General Observations / Other: Truck wash area with water tanks.

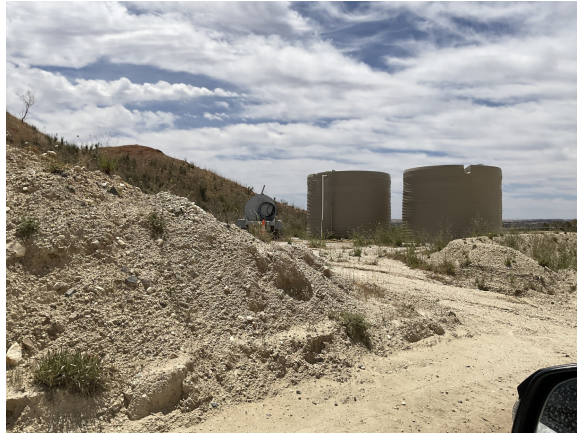
21/11/2024

Surface Water: Water tanks and water cart onsite. Water tanks utilises groundwater from adjacent property.

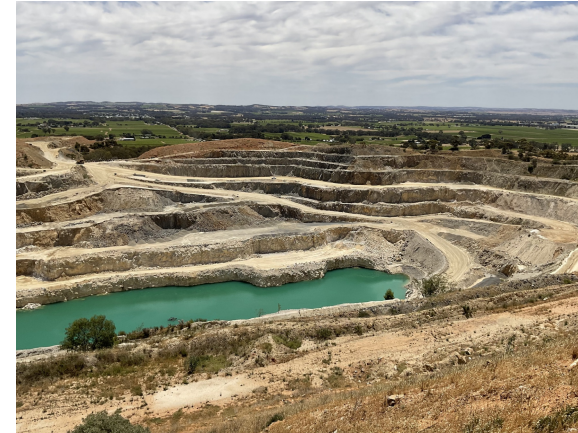
21/11/2024

Surface Water: General views of pit area with surface water / groundwater reservoir at bottom of pit.

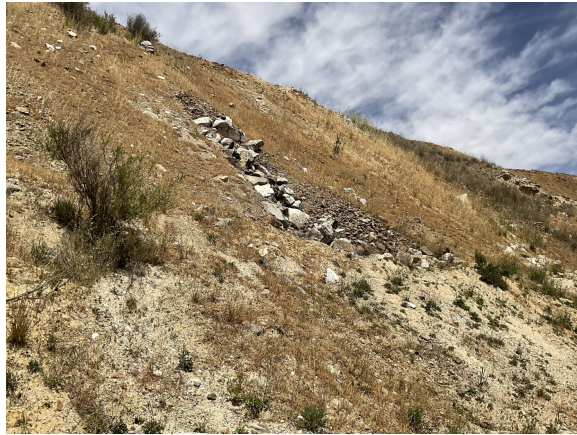
21/11/2024

Surface Water: Rock catchment drainage on quarry walls to prevent erosion.

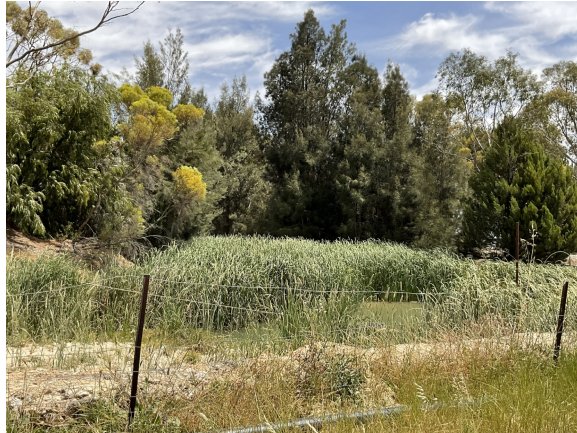
21/11/2024

Surface Water: Sediment trap within MPL 118.

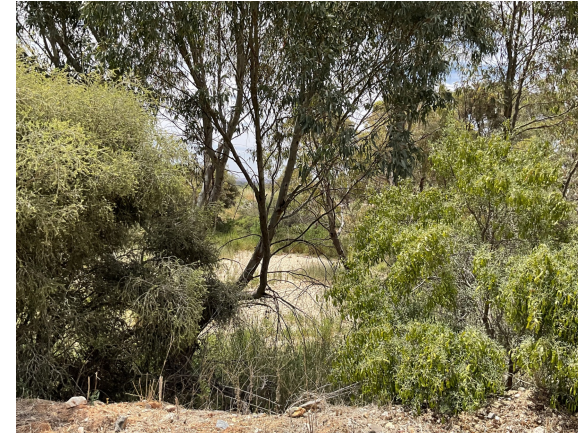
21/11/2024

Surface Water: View of sediment trap adjacent to Jaeckeli Creek in MPL 118.

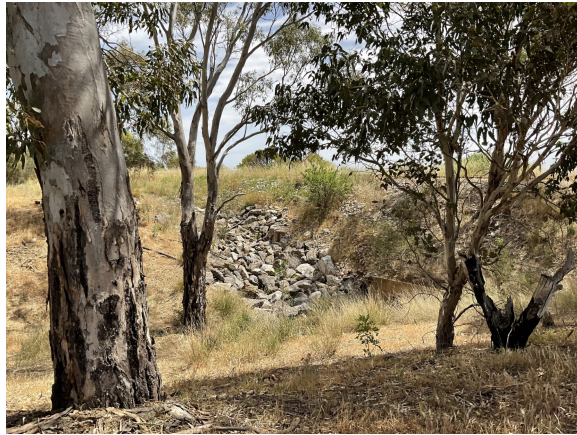
21/11/2024

Surface Water: Surface water discharge area within MPL 118.

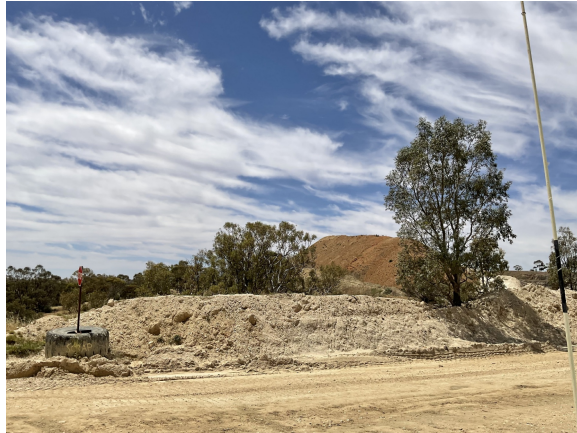
21/11/2024

Rehabilitation: Overburden mound within PM 120 to screen views of operations and working faces.

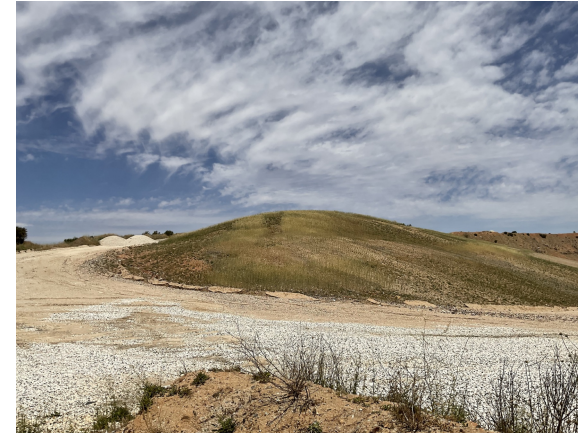
21/11/2024

Rehabilitation: View of recent rehabilitation - eastern overburden dump. Recent re-seeding efforts preventing dust generation.

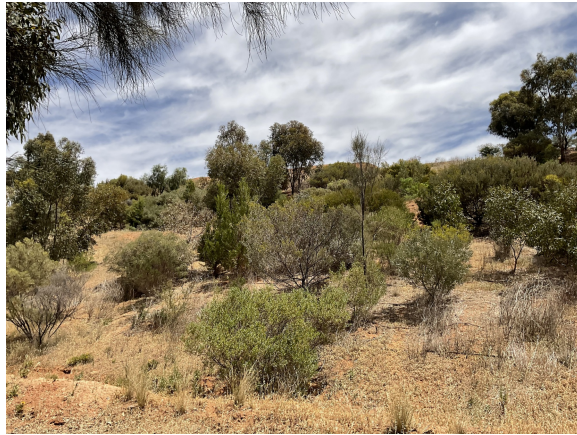
21/11/2024

Rehabilitation: Planted vegetation within north-western boundary of Site (MPL 118).

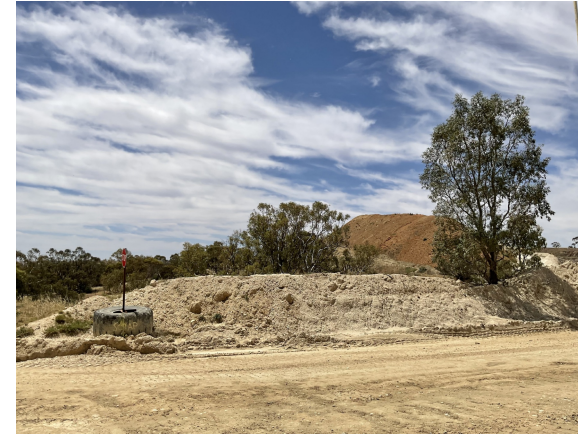
21/11/2024

Stockpile 2: Stockpile 2 located in the north-west corner. Some vegetation growth with no significant evidence of erosion or weeds.

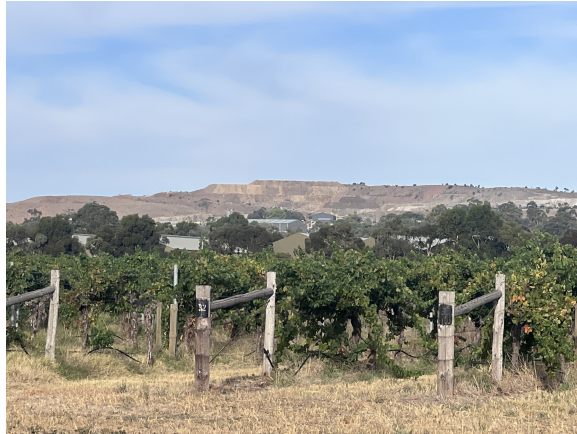
13/06/2024

Station 1: View from Light Pass Road prior to commencement of rehabilitation activities (4 March 2024).

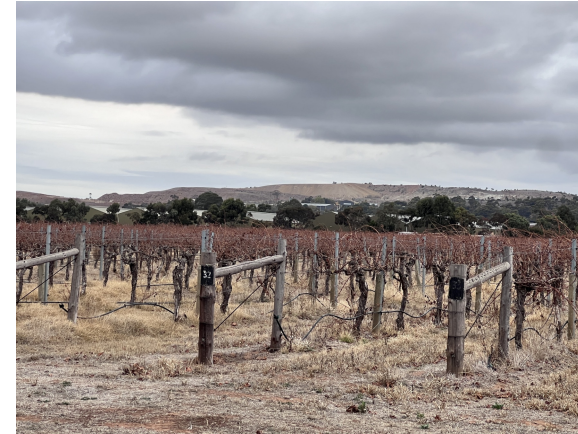
13/06/2024

Station 2: View from Light Pass Road following completion of rehabilitation activities (13 June 2024).

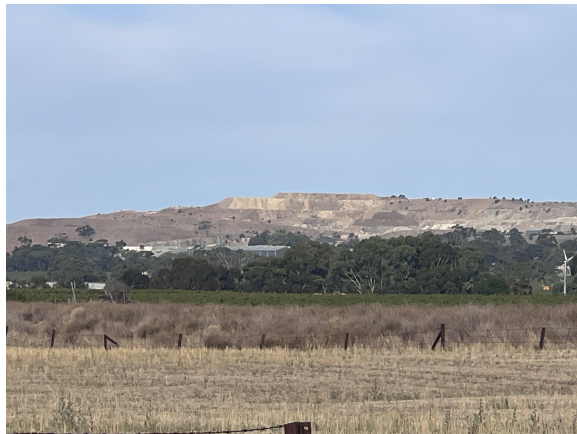
13/06/2024

Station 3: View from Research Road prior to commencement of rehabilitation activities (4 March 2024).

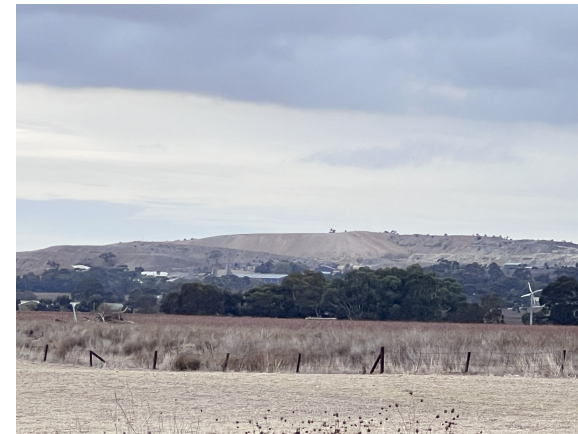
13/06/2024

Station 4: View from Research Road following completion of rehabilitation activities (13 June 2024).

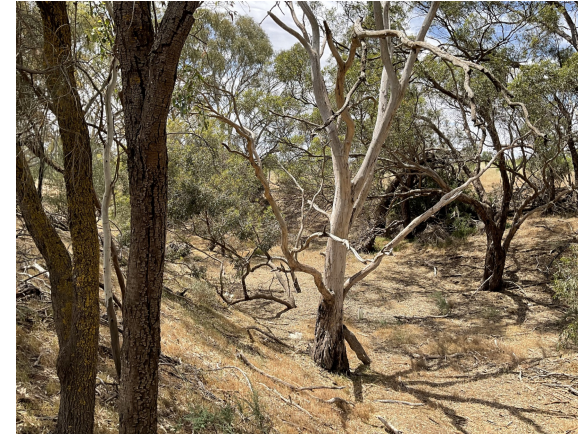
21/11/2024

Photo Point 1: Facing east along Jaeckeli Creek. No vegetation clearance evident.

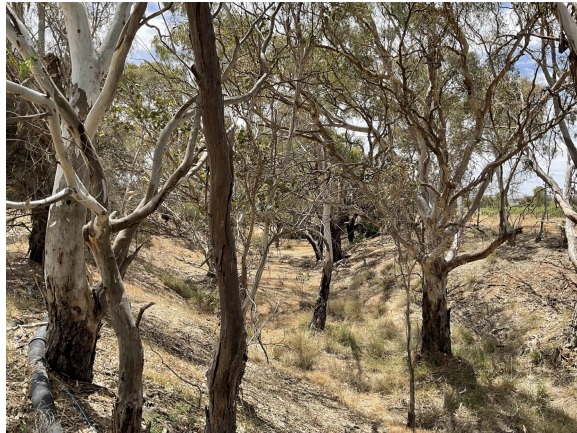
21/11/2024

Photo Point 1: Facing west along Jaeckeli Creek from Photo Point 1. No evidence of vegetation clearance.

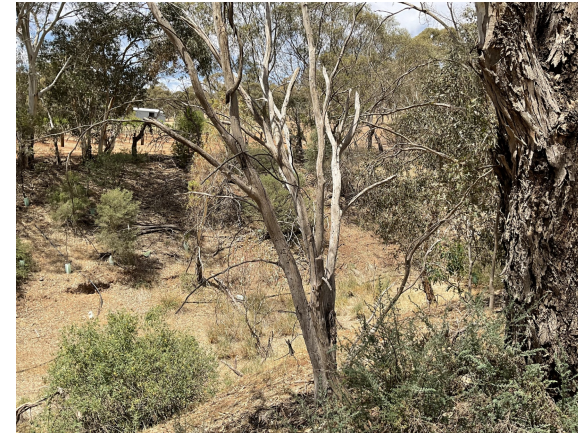
21/11/2024

Photo Point 2: Facing east along Jaeckeli Creek from Photo Point 2. New growth evident. No vegetation clearance.

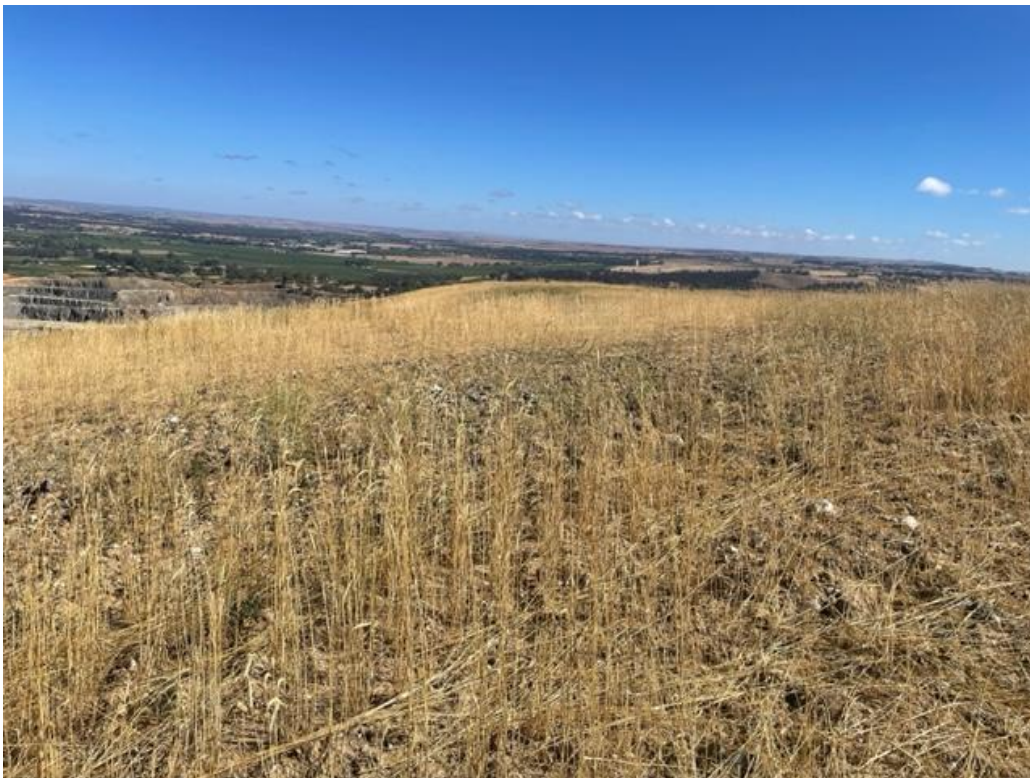
Following major re-structuring of the pit, the topography has undergone significant changes at the eastern end of the site. This creates potential issues including water and wind erosion. This has been mitigated to an extent by creating a lower gradient than other batters at the site. In 2024 hand seeding of up to 350kg of ryecorn and oats was undertaken to promote prompt ground cover and increase soil structure to help combat erosion potential (*see figure 2*). Ryecorn is commonly utilised in the Mallee regions of agricultural South Australia to help prevent wind erosion on sandhills. This area is pencilled in for future rehabilitation via additional hand seeding and tree planting with an expectation of 1000-2000 plantings. Hydroseeding is another potential pathway of increasing vegetation, organic matter, and soil surface stability and will be looked at.

Figure 2 – highlighting the excellent vegetative groundcover achieved by seeding oats and ryecorn

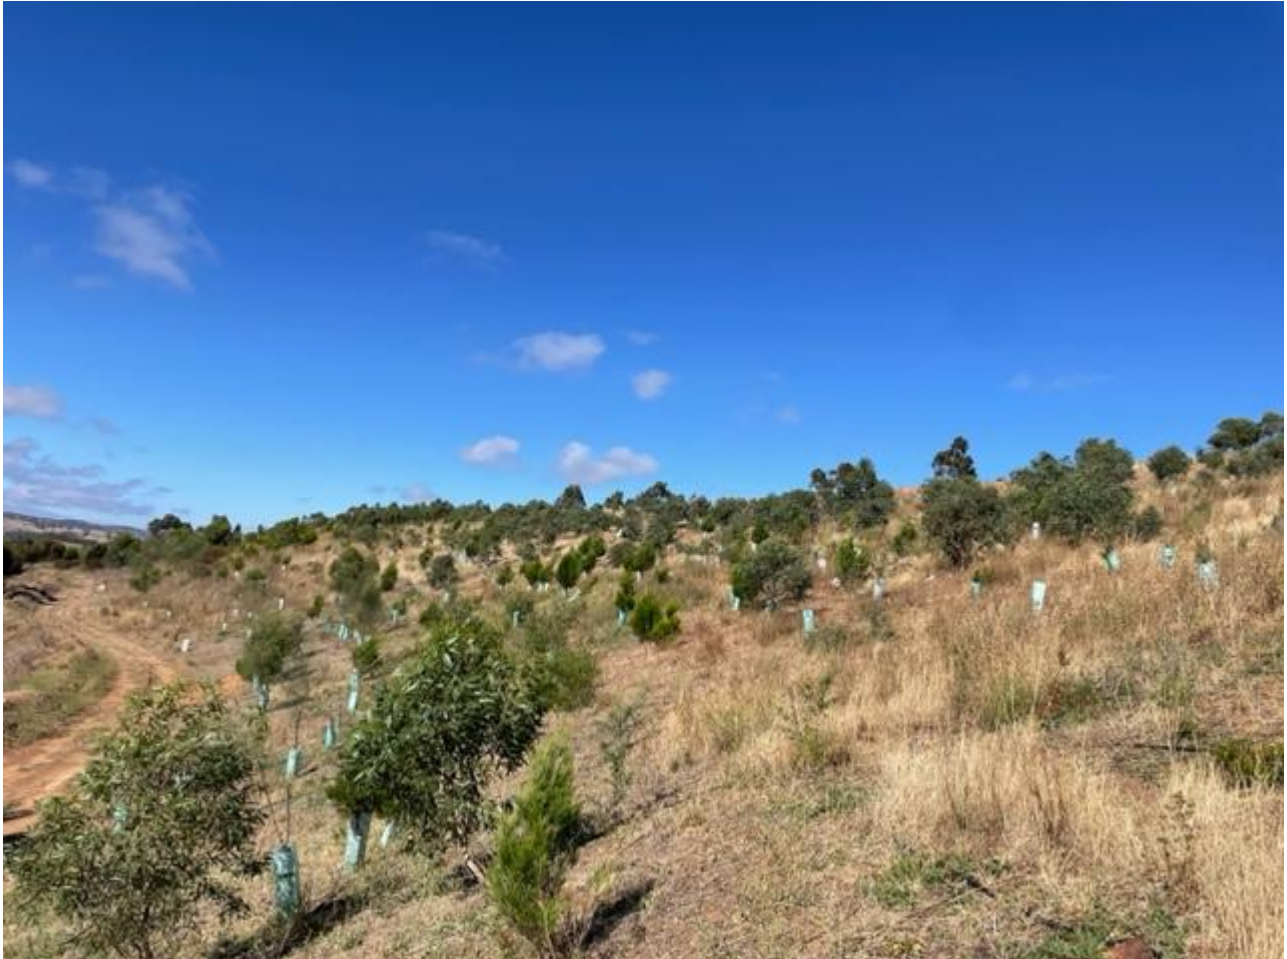
Extensive maintenance and repair of irrigation line across MPL75 has resulted in considerable improvement in the overall health and growth of the juvenile shrubs and trees that populate the area. The trees were mostly planted throughout the 2020 to 2021 period and due to poor irrigation establishment, they had exhibited poor growth rates and, in some cases, death. In 2024, 600 native trees were planted across the MPL75 area to replace previous failed plantings and to further promote the areas revegetation development.

Figure 3 – establishment of trees planted at MPL75 over the past four years

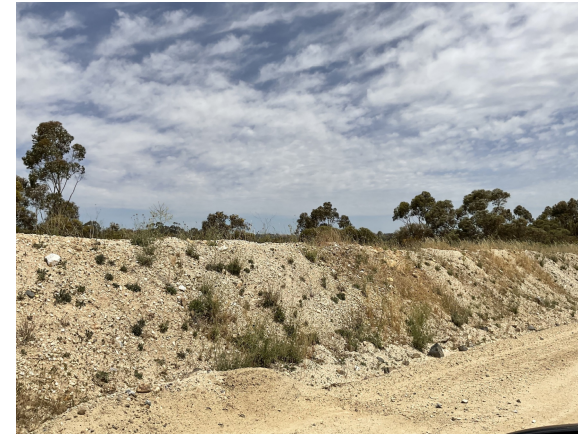
21/11/2024

Some tree tobacco (*Nicotiana glauca*) (environmental weed) individuals were noted to be scattered around the walls of the Site, particularly above haul roads. Many of the individuals were inferred to have been established during the previous reporting period, due to their size. Tree tobacco was noted within the previous assessment in isolated patches. No significant increases in abundance were noted, and no spread onto adjacent properties was observed during the inspection. Removal / treatment by a suitably qualified third-party is recommended to prevent further spread.

Photo 3: Photo facing north from north eastern corner of PM 120. Some tree tobacco individuals noted on benching. Weeds on landscape outside of disturbed area generally limited to annual grasses with dieback present.

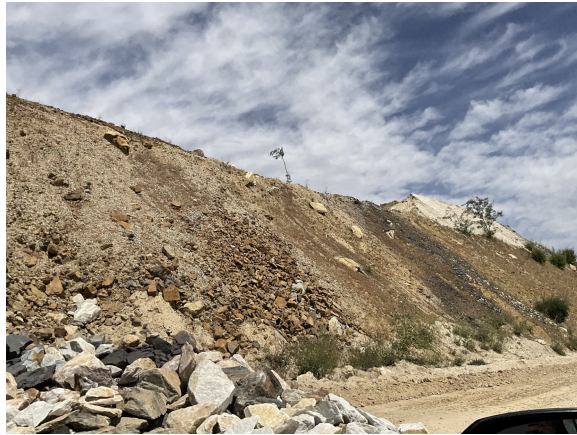
21/11/2024

Photo 4: Perimeter bunding along southern edge of PM 120. Weeds generally limited to annual grasses with dieback evidence.

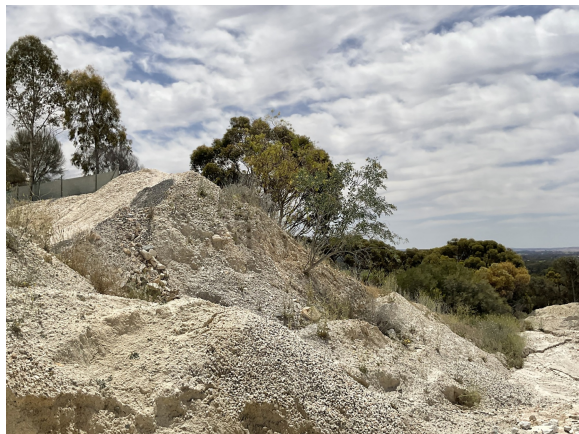
21/11/2024

Photo 7: View facing south from Jaekeli Creek in MPL 118. Evidence of weed dieback. Weeds generally limited to annual grasses.
