SELLICKS HILL QUARRY (EML 5440, PM 163 & PM 237)

Annual Compliance Report

Date: October 2024

Report period: 31/08/2023 – 30/08/2024

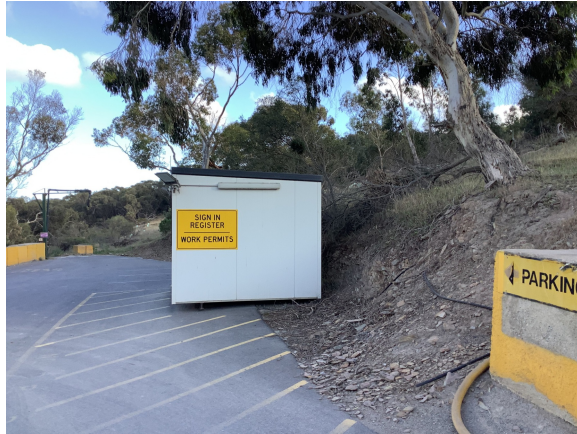
24/10/2024

General Observations / Other: Site sign-in office.

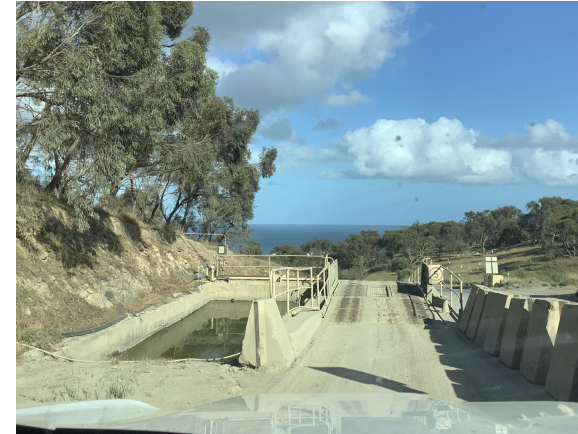
24/10/2024

General Observations / Other: Rumble grid at Site exit point and sediment dam to prevent surface water discharge onto Main South Road.

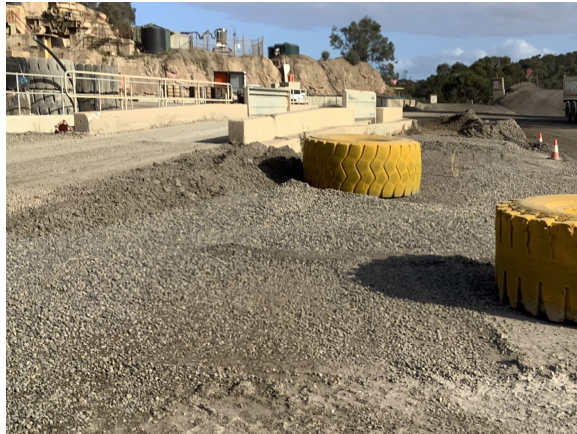
24/10/2024

General Observations / Other: Wheel wash.

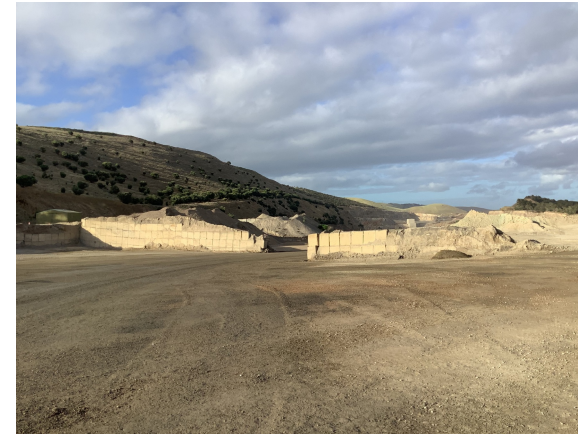
24/10/2024

General Observations / Other: General Site views of product stockpiling area.

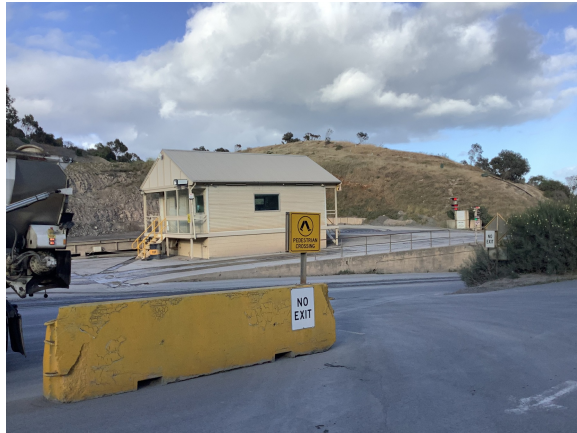
24/10/2024

Public Safety: View of signage onsite and weighbridge.

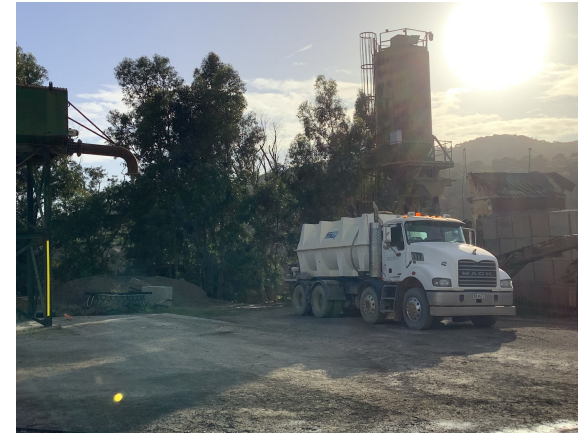
24/10/2024

Dust: Water truck present onsite.

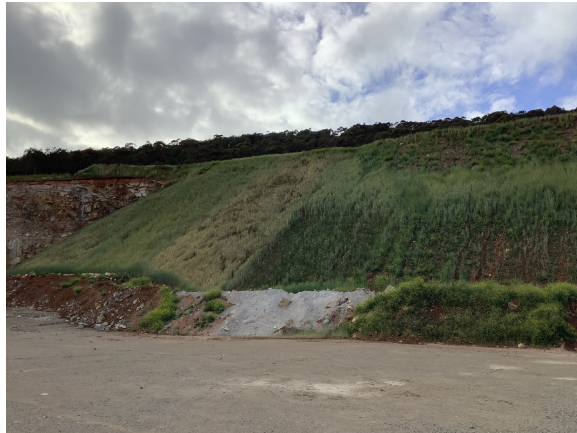
24/10/2024

Dust: Re-seeding (progressive rehabilitation) of disturbed areas to prevent dust and erosion.

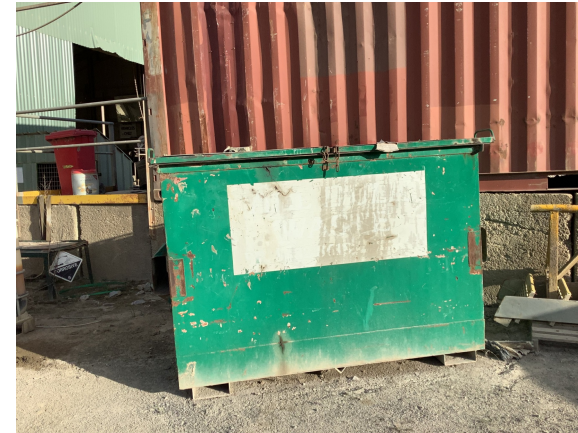
24/10/2024

Waste & Hydrocarbon Management: General waste bin.

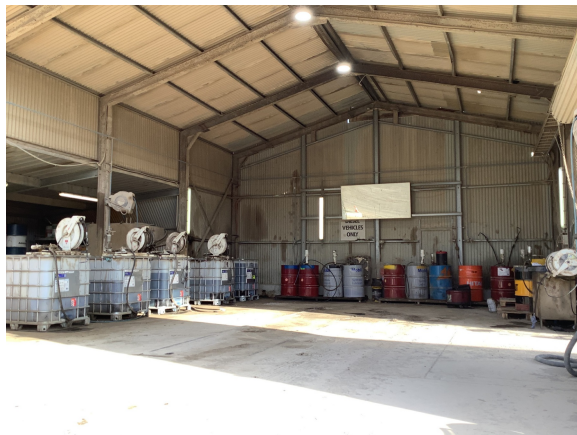
24/10/2024

Waste & Hydrocarbon Management: View of oil storage shed.

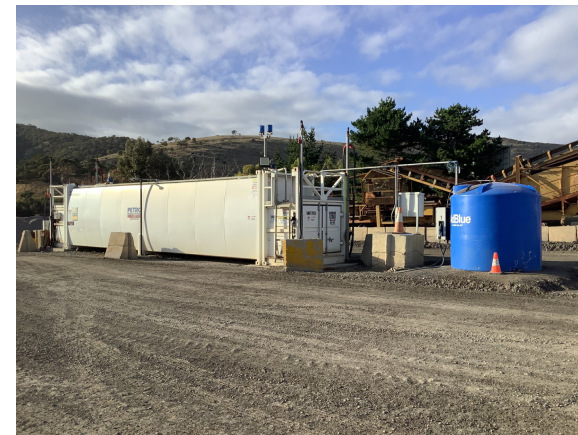
24/10/2024

Waste & Hydrocarbon Management: Self-bunded fuel tank located onsite.

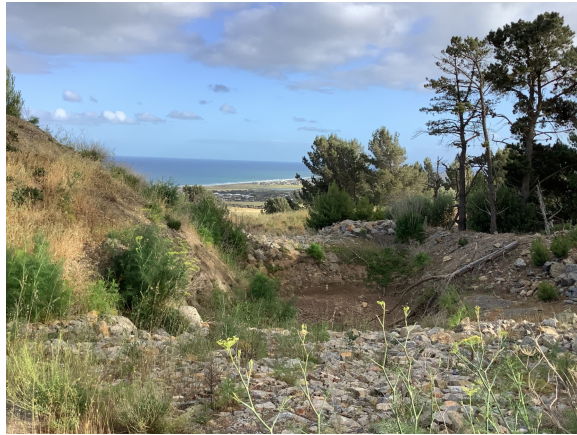
24/10/2024

Erosion, Sediment and Stormwater Management: Western sediment dam.

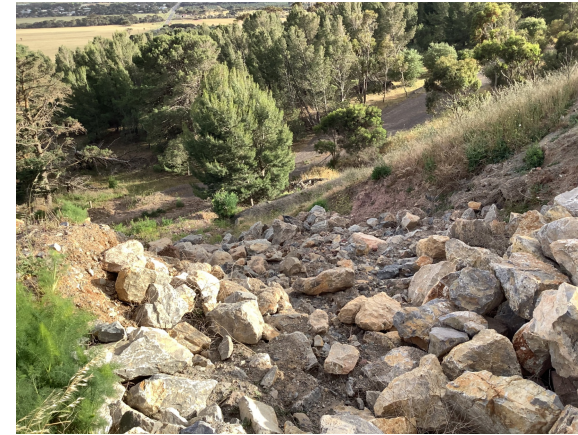
24/10/2024

Erosion, Sediment and Stormwater Management: Surface water bund.

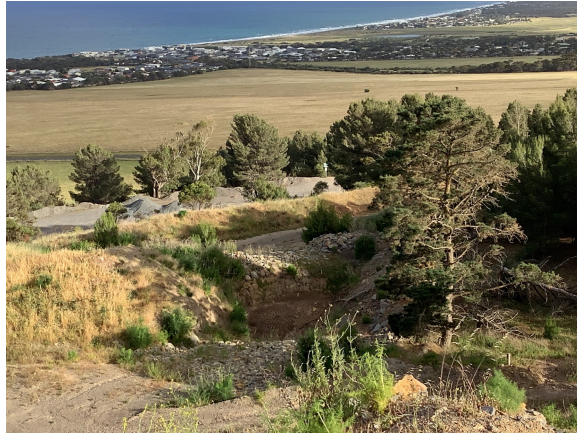
24/10/2024

Erosion, Sediment and Stormwater Management: Western sediment catchment.

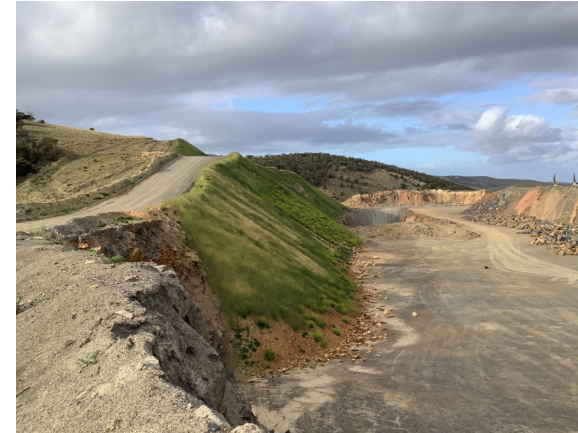
24/10/2024

Erosion, Sediment and Stormwater Management: Haul road sloping / bunding well-vegetated to prevent erosion.

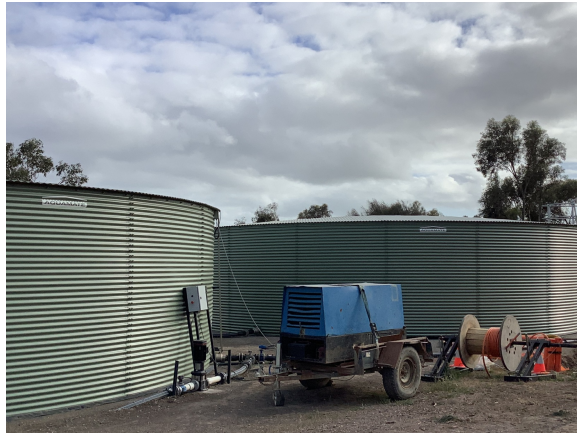
24/10/2024

Erosion, Sediment and Stormwater Management: Water tanks installed during the reporting period to manage water supply issues as a result of Mina South Road upgrades and boost water reliability.

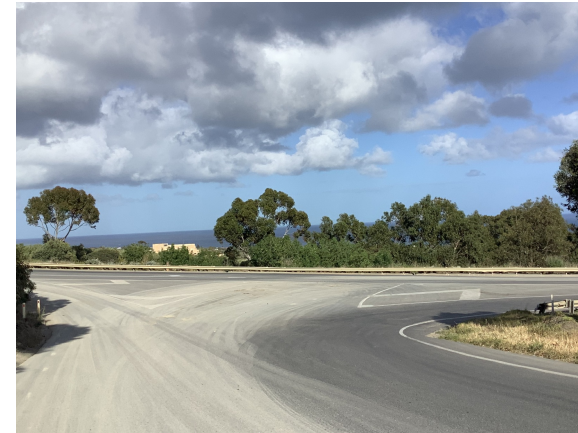
24/10/2024

Traffic: Main intersection / Site entrance showing minimal drag out and no obstructions.

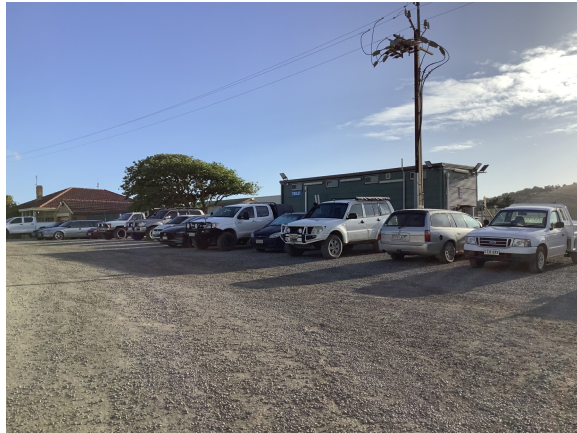
24/10/2024

Traffic: Site personnel light vehicle carpark and main Site office.

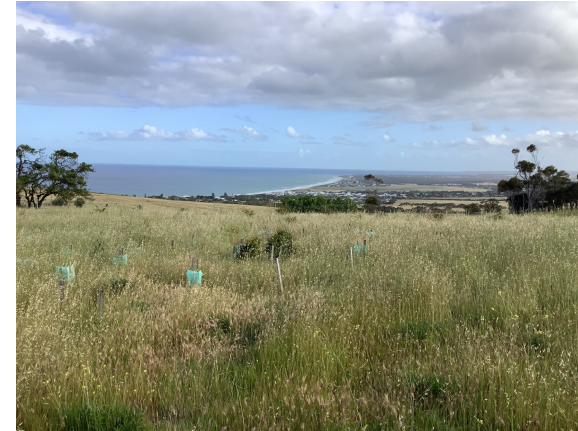
24/10/2024

Native Vegetation: Evidence of rehabilitation in PM237.

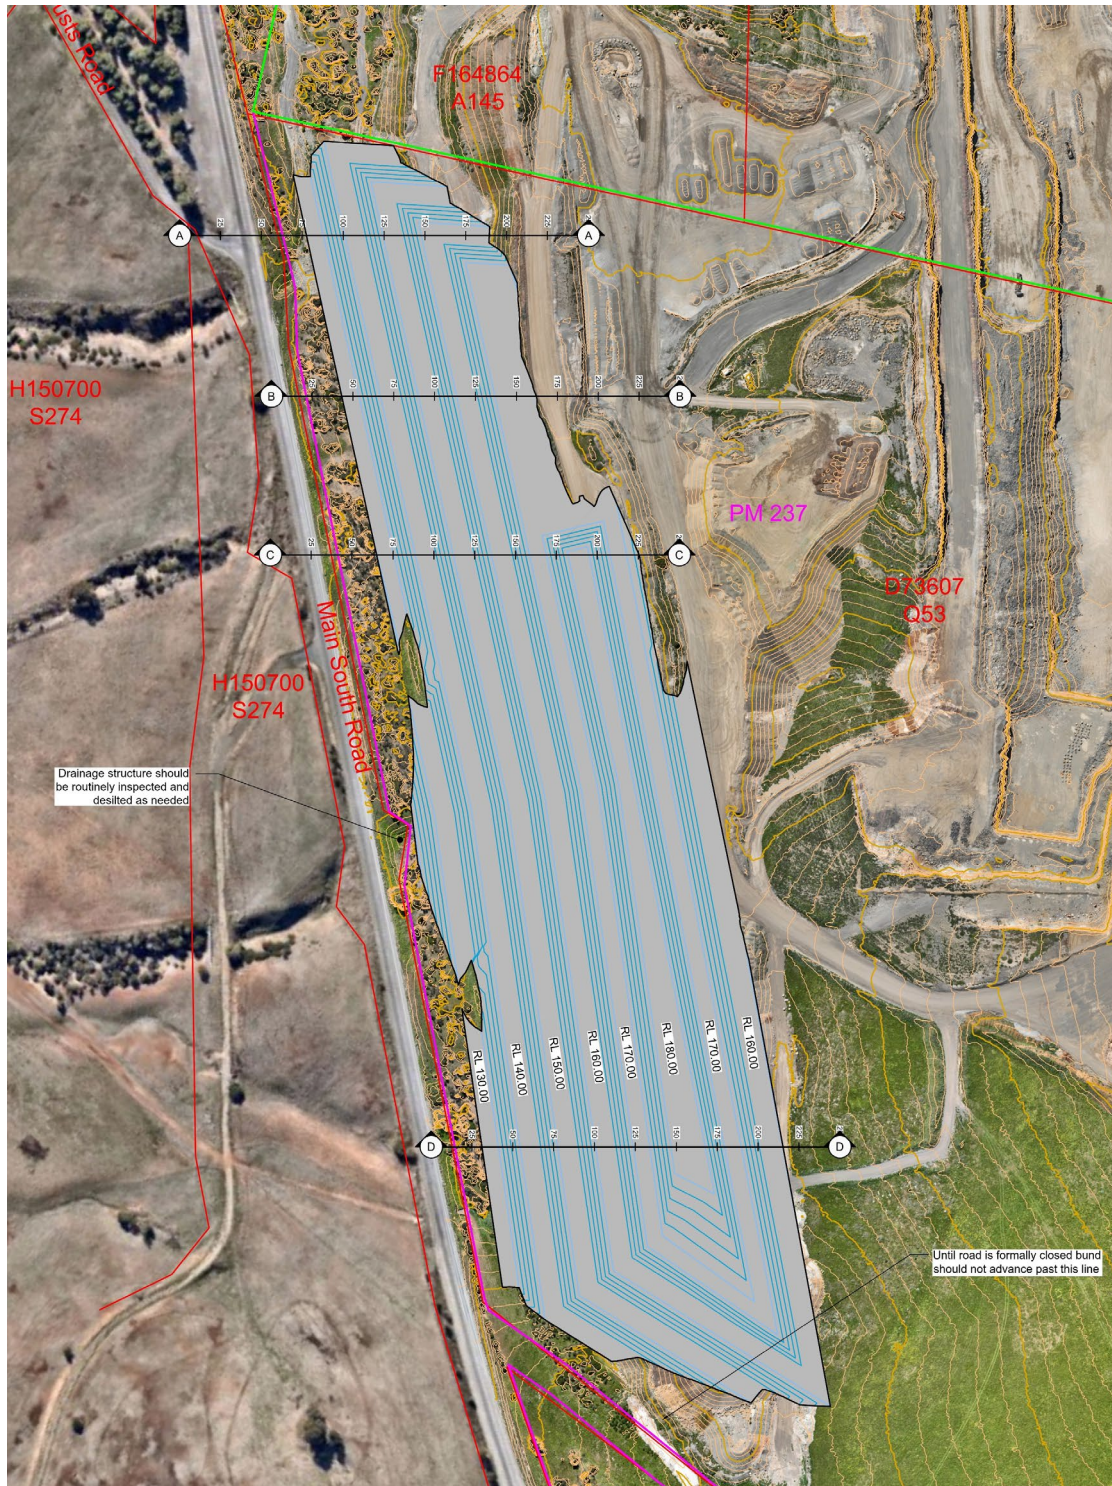
Figure 15: Western Screening Mound cross sections location plan.

Cross-sections have been taken through the Western Screening Mound to assess compliance with the approved structural design as outlined in the MOP PEPR; refer to **Figure 15**.

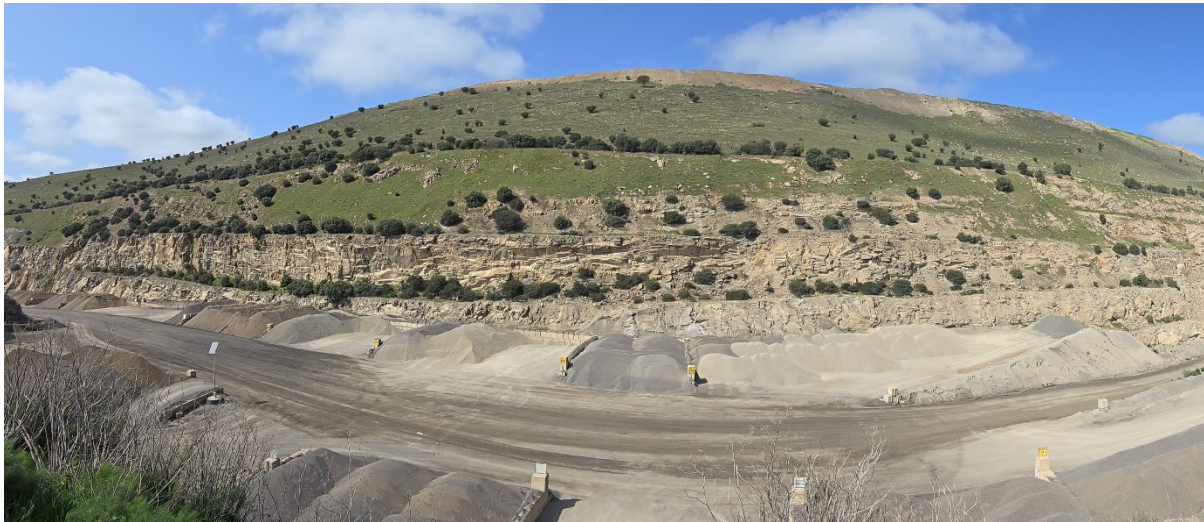
View from Station 2

A few minor rock falls were observed as identified by the red circle polygons. Some larger and cluster of rock falls can be observed in the larger red Polygon on the right hand side, which is discussed further in Station 3 observations. The upper bench and Hillside have large, vegetated areas which show deformation (Cut/Fill) in the heatmap as identified within the green polygon. This is due to vegetation growth over the period and may not be attributable to movement.

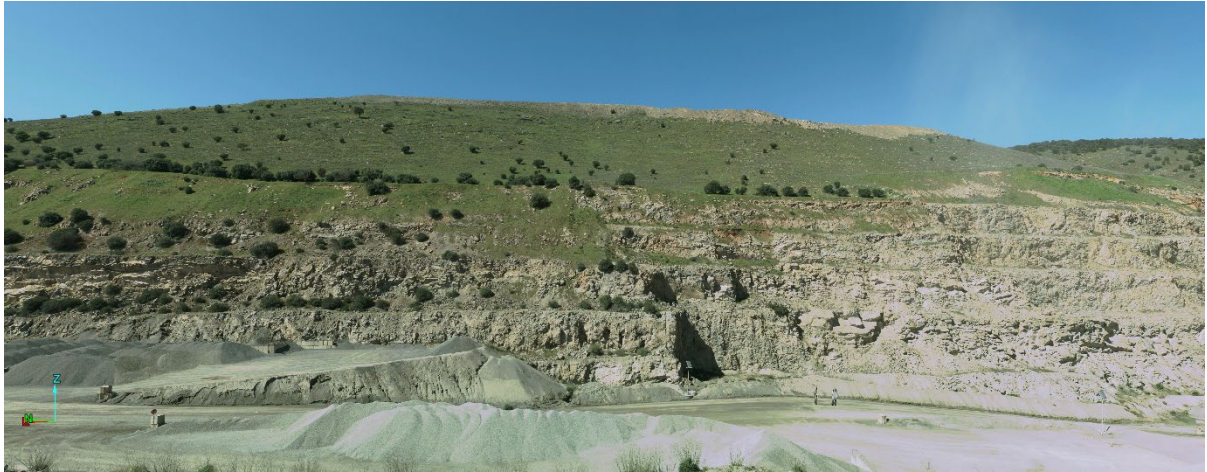
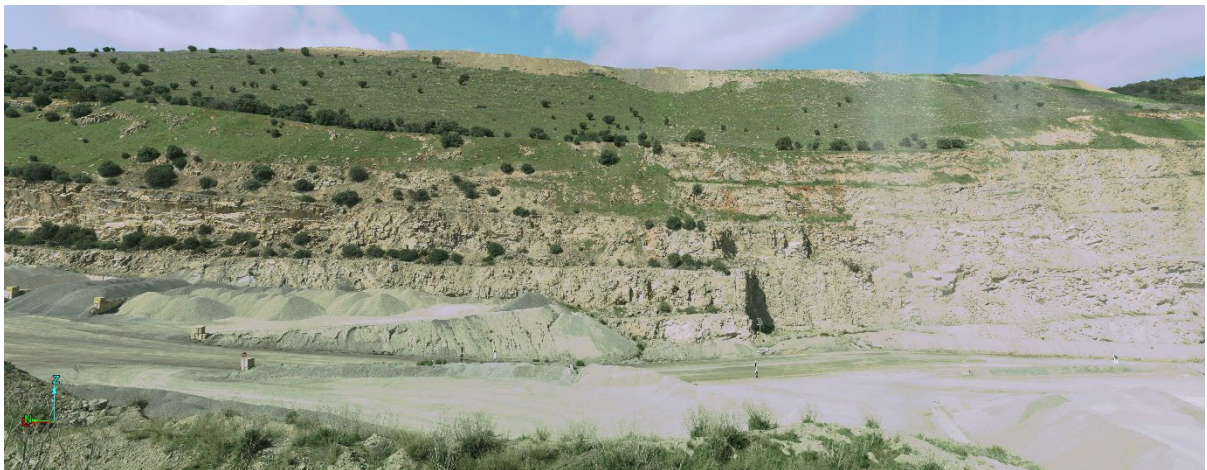
View from Station 3

A few minor rock falls were observed as identified by the red circle polygons. Within area 1 – ST3, there were a number of rock falls observed across multiple benches. These rock falls are occurring in an area where walls exhibit loose and disjointed masses of rock. This area is shown in more detail below. The upper bench and Hillside have large, vegetated areas which show deformation (Cut/Fill) in the heatmap as identified within the green polygon. This is due to vegetation growth over the period and may not be attributable to movement.

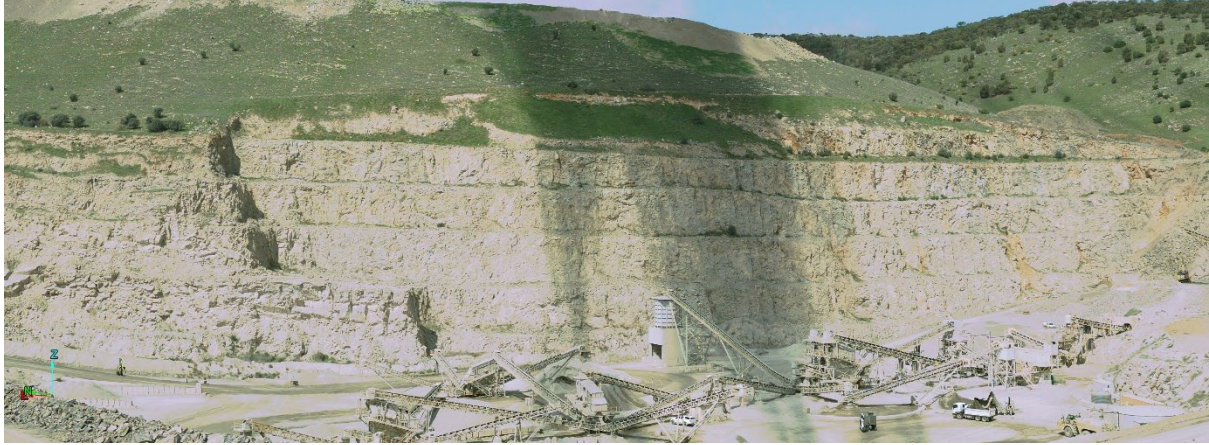
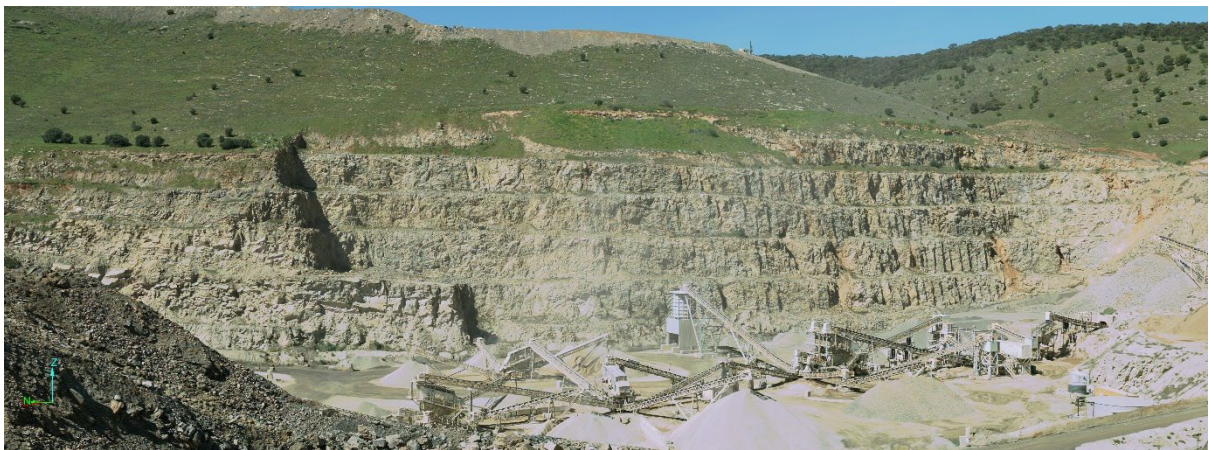
View From Station 4

A few minor rock falls were observed as identified by the red circle polygons. Some scouring is occurring within the yellow Polygons, likely from water erosion. This was also observed in the last deformation scan report. The upper bench and Hillside have large, vegetated areas which show deformation (Cut/Fill) in the heatmap as identified within the green polygon. This is due to vegetation growth over the period and may not be attributable to movement.

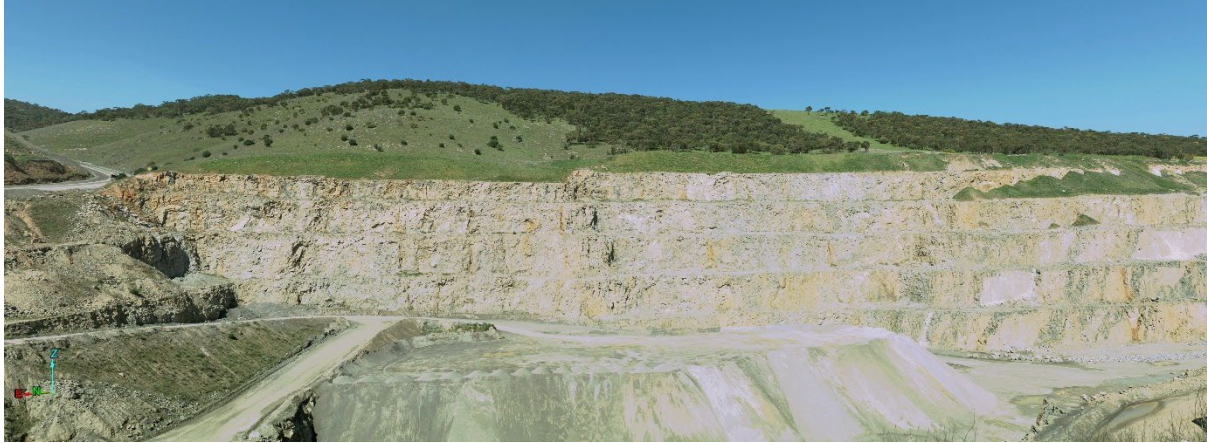
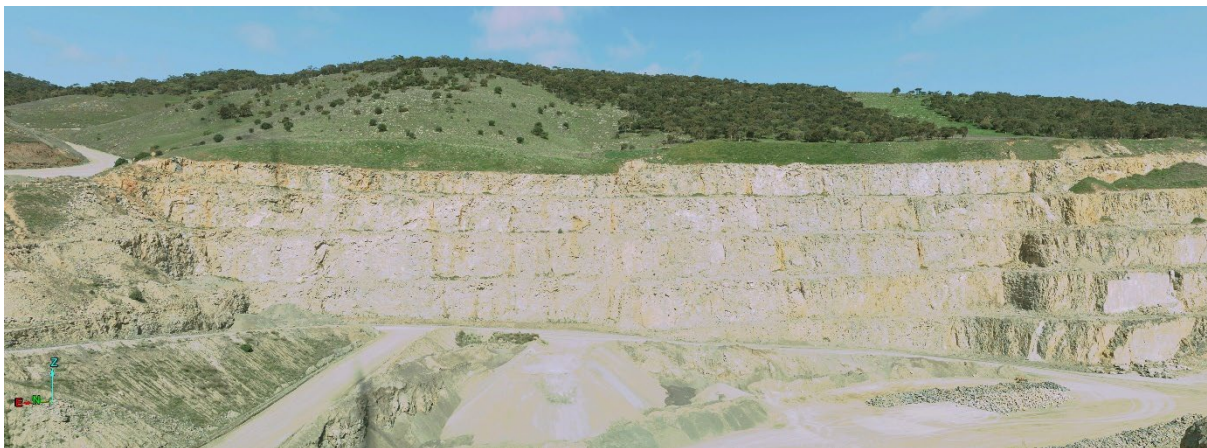
View from Station 5

A few minor rock falls were observed as identified by the red circle polygons. The upper bench and Hillside have large, vegetated areas which show deformation (Cut/Fill) in the heatmap as identified within the green polygon. This is due to vegetation growth over the period and may not be attributable to movement.

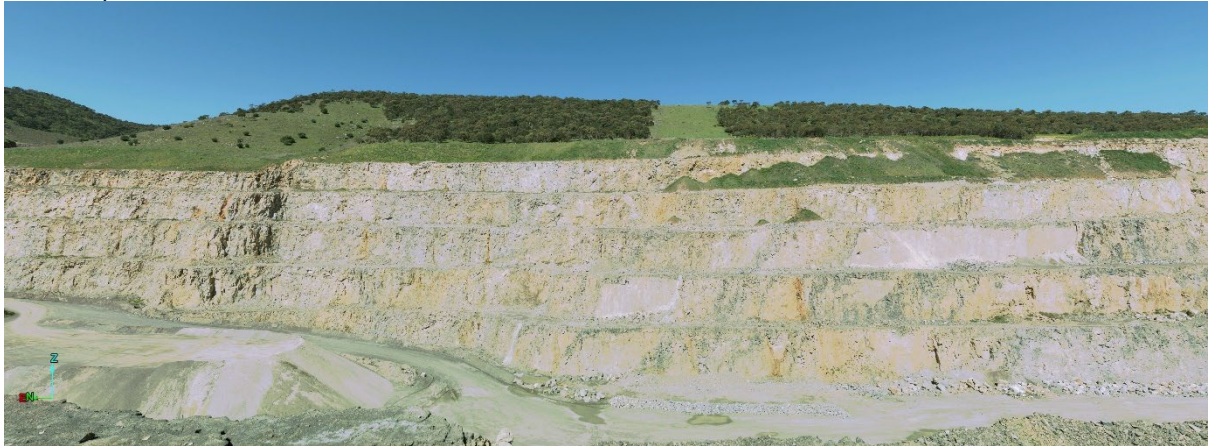
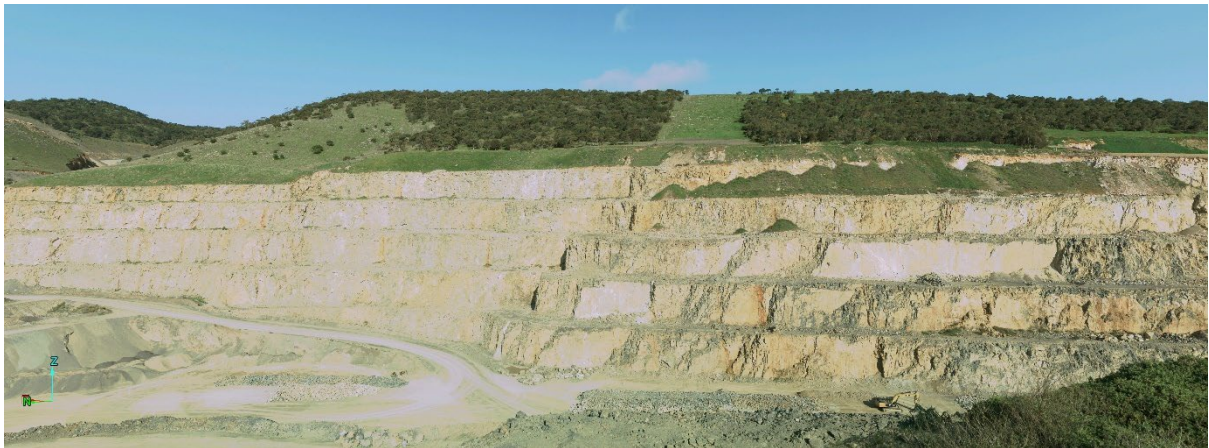
View from Station 6

A few minor rock falls were observed as identified by the red circle polygons. The upper bench and Hillside have large, vegetated areas which show deformation (Cut/Fill) in the heatmap as identified within the green polygon. This is due to vegetation growth over the period and may not be attributable to movement. A slump is seen to be occurring on the southern end of a fill embankment, identified by the blue polygon.

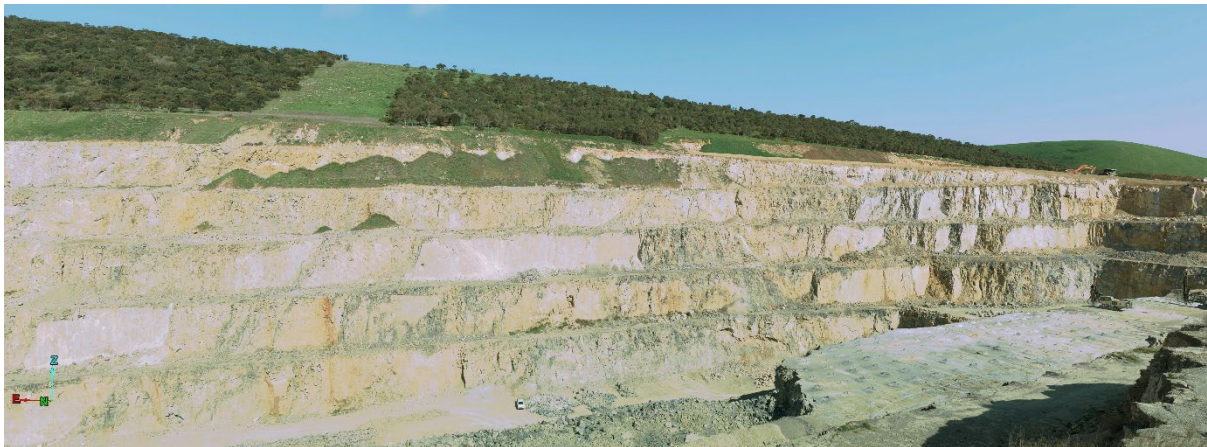
View from Station 7

A few minor rock falls were observed as identified by the red circle polygons. Rockfall appears more frequent within the southern end of the pit which is likely as a result of blasting impact. The upper bench and Hillside have large, vegetated areas which show deformation (Cut/Fill) in the heatmap as identified within the green polygon. This is due to vegetation growth over the period and may not be attributable to movement. A slump is seen to be occurring on the southern end of a fill embankment, identified by the blue polygon.

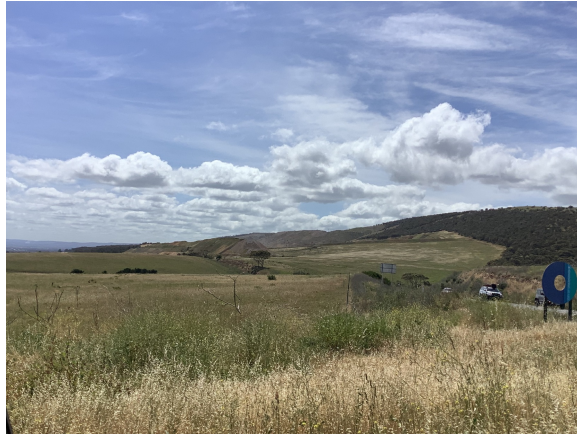
Photo 1: Facing north east along Main South Road. View of visual screening bund but no views of quarry operations.

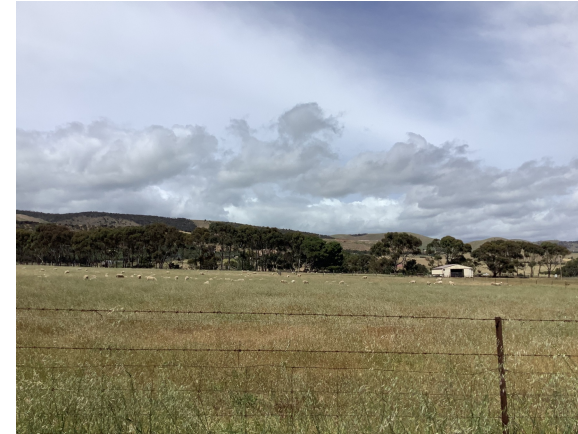
Photo 1: Facing south west towards Main South Road. Minimal views of product stockpiles, but no views of operations.

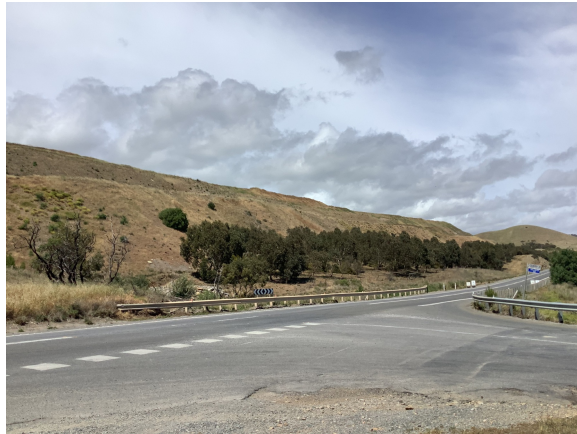
Photo 2: View from intersection of Country Rd and Main South Rd intersection facing South. No views of quarry operations or working faces.

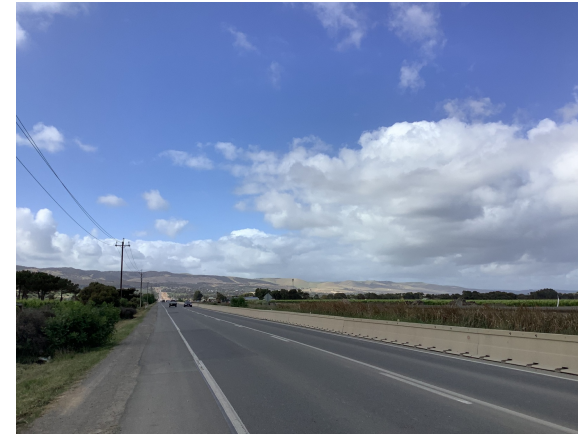
Photo 3: Views facing South from Main South Road. Minimal views of quarry faces / product stockpiles but no views of quarry operations.

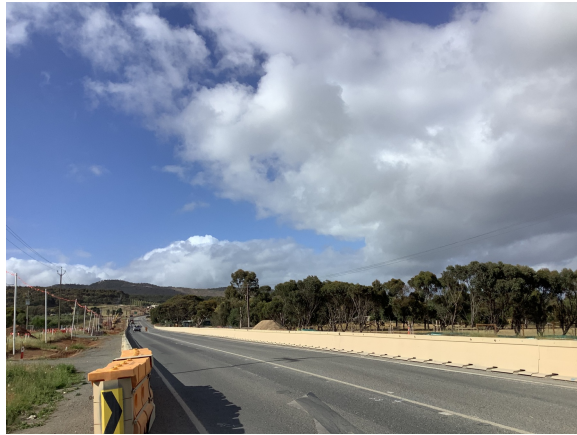
Photo 5: Views facing South on Main South Road. Road vegetation effectively screening operations.

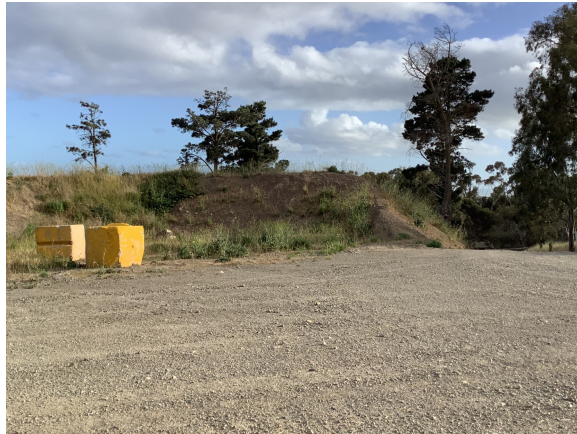
Photo 6: Visual amenity bunding and tree screening south-west of the residence in EML 5440. Residence is effectively screened from Site operations.

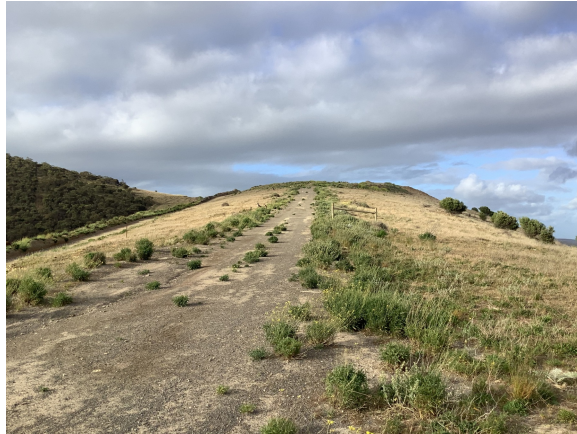
24/10/2024

Weeds and Pests Photo Location 1: Minor weed presence.

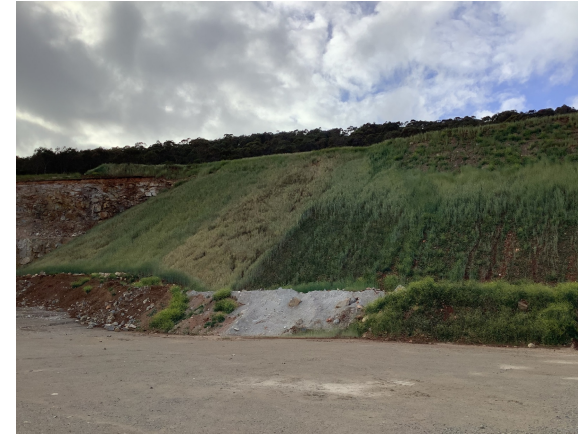
24/10/2024

Weeds and Pests Photo Location 2: Evidence of Rye Grass seeding.

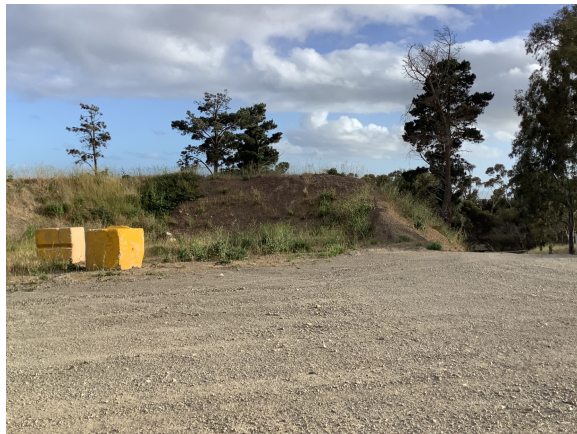
24/10/2024

Weeds and Pests Photo Location 3: Minor weed presence.

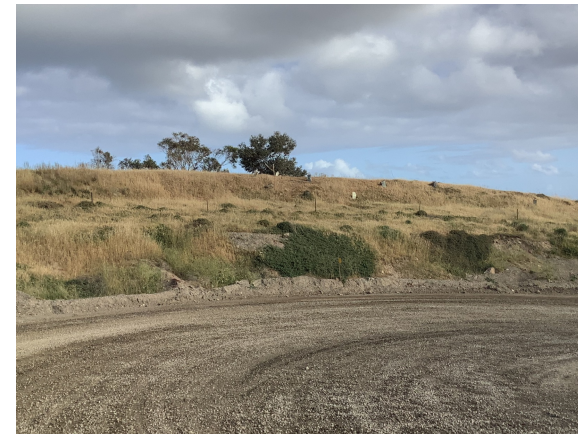
24/10/2024

Weeds and Pests Photo Location 4: Minor weed presence.

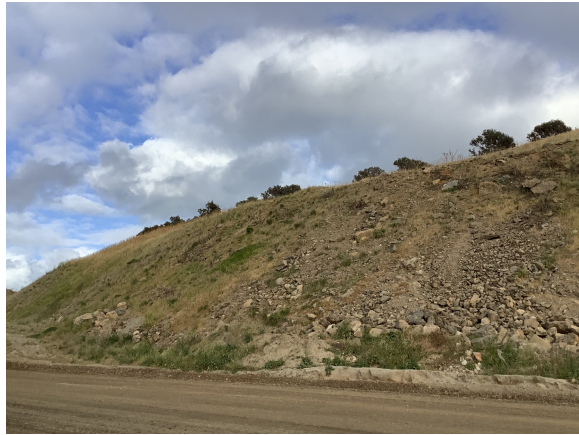
24/10/2024

Weeds and Pests Photo Location 5: Minor weed presence.

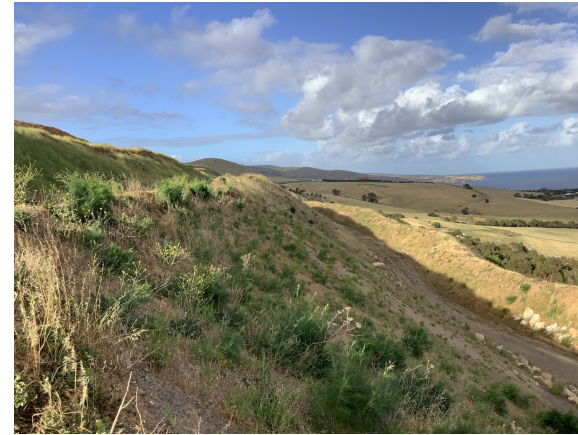
24/10/2024

Weeds and Pests Photo Location 6: Minor weed presence.

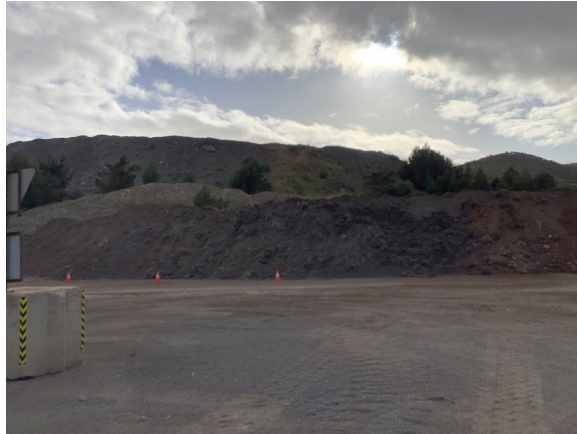
24/10/2024

Topsoil Stockpile Inspection: Topsoil stockpile. Free from weeds.
